## **Arboricultural monitoring report**

**5-9 BERKELEY AVENUE, READING, RG1 6EL**

**Site visit undertaken on the 20 January 2020**

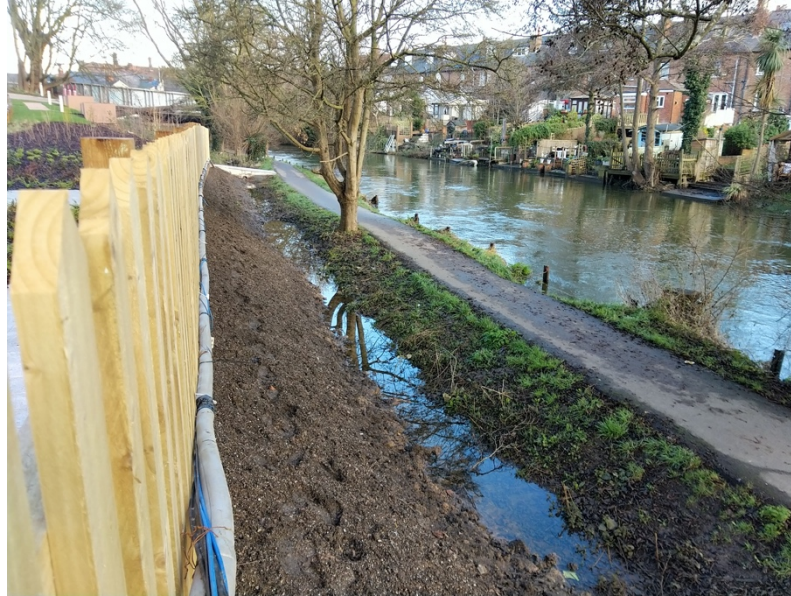
*Photo 1: The image shows the area of the completed landscape works on the eastern boundary and the retained offsite tree on the river path.*

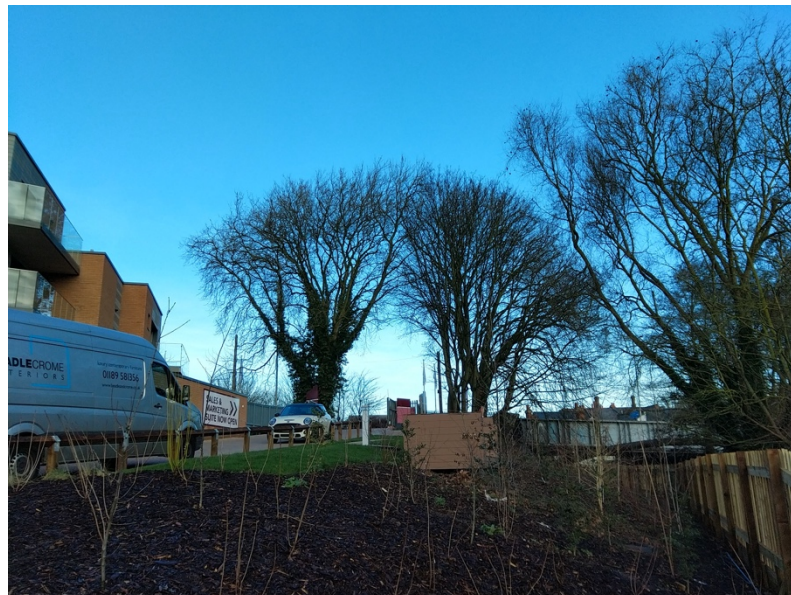
*Photo 2: The image shows the retained trees at the northern entrance. All work here is now completed and the trees were observed to be in a good condition with a high bud density and good extension growth from the previous growing season.*

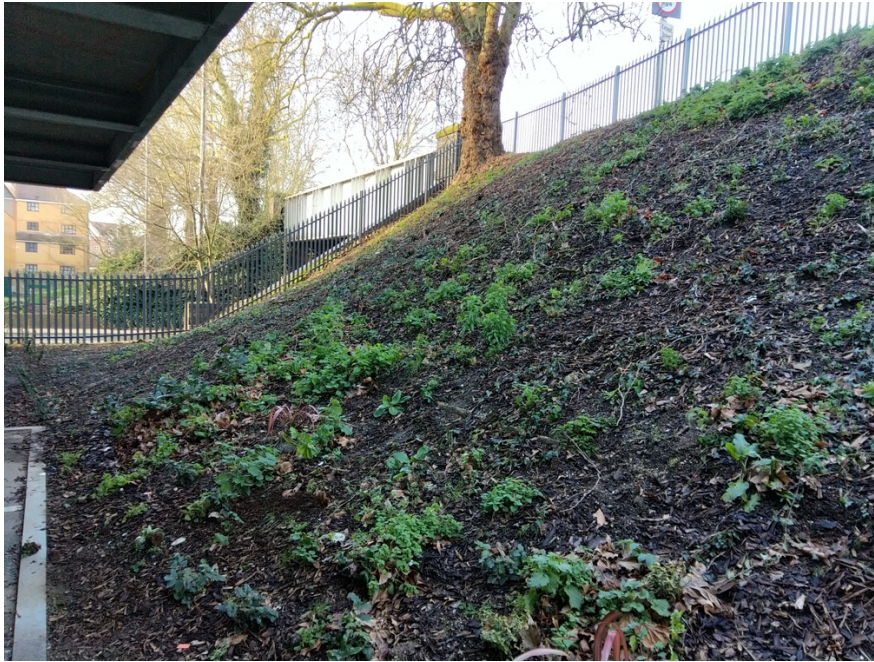
*Photo 3: showing the completed soft landscape works on the northern embankment adjacent T1. These works were completed without any impacts upon the retained tree. The tree was observed to be in a good condition with a high bud density and good extension growth from the previous growing season.*

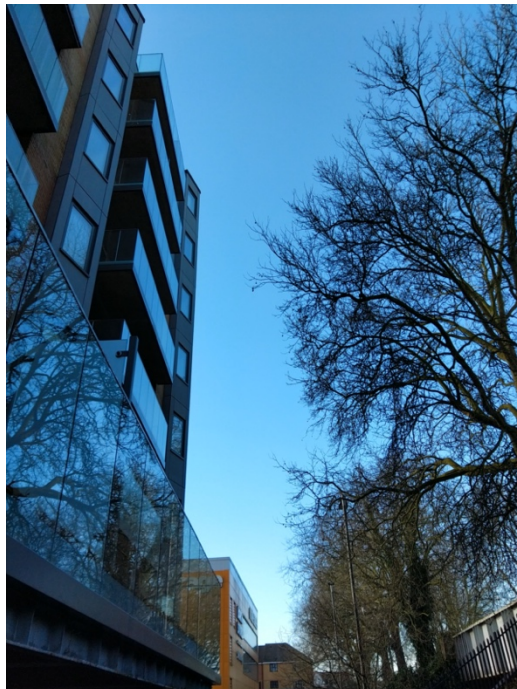
*Photo 4: showing the clearance between the northern elevation the finished building and T1 now that the scaffold has been removed.*
