5-9 BERKELEY AVENUE, READING, RG1 6EL

Planning Reference: 181640

*'Application for approval of landscaping details reserved by condition 7 of permission 101656/EXT (10/01567/EXT) as allowed on appeal ref. APP/E0345/A/11/2151515/NW'*

10 April 2019

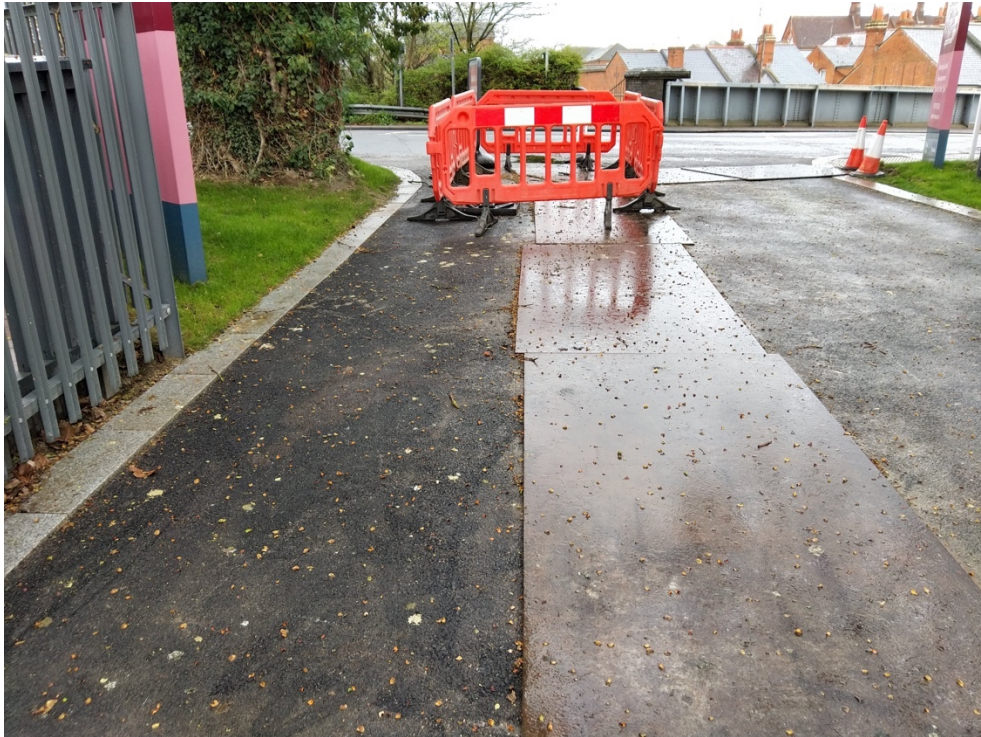
I carried out a visual inspection of the area which revealed the trench had been excavated and the final wearing course of the adjacent road surface installed. The excavated trench had been, in part, backfilled. A one metre section closest to Berkeley Avenue (containing the connection valve) had not been back filled. The wearing course of tarmac had not been installed along the alignment of the trench. The trench was mostly covered by temporary steel road plates making a full inspection of the trench impossible. This can be seen in image 1, overleaf.

Image 1: Looking north towards Berkeley Avenue from within the site. The trench is located beneath the road plates and the subject London Plane is located to the left of frame.

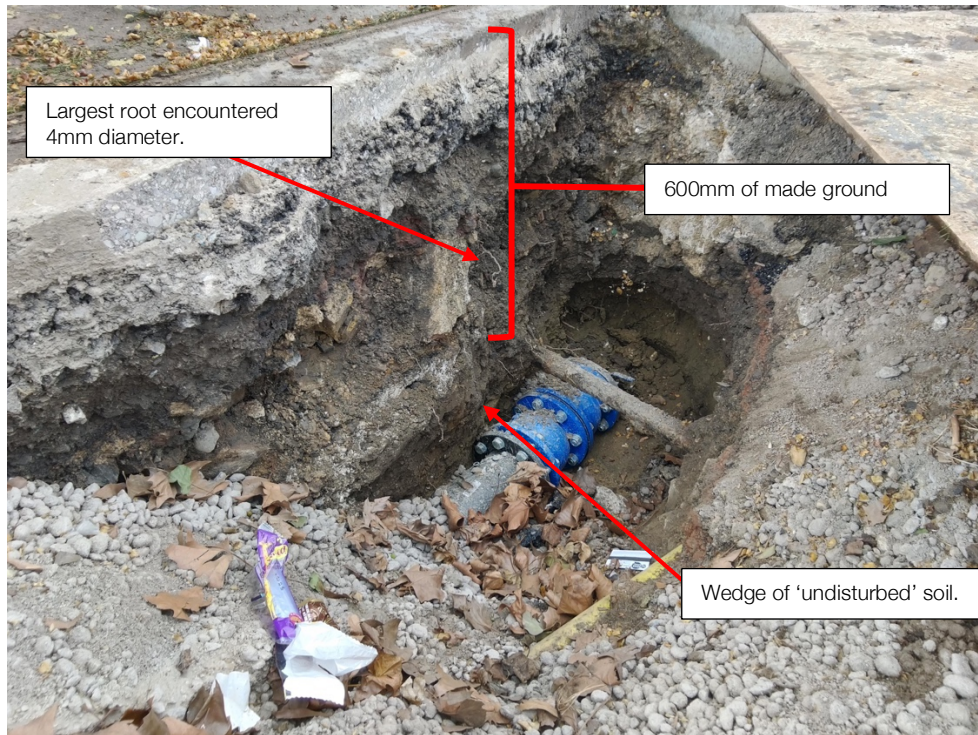
Once the road plates had been removed it was apparent that the section of trench containing the connection valve had not been backfilled. In this part of the trench the made ground was present to a depth of approximately 600mm however the depth of made ground increased as the trench extended further into the site. A wedge of what is believed to be undisturbed (relatively) in situ soil was present adjacent the connection valve itself. In this section of the trench I observed 11 fine roots emanating from the side of the trench closest to the tree. The size of the roots ranged from 1-2mm, however, one 4mm diameter root was also observed. The roots observed were mostly located within the 'undisturbed' wedge of soil adjacent the connection valve. This can be seen in image 2, overleaf.

Image 2: Looking at the western face of the trench excavation adjacent the connection valve.

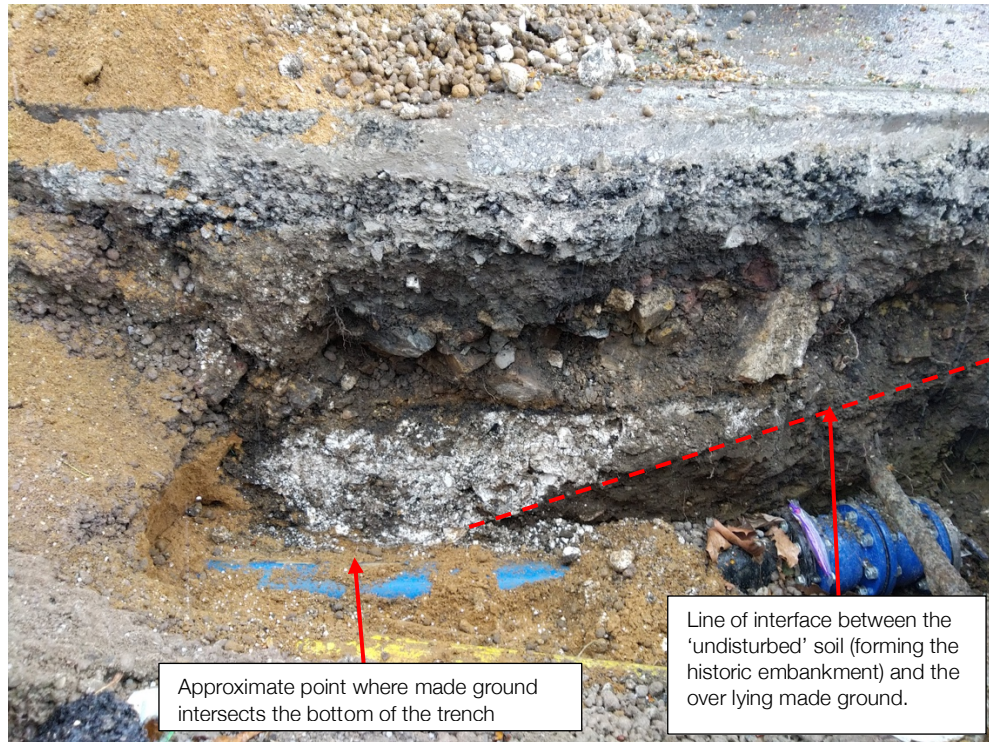
Due to the presence of the apparent undisturbed soil, I requested the trench backfill material be excavated further. In total, approximately 2.5 linear metres of trench backfill was removed. The removal of the backfill material revealed the face of the trench closest to the tree (western) to be formed of made ground. The made ground included mixed aggregates formed of sub-base, broken concrete, tarmacadam and brick fragments. This can be seen in Image 3 overleaf.

Image 3: Looking at the western edge of the trench excavation with the depth of made ground increasing towards the right of frame.

However, at some point in the past a vehicle access was created between the subject tree and the bridge over the River Kennet. I believe the levels within the site were built up using made ground in order to achieve this. This can be seen in Image 3. Given the age of the London Plane, I also believe its primary and structural root system would have established in the soil horizons beneath the made ground (within the former embankment) and this is the reason why no significant roots have been encountered within the trench.
