# Bat Survey Report – Preliminary Roost Assessment

175 Kentwood Hill,  
Tilehurst RG31 6JE

February 2021

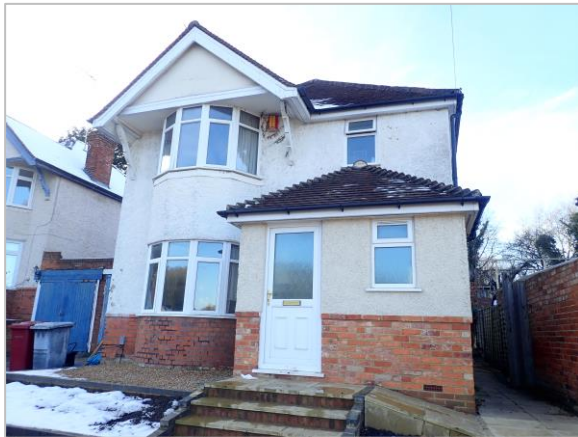
*Photo 1 Front of house*

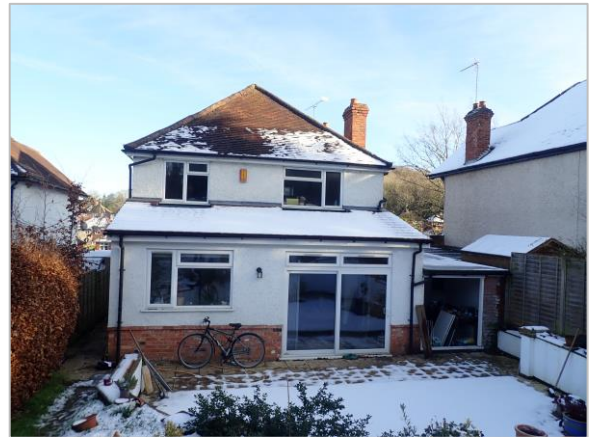
*Photo 2 Rear of house*

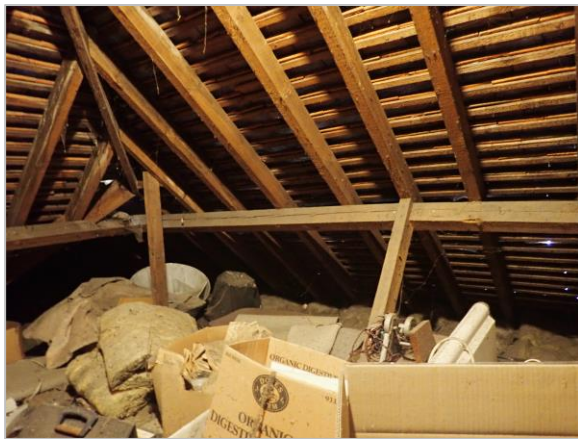
- 3.7. Photos 3 and 4 show the general conditions of the loft. Internally, the loft has a layer of modern glass fibre insulation between the joists, laid over the top of the traditional lath and plaster ceiling of the floor below. There is no lining to the roof tiles and as a result of this, a moderate level of wind-blown dust and debris was noted across all the floor areas and stored household items. However, this was not deep or dense enough to preclude a thorough search of the horizontal surfaces. No bat droppings or other evidence of bat roosting activity was seen in any areas of the loft during this search (Photos 5 to 7).

*Photo 3 General conditions in loft*

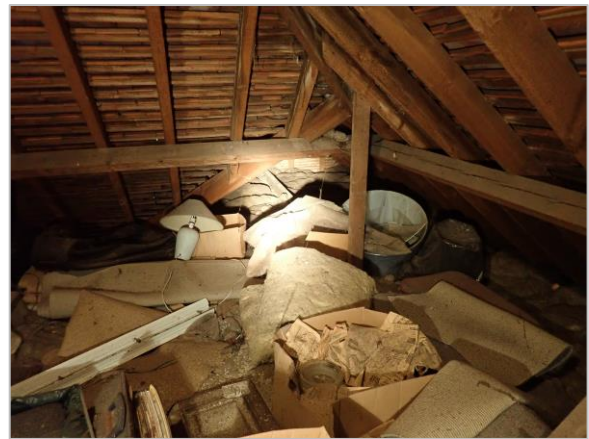
*Photo 4 General conditions in loft*

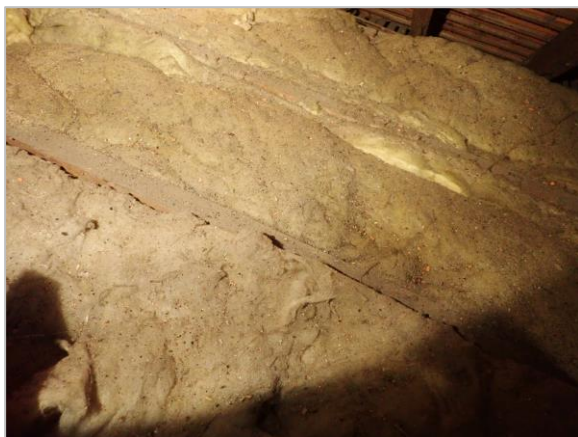
*Photo 5 Loft insulation*

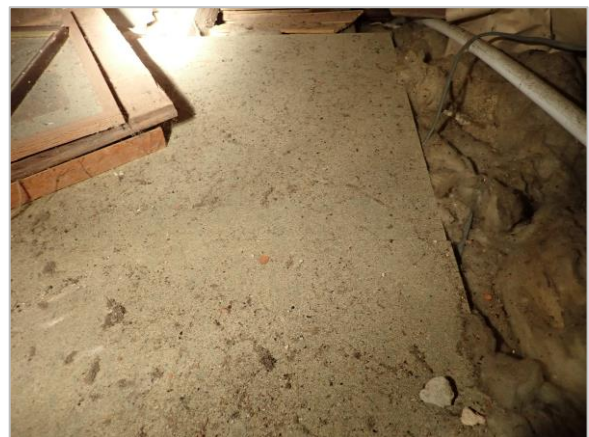
*Photo 6 Loft floor boarding*

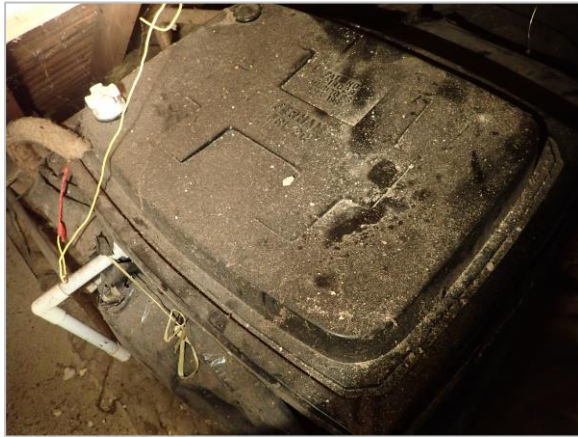
*Photo 7* Top of water tank

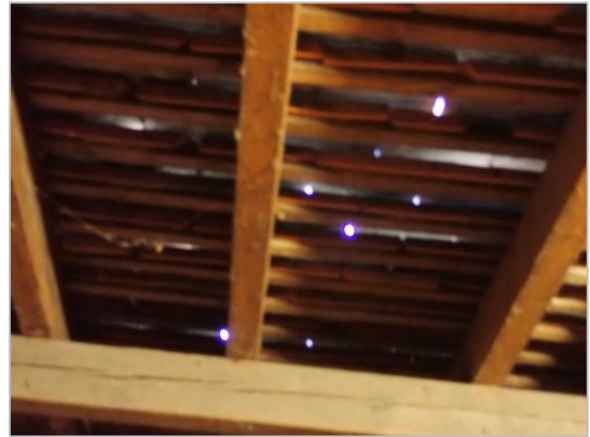
- 3.8. The undersides of the roof tiles are exposed and there are small areas of visible external light through these (Photo 8). However, none of the gaps across the main roof faces appeared large enough to allow bats into the loft and no larger gaps (e.g., >8-10mm) were observed during the loft inspection.

*Photo 8* Small points of light visible between tiles

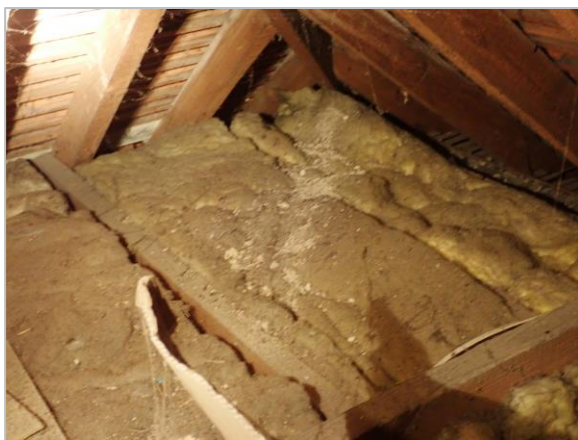
- 3.9. Some areas of visible deterioration to the hip ridge bedding mortar were noted from within the loft, with lines of crumbled old mortar on some areas of loft floor along the hip ridge lines (Photos 9 to 11). Inspection in these areas found a small number of areas where the bedding mortar to the hip ridges had deteriorated and voids were apparent under the ridge tiles. Gaps large enough to allow bats to access the loft from these ridge tile crevices were present in a small number of locations.

*Photo 9* Line of crumbled mortar from hip ridge above

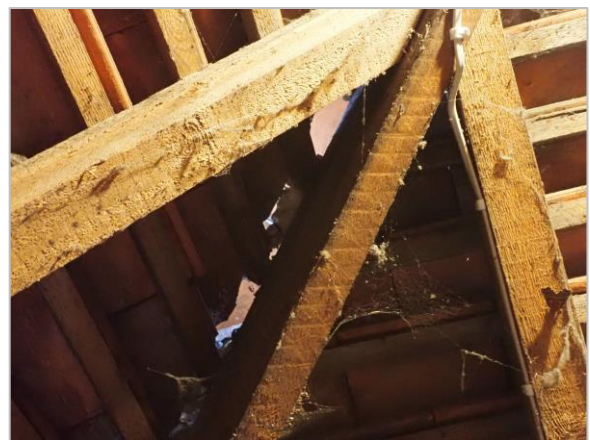
*Photo 10* Exposed underside of hip ridge tile

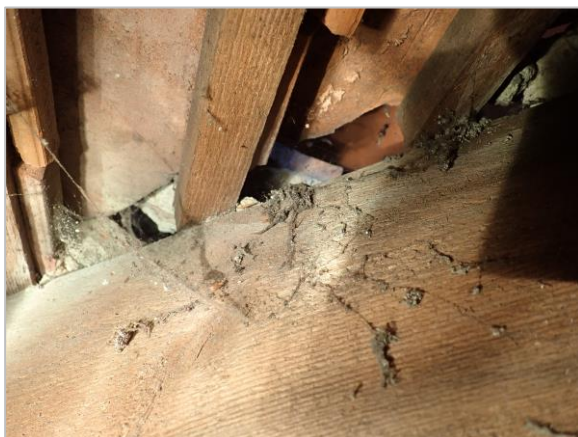
*Photo 11* Ridge beam below ridge tile cavities

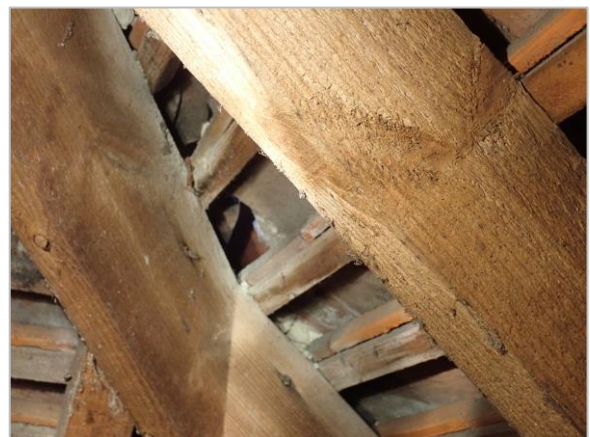
- 3.10. All these areas were closely inspected. Not bats or evidence of bats was seen in any areas under the ridge tiles or associated timberwork or floor areas (Photo 12), and in all cases, there was extensive cobwebbing, with no droppings or other bat evidence caught in the cobwebs (Photo 13), adhering to the adjacent roof elements or on the floor areas below. No bat droppings were visible inside the ridge tile cavities.

*Photo 12* Timberwork below tiles

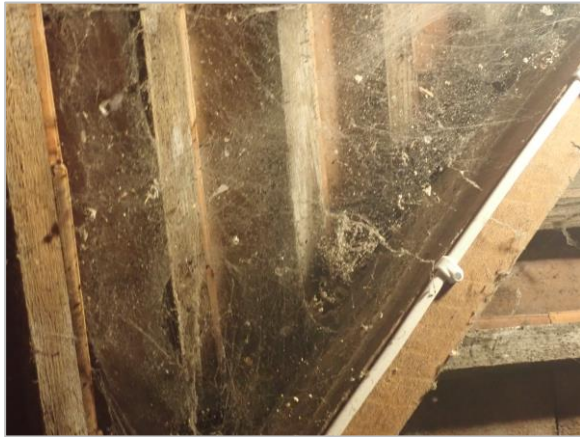
*Photo 13 Heavy cobwebs across hip ridge beam*

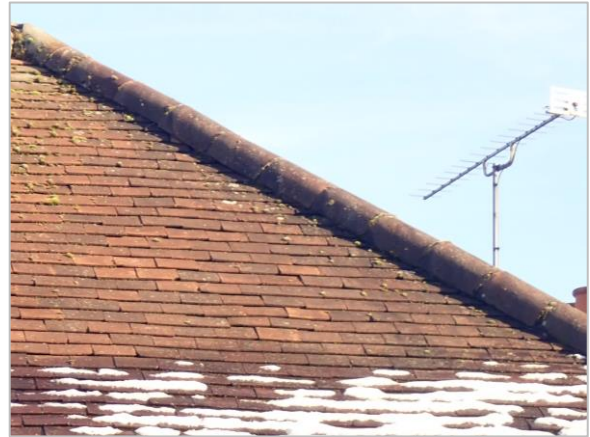
- 3.11. Externally, the main roof tiles were generally closely fitting with only minor unevenness noted during the loft inspection. None of the gaps created over the uneven areas were large enough to allow bat access – see Photos 14 and

*Photo 14 Roof tiles in good condition (rear of house)*

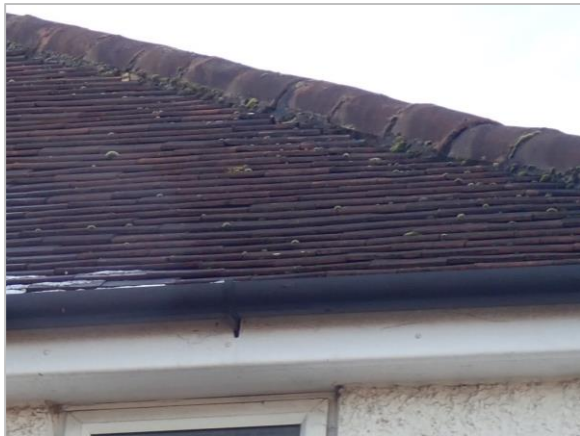
*Photo 15 Roof tiles in good condition (front of house)*

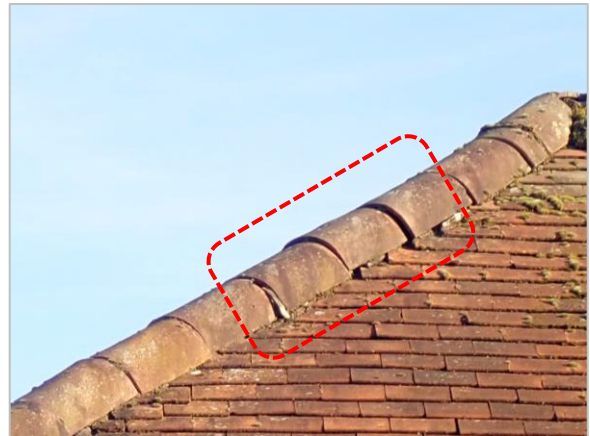
15. Several gaps were noted under the hip ridge tiles where these had previously been indicated during the loft inspection (Photo 16).
- 3.12. The soffits were found to be in good condition and tightly sealed against the external walls (Photo 17). The chimney flashing was in good condition (Photo 18).

*Photo 16 Missing mortar to hip ridge tile (see also Photos 9 and 10)*

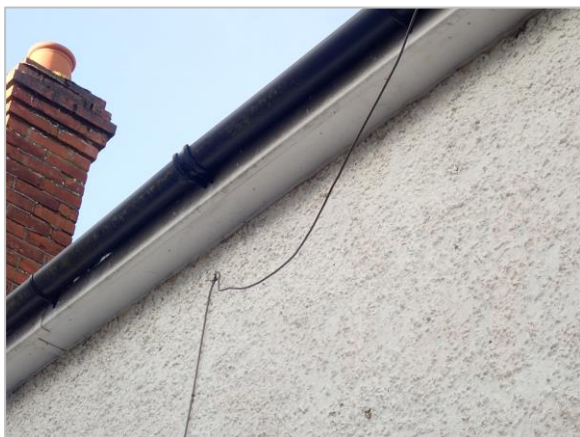
*Photo 17 Soffit tight to external wall*

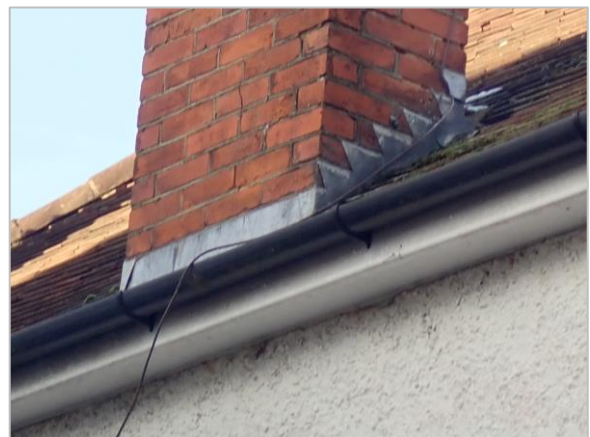
*Photo 18 Chimney flashing in good condition*
