# Clive Hudson Associates

Our ref: 216061/ Rowberry Morris Solicitors - 17 Castle St, Reading – boundary wall / Structural Inspection - Rev O  
Your ref:

### **Re: Structural Inspection – Boundary wall at 17, Castle Street, Reading**

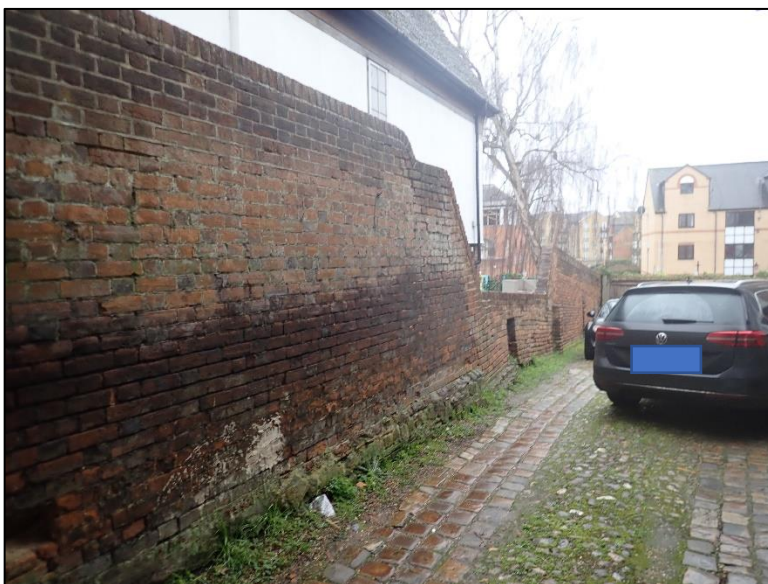
Figure 1. Partial view of wall  
(looking south from the carriage entry of  
No. 17)

Clive Hudson Associates Ltd were instructed following concerns raised regarding the wall's stability / structural integrity (the wall distorts laterally, and there is a significant crack and lateral displacement at the top of the wall at its southern end).

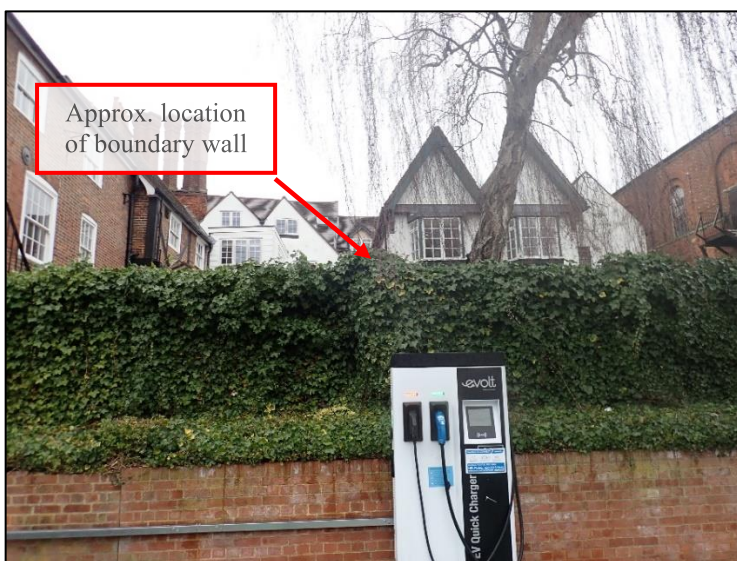
Figure 4. View of the southern boundaries of Nos. 17 and 15.

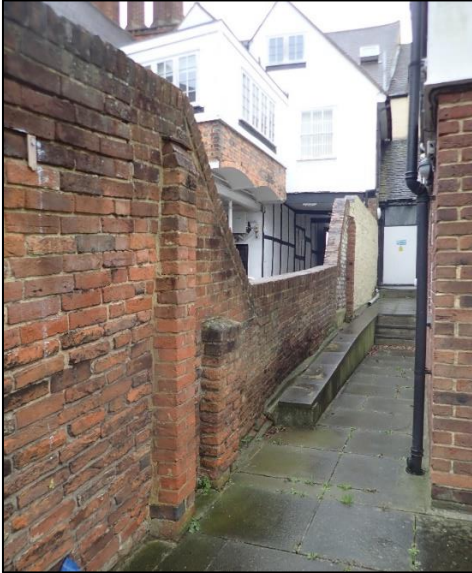
A drainage gully has been formed in concrete at the foot of the wall on the east side, which runs for approx. two thirds of the wall's length. The water from this gully then discharges onto the paved area to the south of the building.

Figure 5. Drainage gully formed at the foot of the wall on No. 15.'s side.

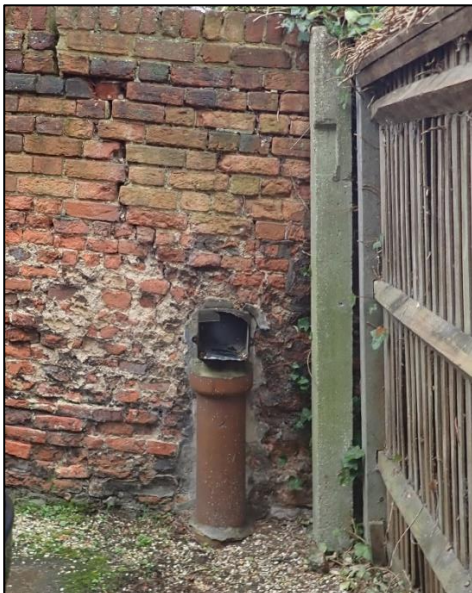
On the west side, there is a rainwater downpipe and drain at the northern end of the wall and a drainage vent at the southern end of the wall. We are unsure whether the vent is active or redundant or what this vents / vented.

Figure 6. Drainage vent at the southern end of the wall on No. 17.'s side.

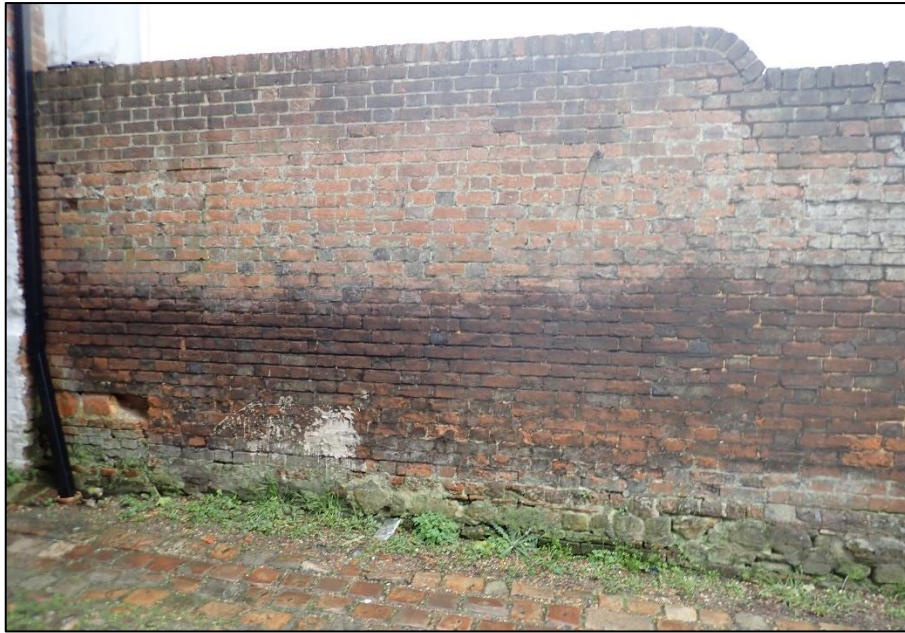
- i. The upper section of the wall is in a reasonably good structural condition for its age and generally requires re-pointing with an appropriate lime-mortar mix. There is a small recess on the left hand-side which has been partially infilled with clay tiles laid on edge. As a matter of good practice, we would recommend the clay tiles are removed and the recess is infilled with clay tile creases laid horizontally in an appropriate lime mortar.

Figure 8. General view of the upper section of wall

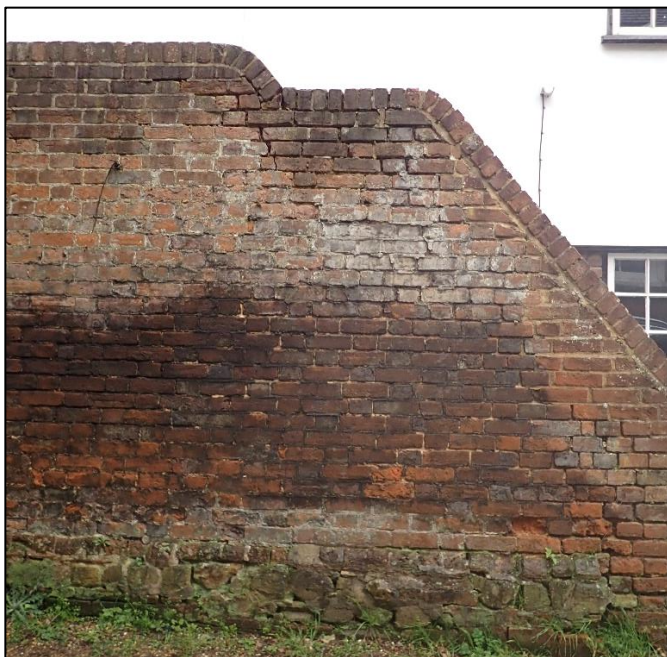
- ii. The base of the wall on the west side is noticeably damp with algal growths and staining observed. We would assume this has been caused by rainwater splashing off the ground and back onto the wall. Subject to intrusive investigations to confirm the nature of the footings, we would allow for the existing earth / compacted ground to be replaced with a more permeable material, such as pea shingle.
- iii. There were localised areas of brick degradation; but these do not warrant immediate structural concern and could be repaired using a lime mortar 'plastic repair', or the affected bricks could be carefully cut out and replaced with either clay tiles creases, or with new bricks which are similar in size, texture, and colour as the surrounding brickwork.

Figure 9. General view of the southern end of the upper section of wall.

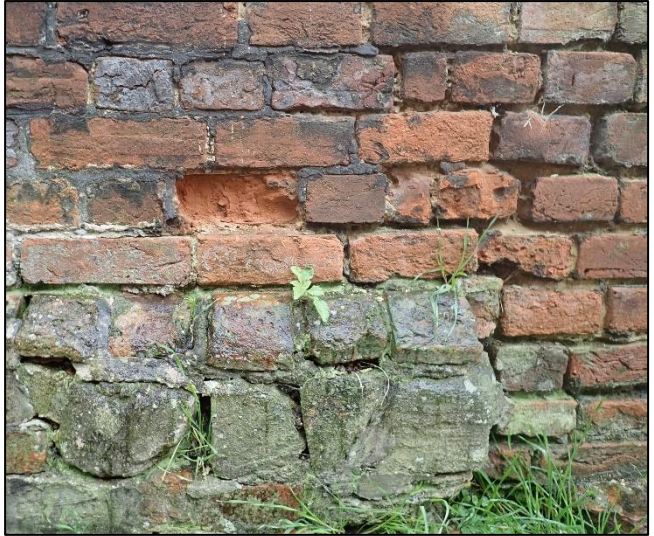
Figure 10. An example of spalling brickwork.

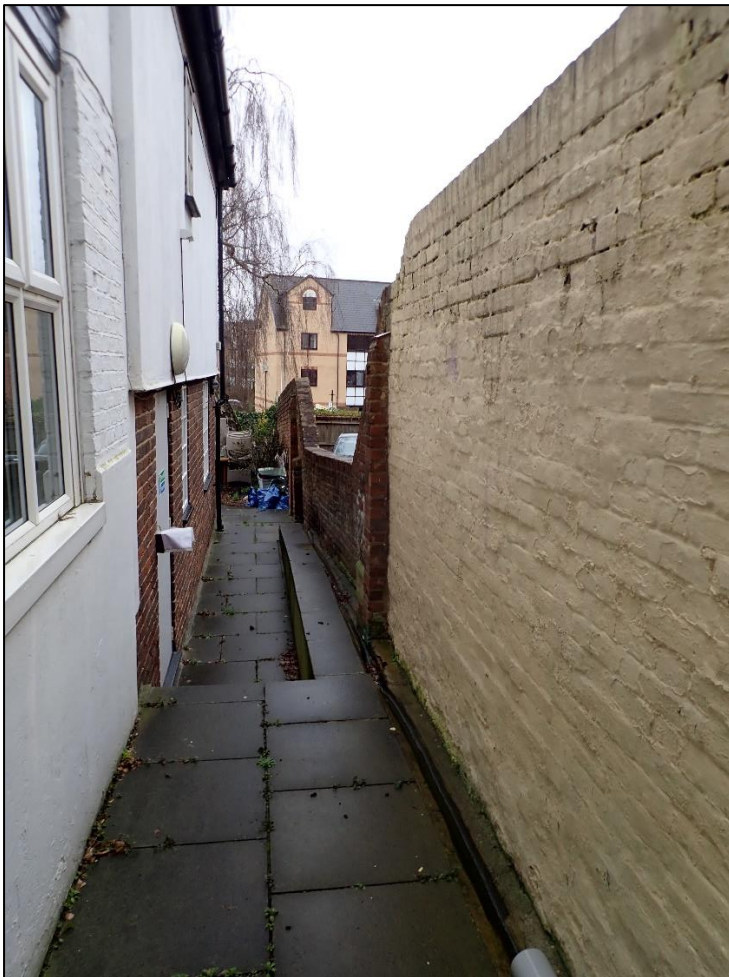
- iv. On the east side, the wall has been painted with a modern masonry paint and the brickwork at the southern end of this section has been re-pointed in a grey cementitious mortar. While it does not warrant immediate structural concern, we would recommend the wall is re-pointed using a more appropriate lime mortar mix and the paint is removed and replaced, if necessary, with a more breathable paint.

Figure 11. A view of the upper section of wall (looking south).

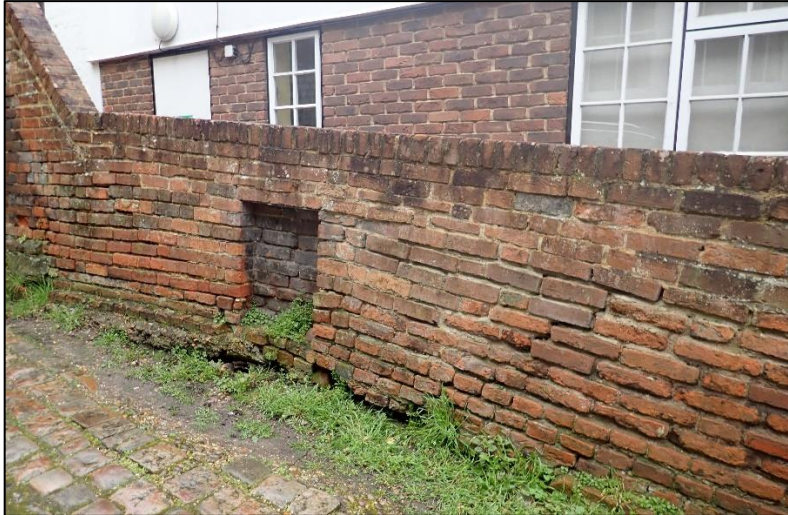
- v. It appears the middle section of the wall has been re-built at some point in time with evidence of a thin concrete footing projecting out of the ground at the northern end of this section (Figs. 12-13)

Figure 12. General view of the middle section of wall.

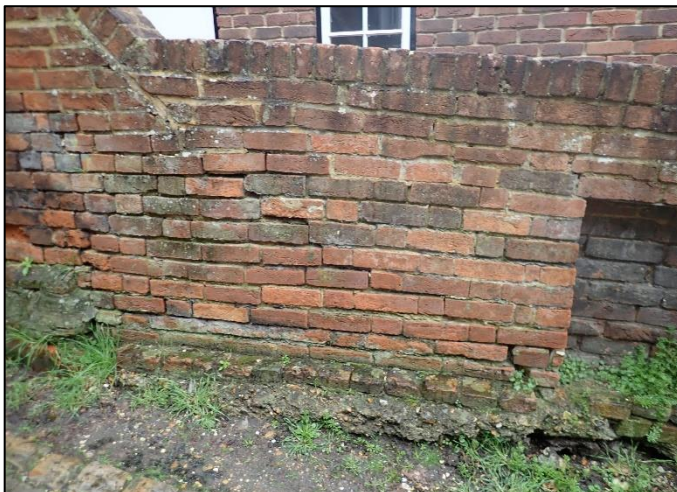
Figure 13. Evidence of a concrete footing at the north end of the middle section.

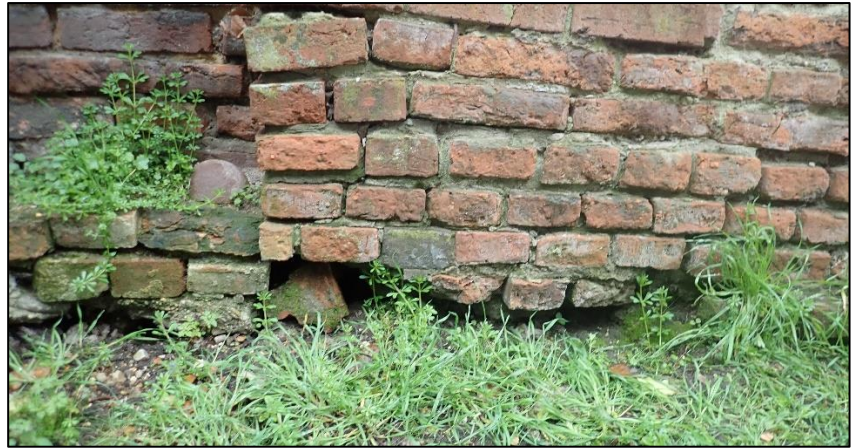
- vi. Approximately half-way along this section the wall has been undermined with gaps observed below the apparent bottom course of brickwork and the ground (Fig.14). It appears further undermining has occurred due to rats tunnelling beneath the wall.

Figure 14.  
Undermining of wall.

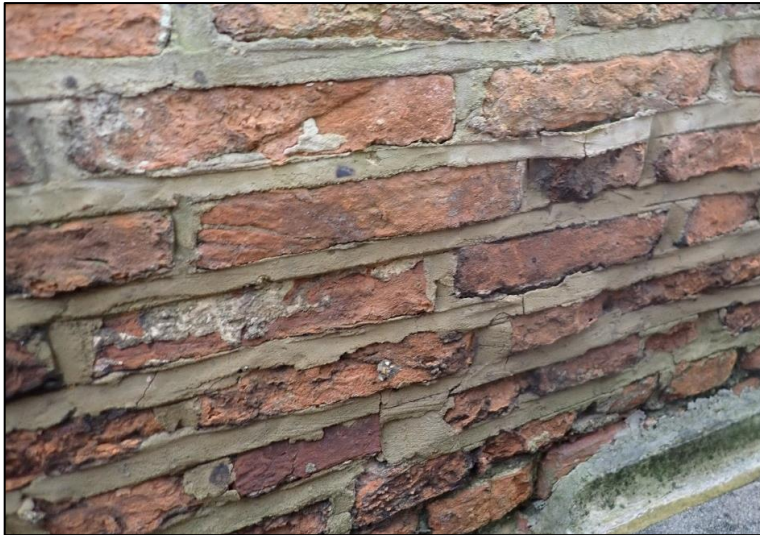
Figure 16.  
Cementitious pointing on the  
east side of the middle  
section of wall.

- viii. While it is not a structural matter per se, it should be noted the foot of the wall on the east side has been re-pointed in a cementitious mortar (Fig. 16).

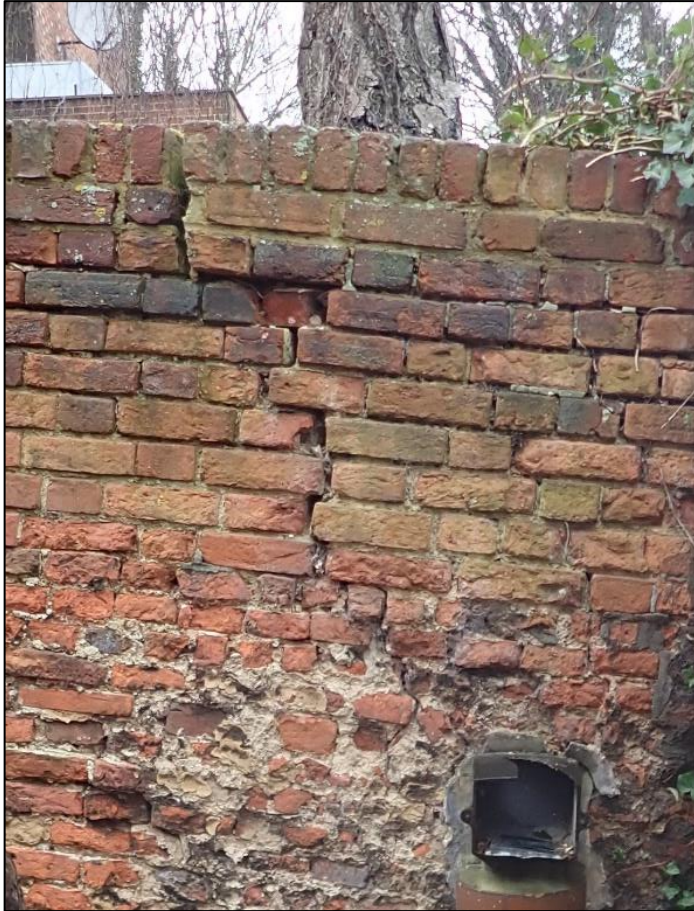
- ix. The lower section of wall generally consists of a combination of historic, 2" thick brickwork and later, probably 19<sup>th</sup>-century, brickwork above it. As one would expect the historic brickwork shows signs of brick degradation (loss of surface / spalling) but this does not warrant immediate structural concern and requires re-pointing and localised 'plastic repairs' / brick replacement only.
- x. At the southern end of the wall there is a significant tapered crack with the brickwork either side of the crack displaced laterally (Figs. 17-20). The crack appears to run from the drainage vent up the wall with a crack width of 35mm and a lateral displacement of 50mm recorded in the coping brickwork. Further slight cracks were also observed on the east face of the wall (Fig. 22).

From the inspection it appears the brickwork to the south of the crack has lifted and displaced laterally and is consistent with root penetration into the brickwork, which has grown / expanded over time.

Figure 17.  
Tapered, vertical crack at  
the south end of the wall.

At this stage, we would recommend contact is made with the freeholder of No. 15 to discuss the possibility of removing the tree and its root ball before any remedial works commence. As part of the process, we would recommend the health, age, and stability of the tree is confirmed by a competent arboriculturalist as its lean gives us cause for concern (Fig. 24).

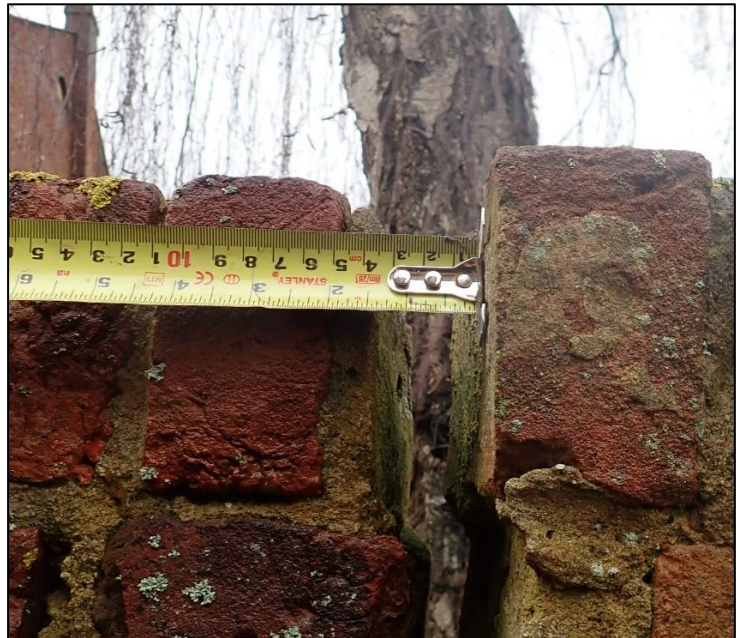
Figure 18.  
Crack width between  
the coping bricks.

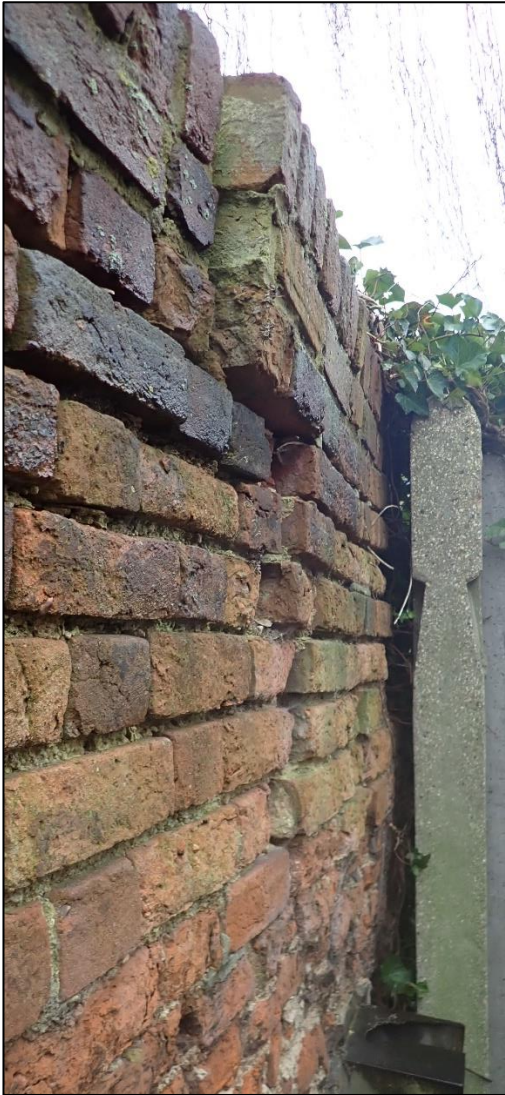
Figure 19.  
Laterally displaced  
brickwork.

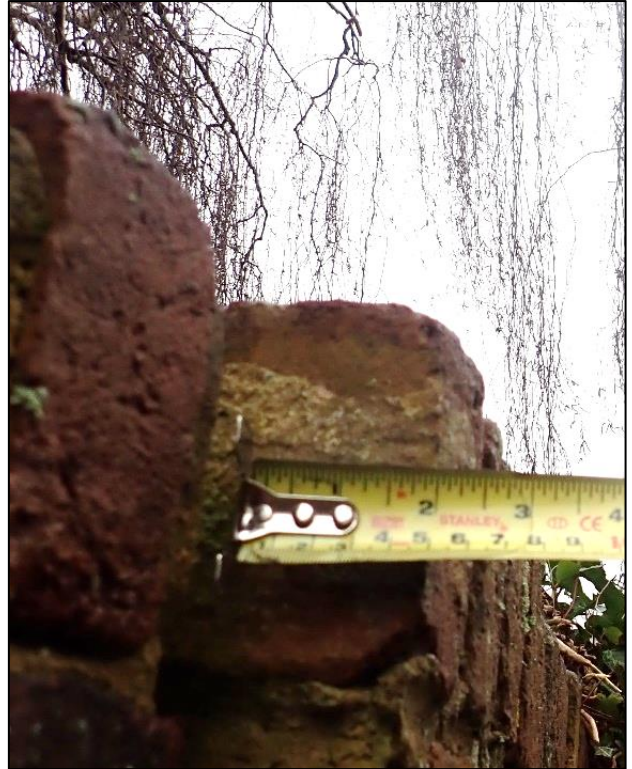
Figure 20.  
Lateral displacement  
between the coping bricks.

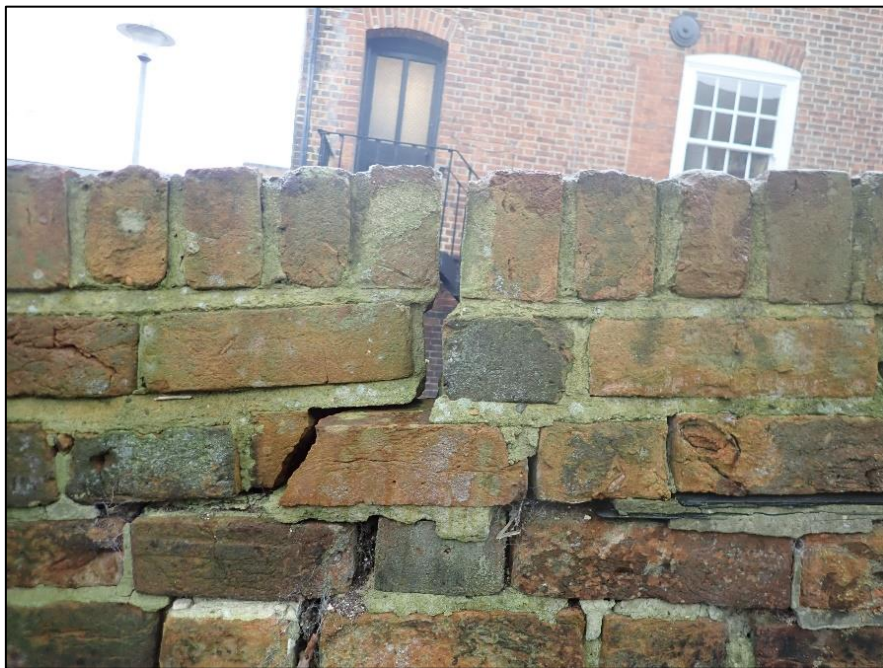
Figure 21.  
View of the crack at the top of the wall from No. 15.

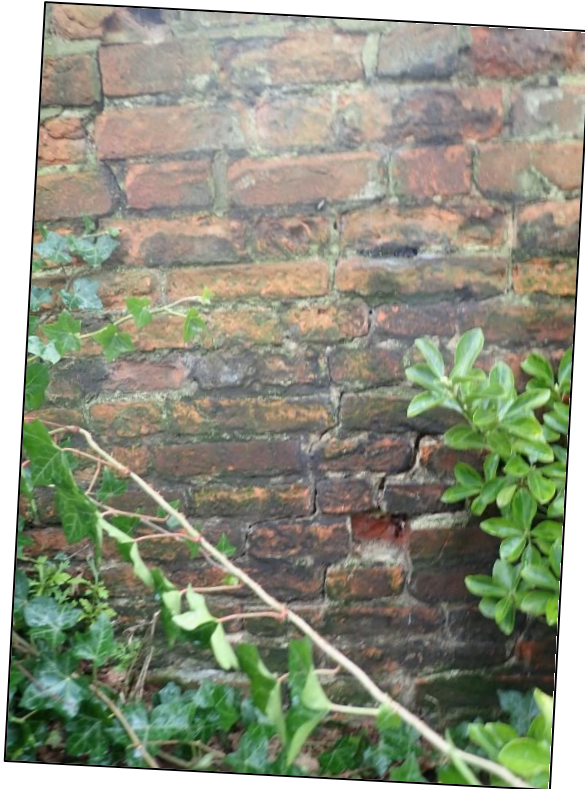
Figure 22.  
Vertical, slight cracks in the  
brickwork on the east side.

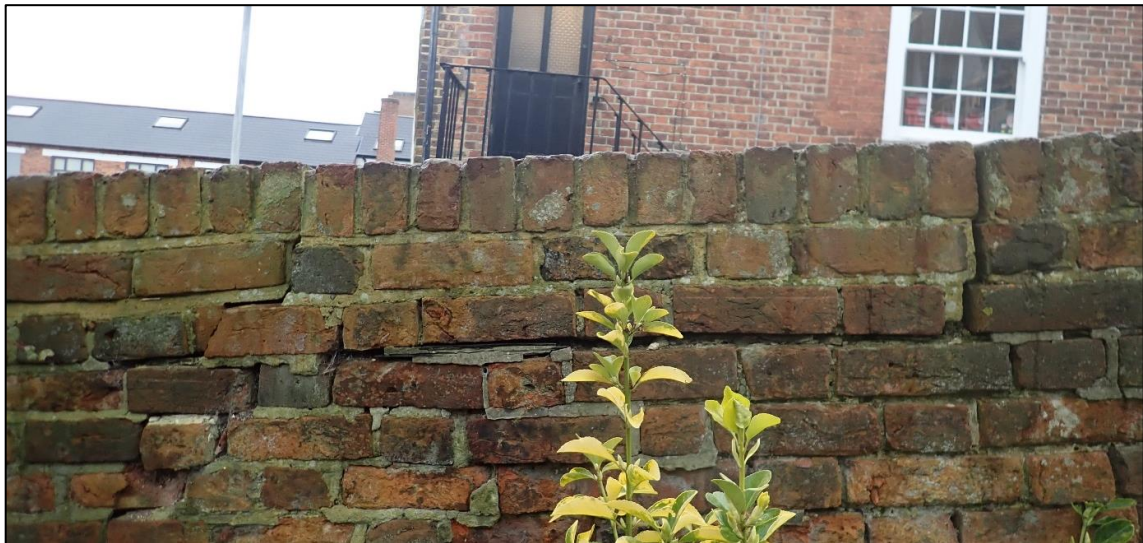
While un-related, the coping bricks and the two courses of bricks below this were noticeably loose for approximately 900mm (Fig. 23).

Figure 23. Loose brickwork to the north of the crack.

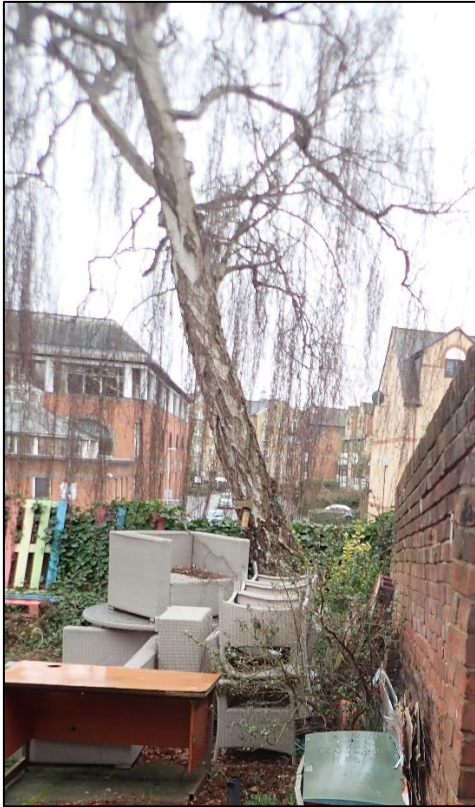
Figure 24.  
General view looking south  
from No. 15 with the willow  
tree at the far end of the wall.

While it is not a structural issue, we would also recommend contact is made with the Tree Officer as we understand the tree may have statutory protection being within a conservation area. However, we would assume the wall pre-dates the tree and has its own statutory protection being within the curtilage of two listed properties.

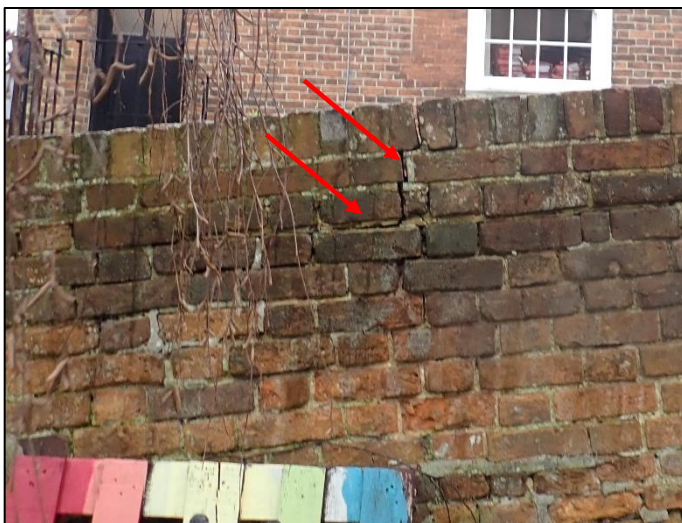
- xi. To the north of the tree, the wall leans noticeably to the east. Unfortunately, due to the quantity of items being stored against the wall and the shrubs growing against it, it was not possible to get a series of accurate out-of-plumb readings. However, to the left of the plastic storage box, an out-of-plumb of approximately 100mm was recorded. At this stage, we would recommend permission is sought from the freeholder of No. 15 to move the items away from the wall so that a more accurate set of readings can be taken.
- xii. A further crack was observed at the head of the wall to the right of the painted pallet (Fig. 25). The cause of the movement is unknown; but it would appear the coping bricks and the two courses of bricks below this may be loose. As part of the next phase, we would recommend the integrity and stability of this brickwork is confirmed.

Figure 25.  
Cracking at the head of the  
wall to the right of the painted  
pallet.
