# Bat Survey Report – Preliminary Roost Assessment

35 Balmore Drive, Caversham,  
Reading, Berkshire RG4 8NL

December 2020

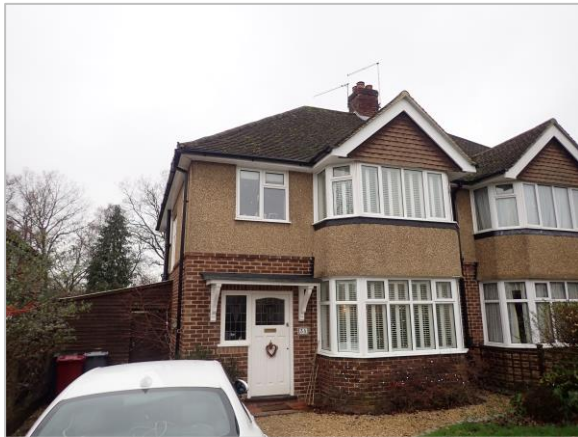
*Photo 1 Front of house*

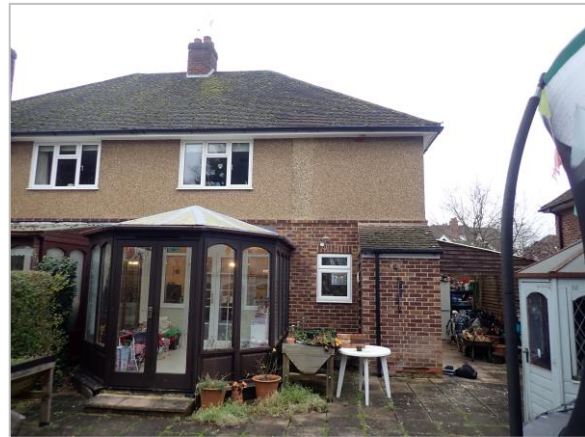
*Photo 2 Rear of house*

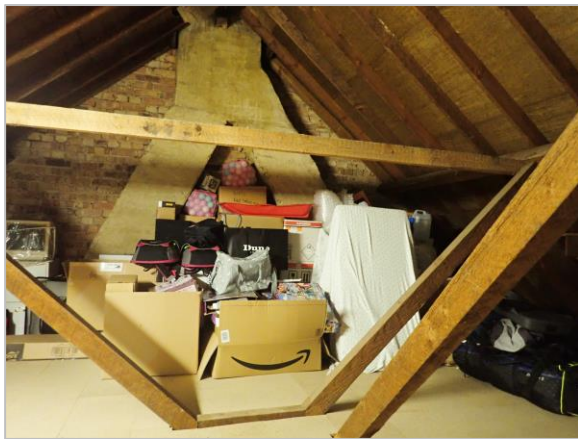
- 3.6. Internally, the loft was readily accessible – see Photos 3 and 4 for general views of the loft conditions. The floor areas were found to be clear, with no evidence of bat roosting activity (Photo 5). The ridge beam, hip apex, and rafters were examined (Photos 6 and 7), and no recent or historic bat evidence was seen.
- 3.7. The area around the top of the chimney was closely inspected, as were the vertical faces of the chimney breast and partition wall, and the floor areas below these – see Photos 8 and 9. Although there was a fair degree of wind-

*Photo 3 General conditions in main loft (northern partition wall)*

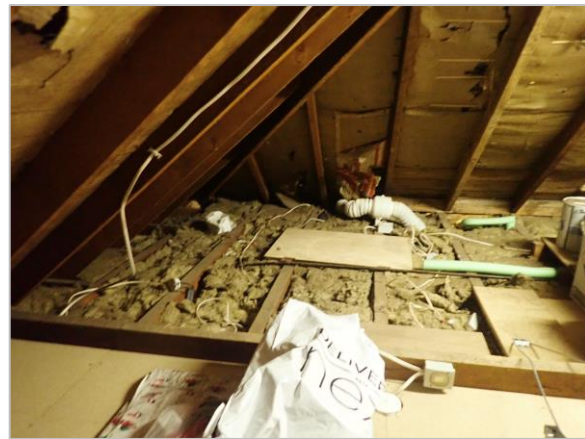
*Photo 4 General conditions in main loft southern hip gable end)*

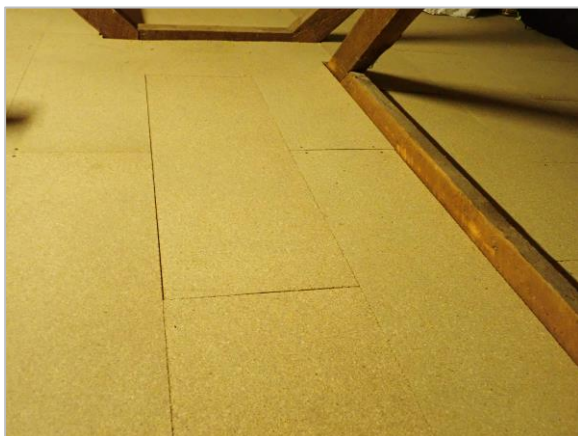
*Photo 5 Main floor area of loft*

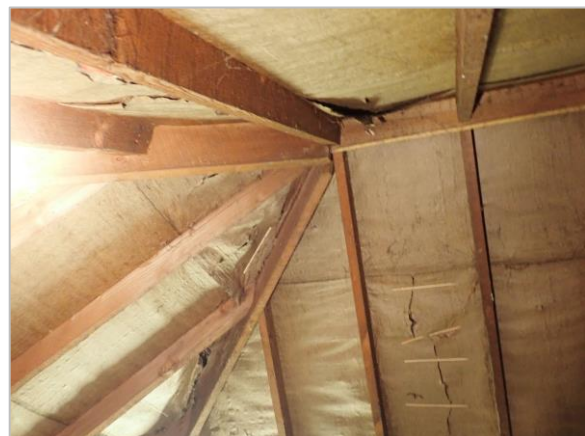
*Photo 6 Ridge, rafters, and hip apex timbers*

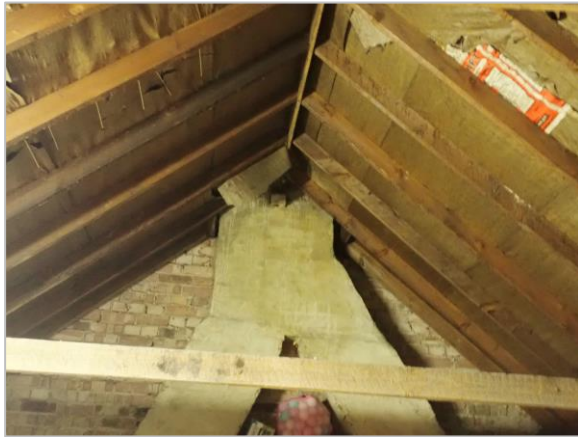
*Photo 7 Ridge*

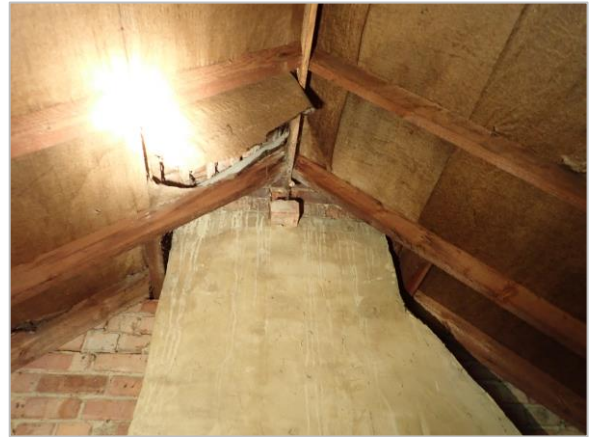
blown dust and debris in some areas, no evidence of bat roosting activity was seen in any of these areas.

*Photo 8 Top of chimney breast*

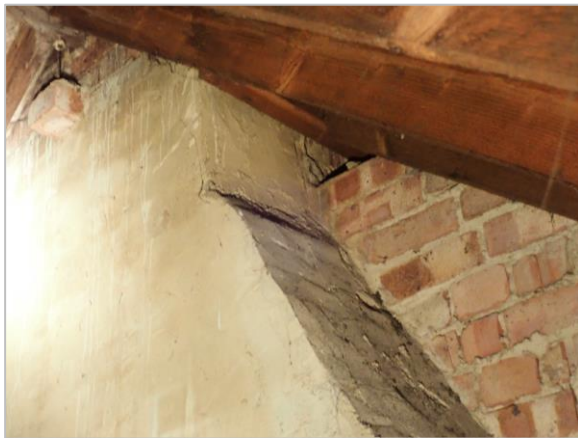
*Photo 9 Chimney breast*

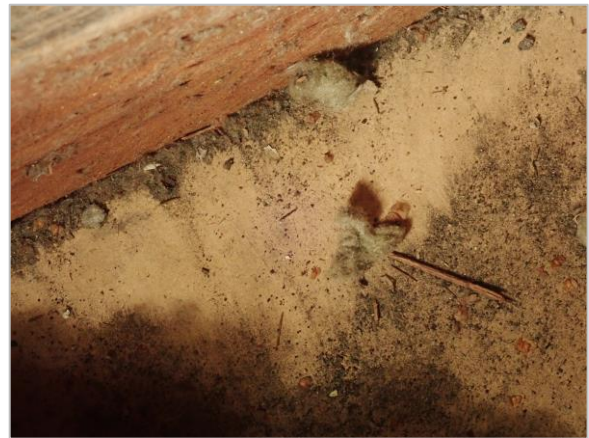
- 3.8. Where possible, spot checks were carried out under the insulation, and no historic bat evidence seen (Photo 10).
- 3.9. The roof underfelt was in fair condition. There were several areas that had previously been damaged and had subsequently been repaired, and a small number of other areas of damage were noted where the underside of the tiles was visible (Photos 11 and 12). No bat evidence was seen in any of these areas, and no external light was visible through gaps between the tiles large enough to allow bat access.
- 3.10. No bat droppings or urine spotting was seen on any floor areas, domestic services, or stored household items.

*Photo 10 Spot check beneath insulation*

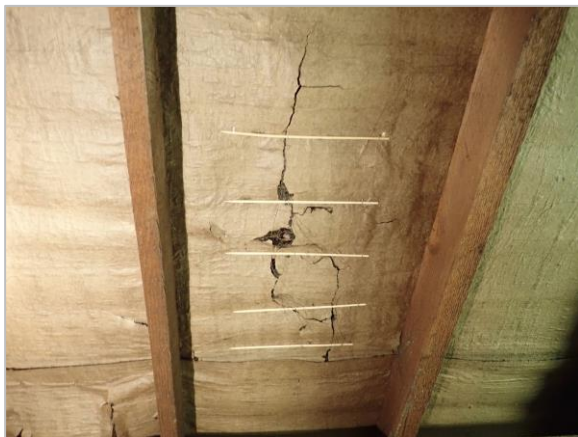
*Photo 11 Repairs to underfelt*

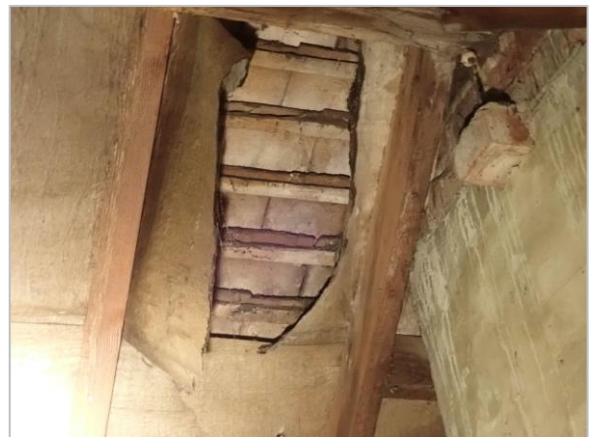
*Photo 12 Damage to felt showing underside of tiles*

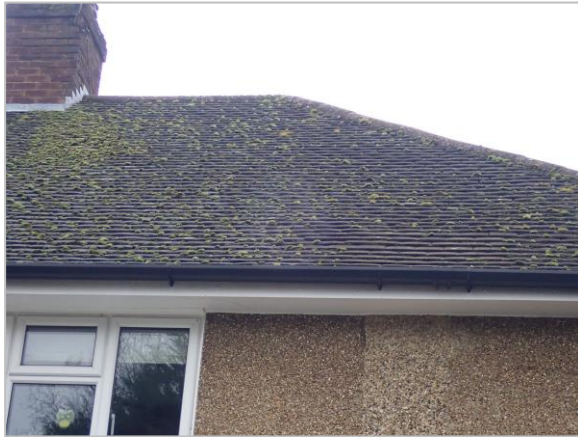
- 3.11. Externally, the roof, ridge, and hip ridge tiles were in a good overall condition. A moderate level of moss growth was noted across the roof faces. No damaged, slipped, or missing tiles were noted, and the tiles appeared well-fitting with no gaps noted that were sufficiently large to allow bats to access – see Photos 13 to 15.

*Photo 13* Roof tiles to rear of house

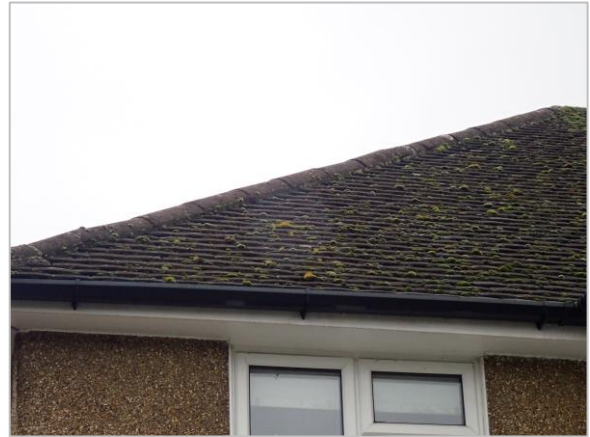
*Photo 14* Roof tiles to front of house

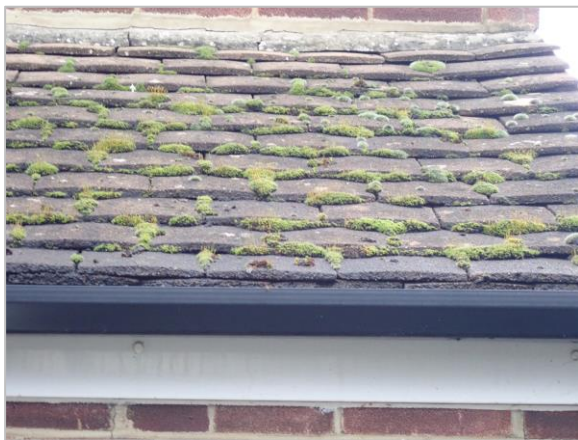
*Photo 15* Roof tiles to small rear single storey extension

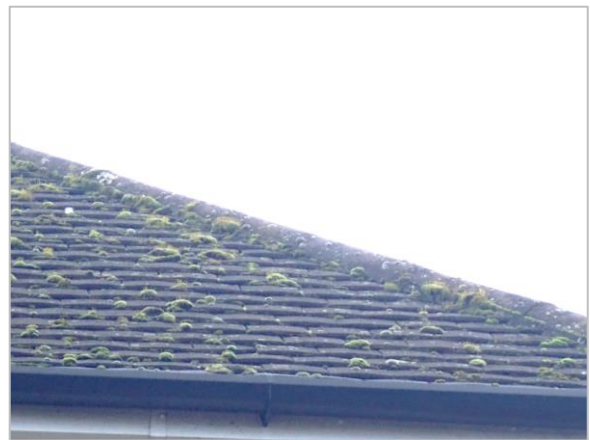
- 3.12. The bedding mortar to the ridge and hip ridge tiles were found to be in good condition with no apparent deterioration or damage (Photo 16).
- 3.13. The flashing around the chimney was in good condition with no lifting or damage noted (Photo 17).

*Photo 16* Hip ridge tiles in good condition

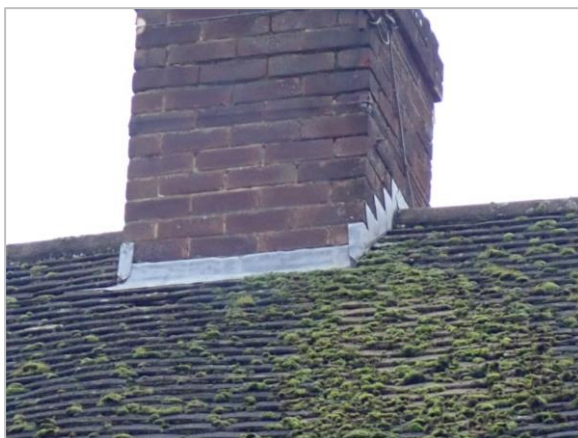
*Photo 17* Chimney flashing

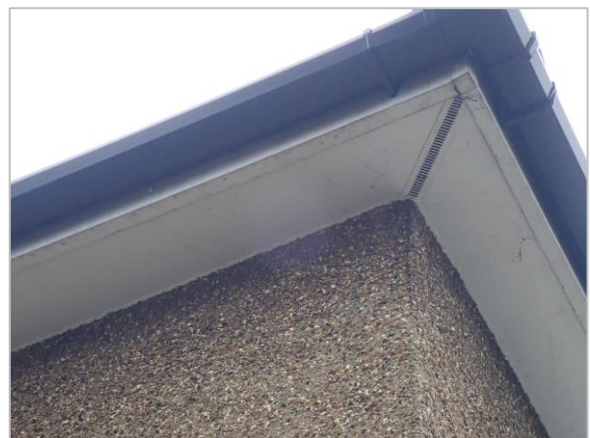
- 3.14. The soffit boxes are understood to have been recently replaced. These were found to be in good condition, and tightly sealed against the external walls with mastic (Photos 18 and 19).

*Photo 18* Soffit around south-west (rear) corner of house

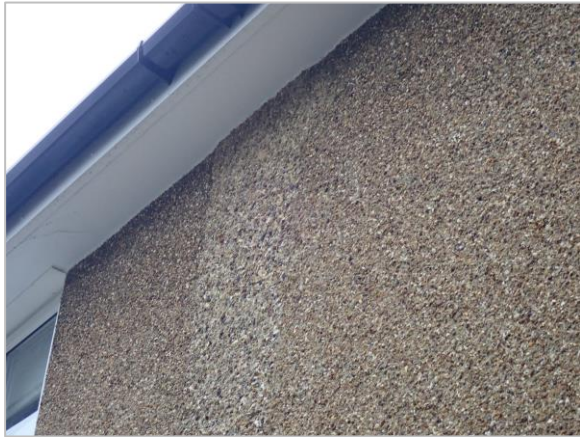
*Photo 19 Soffit*

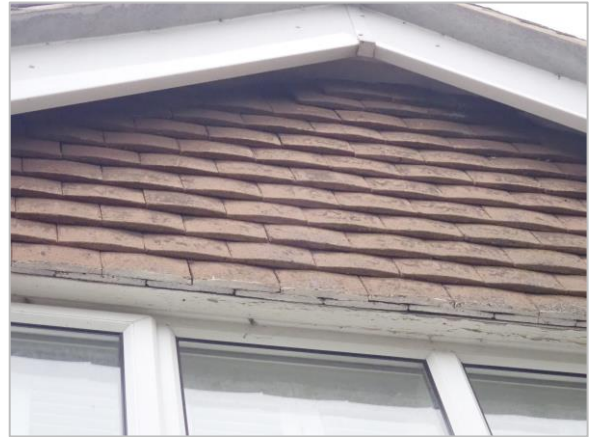
- 3.15. There is a small area of concrete hanging tile to the front bay gable. These were generally found to be in good condition, although some slight unevenness was noted – see Photo 20.

- 4.7. The only area of possible roost suitability at the house is the small area of hanging tile to the front. This is largely unsuitable as the tiles are reasonably well fitting, but the slight general unevenness of the tiles has resulted in a small number of smaller gaps that could occasionally be exploited by crevice-roosting bats.

*Photo 20 Hanging tiles to front of house*
