14th December 2020

Our Ref : JRB/CSM : 20.612

**Visual inspection to :  
Existing Offices at Yeomanry House, 131 Castle Hill, Reading, RG1 7TA.**

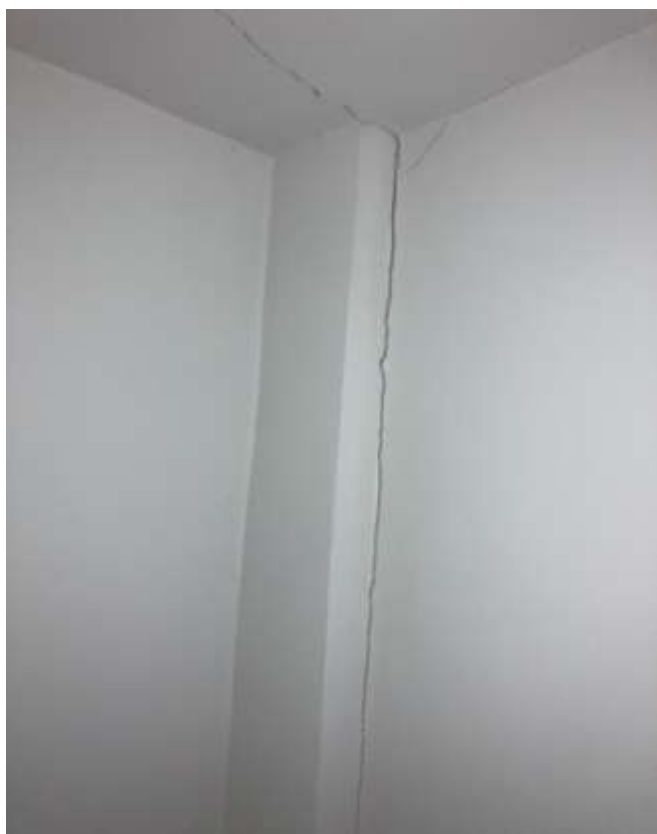
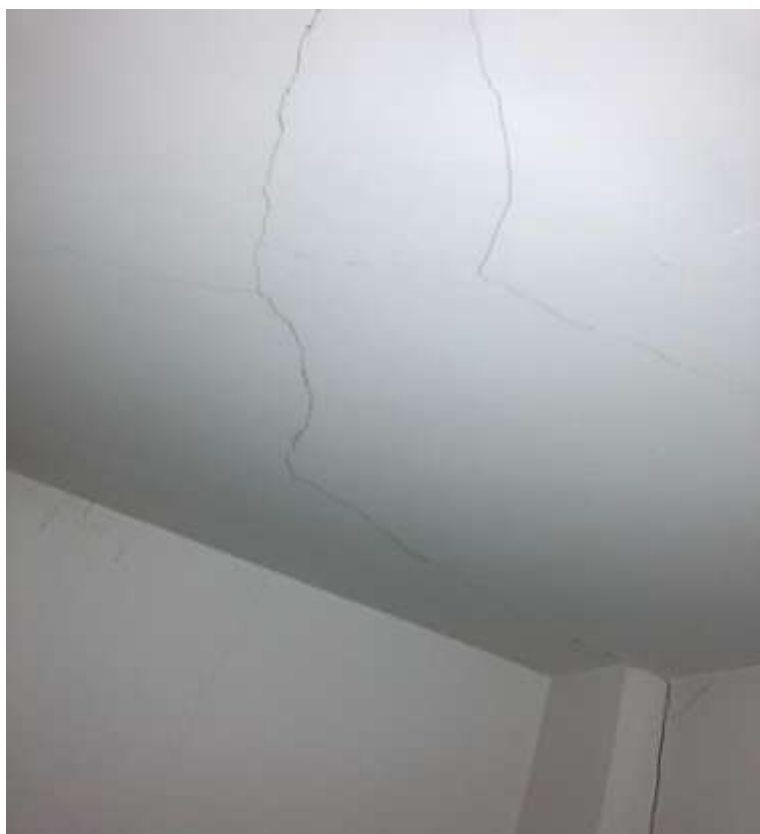
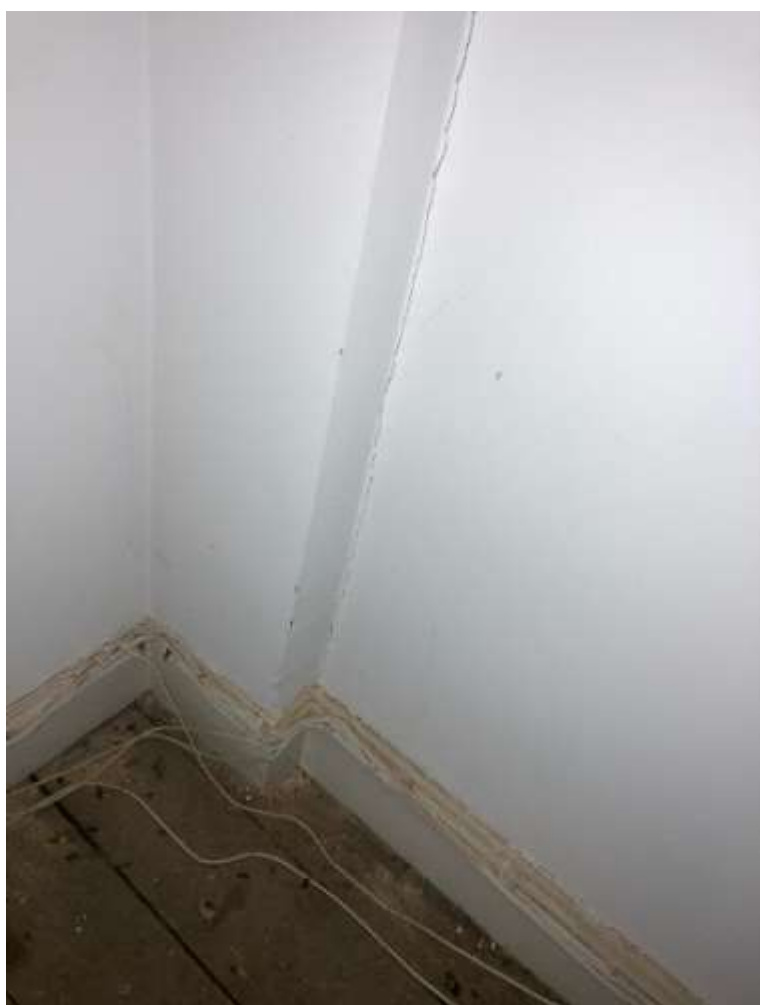
It was noted that on the Second floor staircase landing area in the West Wing there was evidence of larger extent of cracking both in the ceiling and wall adjacent to the chimney stack location. (Photographs 1, 2 & 3) these cracks were not specifically noted within the 2017 condition survey and so it is difficult to determine if these cracks postdate the survey or simply was not recorded. It was not possible to investigate the other side of the wall junction in photograph 1 which is noted as a roof void on the architect's survey plan drawing No. 3556/101 as no access is available.

Looking at these particular cracks and those found in photographs 4, 5, 6 & 7, it suggests that there may have been some spreading of the roof structure, which is due to the rooms in the roof space and lack of lateral restraint to the rafters at external wall level.

1. Cracks in Second Floor West Wing landing Photographs 1, 2 & 3

The cracks witnessed in the second floor of the West Wing which were not highlighted in the original report also look to have some age. Due to the fact these cracks did not appear in the original report, it is suggested that further investigation is carried out by removing an area of plasterwork both on the ceiling and wall to ascertain if the cracks are caused by a breakdown of materials due to age, or as a result of structural movement.

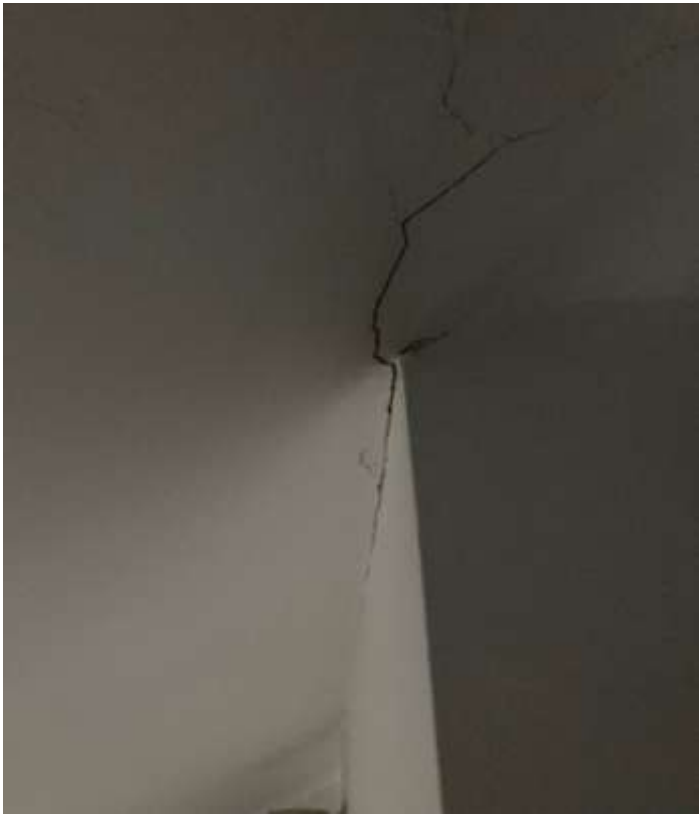
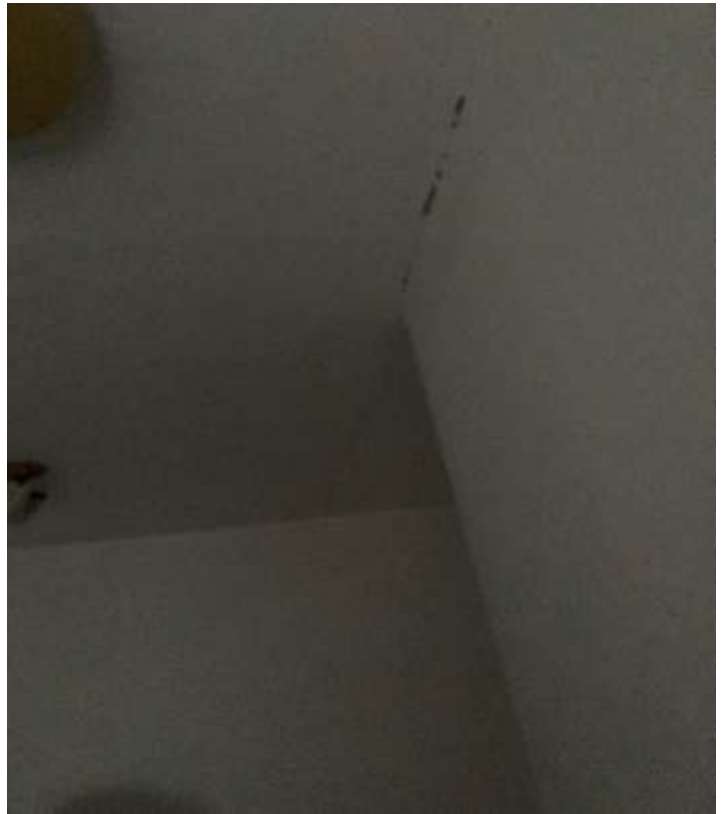
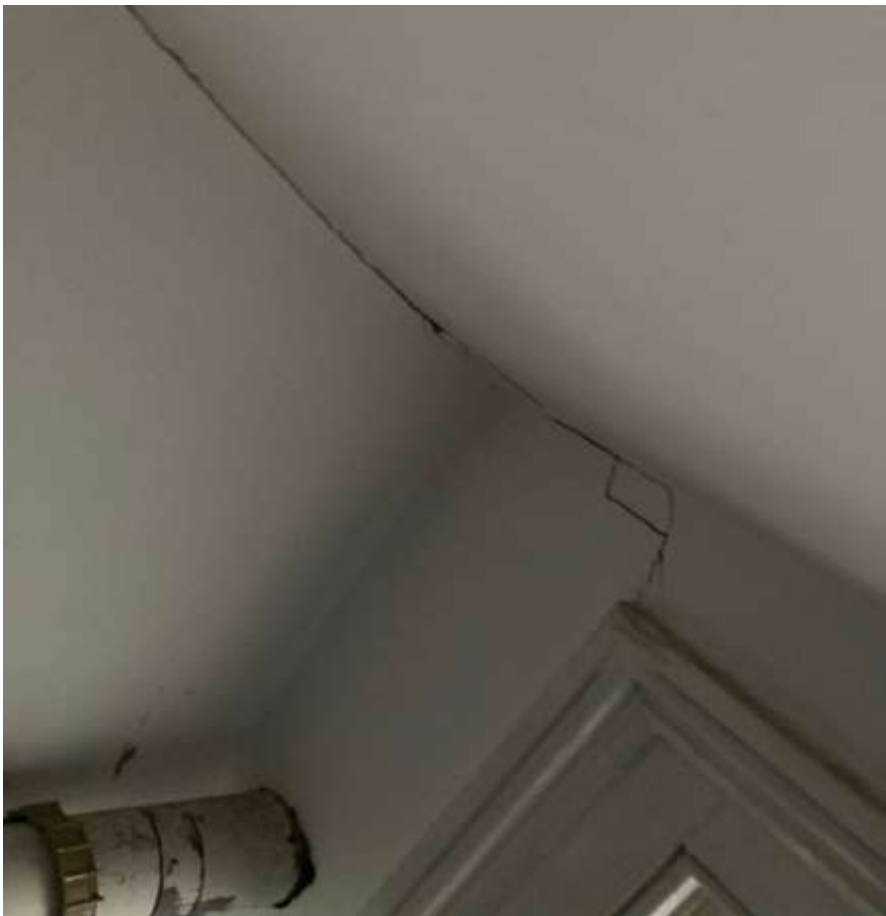
Further cracks are noted within the corridor/ kitchen area within the second floor of the West Wing see (photographs 4, 5 & 6)

2. Cracks in corridor/ kitchen second Floor West Wing Photographs 4, 5 & 6

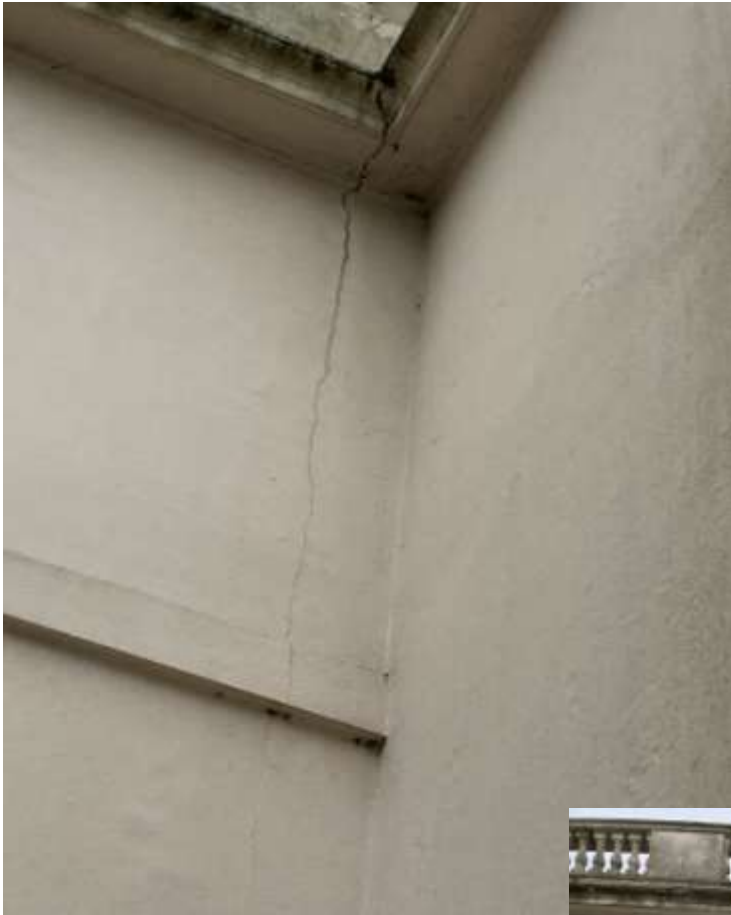
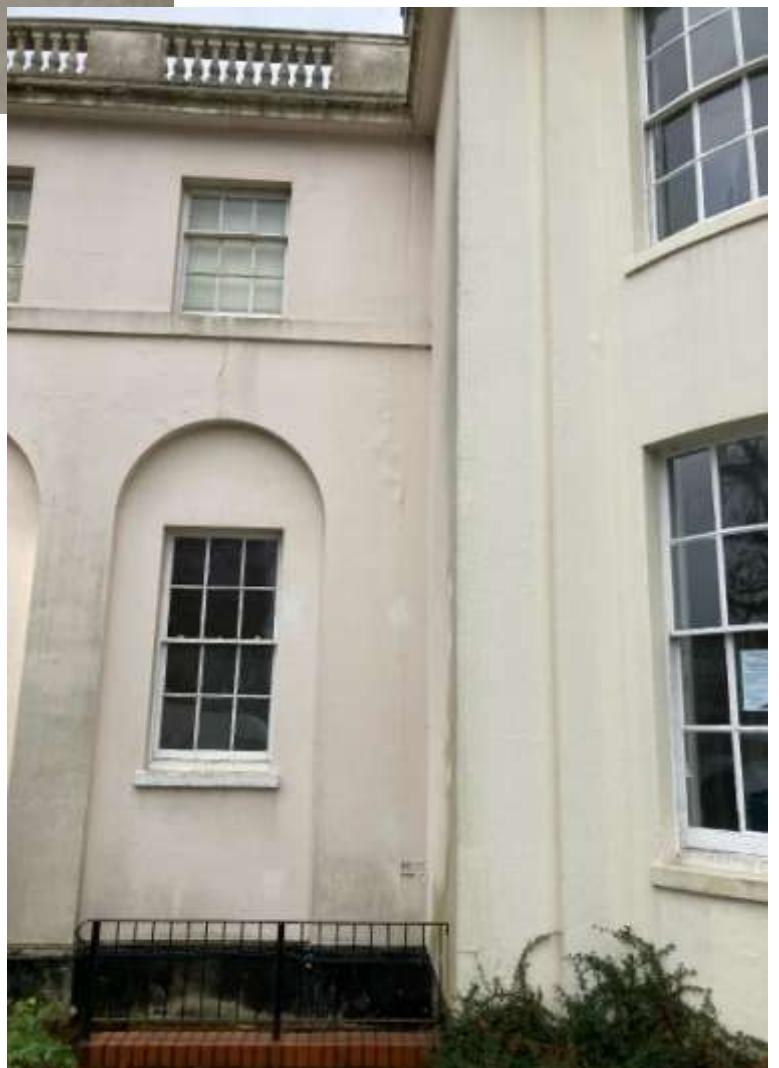
There is an external vertical crack within the North facing East Wing wall adjacent to the junction of central block. This crack widens at the top and runs approximately two stories. (Photographs 7 & 8). An inspection was carried out internally within the rooms directly adjacent the external crack, however there was no visible signs of any cracking, this may be due to previous redecoration within these rooms.

3. Cracks in external render in East Wing Photographs 7 & 8

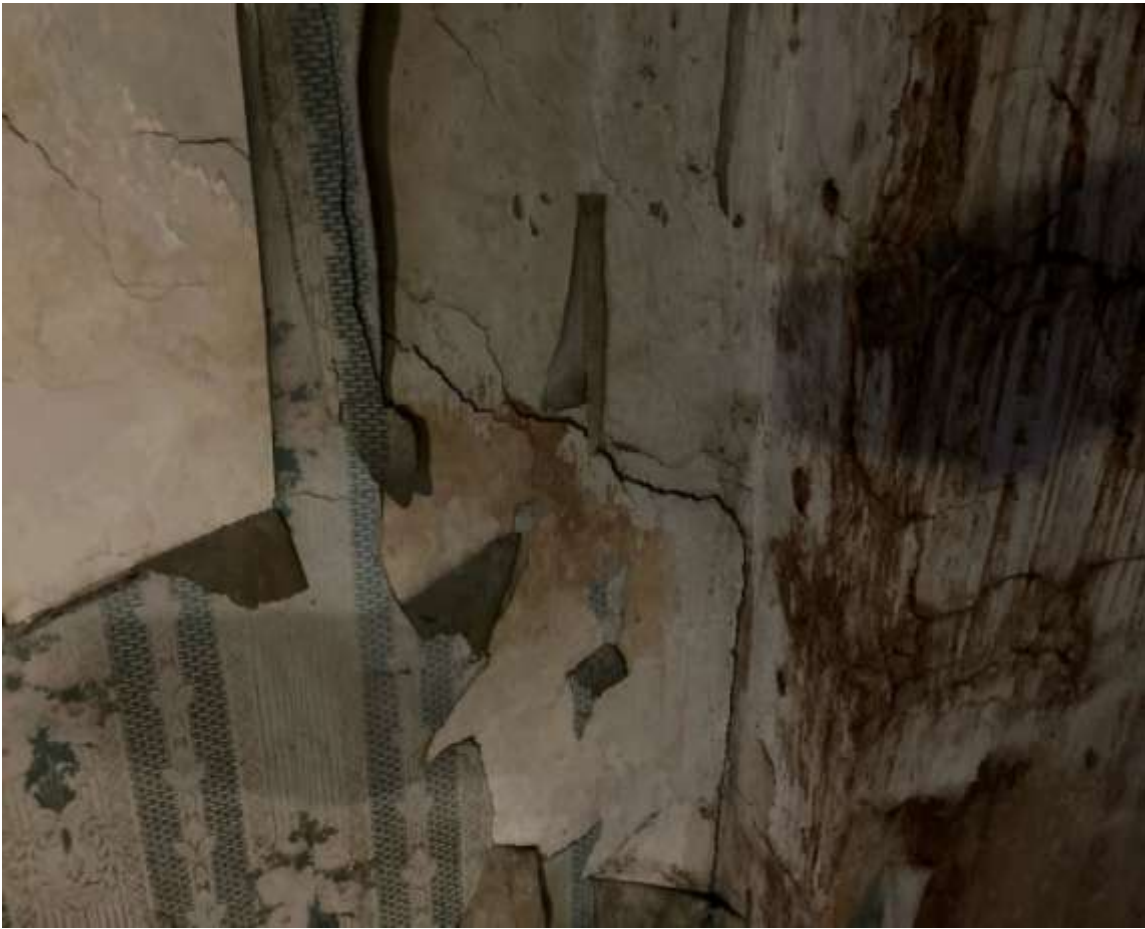
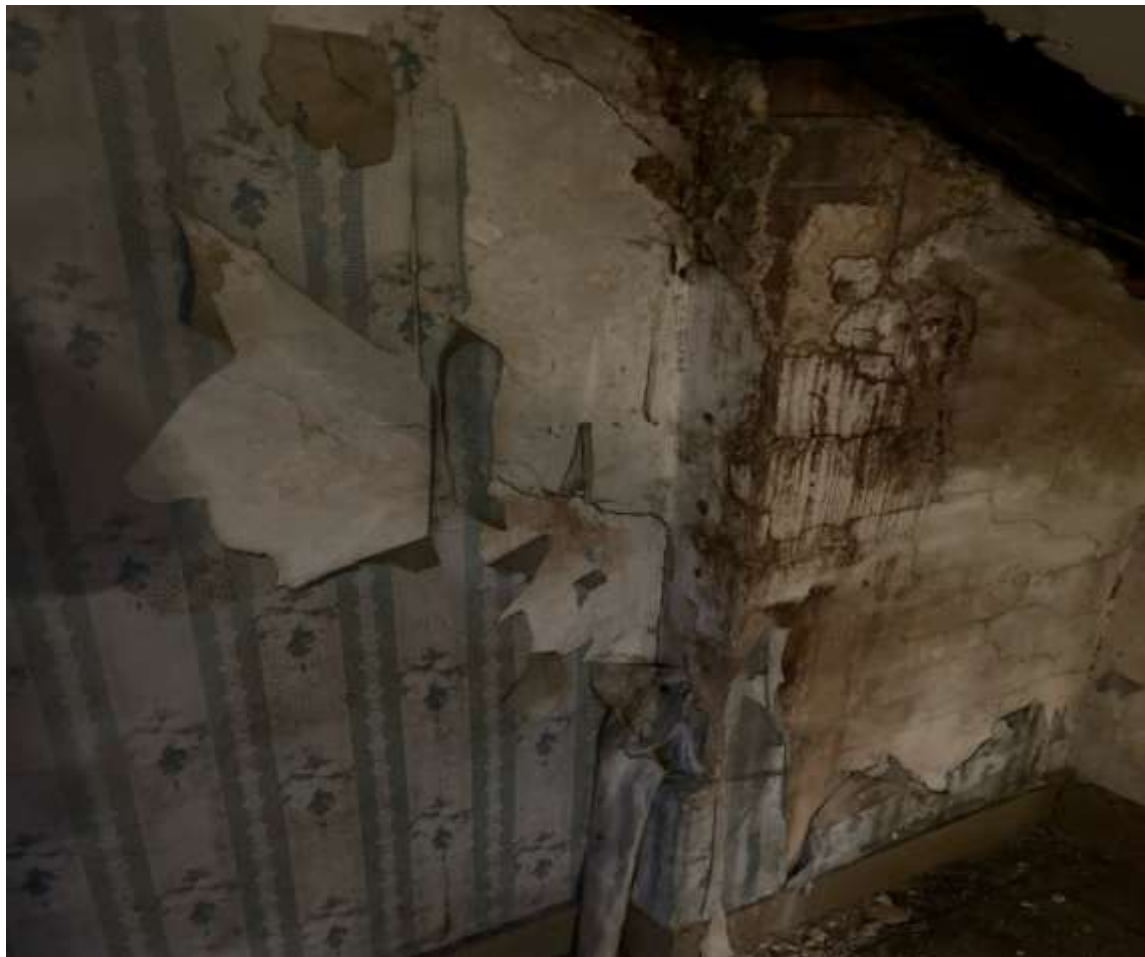
An inspection of the walls within the second floor store room to the East Wing was carried out and there was cracking around the chimney stack (Photograph 9 & 10). It should be noted that the condition of this wall/ crack is similar to that found in the condition report date October 2017.

4. Cracks in second floor Store room East Wing Photographs 9 & 10
