## ADVICE

| <b>Instruction</b> | Broad oak Place |
| <b>FLAC Instruction ref</b> | CC31-1036 |
| <b>Subject</b> | Breach of condition (approved Tree Protection Plan) |

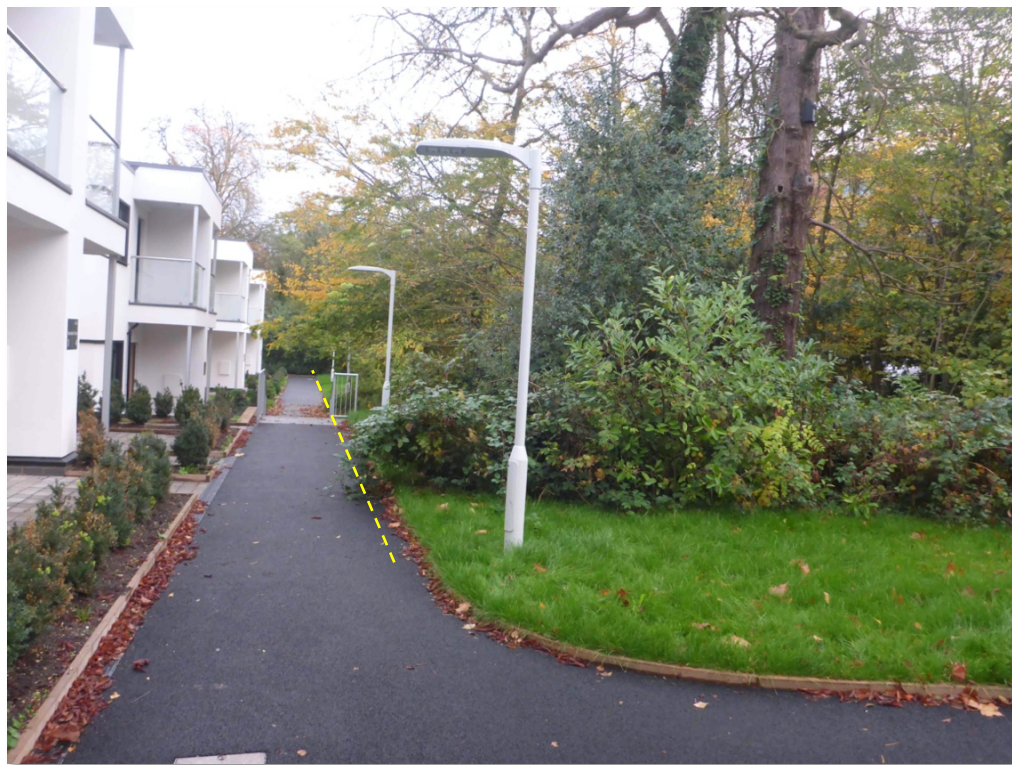
5. We understand the drainage alignment has been constructed beneath the footpath inboard of its southern edge and the electric feed also sits within this trench with short perpendicular spurs off it to the lamp columns (radially) towards the trees (see Figure 3 section detail below).

*Figure 1. Current view east, with horse chestnuts 3029 and 3030 respectively. Dashed yellow line to indicate drainage trench position*

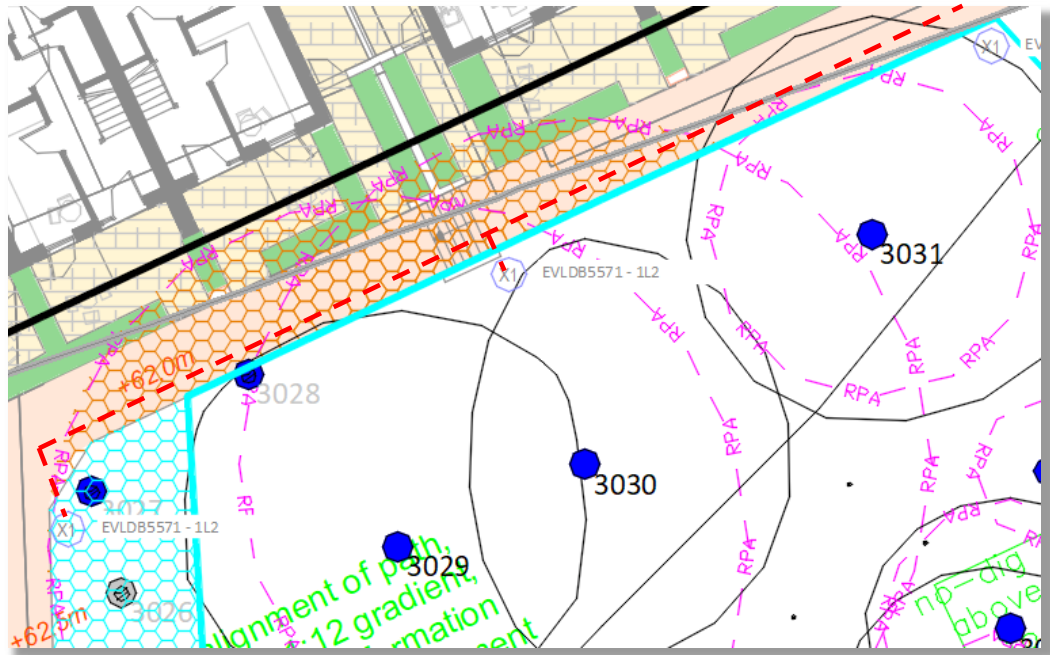
6. The marked-up *Tree Protection Plan* extract at Figure 2 below demonstrates the drainage trench has severed a chord on the north side of the RPAs of 3029 and 3030. This area was specified on the TPP to be protected initially by a combination of tree protection barriers in combination with temporary ground protection during construction, the latter to be replaced by a no-dig permanent surface thereafter, the objective being to avoid intrusions below ground level to safeguard roots for ongoing tree health and stability.

*Figure 2. Extract from tree protection plan FLAC 31-1036.06-D: Orange octagonal hatch indicates area of temporary/permanent no-dig surfacing with dashed red line (added here) to mark-up indicative alignment of electric feed (in common trench) with short spurs radially towards trees to the two lamp columns that have been located within the RPAs. Lamp columns shown as blue octagonal polygons bearing X1 annotations*

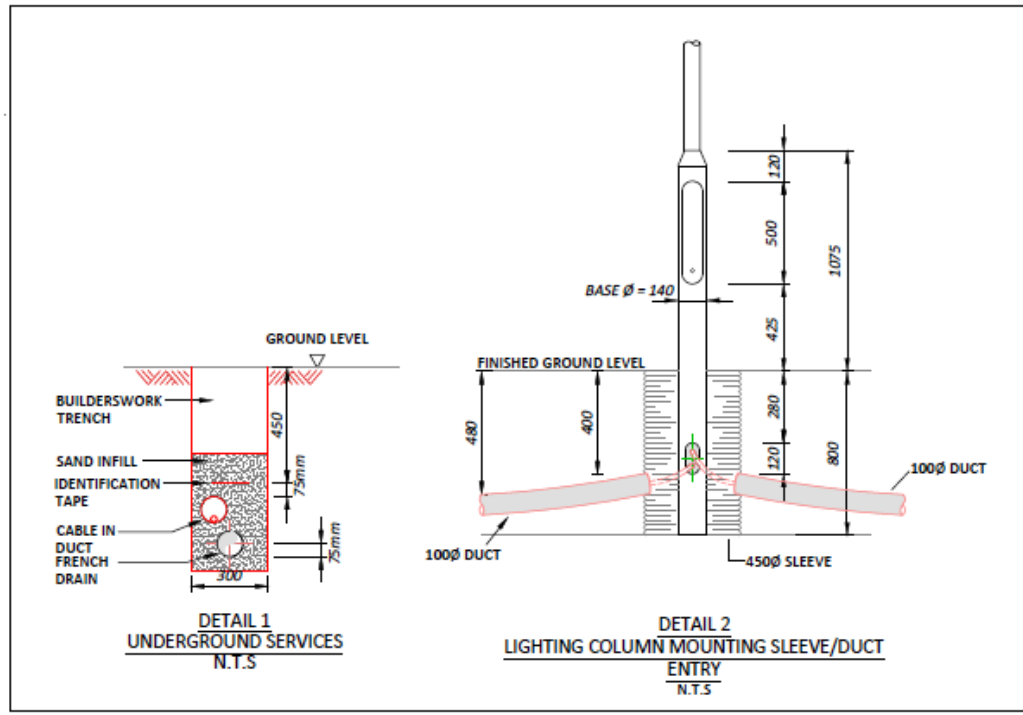
Figure 3. Section detail of common trench for both drainage and electric feed

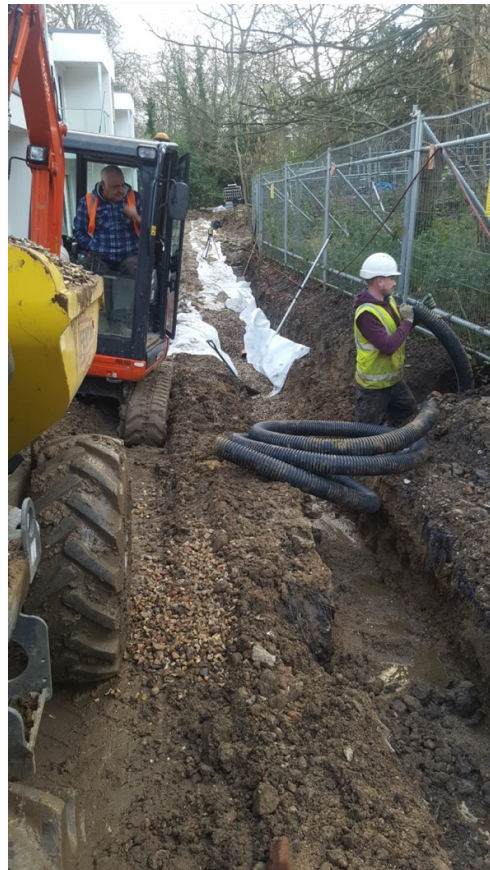
7. The photograph at Figure 4 below (and appended also at larger scale) shows the trench works at time of construction, in relation to the tree protection fencing. We understand that the excavations took place greater than one year ago, accordingly, subterranean investigations would risk further disturbance to existing or potentially regrown roots. By assessment of the photograph no significant roots can be seen on the tree side of the trench.

Figure 4. Common trench to north of tree protection fence within RPAs of 3029 and 3030, shows spur to lamp column opposite 3030 being installed

8. Of course, there are limitations to any conclusions that can be drawn from the Fig. 4 photograph including that it does not fully show the section opposite 3029. However, no significant roots are visible in the photograph and it is our experience of photographing subterranean investigations near to trees that ordinarily where roots are present they can be seen, including roots smaller than 25mm in diameter.
9. We have reviewed the topographical survey prepared prior to redevelopment to learn what we can about the pre-existing site conditions and whether the previous situation may have affected root distribution within the area of disturbance. Figure 5 below depicts an extract of the topo with the FLAC ids. 3029, 3030 and 3031 overlaid including their RPAs.

17. In mitigation for the disturbance to the RPAs at north of 3029 and 3030 and the potential for root severance we make the following management recommendations, which take the form of firstly crown pruning and secondly a scheme of re-assessment:

- i) Horse chestnut 3029 - Reduce height by 3 metres and lateral spread by 2 metres  
(NB past FLAC pruning recommendation not fully actioned, 23.07.19)
- ii) Horse chestnut 3030 – Reduce height by 3 metres and lateral spread by 2 metres

We advise that the pruning to the two horse chestnuts 3029 and 3030 is undertaken within 3 months of this advice.

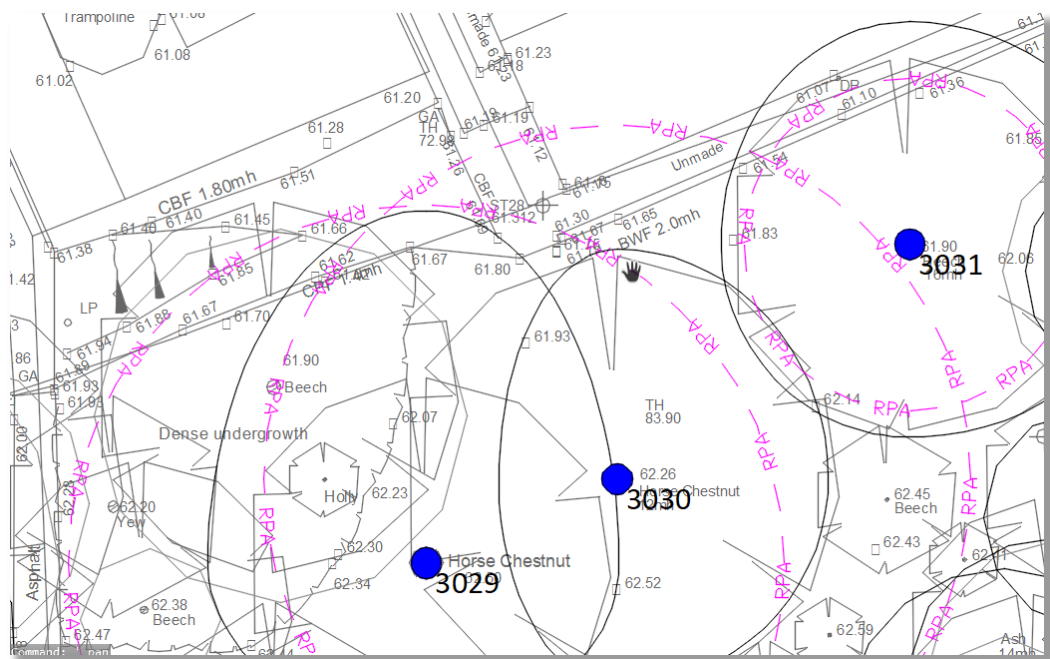
Figure 5. Pre-construction topo extract (thought to originate from 2014) showing information within RPAs at north of 3029 and 3030

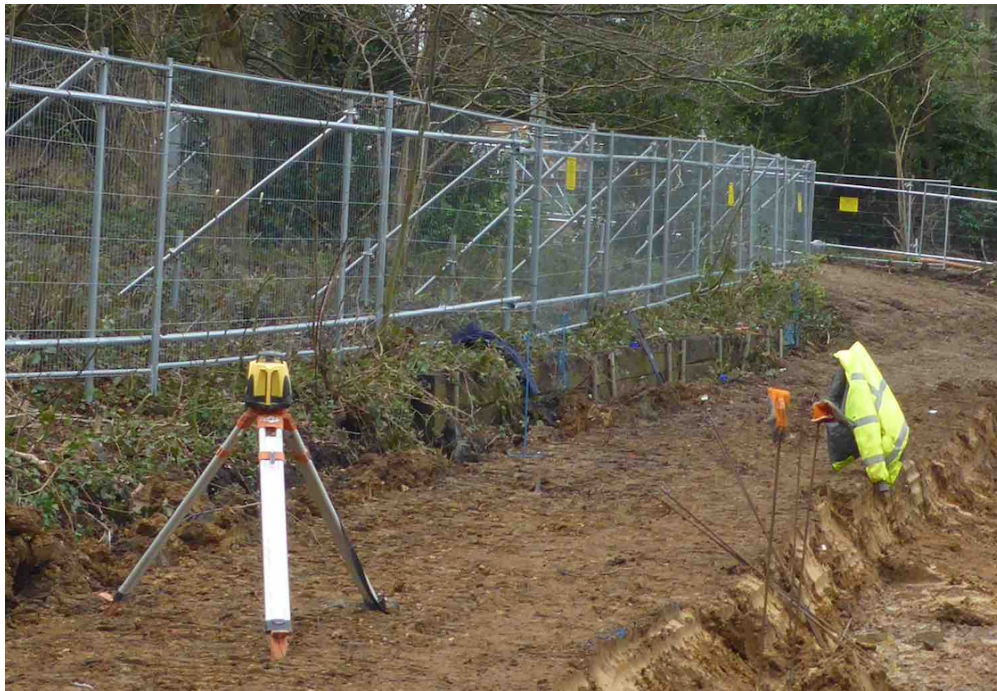
10. The topo survey shows that opposite 3030 the area of disturbance occurs where previously there was a small retaining structure with levels lower to the north. The topo is silent on the precise nature of this feature but a photograph taken during a FLAC site visit (01.03.17, see Figure 6 below) shows a small timber sleeper retaining structure. It is possible that historic ground modelling associated with the previous light industrial site use may have impeded root presence in the area of disturbance.

Figure 6. Photograph extract from FLAC site visit 01.03.17 to show position of former shallow retaining structure opposite 3030 to 3031, diminishing opposite 3029

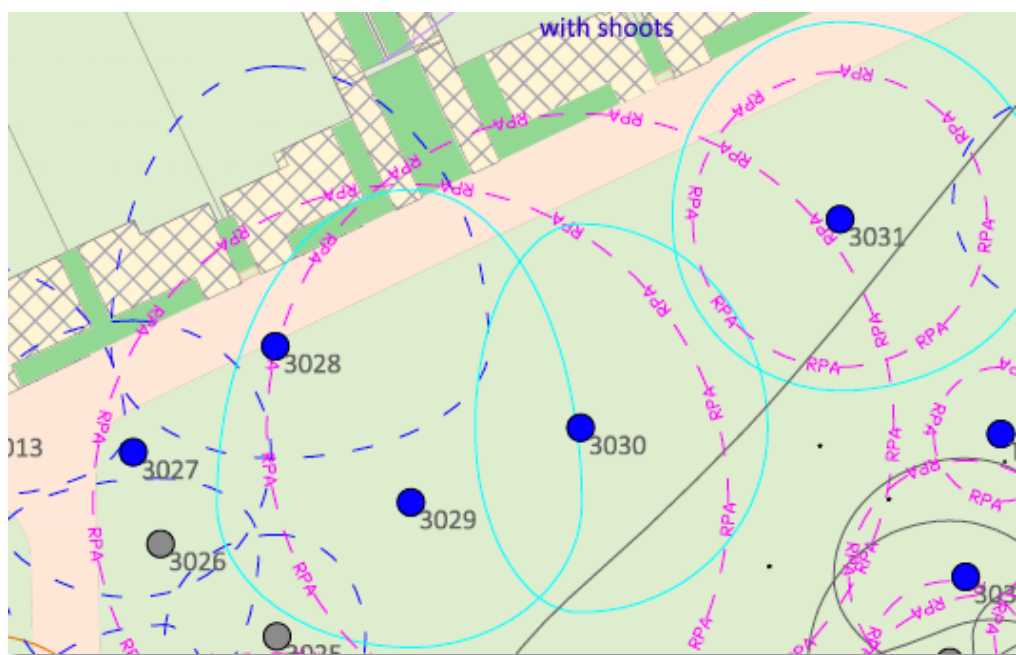
11. We have reviewed our 2015 Planning Submission material, which at its drawing entitled *Tree Survey, Retention & Removal Proposals + Layout* FLAC Drwg No. 31-1036.05-A (see extract at Figure 7 below) shows the previous tree presence in this area.

Figure 7. Plan extract from FLAC Planning Submission material (2015) to show positions of former trees in relation to 3029

12. The drawing extract shows the locations of former trees felled to facilitate development FLAC identifies. 3026, 3027 and 3028 at west to north RPA quadrant. It is possible that roots of these former trees may have dominated the soil such that it was less attractive for root colonization of this area by roots from 3029 due to the inevitable competition for water and nutrients. However, this might only mean that the horse chestnut dispersed fewer roots here rather than no roots.

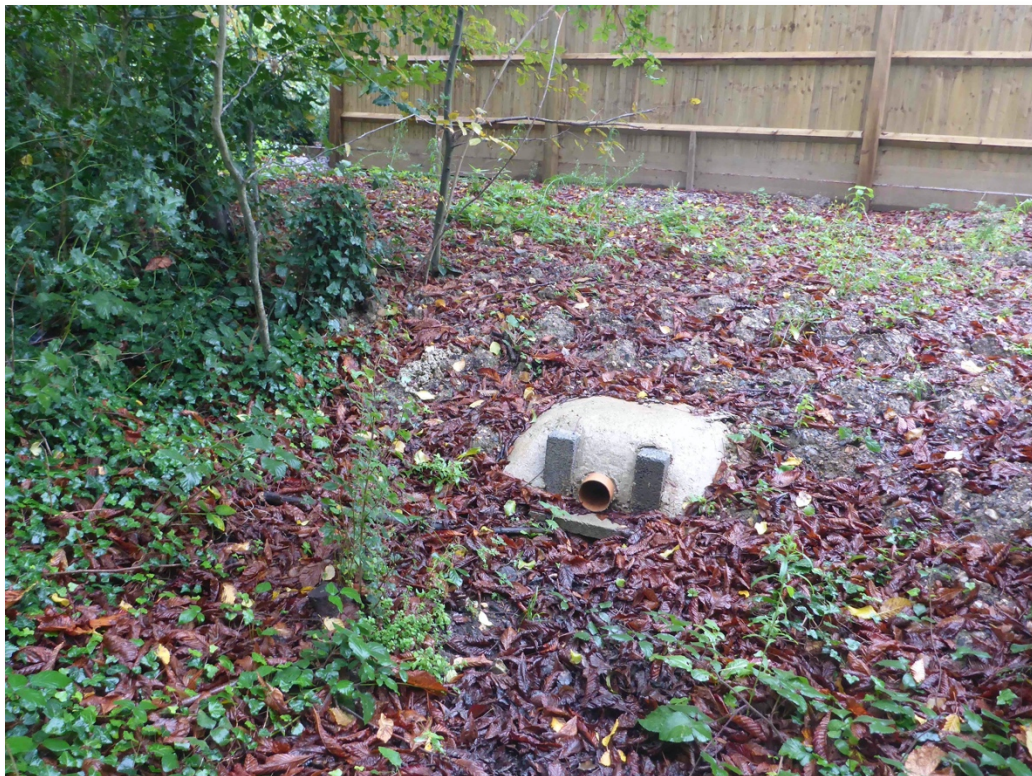
14. The drainage drawing provided to us depicts 3no. land drains discharging into the wooded area to east of the development and a land drain within the RPA of 3051. On site however, we found only one drain discharging into the woodland, in a position not shown on the plan provided to us (see photograph Figure 8 below). Furthermore, we have been told by Francis Construction that the land drain shown on the drawing that lies within the RPA of 3051 has not been constructed.

Figure 8. Land drain discharge located within RPAs of 3047 and 3048

16. We do not anticipate significant disturbance has occurred to 3047 or 3048. No arboricultural mitigation is proposed beyond a schedule of re-assessment of condition as set out below.

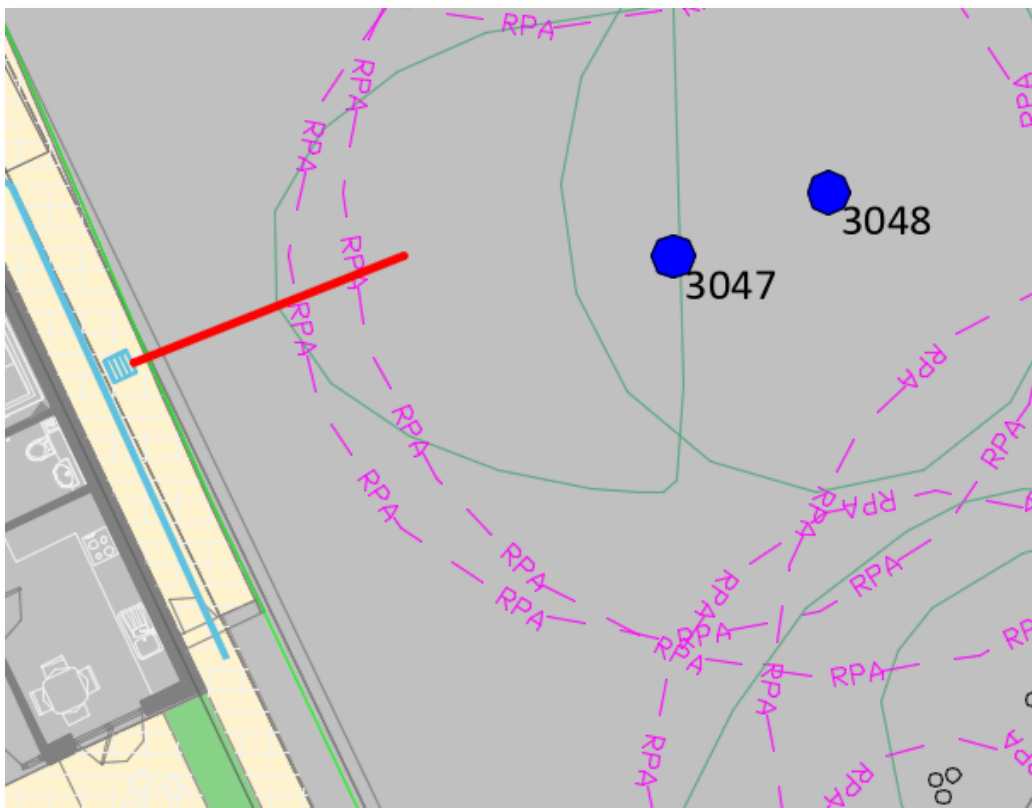
15. The land drain terminates ca. 5.1 metres west of stem centre of 3047, its alignment enters the periphery of the RPAs radially (see marked-up plan extract Figure 9 below). This feature appears to be formed predominantly, if not wholly, within recently made (raised) ground such that it may sit above pre-existing ground levels and intrusion below ground level is thought to be minimal (topo survey does not provide levels for this off site area). Whilst no ill-effects are evident currently, the council may have views on discharge of land drainage into the off site wooded area.

Figure 9. Red line our mark-up to show land drain discharge into west RPA periphery
