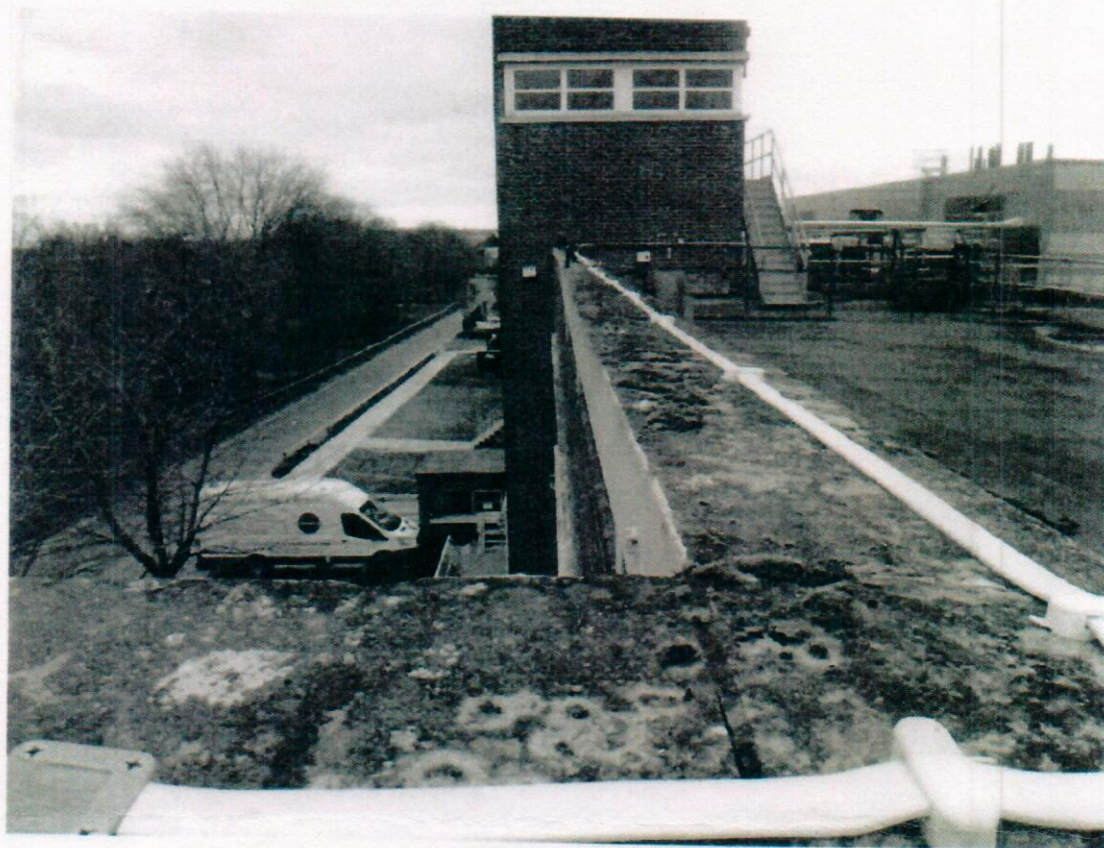
Figure 5 - View along top of parapet wall with worst case deformation
