# Arboricultural Tree Survey<sup>©</sup>

Site: 16 Russett Glade, Emmer Green, Reading RG4 8UJ

Client: Mr Greg Muden Date: March 2021 Surveyor: Hugo Loudon

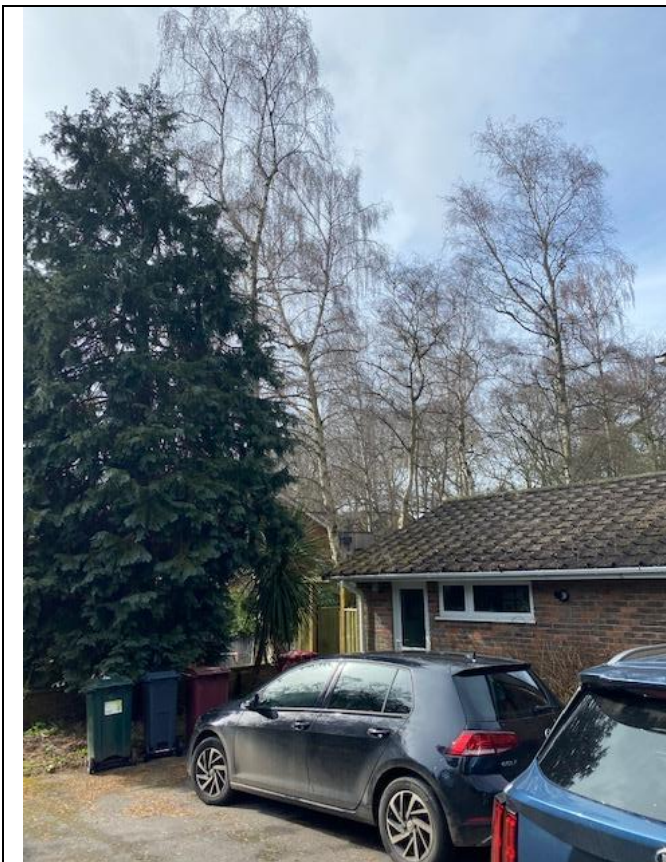
| TREE<br>or<br>GROUP<br>or<br>HEDGE | Species<br>Common Name<br>If tree offsite,<br>record<br>estimated<br>measurements<br>using '#' | DBH at<br>1.5m<br>recorded<br>in<br>mm | Canopy HEIGHT<br>in metres +<br>FIRST BRANCH<br>in metres from<br>ground level<br>with cardinal<br>direction | Branch<br>Spread<br><br>N E S W<br>metres | Age<br><br>Y<br>SM<br>EM<br>M<br>LM<br>OM<br>Vet | SULE<br><br><10<br>10+<br>20+<br>40+ | General<br>Observations | Structural<br>form<br><br>Poor<br>Fair<br>Good<br>Dead | Physiological<br>form<br><br>Poor<br>Fair<br>Good<br>Dead | BS<br>5837<br>RC<br><br>A<br>B<br>C<br>U | BS 5837<br>RPA<br>Radius<br>in metres | Recommended works |
|---|---|---|---|---|---|---|---|---|---|---|---|---|
| T1 | Lawson<br>Cypress | 420 | H: 10m<br><br>FB: 1m/W | N 2<br>E 2<br>S 3<br>W 4 | M | 40+ | Historic sib-stem removal to<br>north.<br><br>Likely to become dominant and<br>shade property in time. | Good | Good | C2 | 5.1m<br>81m <sup>2</sup> | --- |

T1 Lawson Cypress to left

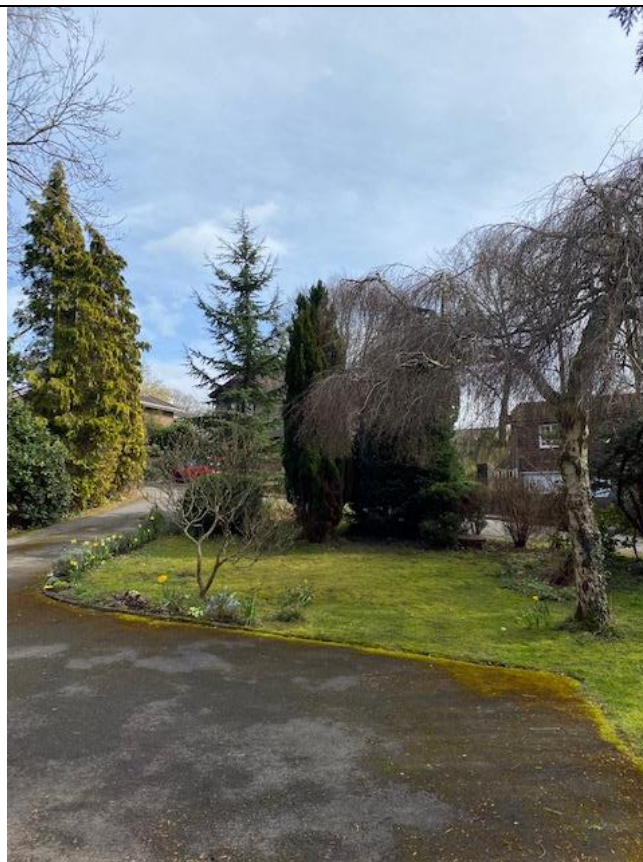
| TREE<br>or<br>GROUP<br>or<br>HEDGE | Species<br>Common Name<br>If tree offsite,<br>record<br>estimated<br>measurements<br>using '#' | DBH at<br>1.5m<br>recorded<br>in<br>mm | Canopy HEIGHT<br>in metres +<br>FIRST BRANCH<br>in metres from<br>ground level<br>with cardinal<br>direction | Branch<br>Spread<br><br>N E S W<br>metres | Age<br><br>Y<br>SM<br>EM<br>M<br>LM<br>OM<br>Vet | SULE<br><br><10<br>10+<br>20+<br>40+ | General<br>Observations | Structural<br>form<br><br>Poor<br>Fair<br>Good<br>Dead | Physiological<br>form<br><br>Poor<br>Fair<br>Good<br>Dead | BS<br>5837<br>RC<br><br>A<br>B<br>C<br>U | BS 5837<br>RPA<br>Radius<br>in metres | Recommended works |
|---|---|---|---|---|---|---|---|---|---|---|---|---|
| T2 | Weeping<br>Birch | 270 | H: 6m<br><br>FB: 3m/E | N 6<br>E 4<br>S 5<br>W 6 | M | 20-<br>40 | Nothing of note. | Good | Good | B2 | 3.3m<br>34m <sup>2</sup> | --- |
| T3 | Yew | 250 | H: 4m<br><br>FB: 0m/E | N 1.5<br>E 1.5<br>S 1.5<br>W 1.5 | EM | 40+ | Maintained as a signature topiary<br>tree. | Good | Good | B2 | 3.0m<br>28m <sup>2</sup> | --- |
| T4 | Atlantic<br>Cedar | 150 | H: 7m<br><br>FB: 1m/S | N 2<br>E 2<br>S 2<br>W 2 | SM | 40+ | Providing street scene function. | Good | Good | B2 | 1.8m<br>10m <sup>2</sup> | --- |

| T5<br>A + B | 2x Lawson<br>Cypress<br>Aureum | A:<br>150x2<br>B: 150,<br>150,<br>120,<br>120 | H: 8m<br><br>FB: 0m/S | N 2<br>E 2<br>S 2<br>W 2 | SM | 10-<br>20 | T5A co-dominant and T5B multi-<br>stemmed.<br>Consistent dead patches of<br>foliage present. Possible<br>Cupressus aphid. | Fair | Poor | C3 | 2.4m<br>18m <sup>2</sup><br><br>3.3m<br>34m <sup>2</sup> | --- |

Road frontage to south. Right to left: T2, T3, T4, T5

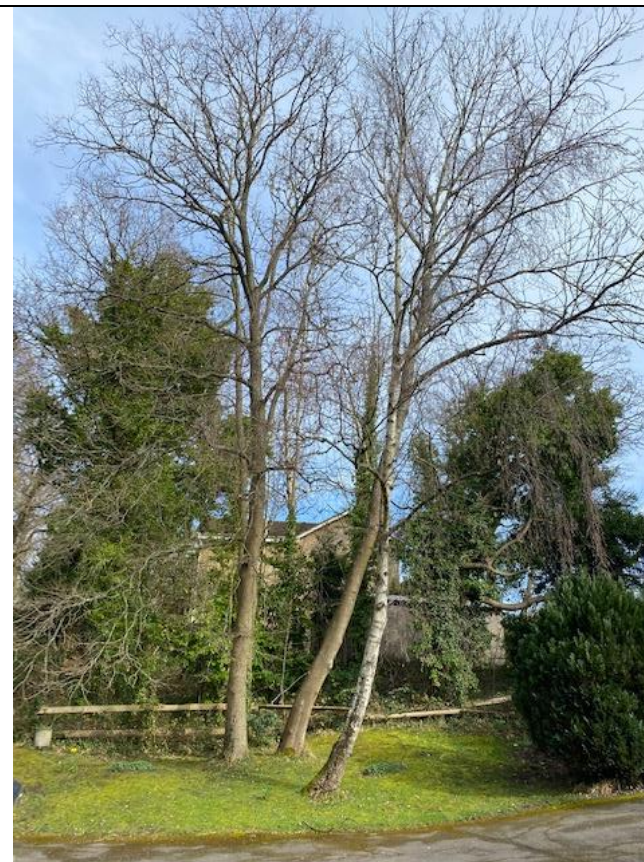
| T6 | Birch | 250 | H: 12m<br><br>FB: 3m/S | N 0<br>E 1<br>S 6<br>W 4 | EM | 10+ | Canopy bias to south.<br>Some evidence of retrenchment. | Poor | Fair | C3 | 3.0m<br>28m <sup>2</sup> | --- |
| T7 | Ash | 330 | H: 14m<br><br>FB: 8m/S | N 3<br>E 3<br>S 7<br>W 3 | M | 10+ | Canopy bias to south. | Good | Good | B2 | 3.9m<br>48m <sup>2</sup> | Monitor for signs of Ash Dieback. |
| T8 | Oak | 380 | H: 14m<br><br>FB: 4m/N | N 6<br>E 3<br>S 3<br>W 5 | EM | 40+ | Drawn form with competitive<br>proximity to T7 and T9. | Good | Good | A1 | 4.5m<br>64m <sup>2</sup> | --- |

T6 in foreground with T7 and T8 behind. Note T8 being of high amenity value

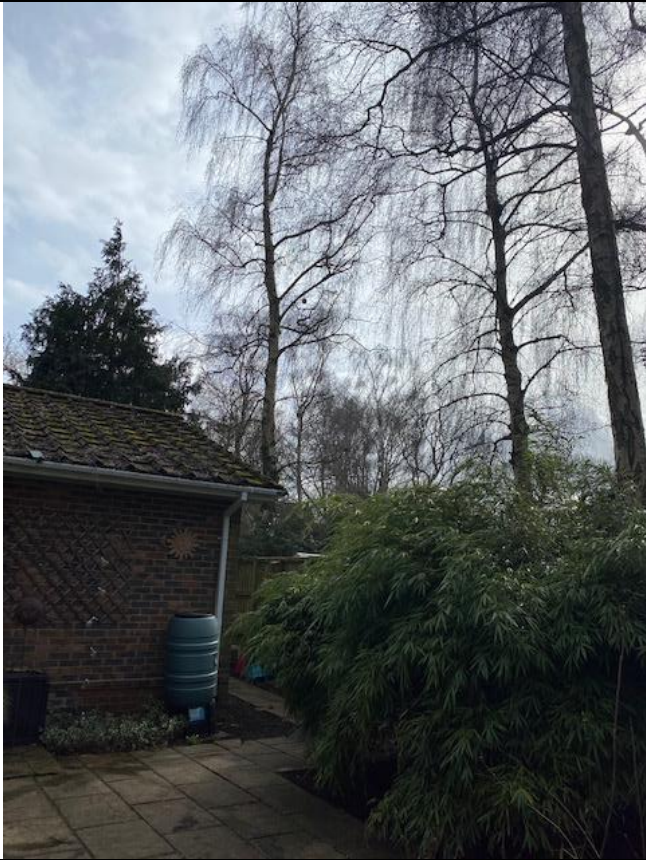
| T10 | Birch<br># | 380 | H: 15m<br><br>FB: 5m/S | N 3<br>E 3<br>S 5<br>W 5 | M | 20-<br>40 | Some basal swelling.<br>Canopy bias to south. | Fair | Good | B2 | 4.5m<br>64m <sup>2</sup> | --- |
| T11 | Birch<br># | 250 | H: 13m<br><br>FB: 5m/S | N 4<br>E 4<br>S 4<br>W 4 | EM | 20-<br>40 | No access to next-door. | Good | Good | B2 | 3.0m<br>28m <sup>2</sup> | --- |

T10 left and T11 far right

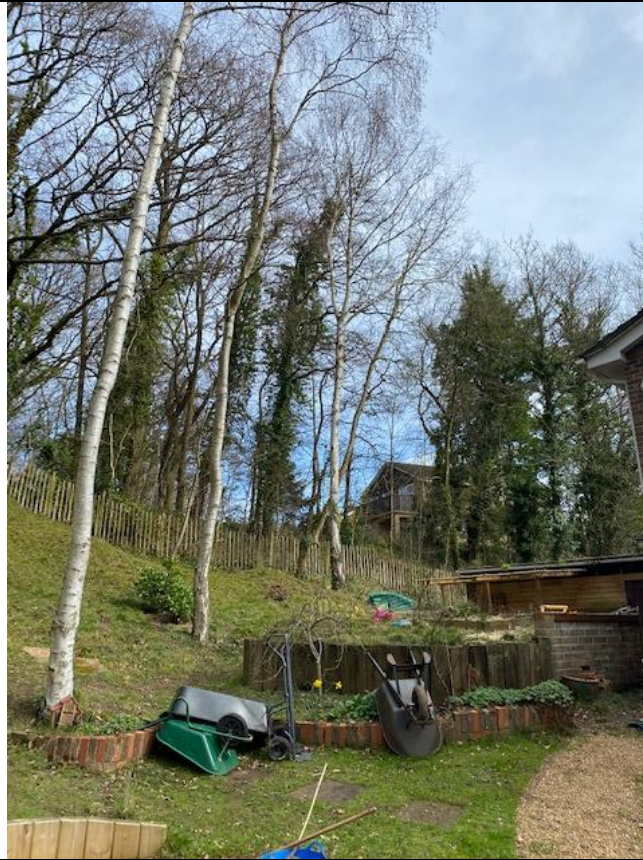
| T12<br>A+B | 2x Birch | 200 | H: 16m<br><br>FB: 8m/S | N 1-3<br>E 1-3<br>S 1-3<br>W 1-3 | EM | 40+ | Nothing of note. | Fair | Fair | B2 | 2.4m<br>18m <sup>2</sup> | --- |

| T13 | Birch | 245 | H: 15m<br>FB: 8m/S | N 3<br>E 2<br>S 5<br>W 5 | M | 20-40 | Bifurcation at 8.0. Basal cambium lost with exposed scar to east. Some embrittlement and wound wood formation. | Poor | Fair | C2 | 3.0m<br>28m <sup>2</sup> | --- |
| T14 | Ash | 150 | H: 15m<br>FB: 7m/S | N 0<br>E 2<br>S 5<br>W 2 | SM | <10 | Acute decay in stem. Historical leader loss apparent to south. Tip dieback issues associated with Ash Dieback Disease. | Poor | Poor | C3 | 1.8m<br>10m <sup>2</sup> | --- |

T12A+B, T13 and T14
