# **61 Baker Street - Listed Building Consent**

## **1.Design and Access Statement**

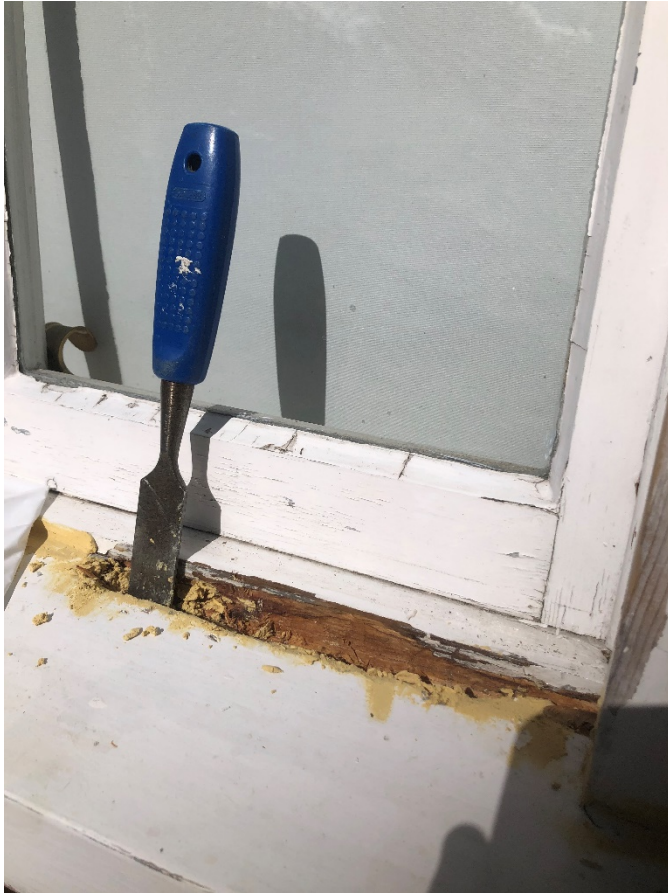
The sills are either original or more probably replacements (at least 35 years ago) and two of those (dining room and bedroom) at the rear (southside) of the property are now badly rotten and need replacement. I initially sought to repair them by filling but the wood is badly rotten and simply absorbing more water. In heavy rain the bedroom window already leaks. Additionally one sash frame (bathroom window) has cracked and rotted and requires repair.

**Dining room window sill – the rot extends the length of the sill**

We plan to cut out the rotten wood in the two sills (dining room and bedroom) and replace with hardwood. Once completed and painted the repairs will be undetectable. The one broken and rotten frame (bathroom) will be similarly repaired and made good.
