## Claim Assessment Report

**Our Reference:** IFS-AVI-SUB-19-0084937

**Policyholder:** Reading Spiritualist Church

**Risk Address:** 81 Baker Street, Reading, RG1 7XY

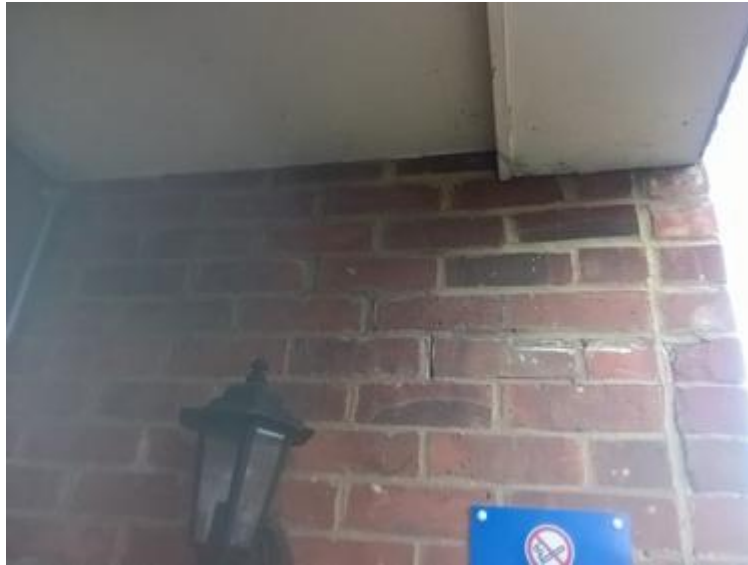
FIGURE 03 External Damage

External cracks to the front and rear of the building also imply foundation related movement over a relatively short period of time.

There is a large street tree to the front of the property which is likely to be the cause of most of the cracks evident in the building, both internal and external.

Generally cracks 1mm wide or less will be filled (internal) or re-pointed (external). Internally, where the cracks are wider than 1mm, but less than 5mm the underlying brickwork or blockwork will be exposed and prior to making good the plaster finishes the cracking will be covered with expanded metal lathe. Where cracks are 5mm across or wider, some form of bed joint reinforcement will be introduced.

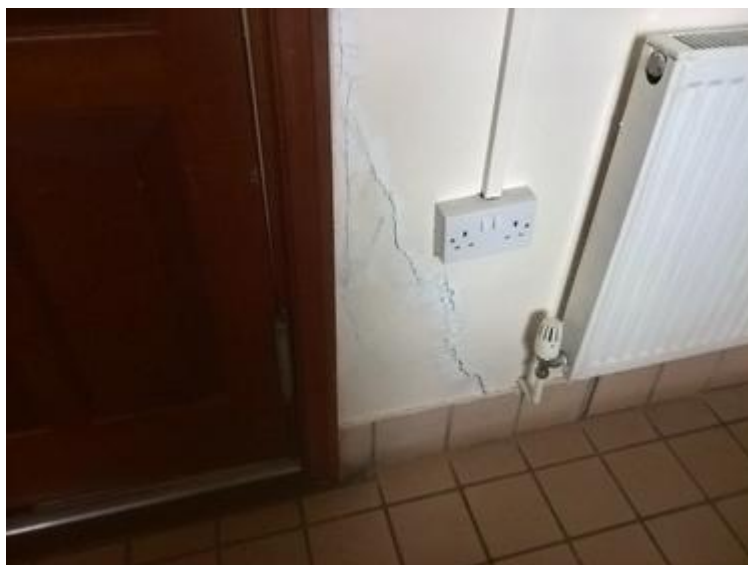
FIGURE 04 Internal Damage 1

Crack patterns and distortions towards the front of the Church Hall would imply foundation related movement has taken place over a relatively short period of time.

Cracks in the Hall, Cloakrooms, and Store room, appear to be all as a result of slight rotation of the foundations particularly to the front of the building.
