# Bat Survey Report – Preliminary Roost Assessment

58 Mayfair, Tilehurst, Reading RG30 4RD

September 2020

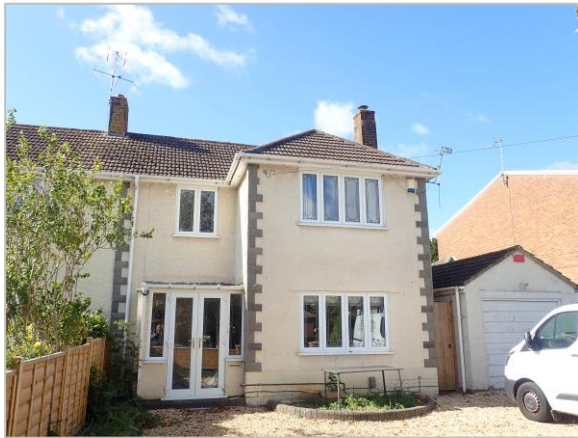
*Photo 1 Front elevation*

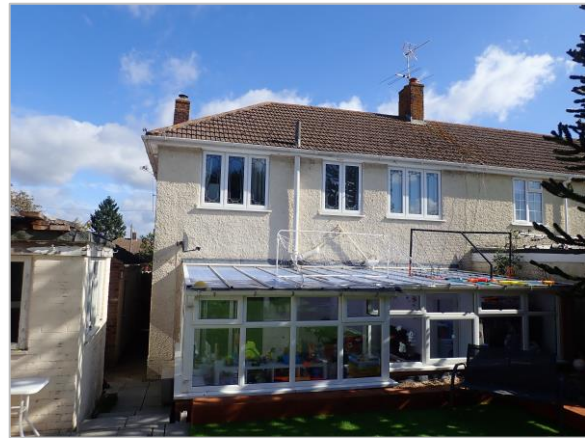
*Photo 2 Rear elevation*

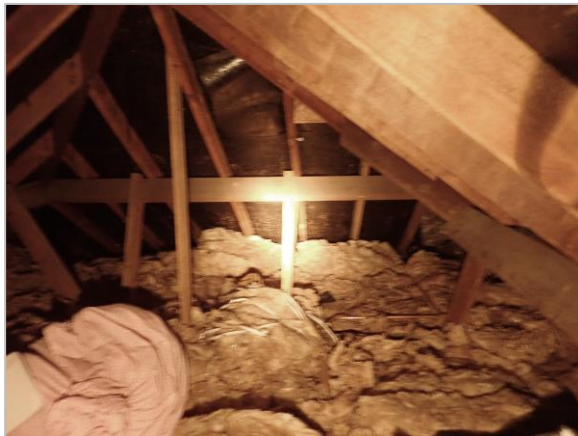
- 3.7. Internally, the loft was fully inspected. Photos 3 and 4 show the conditions in the loft. Examination of all surfaces, including internal timbers, floor, walls, and domestic services was carried out. Particular attention was paid to features such as the ridge apex at either end of the loft and joints in the timber work.

*Photo 3 General conditions in loft (hipped gable end)*

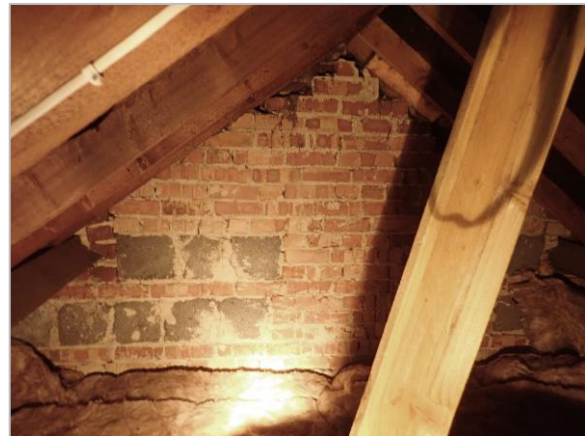
*Photo 4 General conditions in loft (partition wall)*

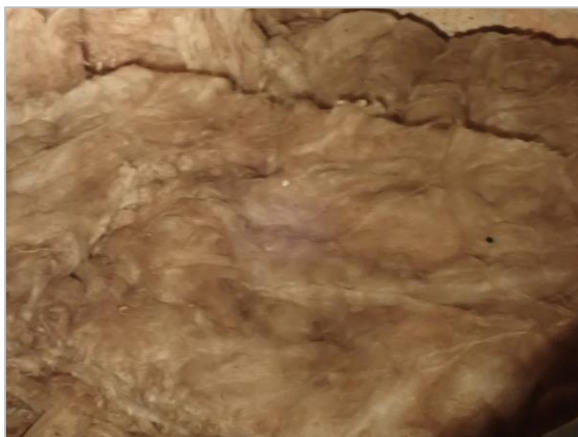
- 3.8. No droppings were seen on the floor (Photo 5) or any stored items (Photos 5-7) or the internal timbers or brickwork between the house and the adjoining property (Photo 8).

*Photo 5 Loft floor*

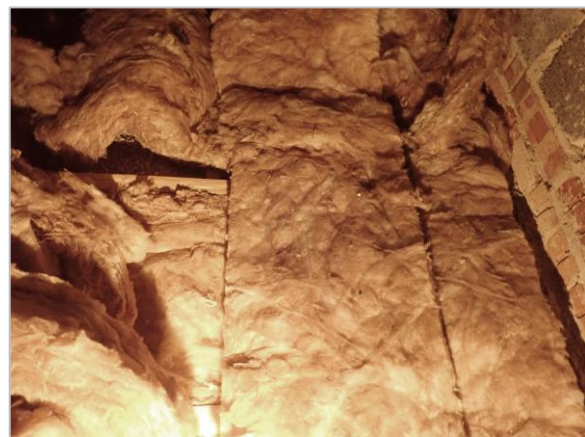
*Photo 6 Loft floor*

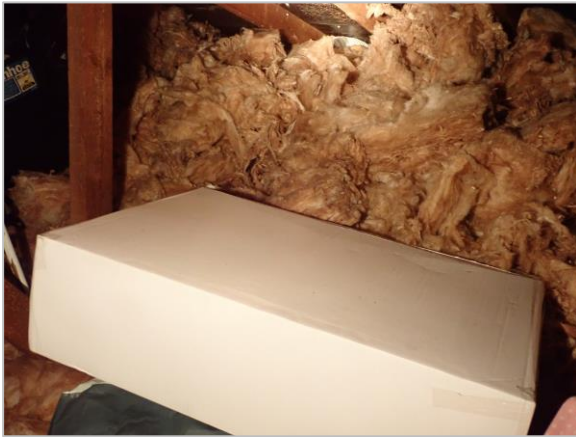
*Photo 7 No droppings on stored items*

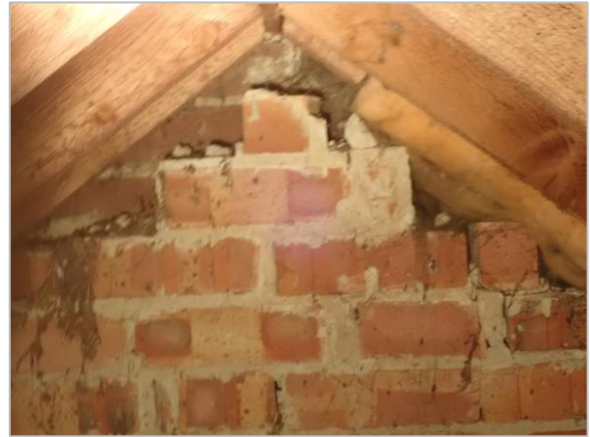
*Photo 8 Brickwork partition wall*

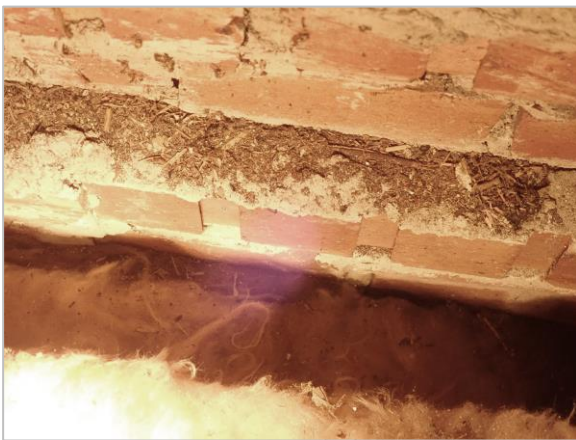
- 3.9. The insulation at the end of the house was carefully inspected, and spot checks were undertaken beneath the insulation in several places. Although a fair degree of dust and debris was noted in some areas, no evidence of recent or historic bat roosting activity was found (Photos 9 and 10).

*Photo 9 Brickwork at base of partition wall (debris but no bat droppings)*

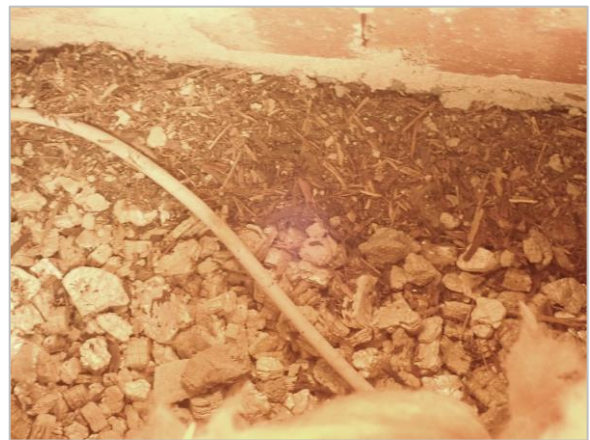
*Photo 10 Spot check under modern insulation*

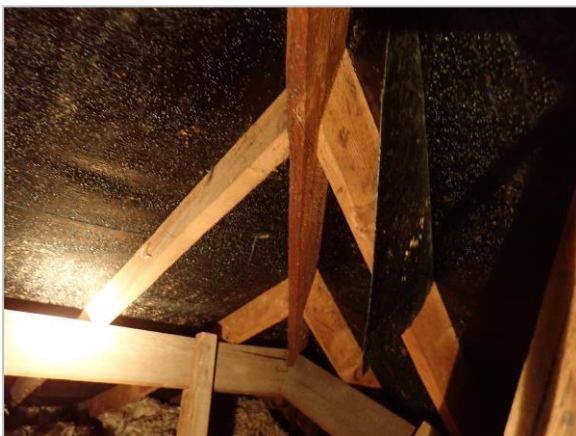
- 3.10. The roofing felt was in generally good condition (Photo 11) aside from a small area of damage (Photo 12). The area around the damaged section was thoroughly inspected and no bat evidence seen. The exposed roof tiles were inspected and found to be well fitting with no gaps present between the interlocking tiles that could allow bats access.

*Photo 11 Roofing felt in generally good condition*

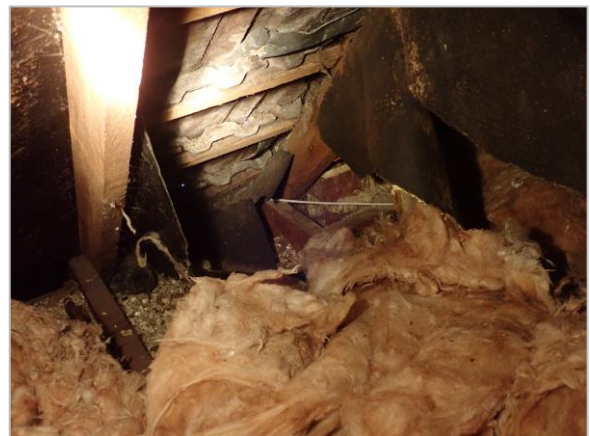
*Photo 12 Section of damaged felt*

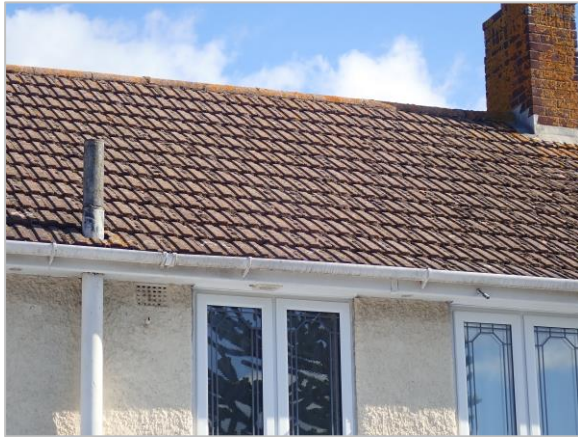
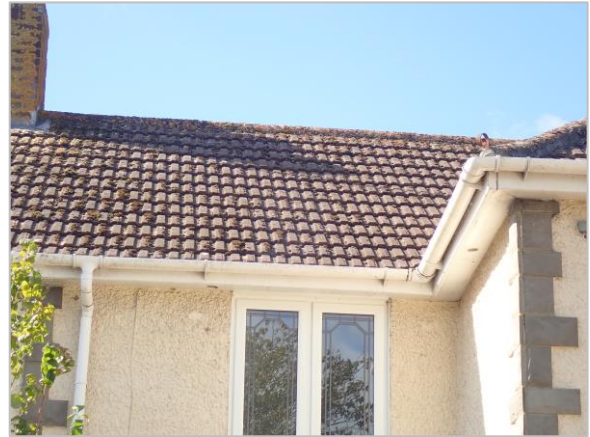
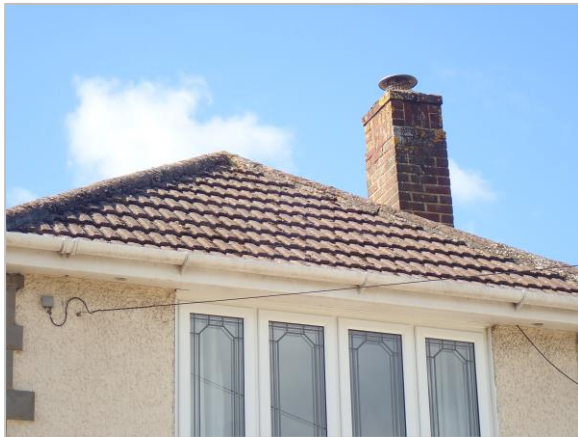
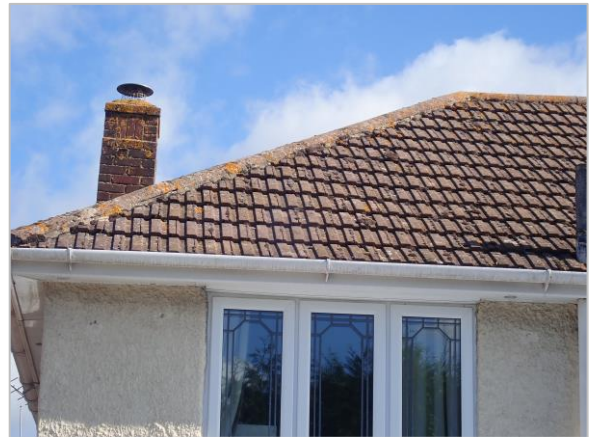
- 3.12. Externally, the roof tiles to front, rear, and side elevations were all found to be in good condition with no areas of damage, missing, or slipped tiles. They were found to be tightly fitting with no gaps. See Photos 13-16.
- 3.13. The ridge tiles and hip bonnets were undamaged, and the bedding mortar was in place with no areas of deterioration that could allow bat access.
- 3.14. There are plastic soffit boxes around the house. These were inspected and found to be in good condition – see Photos 17 and 18.
- 3.15. The garage roof was similarly in good condition with no damage to the tiles. The verge mortar to the garage gable ends was in good condition with no

*Photo 13* Roof and ridge tiles in good condition

*Photo 14* Roof and ridge tiles in good condition

*Photo 15* Roof and ridge tiles in good condition

*Photo 16* Roof and ridge tiles in good condition

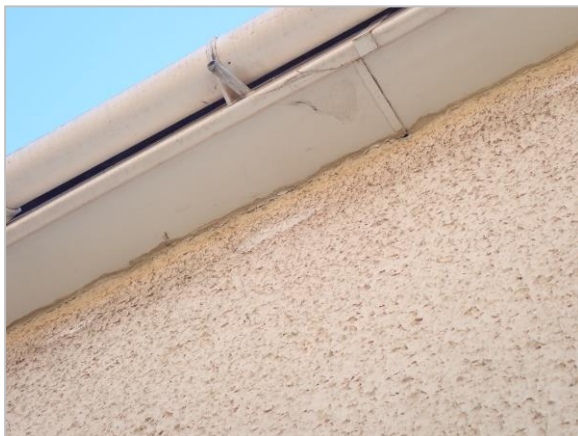
*Photo 17* Soffit in good condition

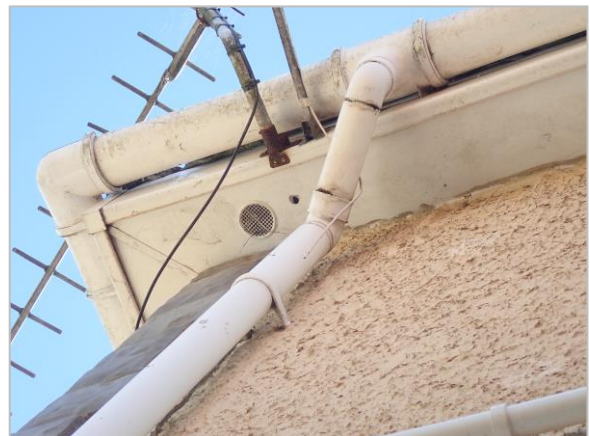
*Photo 18* Soffit in good condition

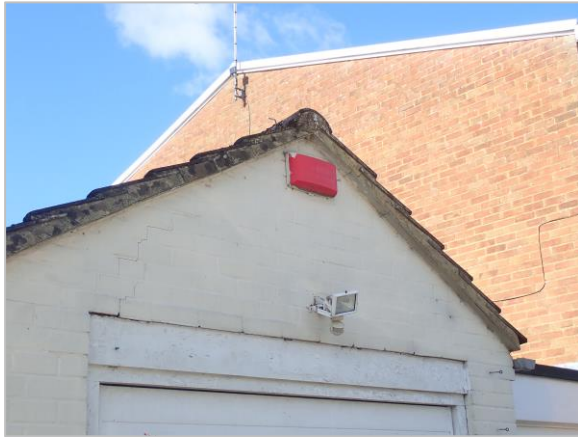
deterioration (Photo 19). The flat roofed section of the garage has a timber fascia, which was found to be in good condition and tight to the external walls with no gaps present – see Photo 20.

*Photo 19 Garage roof in good condition*

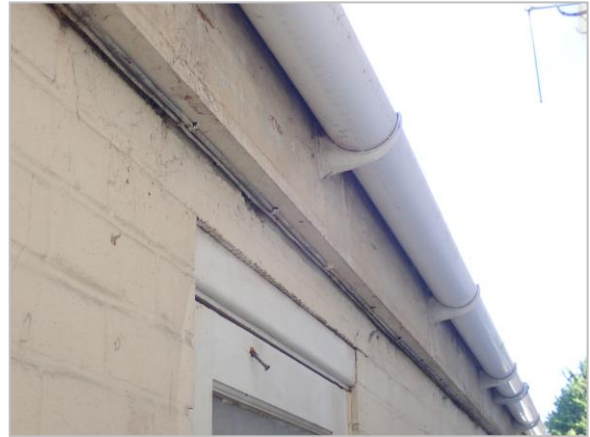
*Photo 20 Fascia around garage*
