# Arboricultural Consultancy for Aviva

| Insured | Mr Alan Carey | Address | 53 Crescent Road, Tilehurst, Reading, RG31 5AH | | |
| ES Ref | SA-244180 | Consultant | Lewis Fraser | Contact No. | 0330 380 1036 |
| Report Date | 21/06/2019 | | | | |

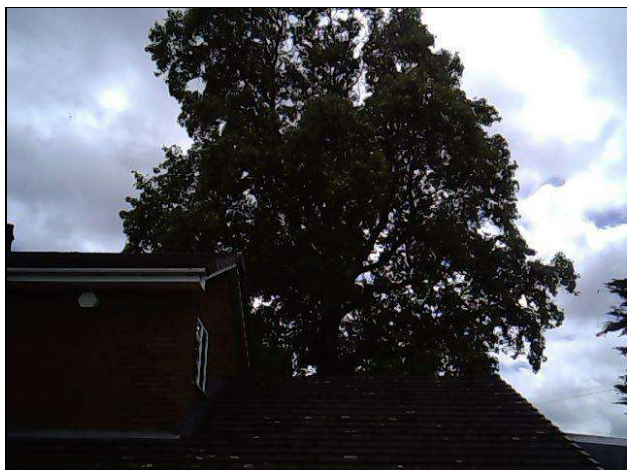
T1 - Tulip Tree

Our survey of the site identified T1 (Tulip Tree), given its position relative to the damage it is in our opinion that the roots identified within TP/BH1 and TP/BH2 will emanate from this vegetation.

In assessing the extent of damage, the potential drying influence of the vegetation on site and based on our site investigations, taking account of vegetation location, relative to the focal area of movement/ damage, it is our opinion that, T1 (Tulip Tree) is considered the dominant feature and accordingly we have identified it as the principal cause of the subsidence damage.

| Tree No. | Species | Age Cat | Approx. Height (m) | Distance to Building (m) * | Ownership | Action | Requirement |
|---|---|---|---|---|---|---|---|
| T1 | Tulip Tree | 2 | 18 | 7.6 | C - Insured | Remove | Remove close to ground level and treat stump to inhibit regrowth. |

Removal of T1 (Tulip Tree) will offer the most certain and reliable arboricultural solution likely to restore long-term stability.

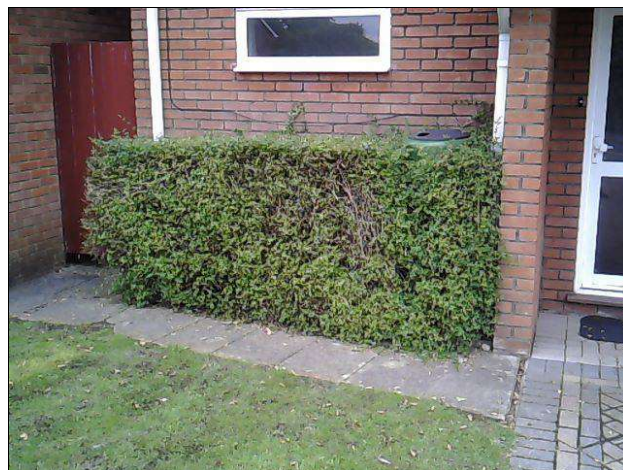
H1 - Jasmine

Please note that the footing of the insured property fall within the anticipated rooting distance of additional vegetation which we believe presents a foreseeable risk of future damage and accordingly we have made recommendations in respect of this.

| Tree No. | Species | Age Cat | Approx. Height (m) | Distance to Building (m) * | Ownership | Action | Requirement |
|---|---|---|---|---|---|---|---|
| H1 | Jasmine | 1 | 1.3 | 0.1 | C - Insured | Action to avoid future risk | Do not allow to exceed current dimensions by way of regular pruning. |

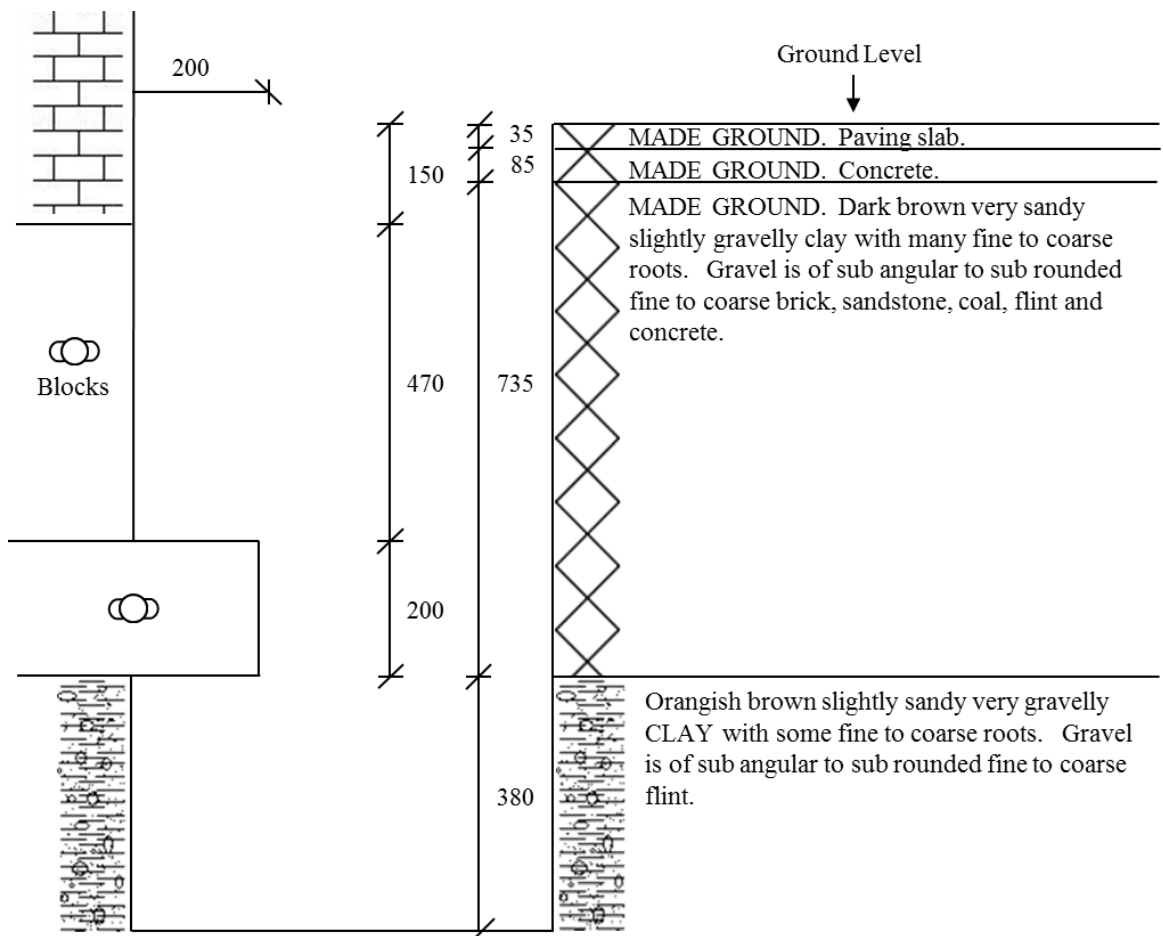
## TP/BH1 Foundation Detail

For strata information below 1.2m, please refer to borehole log TPBH1.

| Location<br>53 Crescent Road, Tilehurst, Reading, RG31 5AH | | | | | | BOREHOLE No<br><b>TP/BH01</b> | | | | | |
|---|---|---|---|---|---|---|---|---|---|---|---|
| 0.82-1.70<br>0.90 | ROOTS<br>B1 | | | | | (1.20) | Trial pit.<br>Base of foundation 0.82m. | | | | |
| 1.40 | HVB2 | 136kPa@1.4m | | | | 1.20<br>(0.90) | Orangish brown slightly sandy very gravelly becoming more gravelly with depth CLAY with some fine to coarse roots. Gravel is of sub angular to sub rounded fine to coarse flint. | | | | |

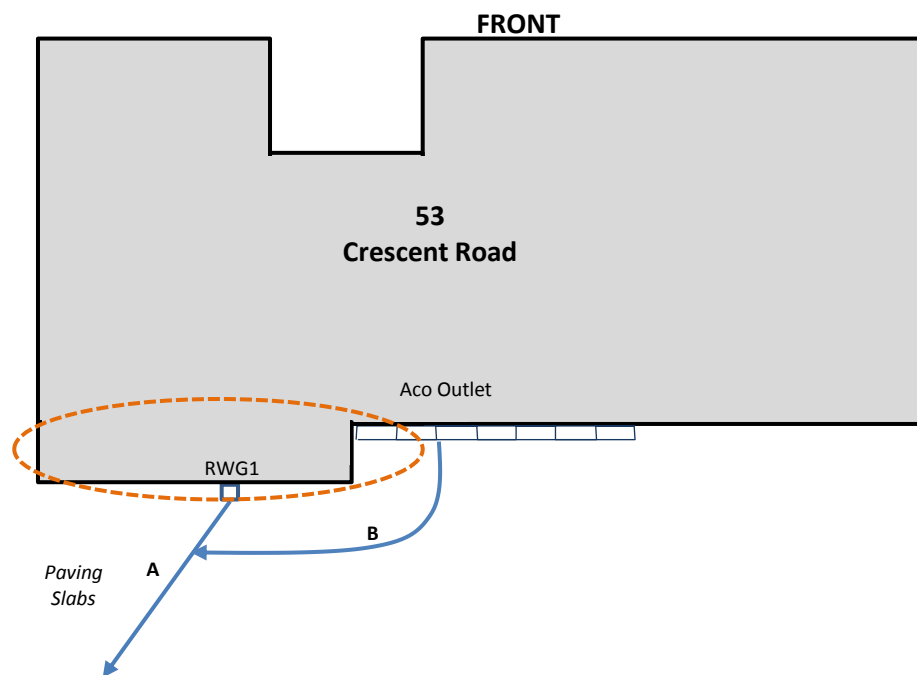
**Drain Run A: RWG1 to Downstream Node Point**

**CCTV Survey Result:** Structural Damage

**Drain Run B: Aco Outlet Downstream to Run A**

To excavate and replace existing gully including 2.75m of pipework.

Survey from excavation within the area of concern and report on findings

Excavate and replace pipework from junction upstream for approx 0.5m to remove defect noted at 1.9m.
