### Level and Crack Monitoring

**Our Ref:** 531994

**Date of Issue:** 21/01/2020

| Address: | <b>71 Milman Road</b> |

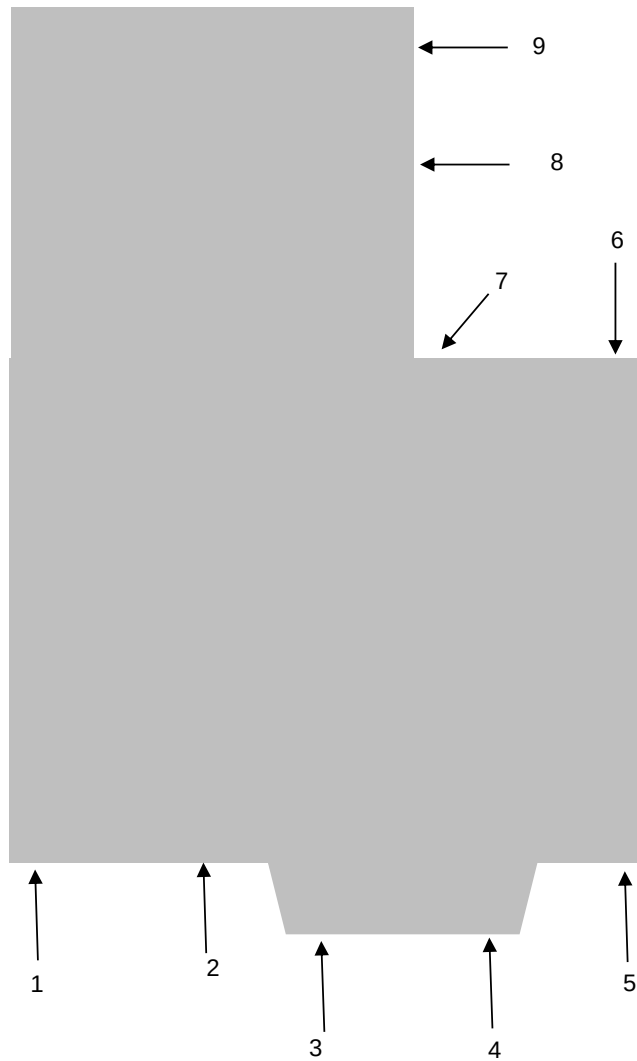
**Level and Crack Monitoring - Site Sketch**

TBM HILTI  
NAIL YELLOW  
SPRAY IN
