**12 Midwinter Close  
Tilehurst  
Reading  
Berkshire  
RG30 6HZ**

# **Preliminary Bat Roost Assessment**

**Ref: R2703/a**

**February 2021**

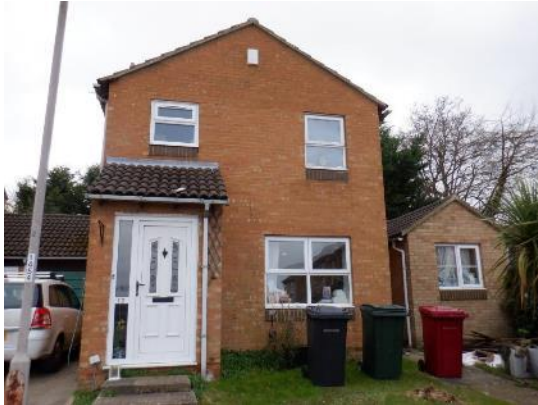
- 3.2.1** The detached house was of modern cavity wall construction with a pitched roof. There was a half pitched, half hipped single storey side extension on the western side of the house with a small bay window on the second storey above the extension, and an attached garage on the eastern side (**Photographs 1 & 2**).

1. Front of the house viewed from the north.

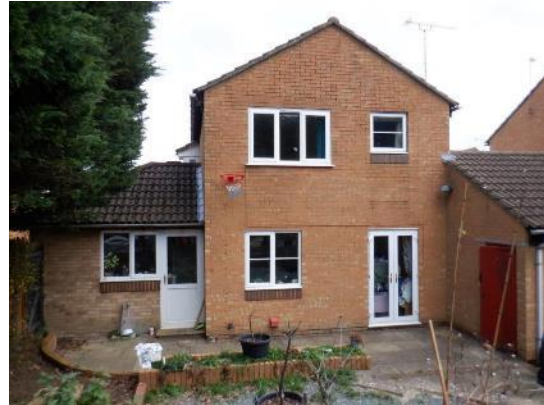
2. Rear of the house viewed from the south.

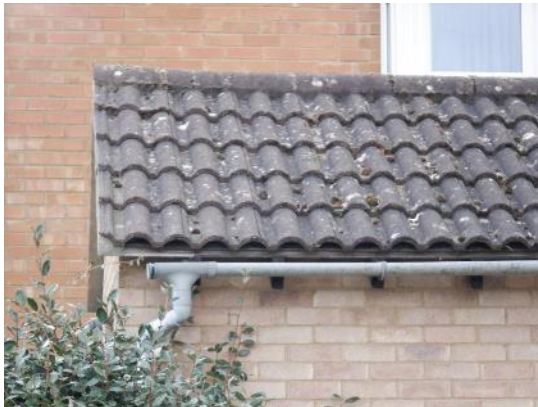
- 3.2.2** The roof of the house and side extension were covered with interlocking S-shaped roof tiles, which were all in place and fitted tightly (**Photograph 3; Target note 1**). The mortar between the hipped tiles was intact on the side extension (**Photograph 4; Target note 2**). The ends of the tiles were blocked with a plastic filling on the western elevation of the house and side extension, with the tiles above the bay window blocked with chicken wire (**Photographs 5 & 6; Target notes 3 & 4**). The vented soffit was intact and flush to the wall around the whole of the house (**Photograph 7; Target note 5**). The mortar and cloaking tiles were intact on the verge of the front elevation of the house and the side extension, with some crumbling mortar at the south-eastern corner of the house (**Photographs 8 & 9; Target notes 6 & 7**). The front porch featured a mono-pitched roof with tight interlocking roof tiles, that were open at the end and had a section of lifted lead flashing on the eastern corner (**Photographs 10 & 11; Target notes 8 & 9**). There was a section of lifted lead flashing where the garage joined the rear of the house (**Photograph 12; Target note 10**).

3. Tight interlocking S-shaped roof tiles.

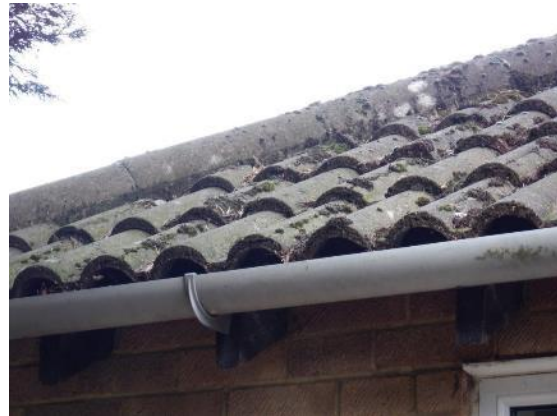
4. Intact hip mortar.

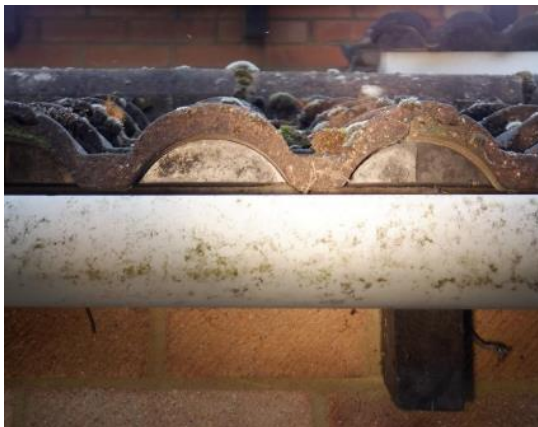
5. End of roof tiles blocked on side extension.

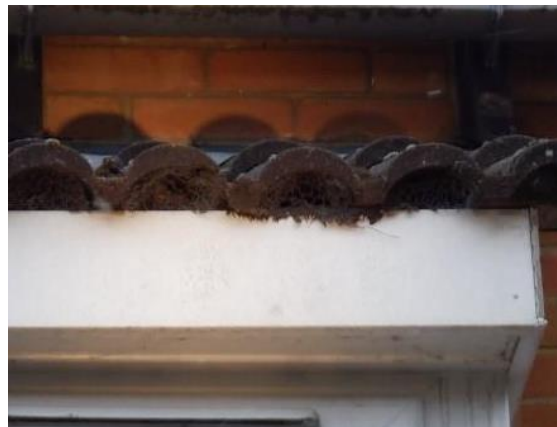
6. End of roof tiles above bay window covered in chicken wire.

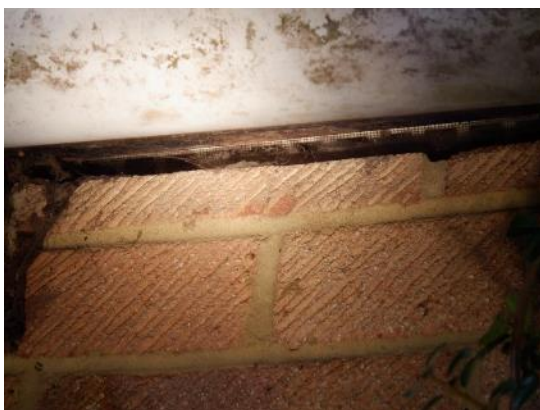
7. Tight vented soffit along eaves of the house, flush to the brickwork.

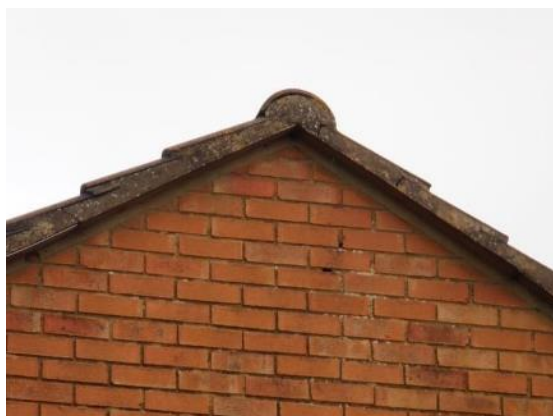
8. Intact mortar and under cloaking tiles on verge of the main roof.

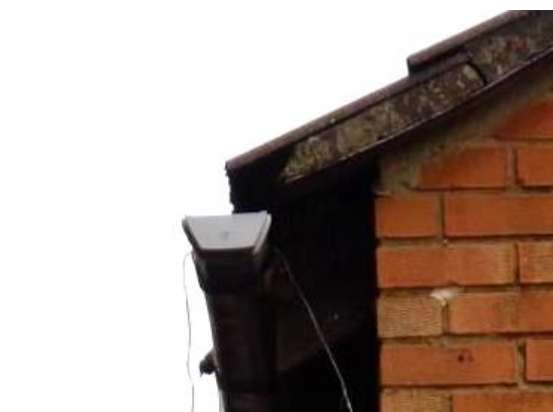
9. Broken mortar under verge tile on the south-eastern corner.

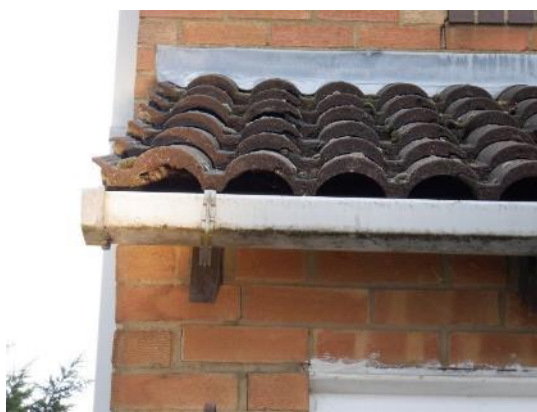
**4.1.1** There were no evidence of bats found during the internal or external survey of the house. The house had limited features suitable for use by crevice-dwelling bat species such as the pipistrelles (*Pipistrellus* spp.) and/or small *Myotis* species, including gaps behind areas of lifted lead flashing and at the ends of the unblocked interlocking roof tiles of the porch on the front elevation.

10. Unblocked verge tiles on porch roof on the front elevation.

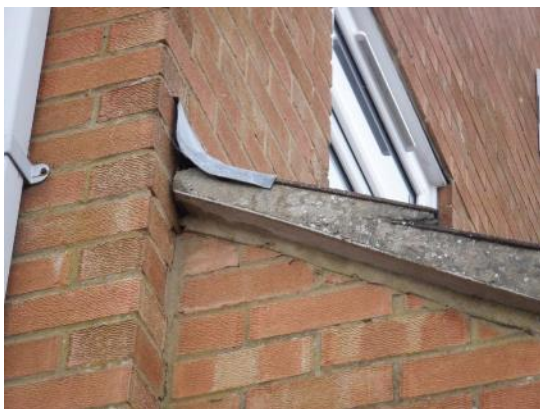
11. Lifted lead flashing on the eastern elevation of the porch roof.

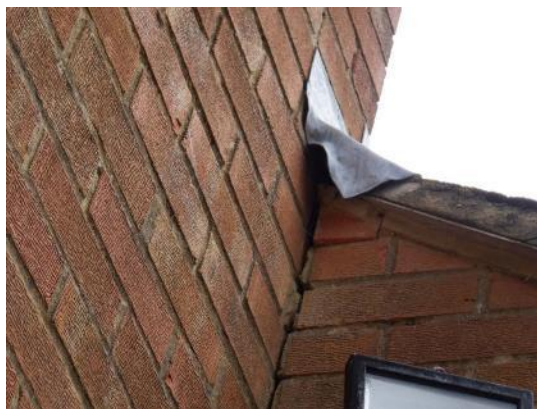
12. Lifted lead flashing on rear elevation where the garage joins the house.

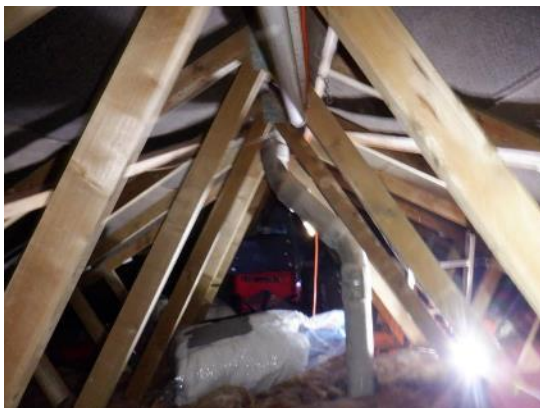
- 3.3.1** The roof void extended throughout the main roof space, with a ridge height of approximately 1.5 metres and the roof was of trussed rafter construction, which made the void cluttered (**Photograph 13**). The roof was lined with hessian and bitumen felt, with pieces of polystyrene creating vents in between the layers of felt (**Photograph 14; Target note 11**). There were two flue pipes in the roof space,

13. Roof void with trussed rafter construction.

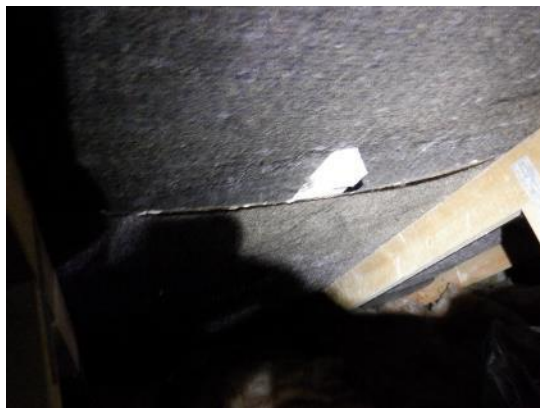
14. Hessian and bitumen felt covering roof, with pieces of polystyrene between the layers.

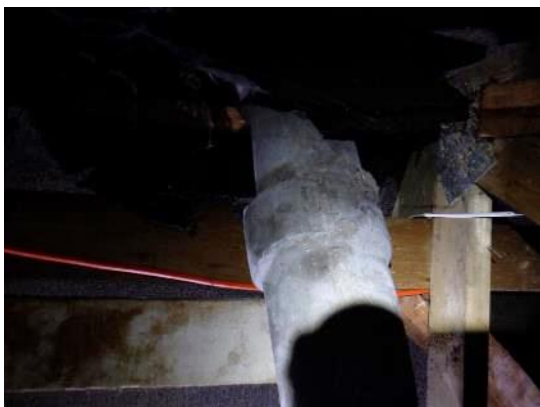
with one made of asbestos, and both had loose bitumen felt around the top of the pipes (**Photograph 15; Target note 12**). The floor was covered with fibreglass insulation, which filled sections of the eaves on the western part of the void, with the eaves open on the eastern side of the void and the wall plate was visible (**Photographs 16 & 17; Target note 13 & 14**). The ridge was moderately cobwebbed, as were the gables which were constructed of blockwork, with the southern gable featuring cobwebbed gaps between the blocks and the roof felt (**Photograph 18; Target note 16**). The northern gable had some paper backed insulation at the apex behind the rafters (**Photograph 19; Target note 17**).

15. Asbestos flue pipe with loose roofing felt around the top.

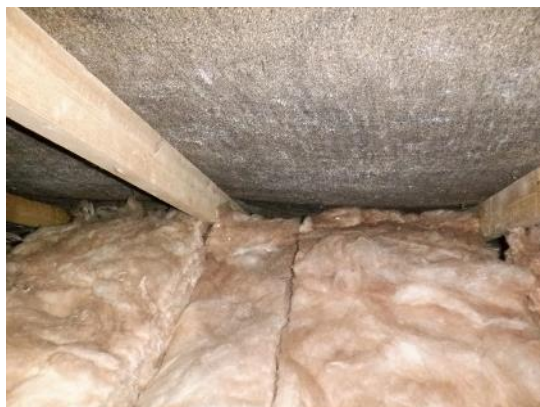
16. Eaves filled with fibreglass insulation on eastern side of the void.

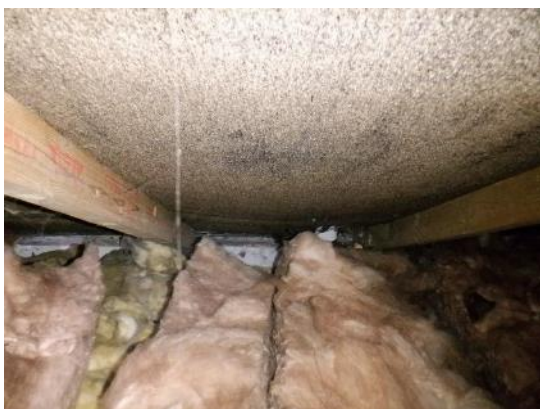
17. Open eaves and top of wall plate visible on the western side of the void.

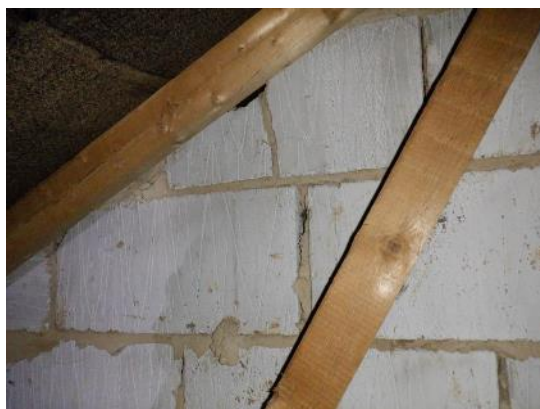
18. Cobwebbed gaps at the top of the blockwork at the southern gable

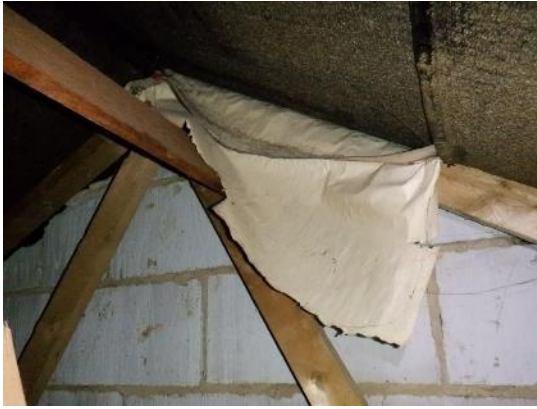
19. Cobwebbed blockwork at the northern gable, with paper bitumen present at the apex behind the rafters.

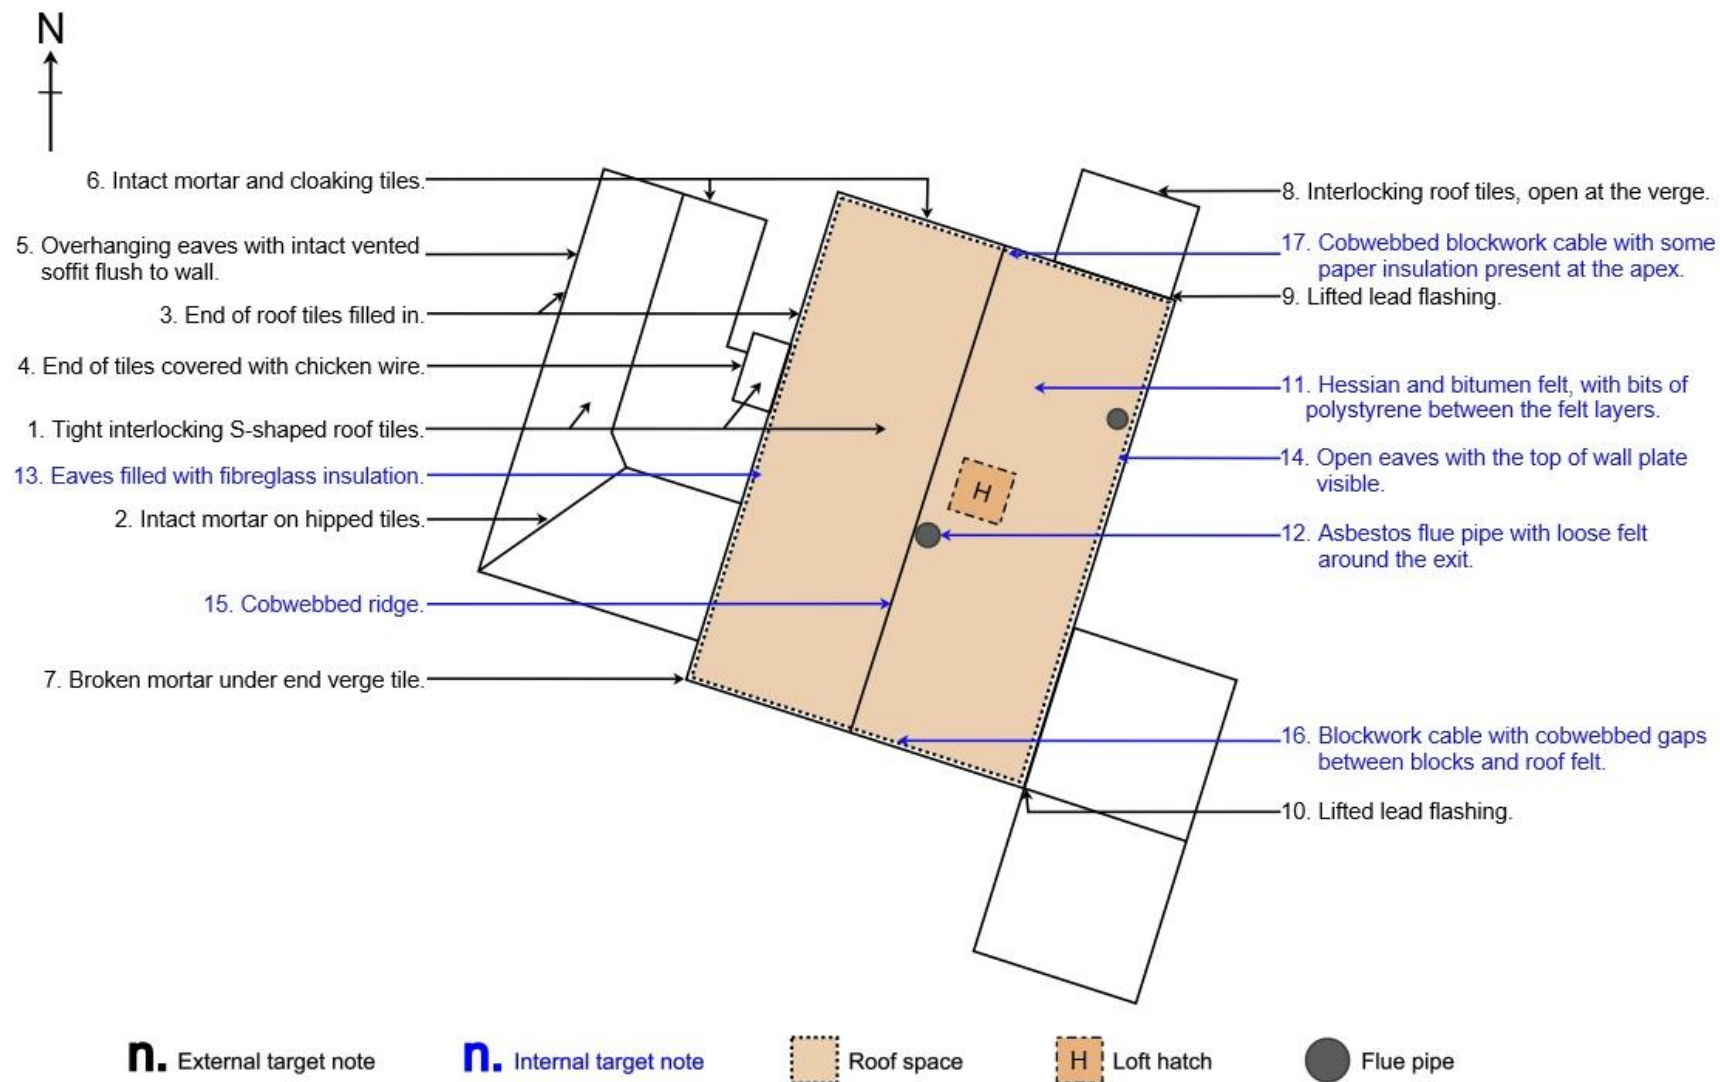
## APPENDIX 2 – PRELIMINARY BAT ROOST ASSESSMENT FINDINGS

- 3.1.1** Photographs of the house are presented in **Appendix 1** and a plan of the external and internal survey findings with associated target notes is shown in **Appendix 2**. The survey findings from the house are described as follows:
