### Level and Crack Monitoring

**Our Ref:** 531994

**Date of Issue:** 01/05/2020

| Address: | <b>71 Milman Road</b> |

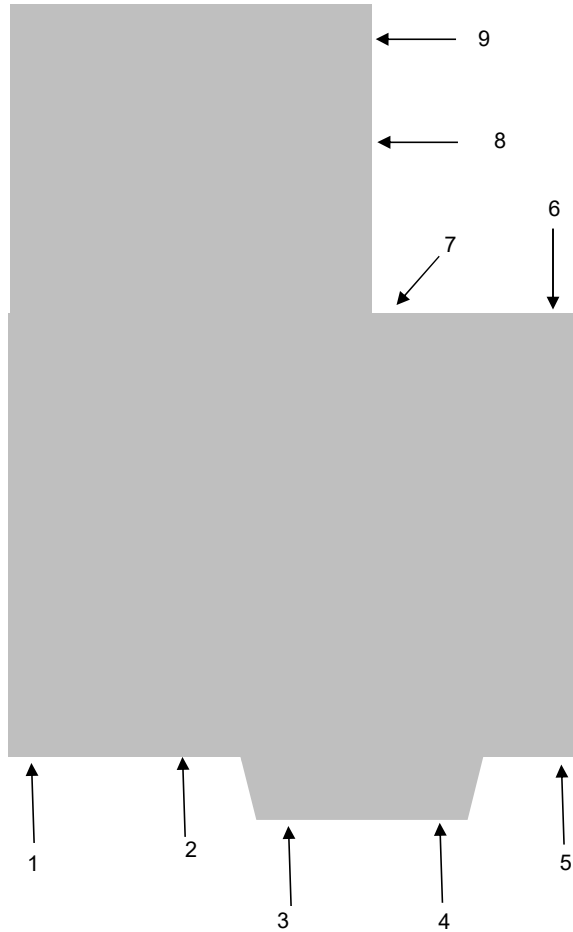
**Level and Crack Monitoring - Site Sketch**

TBM HILT  
NAIL YELLOW  
SPRAY IN
