# Arboricultural Appraisal Report

## Subsidence Damage Investigation at:

The Lodge  
77 Chazey Road  
Caversham  
RG4 7DU

| MWA REF: | SUB191011-5898 |

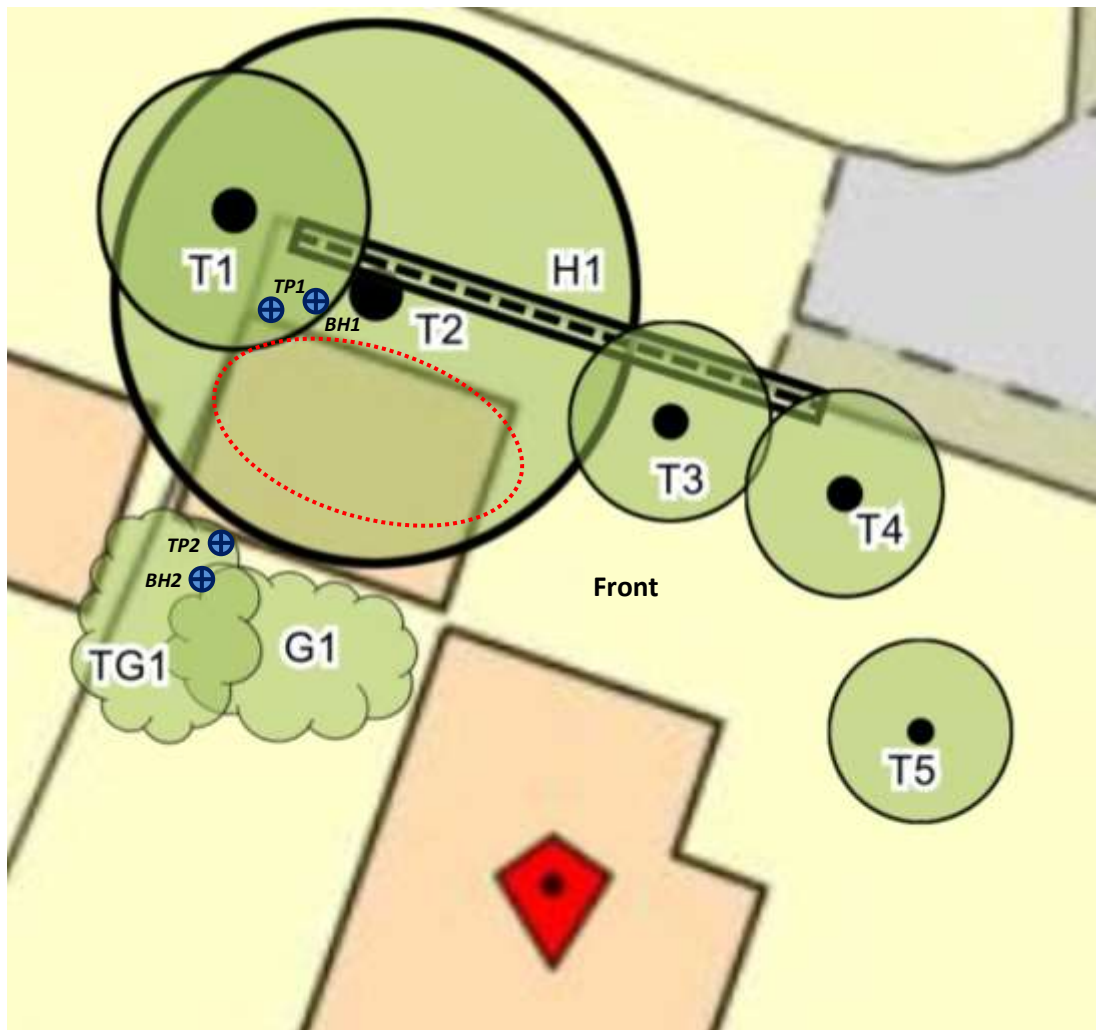
Approximate areas of damage

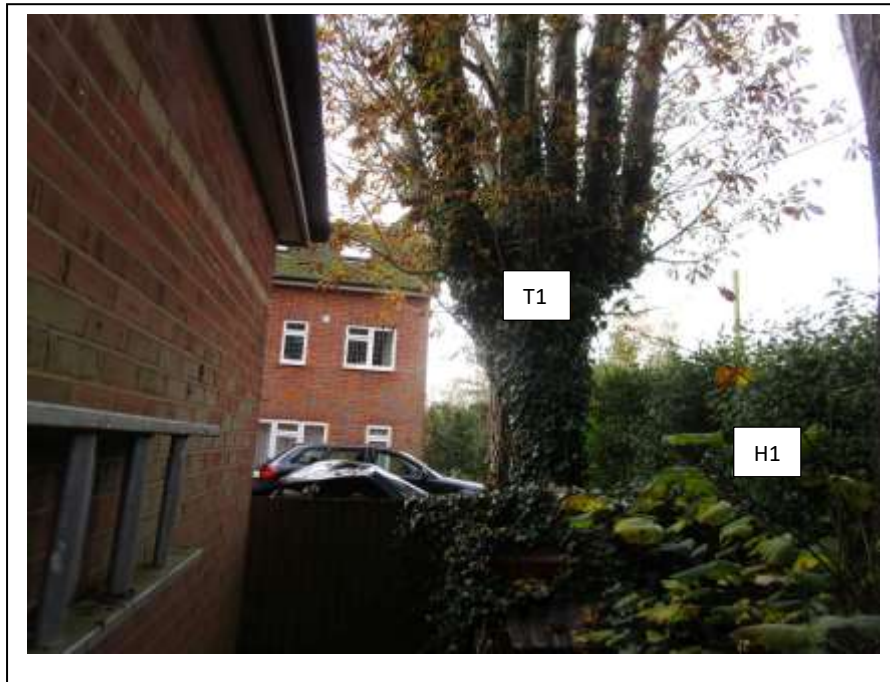
View of T1

T1 is a large tree in close proximity to the garage but it was pollarded c. 5 years ago and has been subject to further management since then. This is likely to have significantly reduced its influence although it remains significant. TG1 is generally smaller vegetation on the side of the garage where soils are mainly sand; as such we do not consider these to be a major factor in the damage.

| Tree No. | Species | Ht. (m) | Dia. (mm) | Crown Spread (m) | Dist. to building (m) | Age Classification | Ownership |
|---|---|---|---|---|---|---|---|
| T1 | Horse Chestnut | 13 | 700 * | 7 * | 3 | Older than Property | Third Party<br>The Coach House<br>Chazey Road<br>RG4 7DU |
| Management history | | Subject to past management/pruning. | | | | | |

If an arboricultural solution is to be implemented to mitigate the influence of the implicated trees/vegetation we recommend that T1 and T2 are removed. Recommended tree works may be subject to change upon receipt of additional information. Other vegetation recorded presents a potential future risk to building stability and management is therefore recommended.

| Tree No. | Species | Ht. (m) | Dia. (mm) | Crown Spread (m) | Dist. to building (m) | Age Classification | Ownership |
|---|---|---|---|---|---|---|---|
| Recommendation | | Remove (fell) to near ground level. | | | | | |

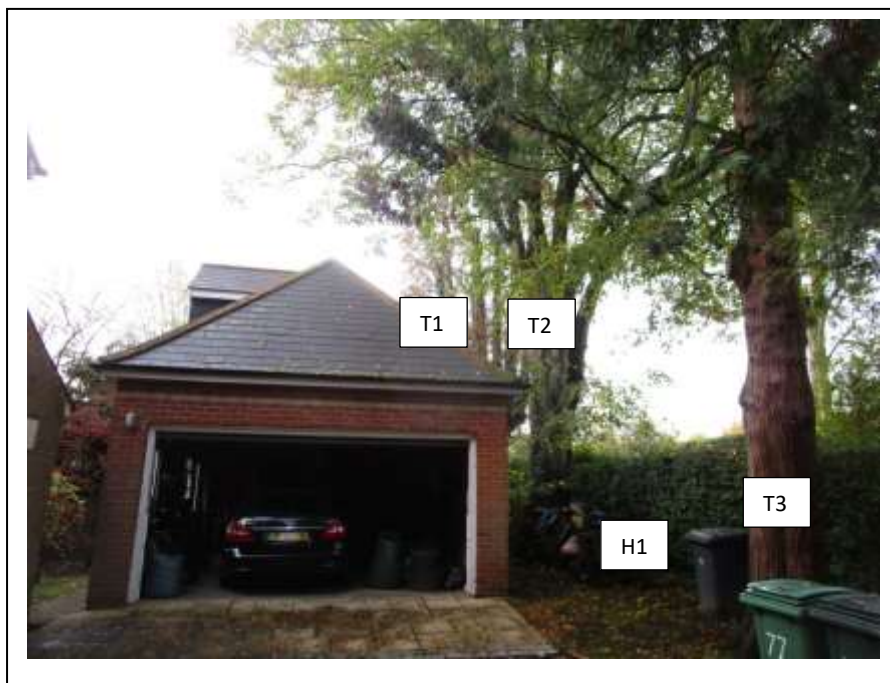
View of front of garage

The current damage affects the front right corner of the garage with internal and external cracking to the walls and cracking along the centre of the floor slab. It was first noticed by the neighbour in December 2018.

At the time of the engineers' inspection (06/03/2019) the structural significance of the damage was found to fall within Category 3 (moderate) of Table 1 of BRE Digest 251.
