# Arboricultural Consultancy for Aviva - Commercial

| Insured | Reading Spiritualist Church | Address | 81 Baker Street, Reading, RG1 7XY | | |
| ES Ref | SA-245627 | Consultant | Giles Mercer | Contact No. | 0330 380 1036 |
| Report Date | 14/01/2020 | | | | |

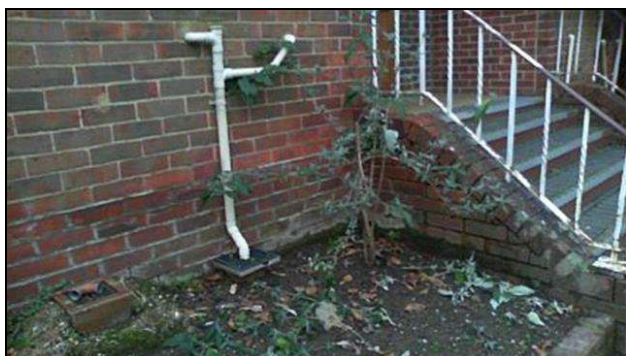
S1 - Buddleia

| Tree No. | Species | Age Cat | Approx. Height (m) | Distance to Building (m) * | Ownership | Action | Requirement |
|---|---|---|---|---|---|---|---|
| S1 | Buddleia | 1 | 1.2 | 0.4 | C - Insured | Action to avoid future risk | Do not allow to exceed current dimensions by way of regular pruning. |

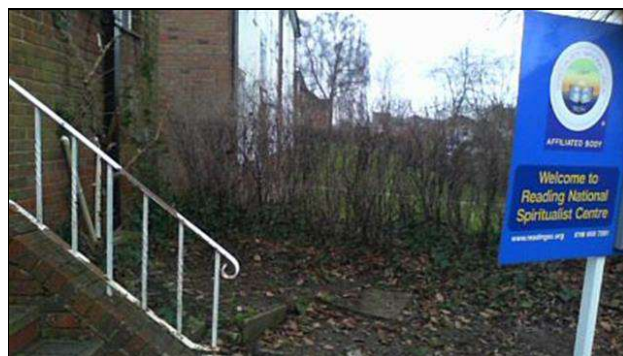
H1 - Snowberry

| Tree No. | Species | Age Cat | Approx. Height (m) | Distance to Building (m) * | Ownership | Action | Requirement |
|---|---|---|---|---|---|---|---|
| H1 | Snowberry | 1 | 2 | 0.5 | C - Insured | Action to avoid future risk | Remove section of hedge to achieve a minimum clearance of 2 m to the property. Balance to be maintained on a regular basis to ensure that current dimensions and influence are not exceeded. |
