**Rivermead Leisure Centre  
Richfield Avenue  
Reading  
Berkshire  
RG1 8EQ**

# **Preliminary Bat Roost Assessment**

**Ref: R2670/a**

**November 2020**

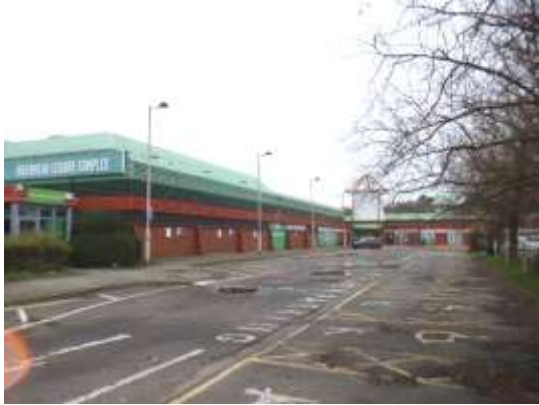
**3.2.1** The Rivermead Leisure Centre was a complex of steel-framed buildings with large flat roofs (**Photograph 1**). The walls were of brick construction at ground floor level with metal cladding above (**Photograph 2**).

**1. Front of Rivermead Leisure Centre viewed from southeast.**

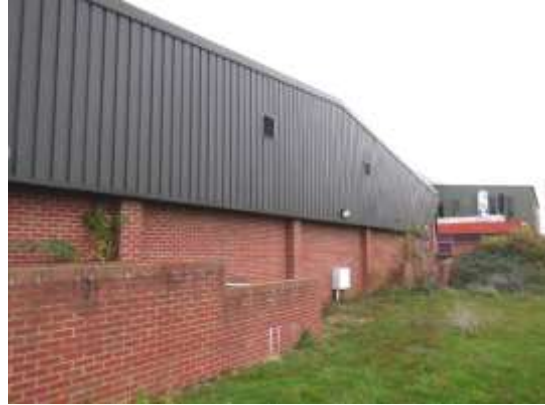
**2. Brick walls with metal cladding above on the gym (western elevation).**

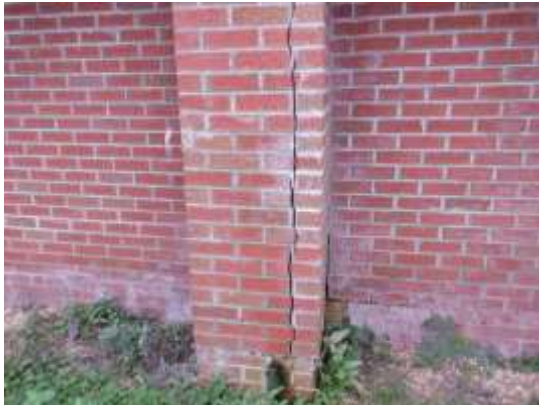
**3.2.2** There was a crack in the gym's brickwork that was closely inspected and showed no signs of use by roosting bats (**Photograph 3; Target note 1**). OSB sheets had been used to seal the gym's windows (**Photograph 4; Target note 2**). There were two Schwegler 1SP Sparrow Terrace bird boxes fixed to the brickwork beneath the metal cladding; one had a bird dropping on its front and the other had been filled with newspaper (**Photograph 5; Target notes 3 & 4**). Bird droppings were observed in a Schwegler 1FQ Bat Roost box that was attached to the wall close to the ground (**Photograph 6; Target note 5**).

**3. Crack in gym brickwork (northern elevation).**

- 4.3.1** In order to confirm the continued absence of bats, the low-suitability potential bat roost features identified will be re-inspected by a licensed ecologist before the building work begins. Demolition works will begin only once the licensed ecologist has confirmed there continues to be no signs of bats present.

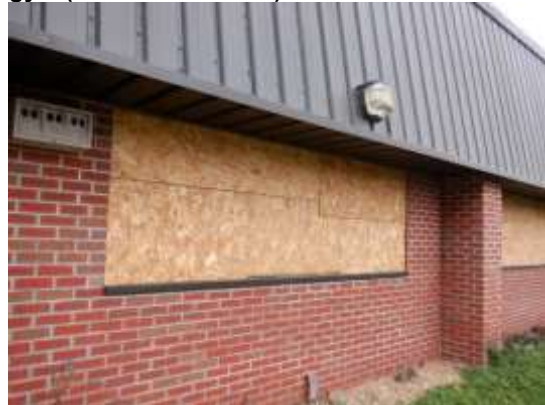
**4. Gym windows sealed with OSB (northern elevation).**

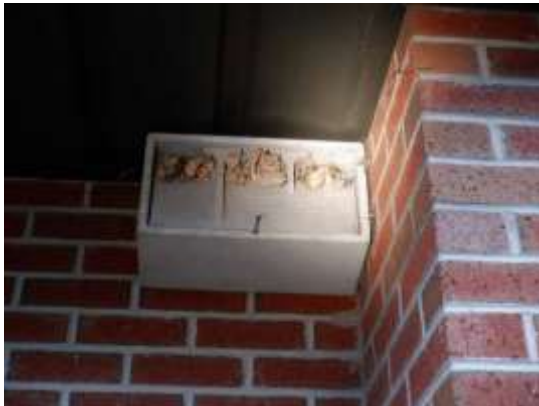
**5. Sparrow bird box filled with newspaper (southern elevation).**

- 4.4.1** The observation of bird droppings on the bat and sparrow terrace boxes indicates the presence of a bird nests. The Wildlife & Countryside Act 1981 (as amended) protects all wild birds and makes it an offence to kill, injure or take a wild bird or to damage or destroy the nest of a wild bird whilst in use or being built. In order to prevent the contravention of this legislation, the demolition should be completed outside of the peak bird nesting season (March to August inclusive), or if carried out within this period, should take place only once a survey confirming nesting birds are not present has taken place. If birds are found to be nesting, to allow the work to take place lawfully, it should be undertaken only once it can be confirmed that the young have fledged and left the nest.

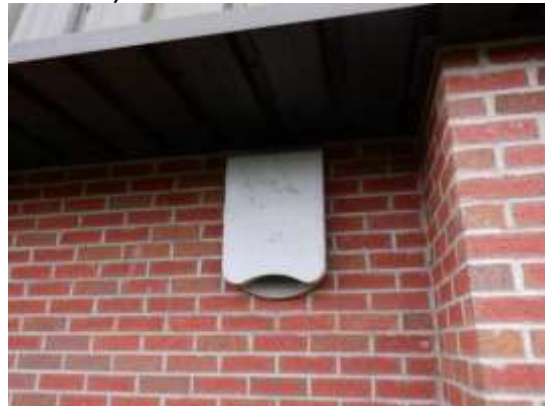
**6. Bat box with bird droppings (northern elevation).**

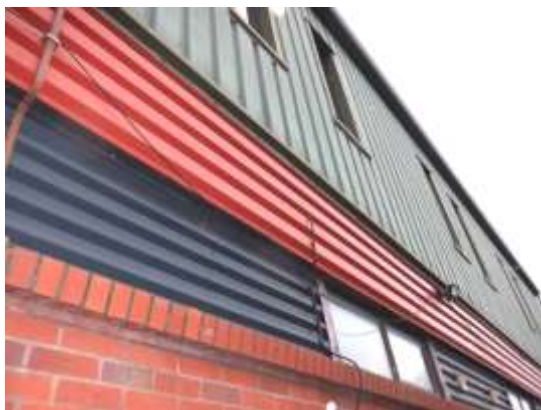
**3.2.3** The metal cladding was tightly bolted to the building complex and lacked opportunities for roosting bats (**Photograph 7; Target note 6**). A section of cladding had been punctured and ceiling tiles were missing above a rear entrance to the sports hall, the features were low-level and showed no evidence of past or current use by roosting bats (**Photographs 8 & 9; Target notes 7 & 8**).

**7. Tightly bolted metal cladding (western elevation).**

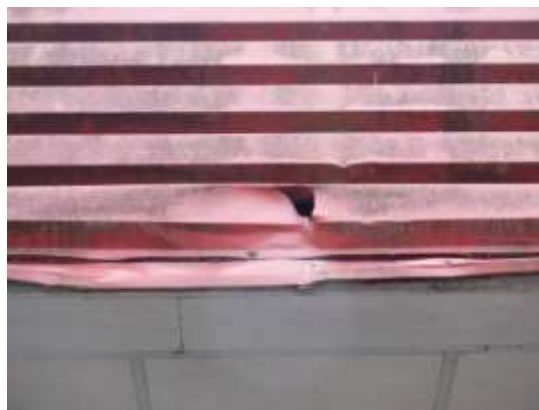
**8. Puncture in metal cladding (northern elevation).**

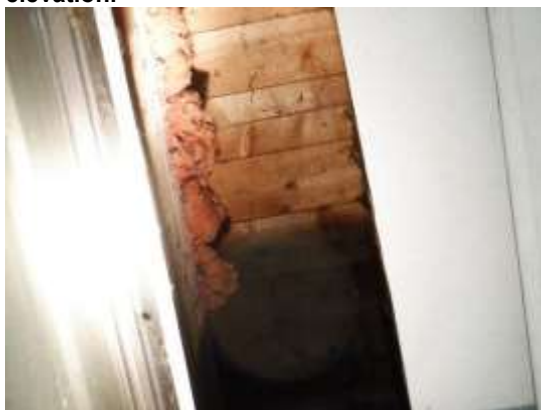
**9. Missing ceiling panels above rear entrance to sports hall (northern elevation).**

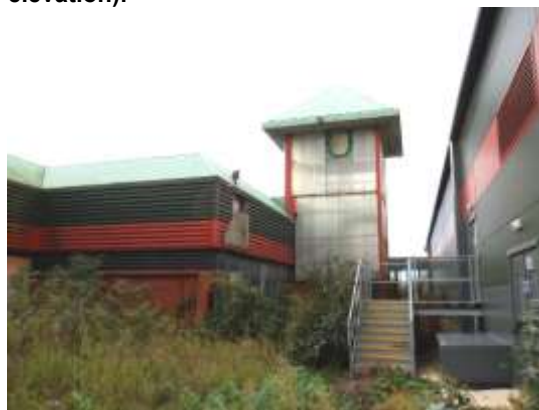
**3.2.4** The water slide had been removed from its tower and the resulting holes had been proofed with polystyrene and timber boards (**Photograph 10; Target note 9**). The vent on the door of the electrical store was damaged and had been temporarily blocked with timber; the rest of the vents were lined with mesh (**Photograph 11; Target note 10**). The roof overhang along the old pool building was also lined with mesh, and fibreglass insulation was visible behind (**Photograph 12; Target note 11**).

**10. Water slide removed from tower (eastern elevation).**

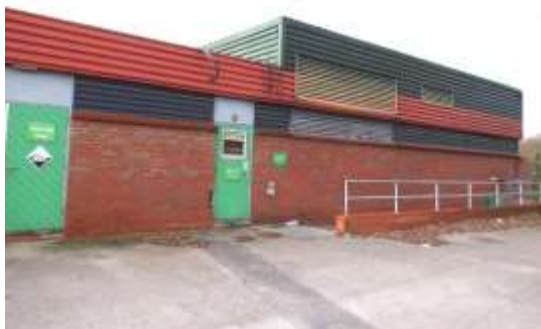
**11. Broken vent on door to electrical store (eastern elevation).**

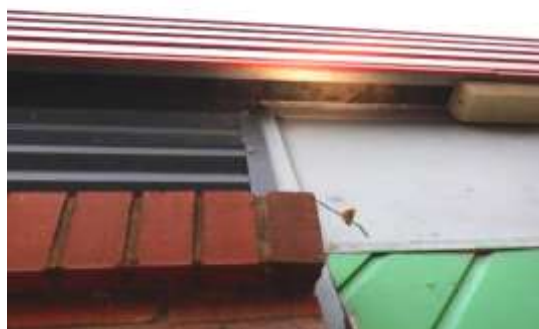
**12. Mesh and fibreglass under pool roof overhang (eastern elevation).**

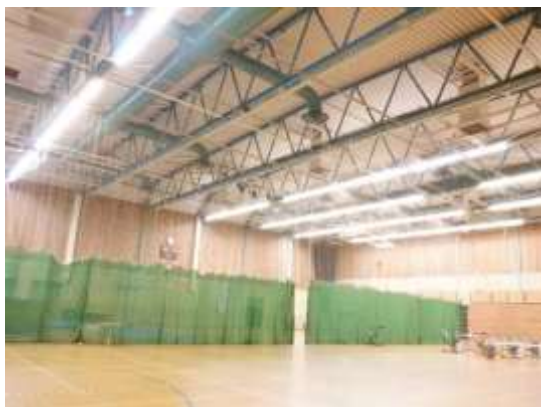
- 3.3.1** The main sections of the Rivermead Leisure Centre complex could be divided into a sports hall, gym, and former swimming pool (**Target notes 12, 13 & 14**). The sports hall was open up to a roof, which was constructed of steel trusses with six boxed air vents and a corrugated roofing material (**Photograph 13; Target note 15**). The higher sections of wall (corresponding to external metal cladding) were covered with timber panelling (**Photograph 14; Target note 16**). An indoor bowling green was contiguous with the sports hall to the south and had a smaller roof constructed of the same steel trusses (**Photograph 15; Target note 17**). Plastic sheeting and fabric were visible behind the panels on the walls of the indoor bowling green. A first-floor dance studio was positioned to the rear of the sports hall and false ceiling tiles (**Photograph 16; Target note 18**).

**13. Sports hall.**

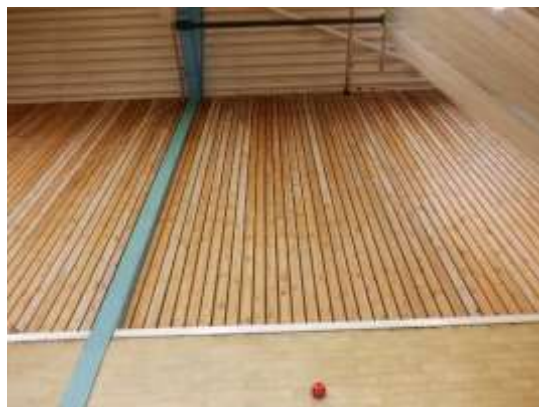
**14. Timber panelling in sports hall.**

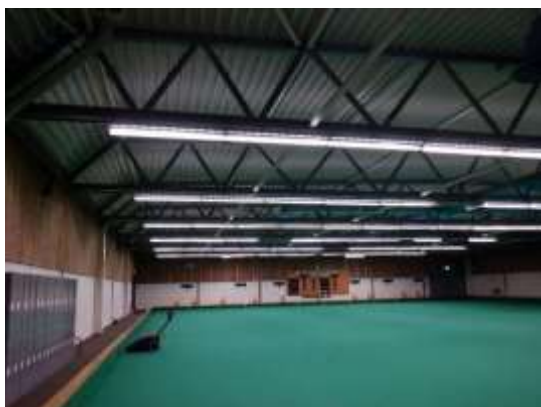
**15. Indoor bowling green.**

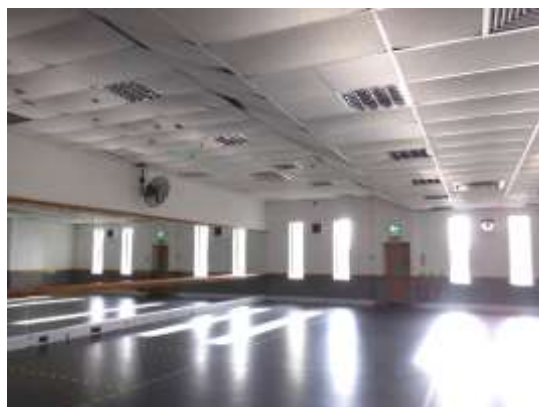
**16. First-floor dance studio.**

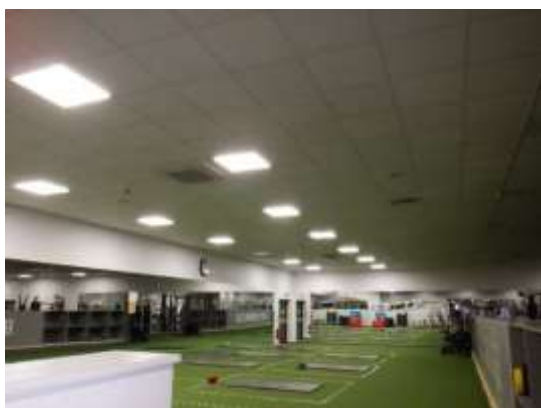
- 3.3.2** The gym had a shallow pitched roof that was hidden by false ceiling tiles (**Photograph 17; Target note 19**). The metal roof was visible in places where the ceiling tiles were missing (**Photograph 18**). Interconnecting parts of the complex, that included a kitchen, corridors, offices and storage, had false ceiling tiles beneath flat roofs (**Photographs 19 & 20; Target note 20**).

**17. Gym.**

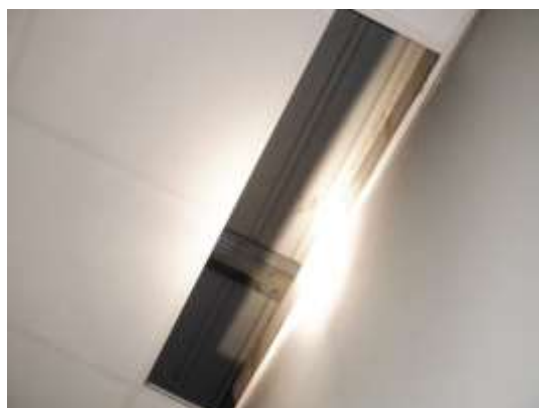
**18. Missing ceiling tile in gym.**

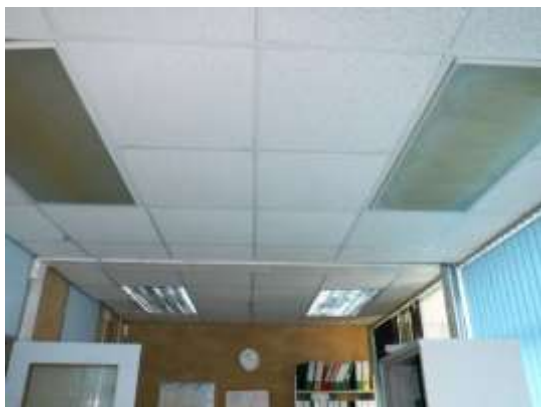
**19. False ceiling tiles in office.**

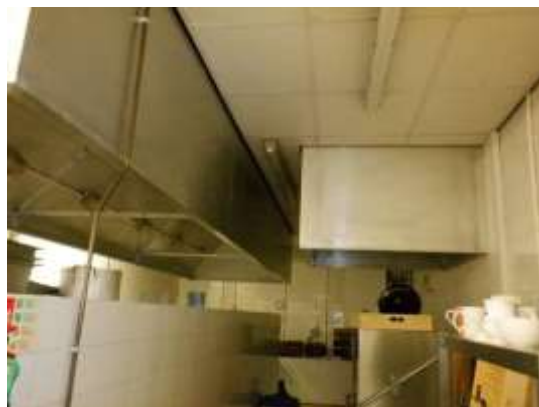
**20. False ceiling tiles in kitchen.**

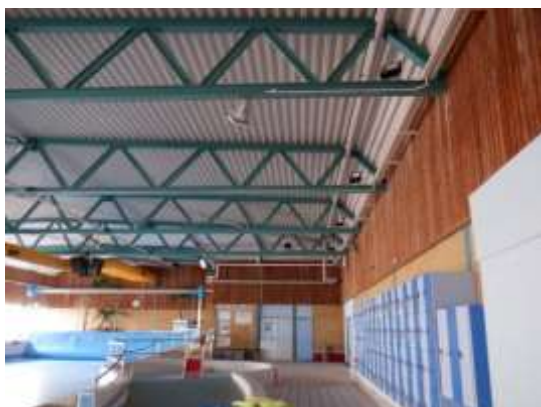
- 3.3.3** The former swimming pool section was open up to a corrugated metal roof with exposed steel trusses (**Photograph 21; Target note 21**). The waterslide tower had a pyramid roof of corrugated metal (**Photograph 22; Target note 22**).

**21. Former swimming pool.**

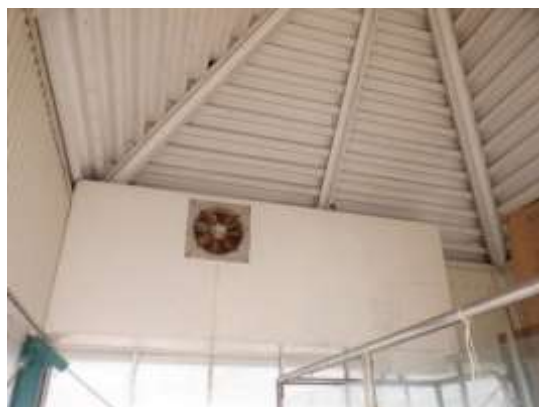
**22. Waterslide tower.**

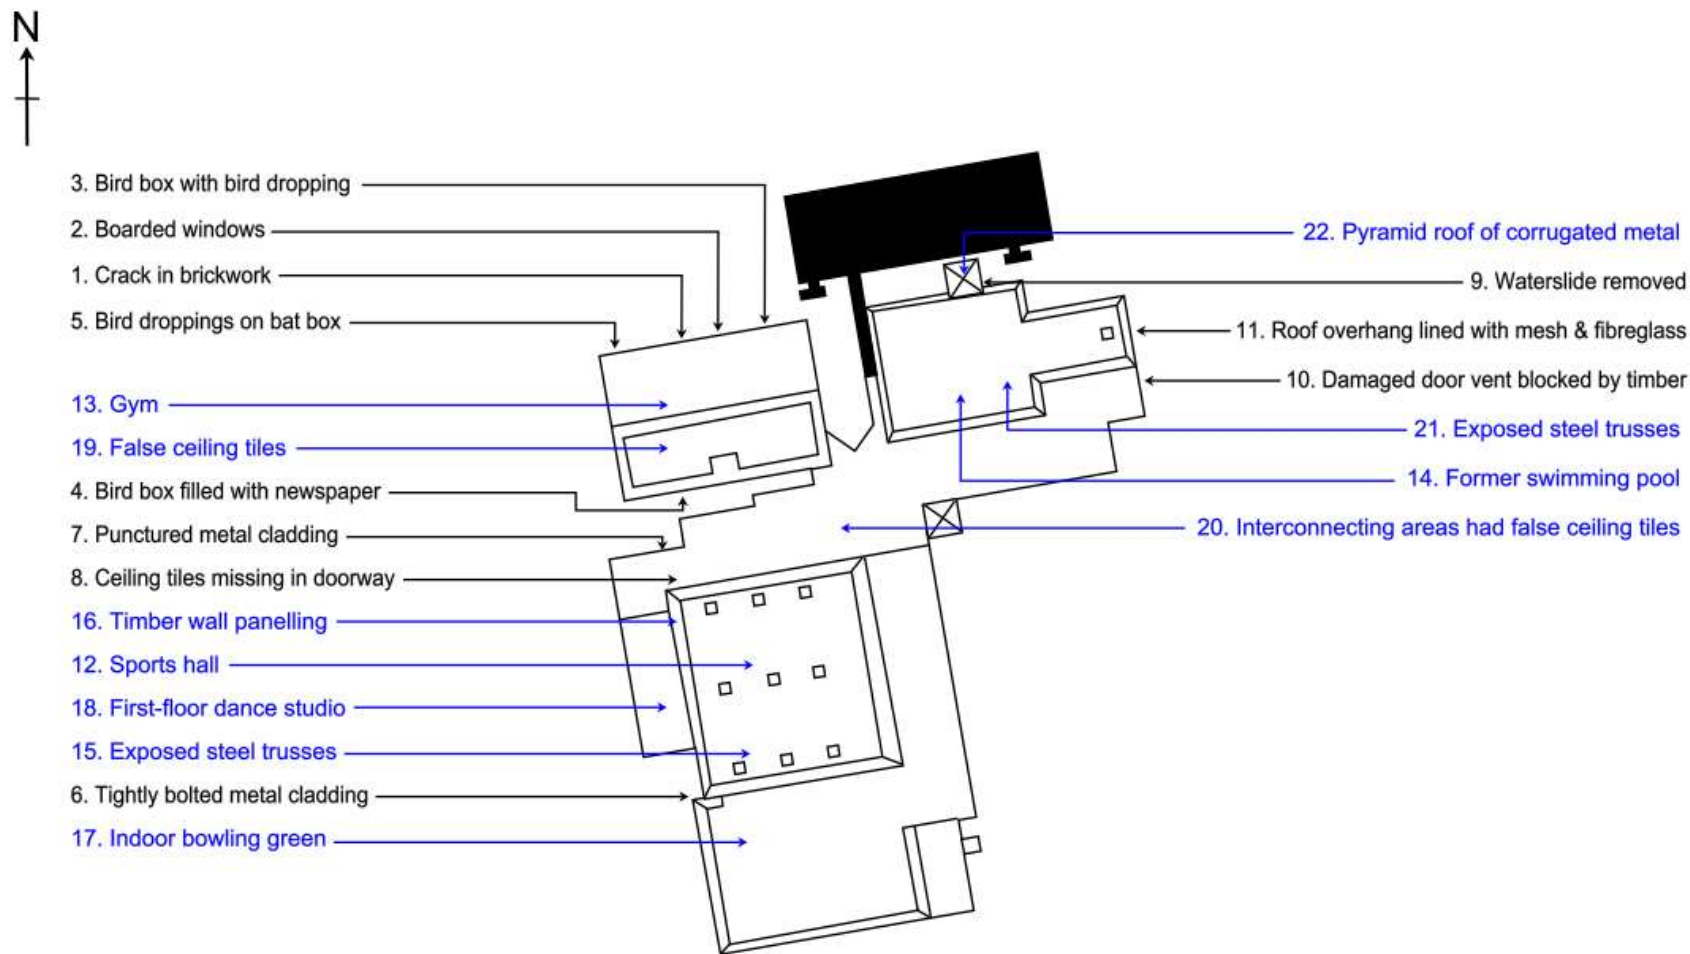
APPENDIX 2 – PRELIMINARY BAT ROOST ASSESSMENT FINDINGS

**3.1.1** Photographs of Rivermead Leisure Centre are presented in **Appendix 1** and a plan of the external and internal survey findings with associated target notes is shown in **Appendix 2**. The survey findings from the exterior and interior of the Centre are described as follows:
