**93 Woodcote Road  
Caversham  
Reading  
Berkshire  
RG4 7EZ**

# **Preliminary Bat Roost Assessment**

**Ref: R2652/a**

**November 2020**

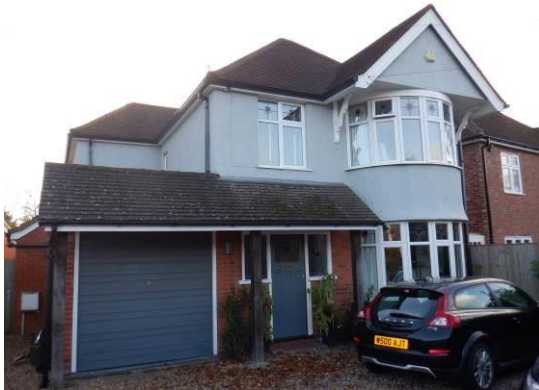
**3.2.1** The house had a hipped roof with a pitched gable end above a front bay window; an adjoining garage, a single-storey rear extension and small side extension (**Photographs 1 & 2**).

1. Front of property viewed from northeast.

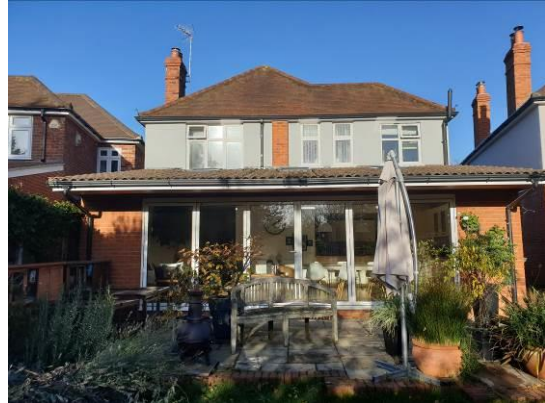
2. Rear of property viewed from southwest.

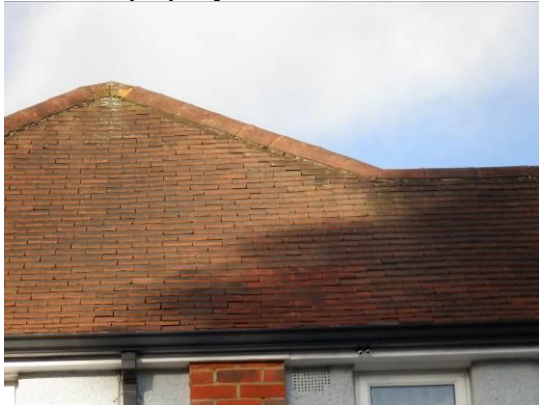
**3.2.2** The hipped roof was covered in machine-made overlapping tiles that were mostly flat and intact, except on the rear elevation where there were several raised tiles; particularly adjacent to the roof hip (**Photograph 3; Target note 1**). A single roof tile was slightly lifted on the southeast elevation offering a potential opening for bats (**Photograph 4; Target note 2**). The ridge and hip tiles were all securely mortared in place (**Photograph 5; Target note 3**). Verge mortar was intact on the front gable end but there was a possible point of bat access through a gap at the apex behind the fascia (**Photograph 6; Target note 4**). Elsewhere the walls were rendered up to the soffits (**Photograph 7; Target note 5**).

**4.1.2** Although the house had several raised roof tiles, they were unlikely to provide crevices suitable for bats because the roof was unlined. In addition, evidence of use by bats would have been visible inside the roof void and therefore it is considered highly unlikely that crevice-dwelling bats such as pipistrelle (*Pipistrellus* spp.) and small *Myotis* species are present. There were potential access opportunities for bats elsewhere, including a gap at the apex of the front gable and gaps in brickwork around porch timbers, but these showed no signs of use by roosting bats.

3. Raised roof tiles adjacent to roof hip (rear elevation).

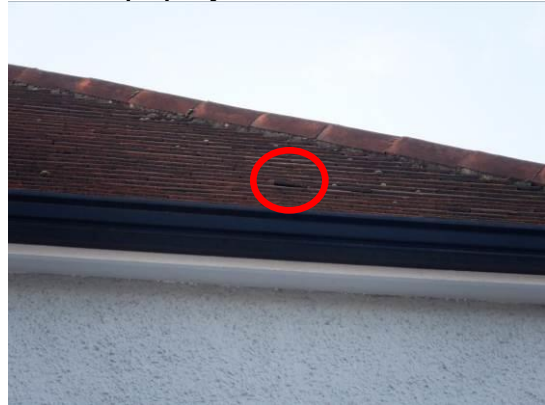
4. Slightly lifted roof tile (southeast elevation).

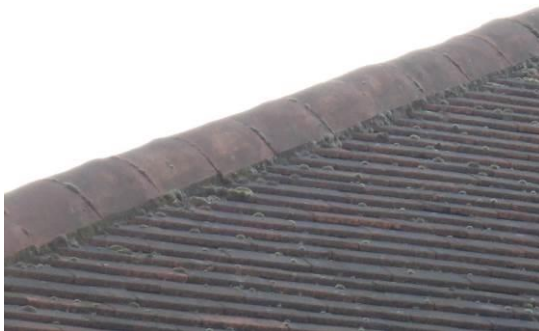
5. Hip tiles securely mortared in place (front elevation).

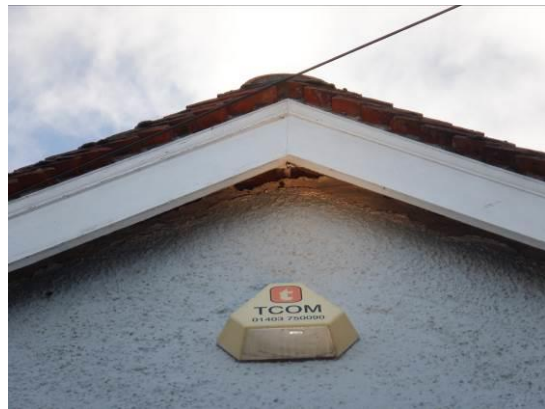
6. Gap at apex of front gable end (front elevation).

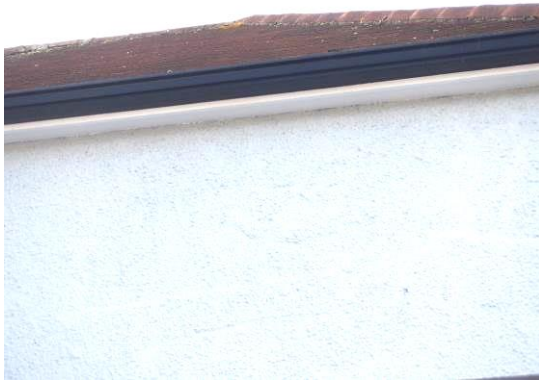
**7. Walls rendered up to soffits (southeast elevation).**

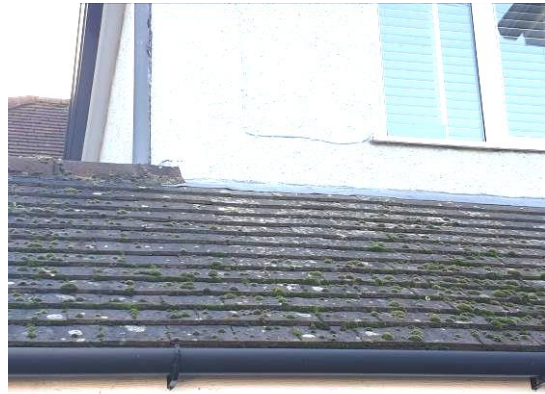
**3.2.3** A front porch roof extended out above the front of the adjoining garage and was covered in flat overlapping tiles with secure ridge tiles (**Photograph 8; Target note 6**). The sides of the porch roof had intact verge mortar and were tightly clad in hanging tiles (**Photograph 9; Target note 7**). There were small, cobwebbed gaps leading into the brickwork around the porch roof timbers (**Photograph 10; Target note 8**). The rest of the garage roof was gently sloping and covered in slates (**Target note 9**). A large hole in the soffit led inside the garage (**Photograph 11; Target note 10**).

**8. Front porch and garage roof (front elevation).**

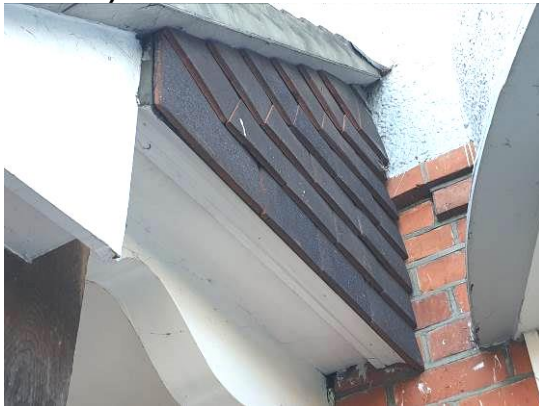
**9. Tight hanging tiles on sides of porch roof (northwest elevation).**

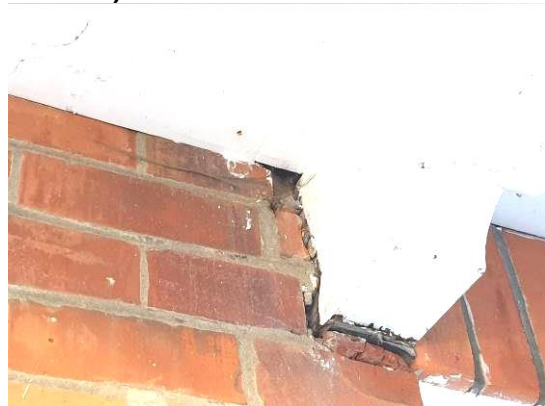
**10. Cobwebbed gap into brickwork around porch roof timber (front elevation).**

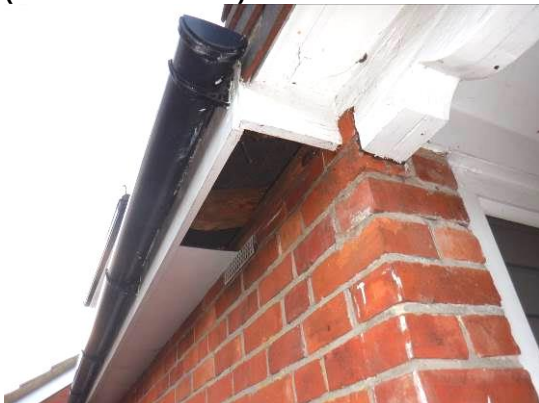
**11. Large hole in soffit leading into garage (southeast elevation).**

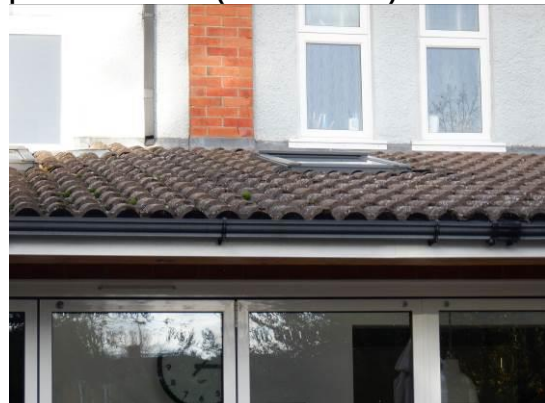
**3.2.4** The single-storey rear extension and small side extension both had tight interlocking roof tiles and intact verge mortar (**Photographs 12 & 13; Target note 11**). Timber barge boards were tightly fixed to the brickwork and the rear extension had a panelled overhang (**Photograph 14; Target notes 12 & 13**).

**12. Tight interlocking roof tiles on rear extension (rear elevation).**

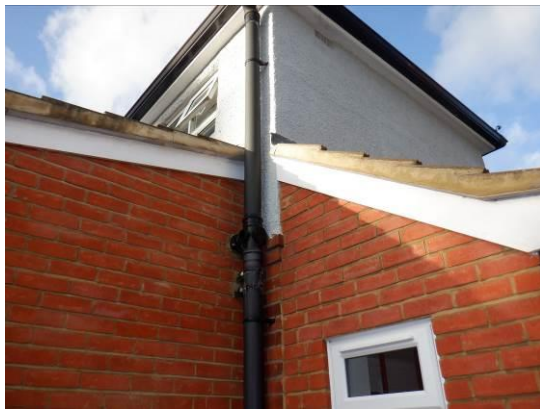
**13. Rear and side extensions with intact verge mortar.**

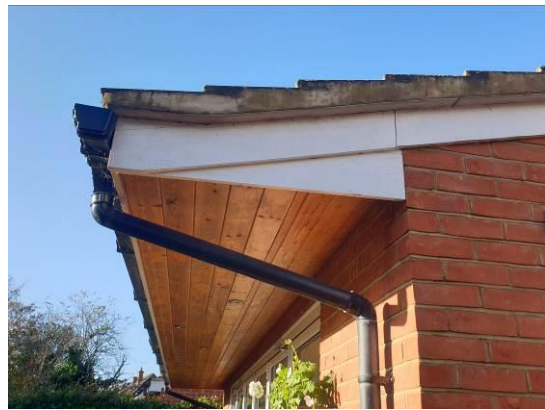
**14. Tight timber barge boards and rear overhang.**

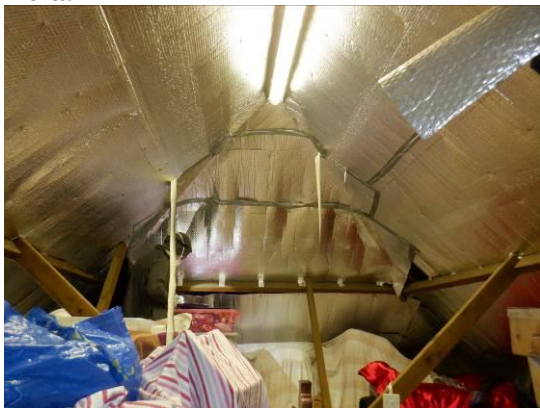
**3.3.1** The roof void covered the two-storey footprint of the house and was accessible via a central loft hatch on the first floor. The void had an approximate floor-to-ridge height of 2.5 metres and was of hipped roof construction (**Photograph 15**). The roof was unlined throughout, but foil bubble wrap insulation had been tacked onto the underside of the rafters (**Photograph 16; Target note 14**). There was fibreglass insulation behind the foil in the front gable end but in the southeast-facing hipped end the roof was bare (**Photographs 17; Target notes 15 & 16**). Space between ridge tiles and the ridge beam was visible behind the foil insulation (**Photograph 18; Target note 17**). Loose chipboards and miscellaneous storage were on the floor with old fibreglass beneath; foil wrapped fibreglass was present along the north western eaves and the front gable end (**Photograph 19; Target note 18**). The front gable end was boarded but had a cobwebbed gap at its apex (**Photograph 20; Target note 19**).

**15. Roof void viewed from rear hipped end.**

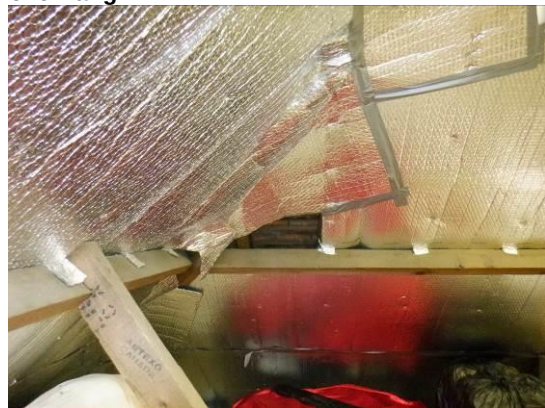
**16. Foil bubble wrap insulation tacked to roof rafters.**

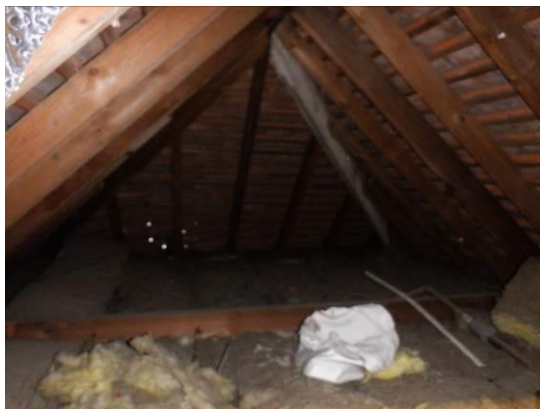
**17. Unlined roof in southeast-facing hipped end.**

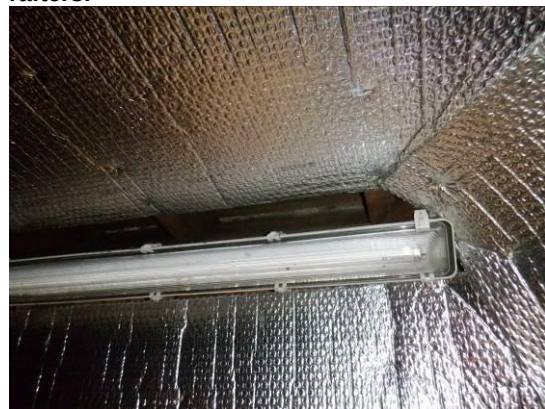
**18. Space between ridge tiles and ridge beam.**

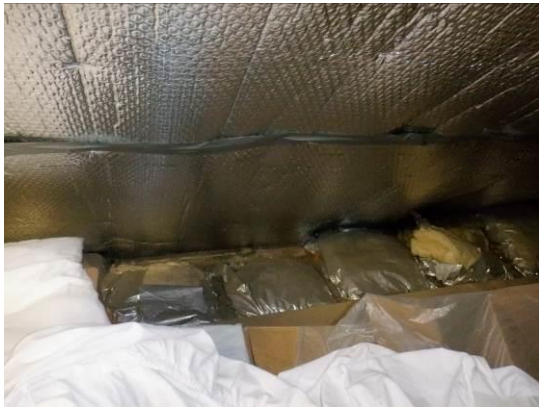
**19. Foil wrapped fibreglass at northwest eaves.**

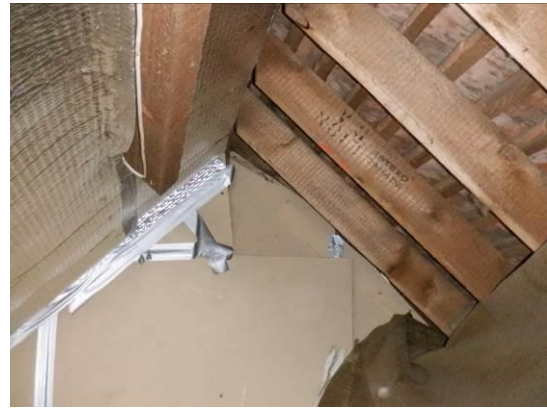
**20. Gap over boarding at apex of front gable end.**

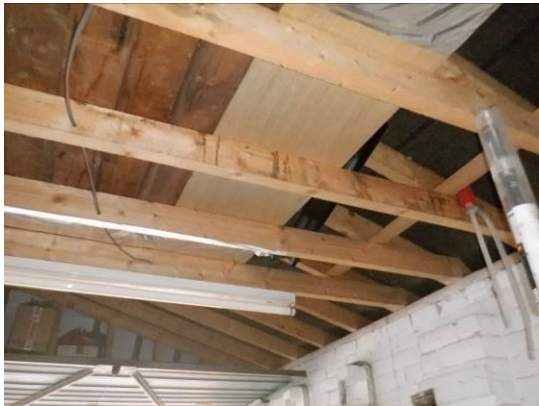
**3.3.2** The adjoining garage roof was open with exposed timber joists and rafters (**Photograph 21**). The roof was lined with bitumen-based roofing felt and a roof light was present at the back of the garage (**Photograph 22; Target note 20**). No signs of roosting bats were visible during the internal inspection of the property.

**21. Open garage roof.**

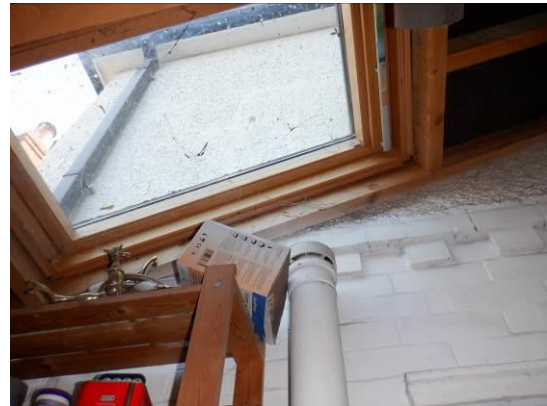
**22. Roof light in garage roof.**
