# **ARBORICULTURAL REPORT**

## **Tree Preservation Order Application**

**Site Ref; Trees at 120 Kidmore Road TPO 393/06.**

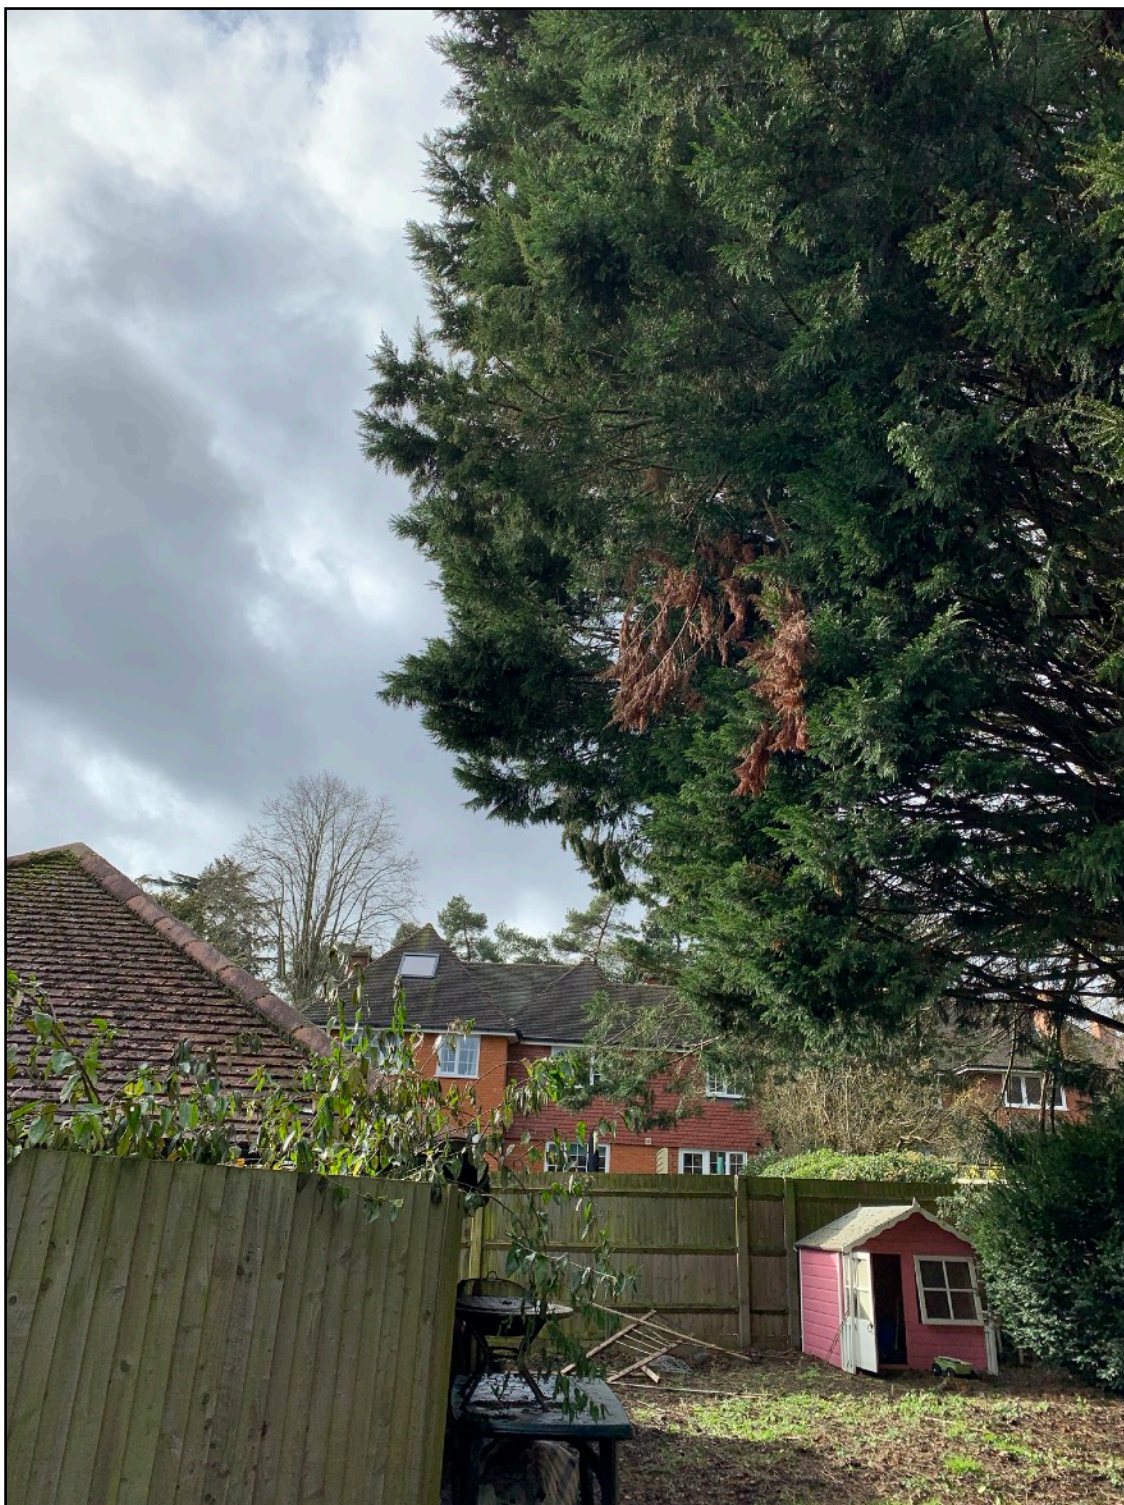
- 3.4 The two mature Leyland Cypress trees (growing as one) were inspected and noted to be outwardly healthy.
- 3.5 The lower canopies extend over the boundaries of 5 Charlotte close and has become over bearing (**See overhead google plan**). The branches extend over the boundary fence, over the children's play area and partially over the garage (**Photo 1**).

Photo 1 (T1 & T2 ) - Leyland Cypress canopy overhang.

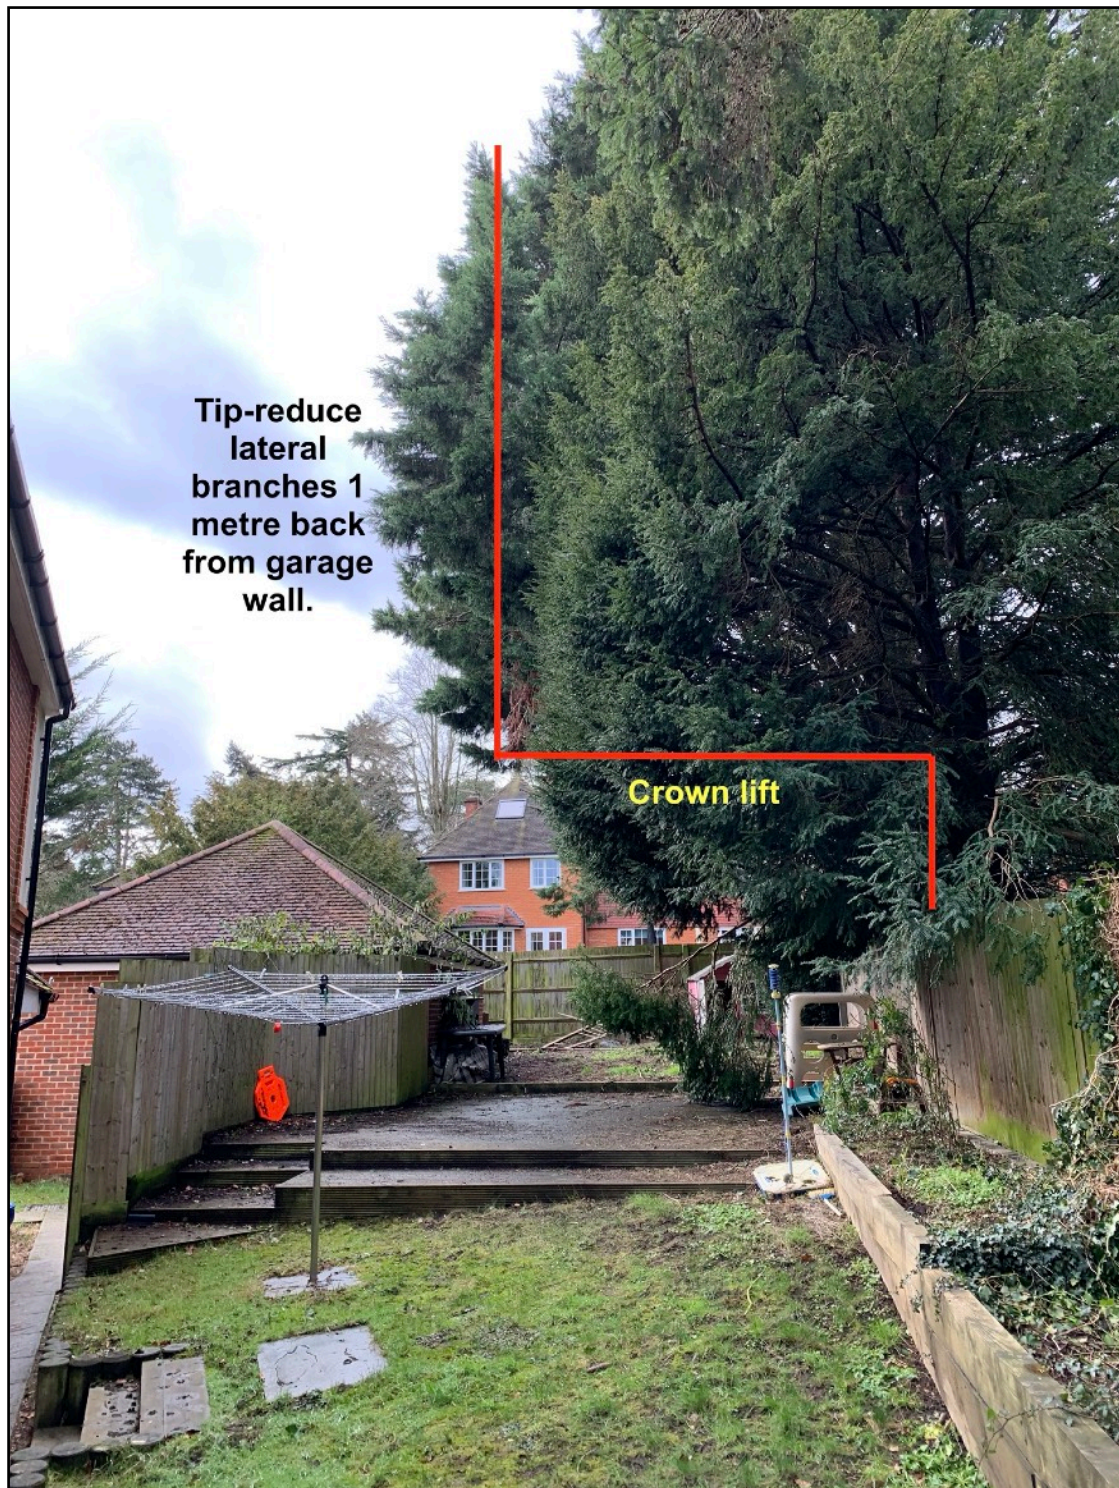
Photo 2 (T1 & T2) - Pruning annotations

- 3.8 In order to alleviate the concerns raised, tip-reduction and crown lifting works have been recommended (**See annotated Photo 2**) in order to allow natural light beneath the canopy and make the area more usable.

- 5.1 Selectively prune by undertaking a crown lift to the height of the garage ridge, by removing 1st and 3rd lowest branches. With the ultimate result in creating height clearance to ridge height (**See photo 2**).
- 5.2 Selectively prune by undertaking a tip-reduction of remaining canopy (secondary branches), extending over the garage by 1 metre from garage wall (**See photo 2**)
- 5.3 Also remove dead/snapped branches back to suitable pruning points.

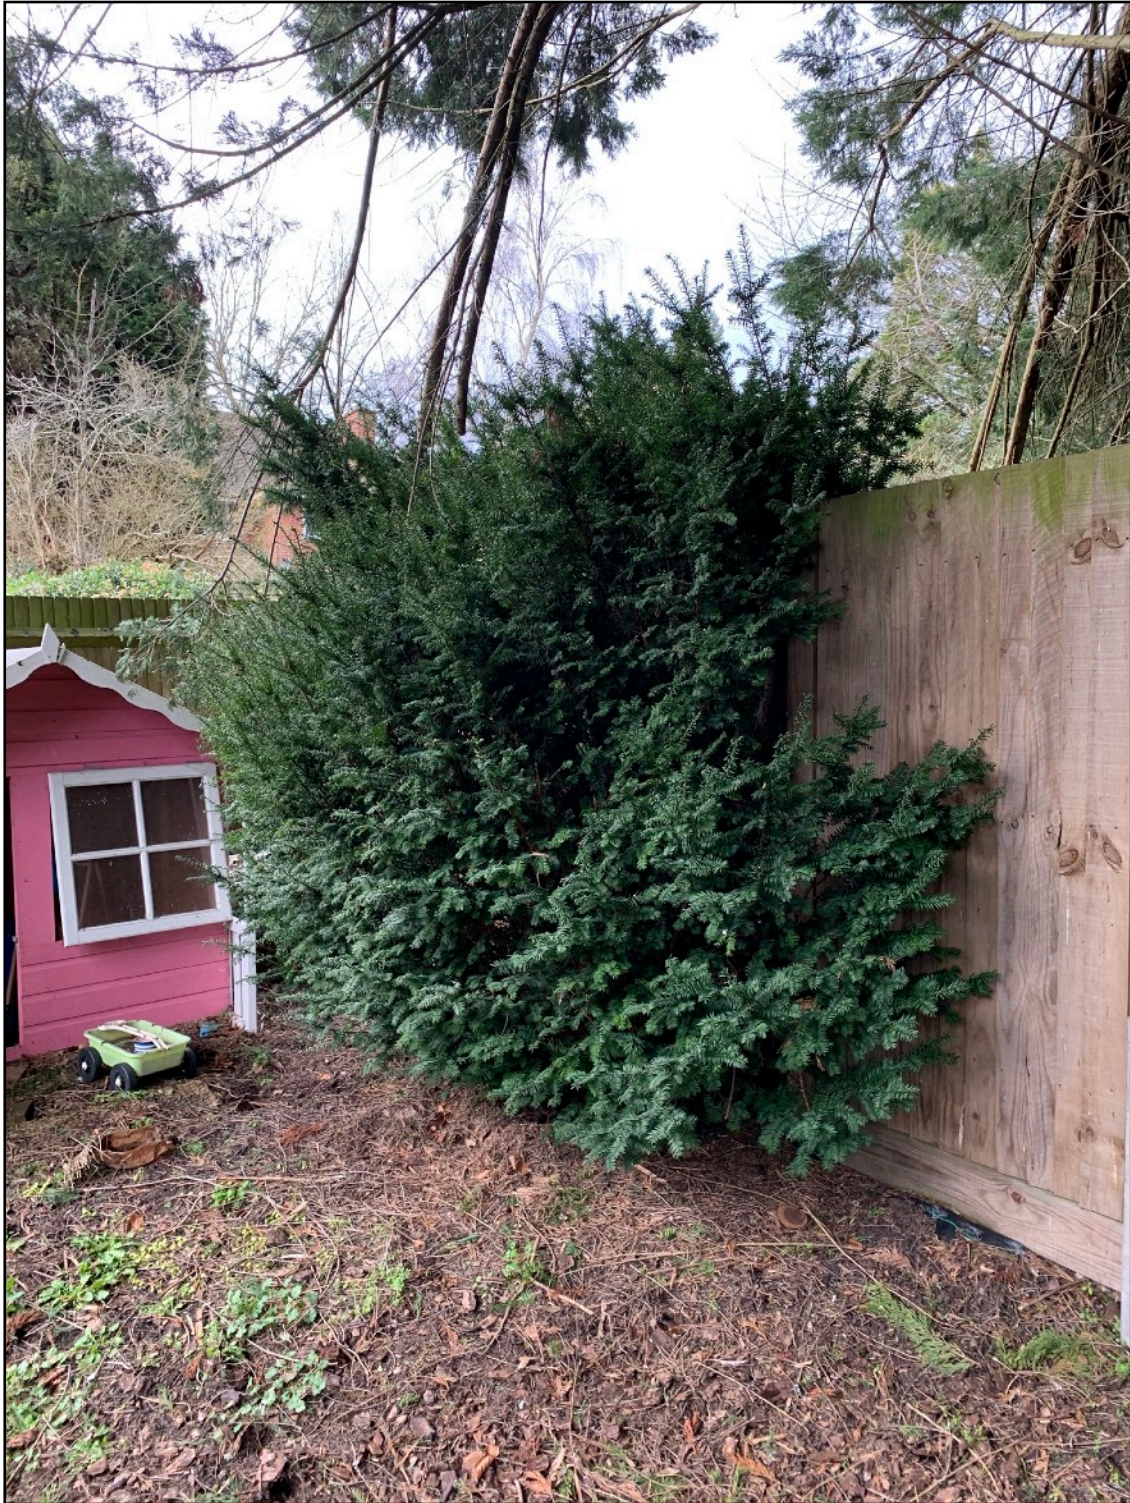
- 3.10 The small Yew tree (**Photo 3**) was inspected and noted to be outwardly healthy.
- 3.11 It is not clear as to whether the tree is covered by the TPO, however for transparency purposes this tree has been included.
- 3.12 This small tree straddles the boundary and its removal is requested due to its poor location and potential future growth. This tree is not considered sustainable.

Photo 3 - Yew tree

- 5.7 Remove tree to ground level.

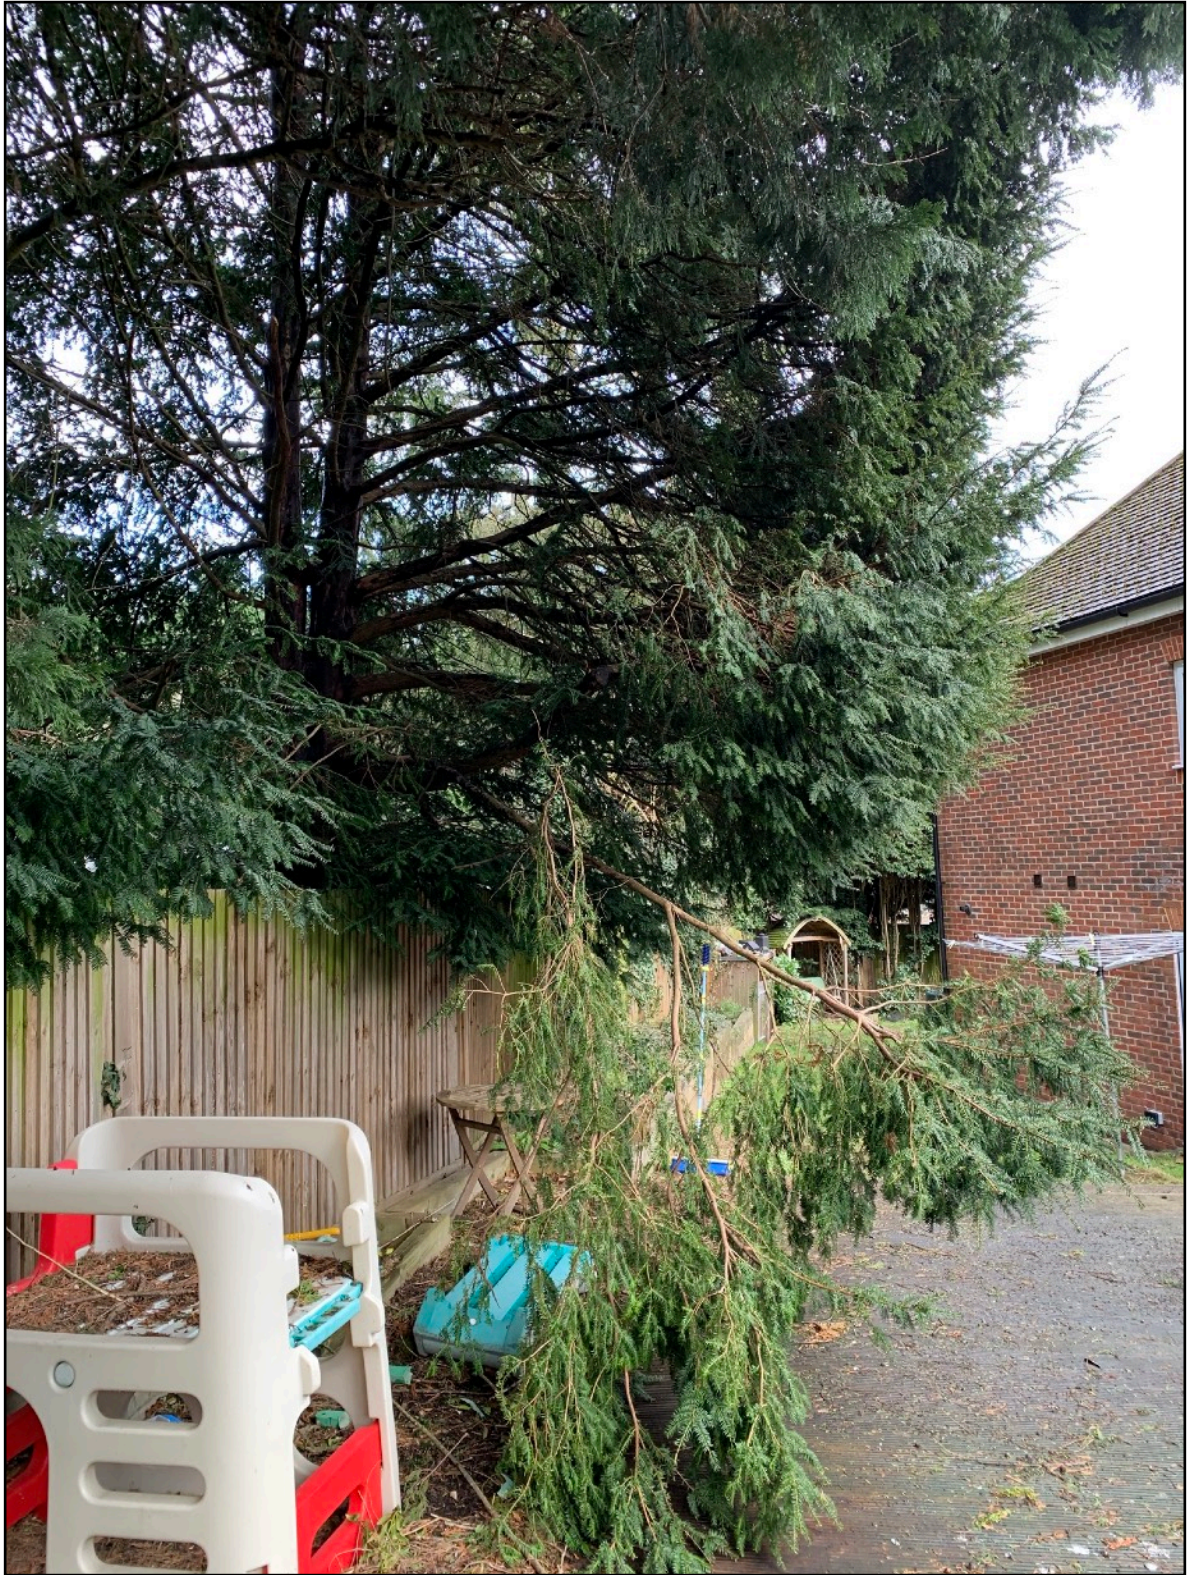
- 3.13 The young Yew tree (**Photo 4**) was noted to be outwardly healthy and reasonable condition. A Small branch has suffered wind damage and is currently hanging down over the property (5 Charlotte Close).
- 3.14 The young Yew tree located next to T2, also forms part of the dense evergreen screen. The lower branches of this tree hang low (below head height), into the side garden of 5 Charlotte Close.
- 3.15 In order to alleviate the impact of this tree, crown lifting works have been requested in order to provide head room below the trees canopy and attempt to allow natural light beneath the canopy and through the garden.

Photo 4 - Yew (T4)

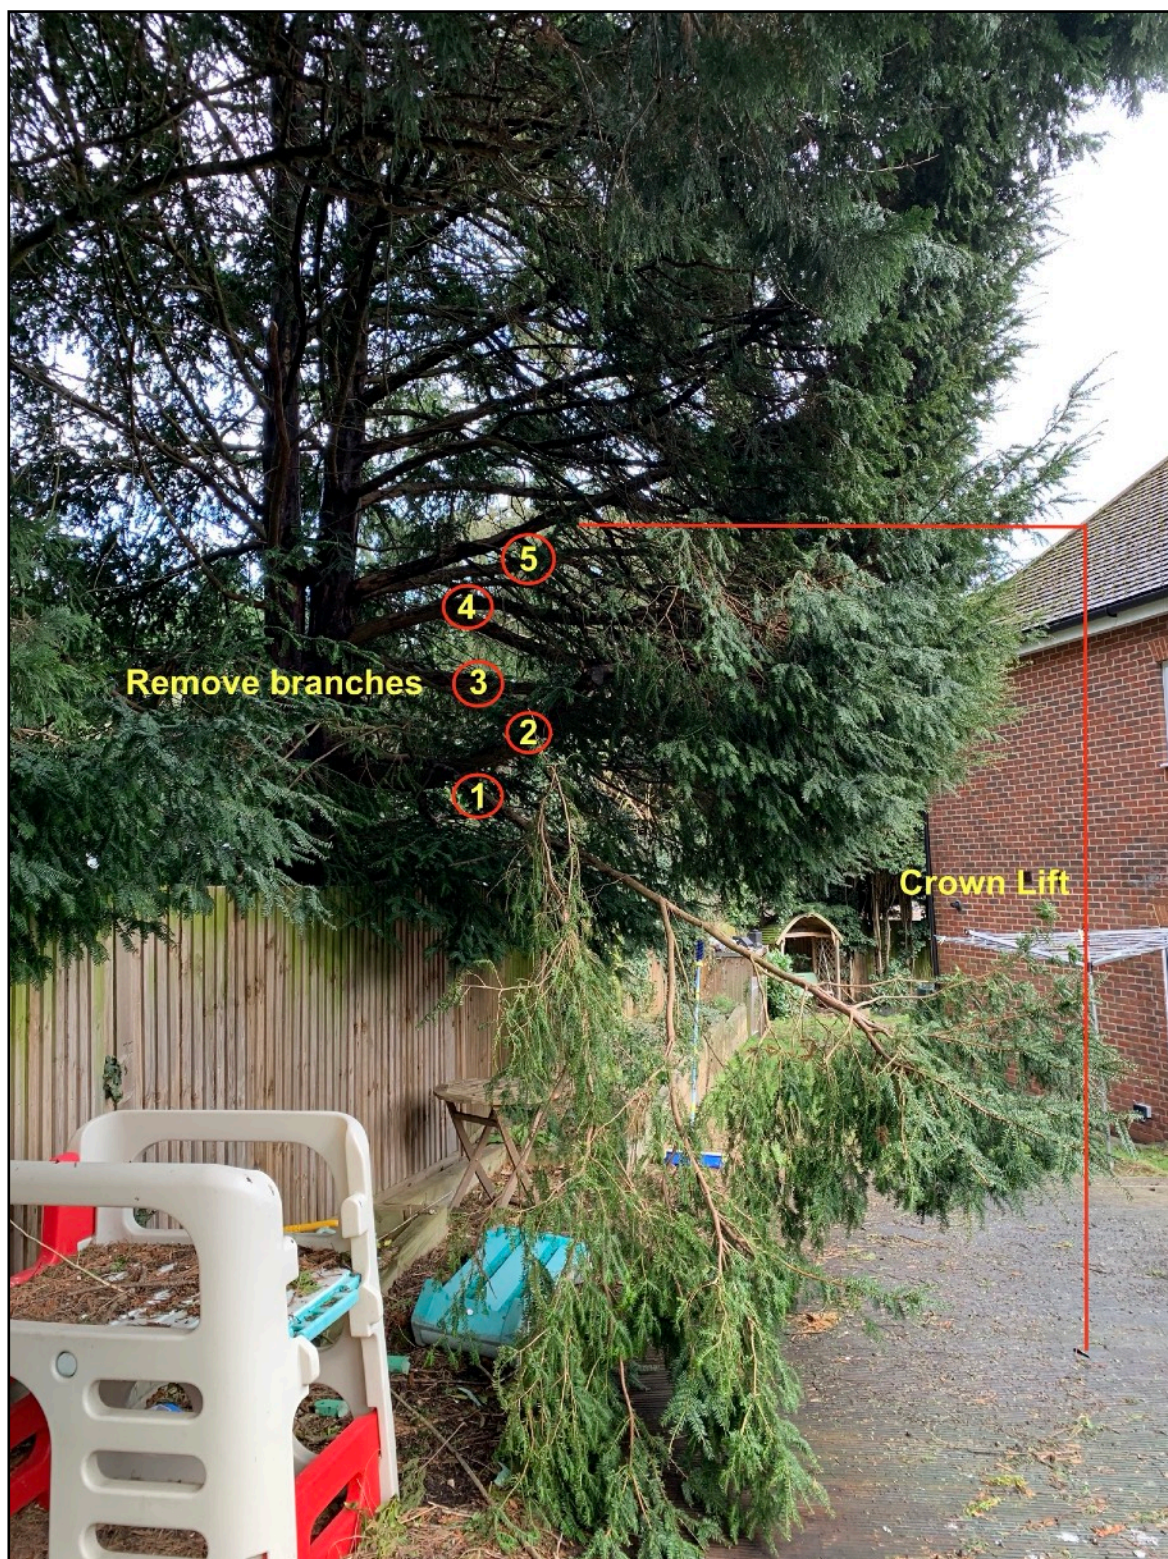
Photo 5 - Yew (T4)

- 5.8 Crown lift by removing the first 5 lowest branches extending into property, back to suitable pruning point, resulting in a clearance of c3.5m above ground level (**Photo 5**).

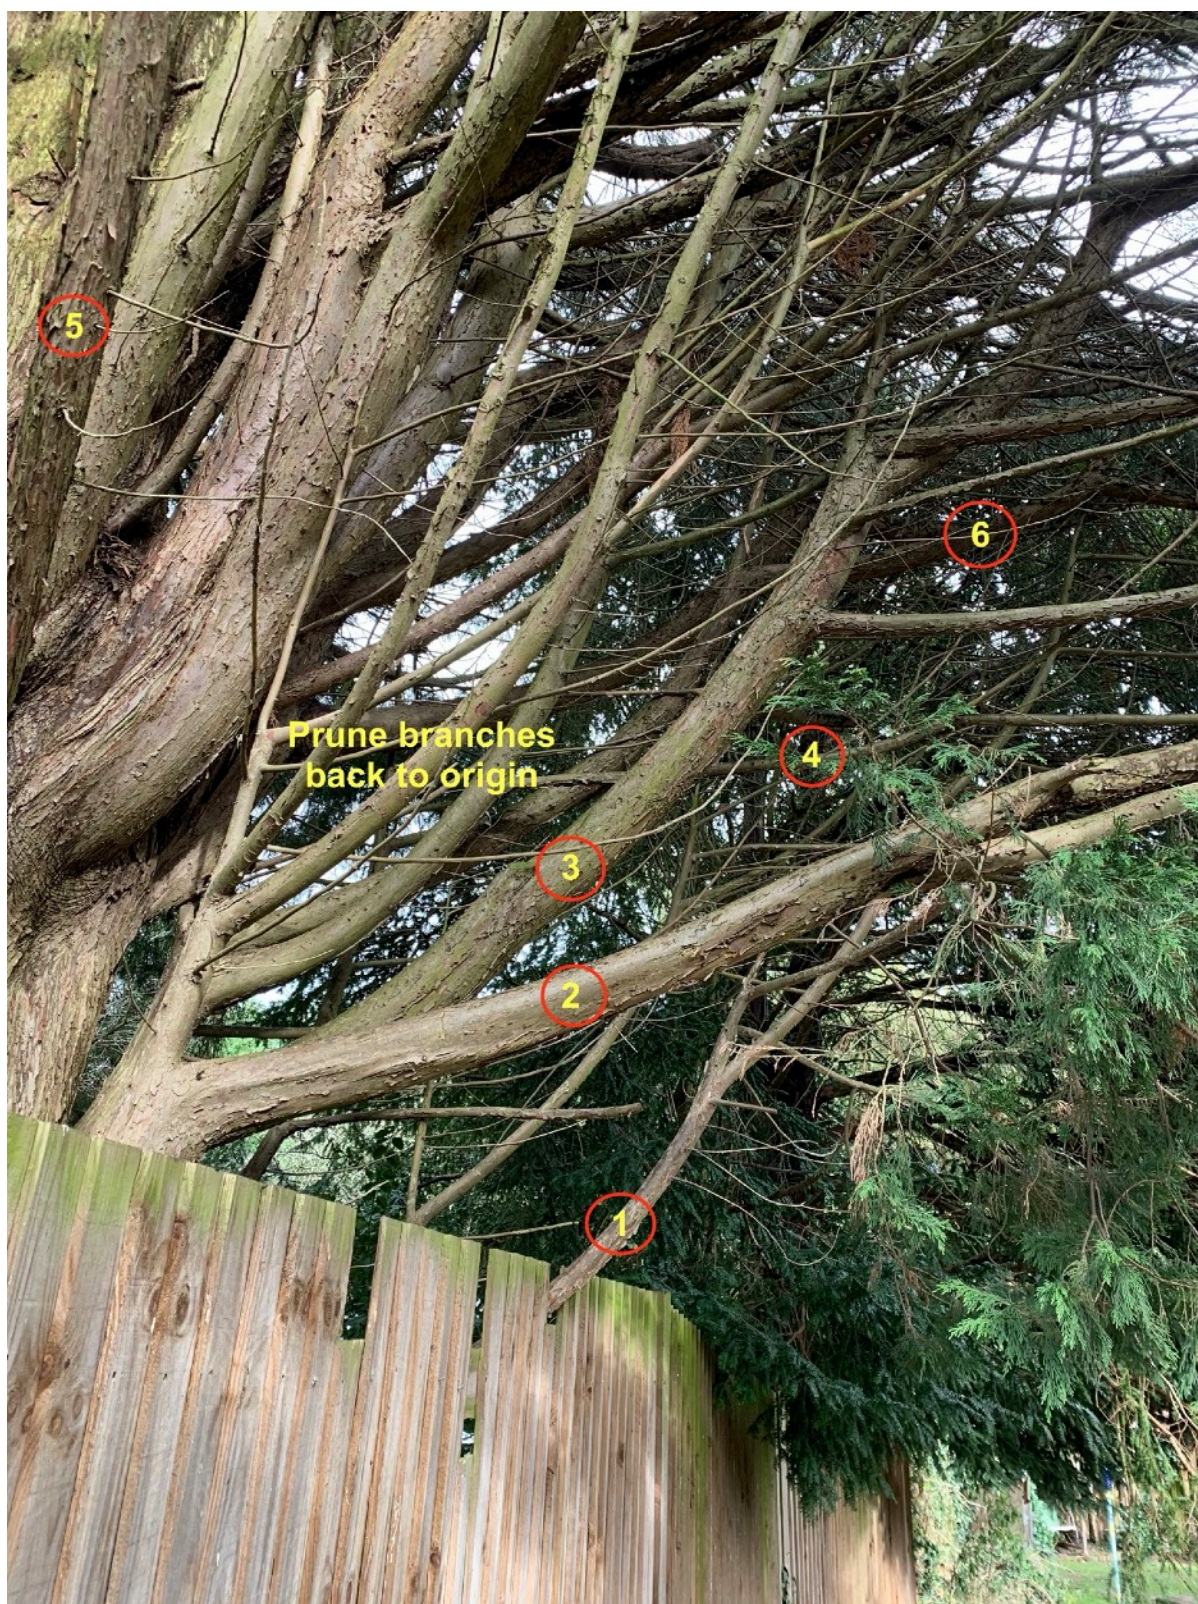
Photo 6 - Leyland Cypress (T2)

- 5.4 Selectively prune by undertaking a crown lift to the height of the garage ridge (inline with T1), by removing **6** lowest branches (**See photo 6**).
- 5.5 Selectively prune by undertaking a tip-reduction of remaining canopy (secondary branches), extending over the garage by 1 metre from garage wall.
- 5.6 Also remove dead/snapped branches back to suitable pruning points.
