**19 Surley Row  
Emmer Green  
Reading  
Berkshire  
RG4 8PW**

# **Preliminary Bat Roost Assessment**

**Ref: R2634/a**

**October 2020**

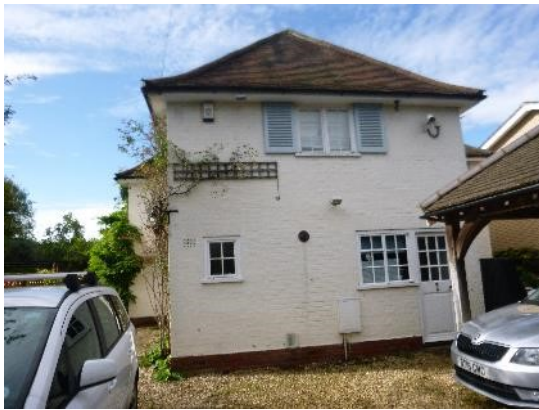
- 3.2.2** The northern side of the house featured a section of flat roof in between two hipped roofs that looked of newer construction to the rest of the property (**Photograph 1 & 2**). The hipped roof to the front of the house had uneven tiles with gaps underneath them (**Photograph 3: Target note 1**) with intact hipped tiles. A tight wooden soffit ran the length of the eastern elevation of the house with no gaps (**Photograph 4: Target note 2**). The lead flashing was tight around the chimney breast, as were the ridge tiles leading up to the chimney (**Photograph 5: Target note 3**). Above the entranceway was a flat roof porch, with flat tiles and intact soffit that were tight to the walls (**Target note 4**). The south-eastern wall had a wisteria plant growing up and covering nearly the entire wall (**Photograph 6: Target note 5**) but where visible, the soffit was fitted tightly (**Target note 6**). To the rear of the property was a single storey hipped roof that had a gap in the mortar under the hip tiles (**Target note 7**) and uneven roof tiles with gaps underneath (**Photograph 7: Target note 8**). The rear elevation of the house had a tight soffit running the length of the side (**Photograph 8: Target note 9**). There was a slightly lifted tile below the ridge of the main roof, beside of the chimney (**Photograph 9: Target note 10**) with the rest of the roof and hip tiles all tight and intact. The newer section of roof, to the northern side of the house, had flat and intact roof, verge and hip tiles (**Photograph 10: Target note 11**). The newer roof had two sections of hipped roofing with a section of flat roof between them (**Target note 12**). The roof tiles on the north-eastern elevation were flat and the soffit was flush with the wall (**Photograph 11: Target note 13**). The windows around the house had open shutters pinned back to the wall, with gaps between the slats with no

1. Front of the house viewed from the northeast.

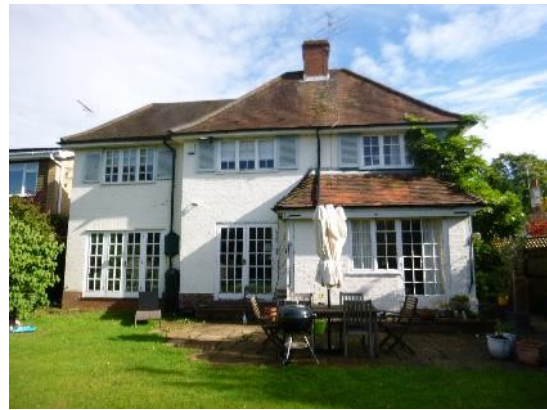
2. Rear of the house viewed from the southwest.

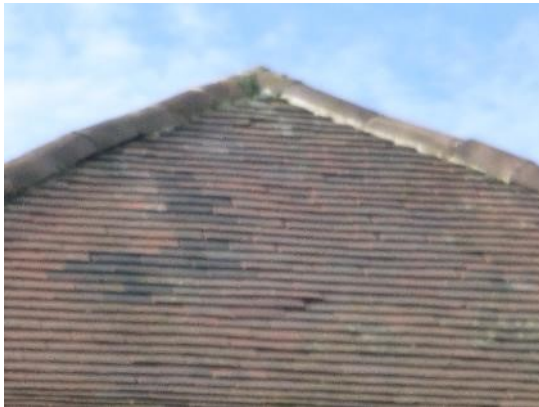
- 4.1.1** There was no evidence of roosting bats (i.e. droppings or staining) found during the roost assessment. The house had some features suitable for allowing bats access, i.e. gaps under tiles and missing mortar under occasional hipped tiles of low bat roost potential. However, the gaps under the tiles were in the unlined section of the roof and therefore did not provide hidden crevices suitable for bats and there were not any bats or droppings visible within the roof void and as such it is considered unlikely that the house supports bats.

3. Uneven roof tiles to the front of the house.

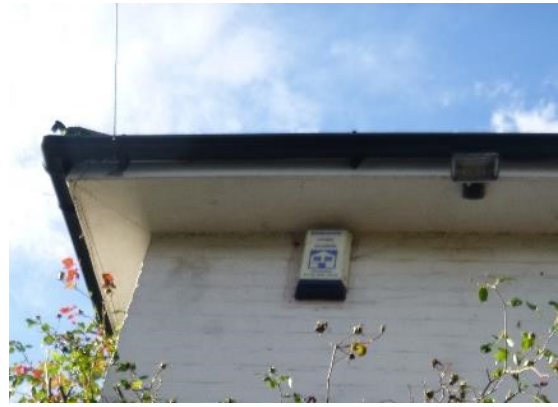
4. Tight wooden soffit, flush to wall.

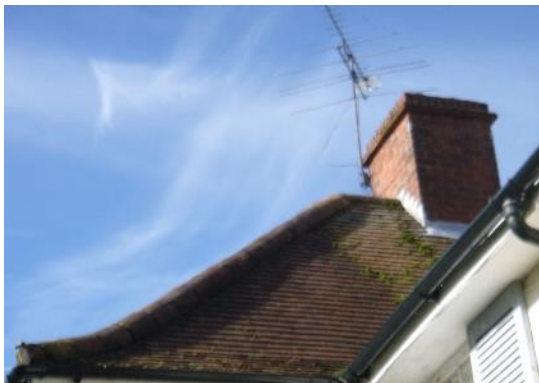
5. Tight lead flashing around base of the chimney; Intact hip, ridge and flat roof tiles.

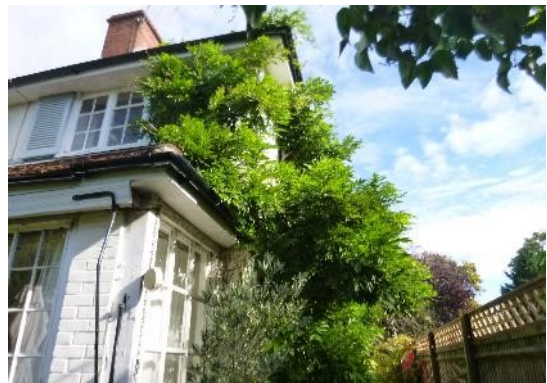
6. Tight lead flashing around base of chimney; slightly lifted tile below chimney.

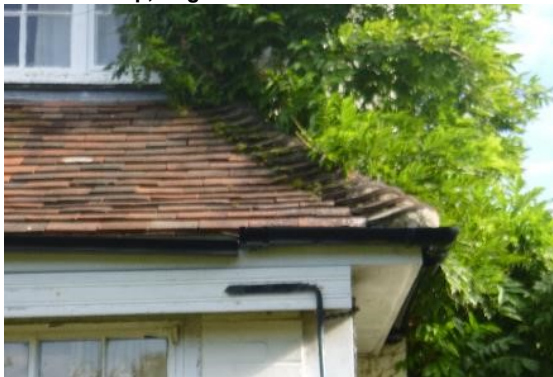
7. Uneven roof tiles on top of hipped roof to the rear of the house; gaps in mortar under the hip tiles.

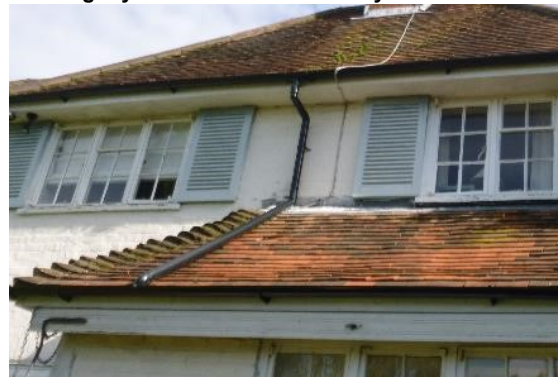
8. Tight wooden soffit around the rear elevation of the house.

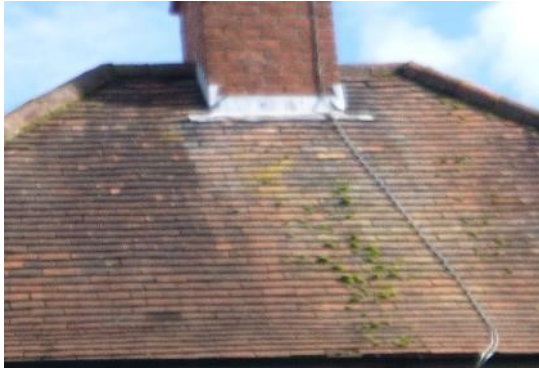
9. Slightly lifted tile below the ridge next to the chimney; intact hip tiles and mostly flat roof tiles.

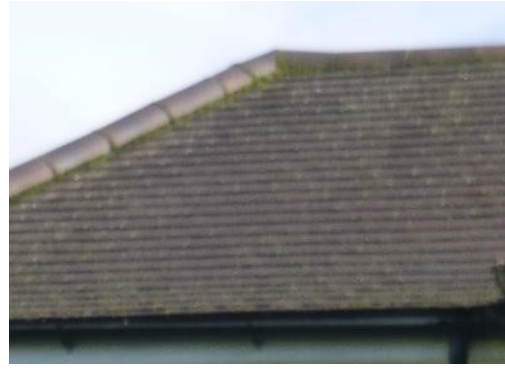
10. Flat and intact roof, verge and hip tiles on the newer extension to the northern side of the house.

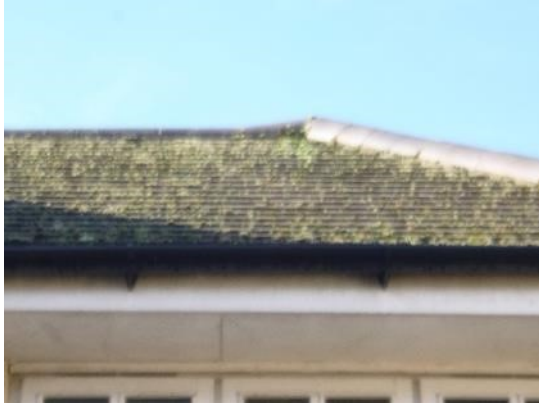
11. Tight roof tiles on the north-eastern side of the house: soffit flush with the wall.

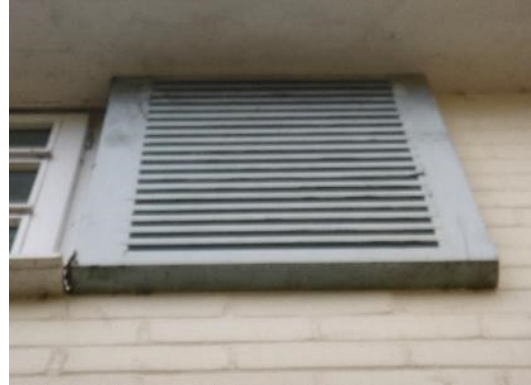
promise for roosting opportunities (**Photograph 12: Target note 14**).

12. Open shutters on windows, with no promise for roosting opportunities.

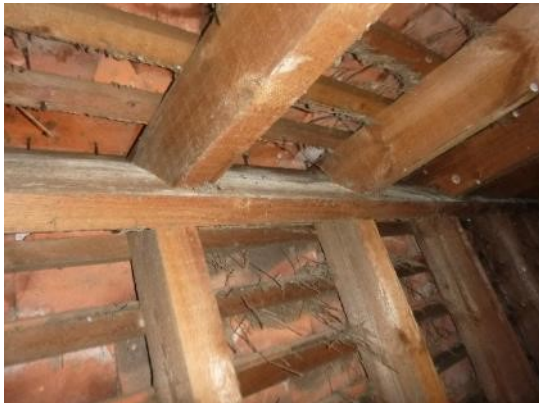
**3.3.1** The roof void was accessible via a hatch on the first floor. The roof was unlined, with the underside of the tiles visible in the main section of the void with remnants of old straw insulation hanging around the tiles in places (**Photograph 13: Target note 15**). The floor was partially boarded along the middle of the roof space, with older fibreglass insulation present towards the eastern side of the void, and with newer fibreglass insulation - laid in the last 12 months - towards the southern side of the void (**Photograph 14 & 15: Target note 16**). The eaves of the roof were mostly open where there was the older fibreglass insulation, and had been filled in the areas that had the new insulation (**Target note 17 & 18**). The void in the hipped roof extension to the northern end was inaccessible due to the trussed rafter construction, however, the roof was visible and lined with a breathable roofing membrane, that looked intact (**Photograph 16: Target note 19**). Around the chimney stack, the beams were tight to the brickwork and it was heavily cobwebbed (**Photograph 17: Target note 20**). Towards the north-eastern side of the roof void there was a large covered water tank, with a section of boarded flooring around it (**Photograph 18**). The hipped roof had a square section covered in a breathable roofing membrane, where it looked like there had been some repair work carried out in the past (**Photograph 19: Target note 21**). Along the side of the void there were rolls of fibreglass insulation that was yet to be put down (**Target note 22**). Within the void were numerous old wasps' nests (**Photograph 20: Target note 23 & 24**).

13. Unlined roof, with underside of roof tiles exposed; remnants of old straw insulation.

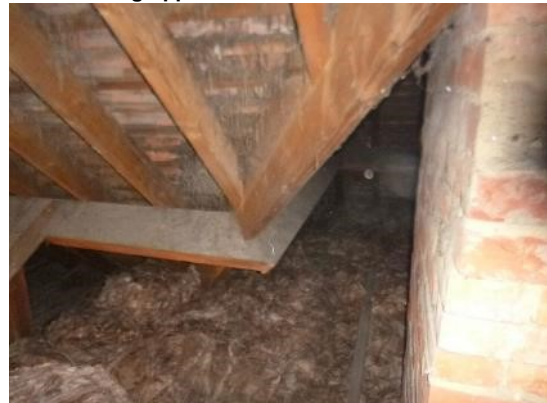
14. Newer fibreglass insulation laid to the south of the void around the chimney.

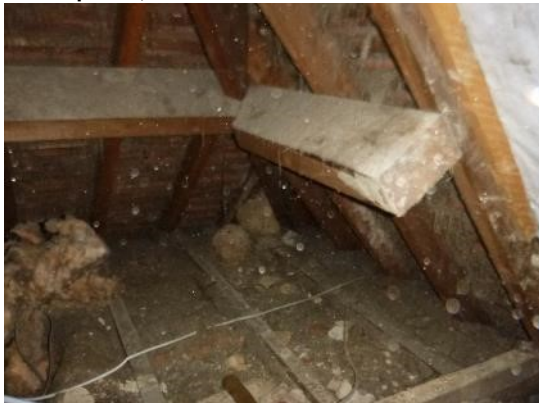
15. Older fibreglass insulation around the loft hatch and to the north-eastern side of the void.

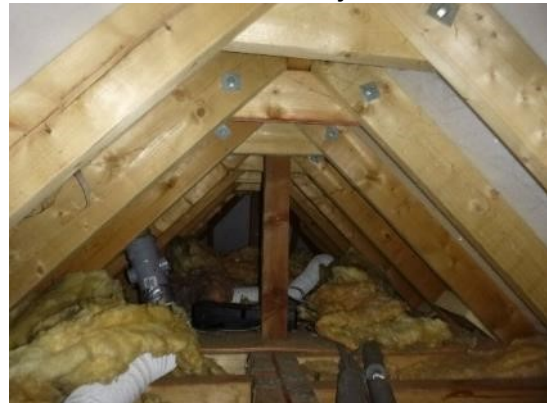
16. Hipped roof extensions with intact breathable membrane lining.

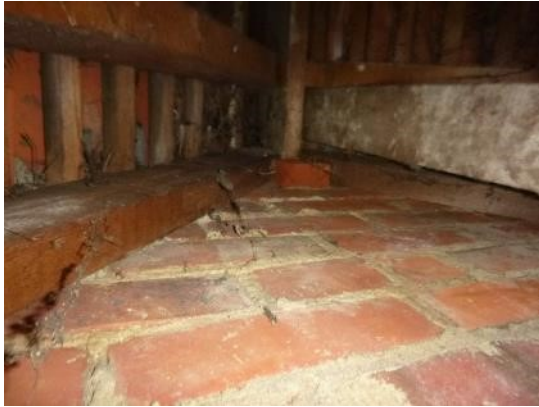
**17. Beams and rafters tight to brickwork around the chimney.**

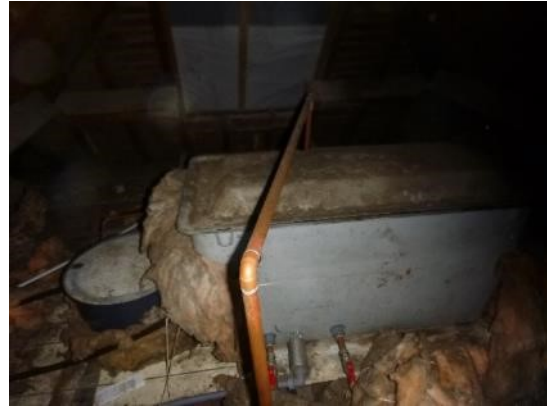
**18. Covered water tank to the north-eastern end of the void.**

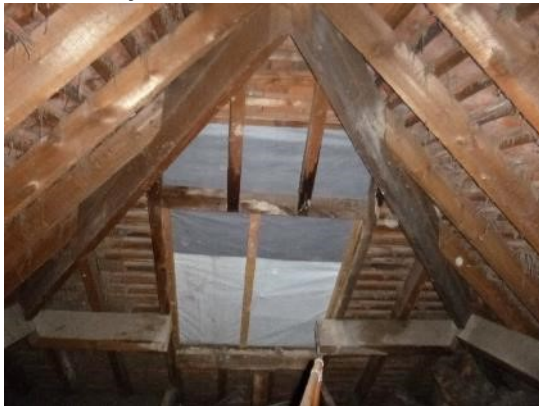
**19. Area of hipped roof covered in plastic sheeting and breathable roofing membrane.**

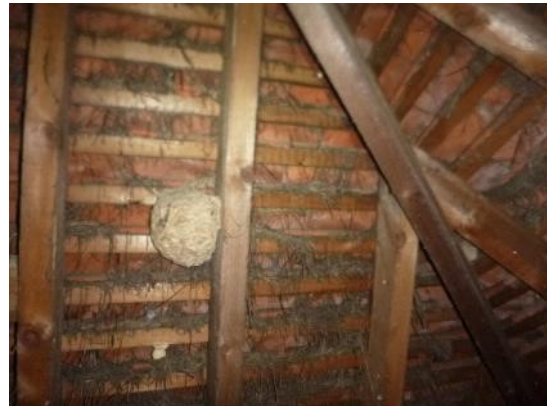
**20. Old wasp nest present in the roof void.**
