# Site Investigation Report

The Lodge  
77 Chazey Road  
Caversham  
Reading  
Berkshire

Client: Crawford & Company

Optera Reference: 4146

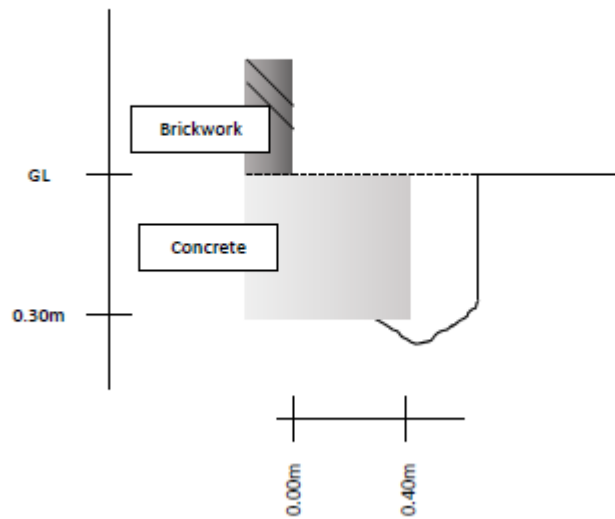
Figure 2 – EH1 cross-section

EH1 was formed using a hand-auger and taken to 1.20mbgl, where it was terminated due to constant pit collapse.

Roots of live appearance were encountered in EH1 to a depth of approx. 0.30mbgl.

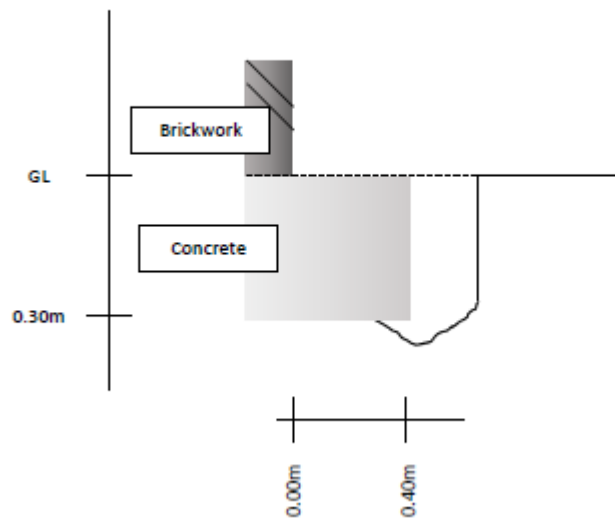
Figure 3 – EH2 cross-section

EH2 was formed using a hand-auger and taken to 0.70mbgl, where it was terminated due to constant pit collapse.

Roots of live appearance were encountered in EH2 to a depth of approx. 0.30mbgl.

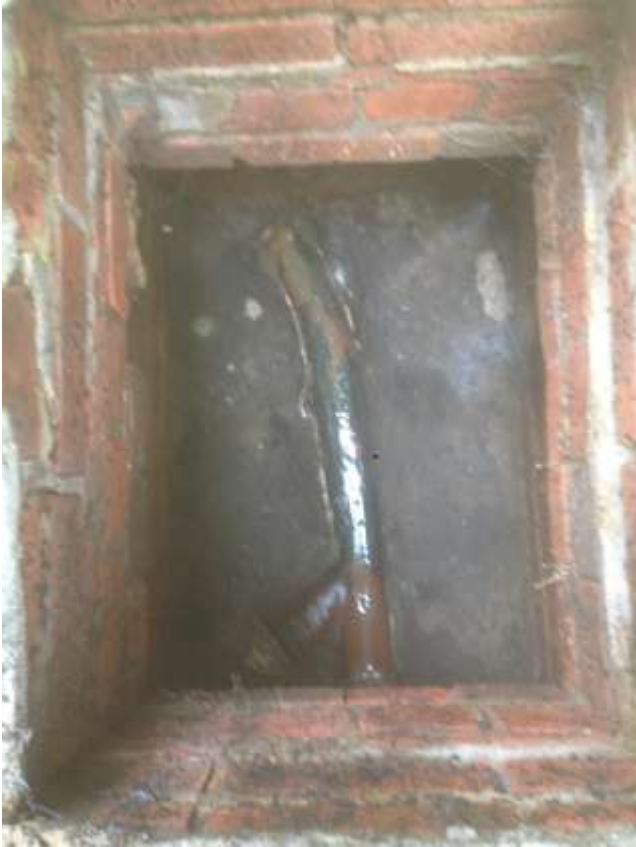
Photo 4 – IC1

The inspection chamber, all observed runs, and the surface gully were all in good working condition with no sign of displacement however there was notable root ingress in Run B and Run E.

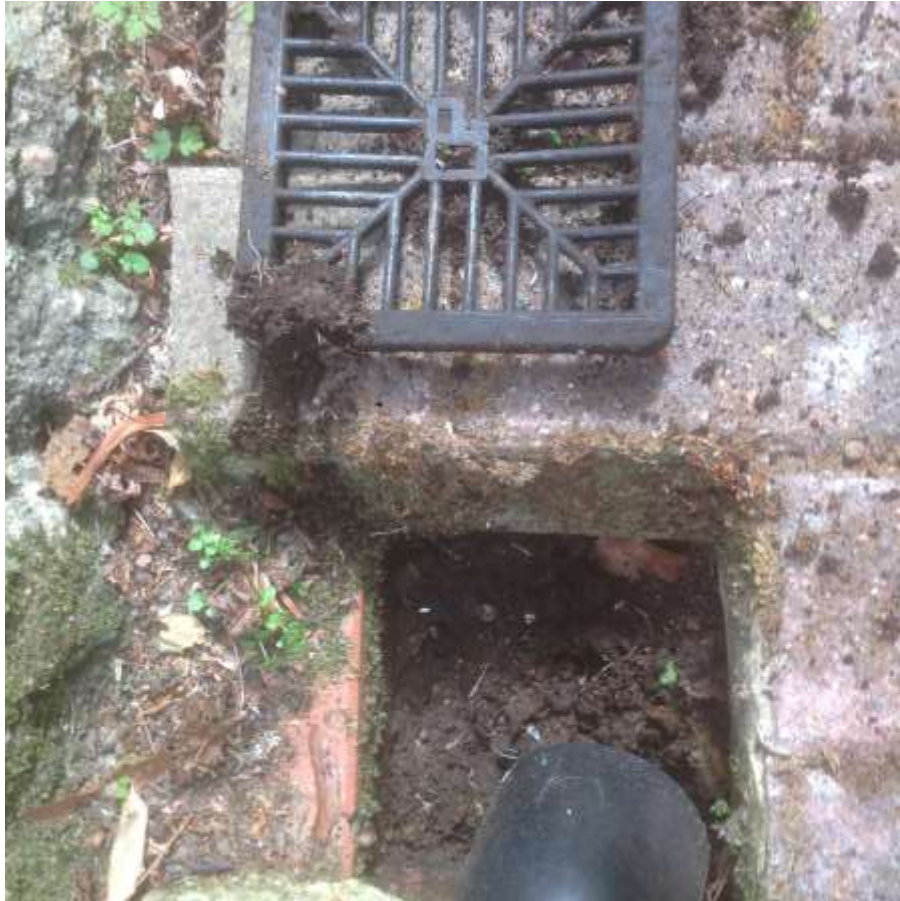
It was not possible to survey SW1 due to the gully being fully blocked. An attempt was made to clear the gulley by hand and with water but was still inaccessible to the camera.

Photo 6 – Blocked SW1
