# Arboricultural Consultancy for Aviva - Commercial

| Insured | Reading Spiritualist Church | Address | 81 Baker Street, Reading, RG1 7XY | | |
| ES Ref | SA-245627 | Consultant | Giles Mercer | Contact No. | 0330 380 1036 |
| Report Date | 14/01/2020 | | | | |

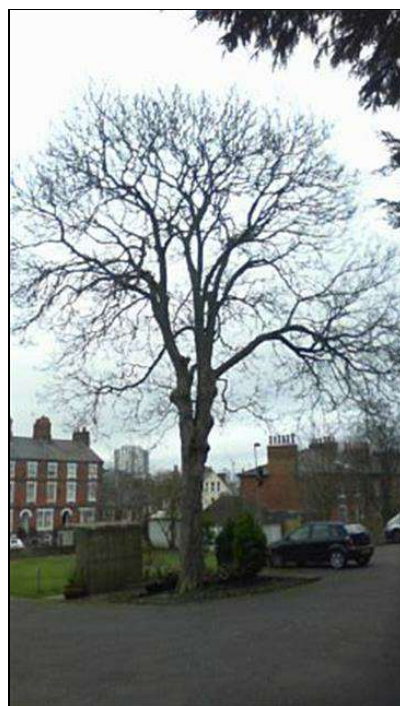
T3 - Sycamore

| Tree No. | Species | Age Cat | Approx. Height (m) | Distance to Building (m) * | Ownership | Action | Requirement |
|---|---|---|---|---|---|---|---|
| T3 | Sycamore | 1 | 16.5 | 10.4 | C - Insured | Action to avoid future risk | Do not allow to exceed current dimensions by way of regular pruning. |

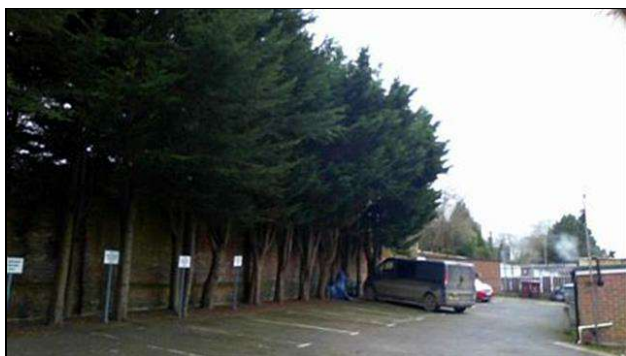
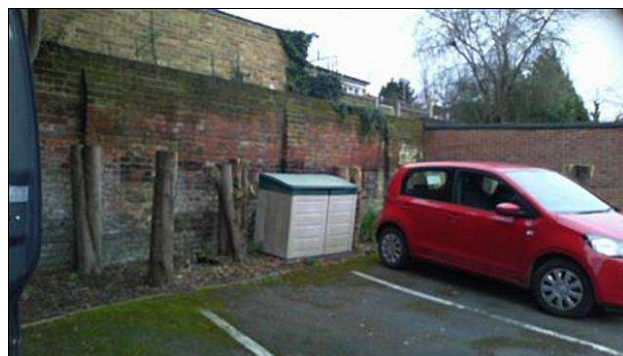
TG3 - Cypress

| Tree No. | Species | Age Cat | Approx. Height (m) | Distance to Building (m) * | Ownership | Action | Requirement |
|---|---|---|---|---|---|---|---|
| TG3 | Cypress | 1 | 10 | 9.9 | C - Insured | Action to avoid future risk | Do not allow to exceed current dimensions by way of regular pruning. |

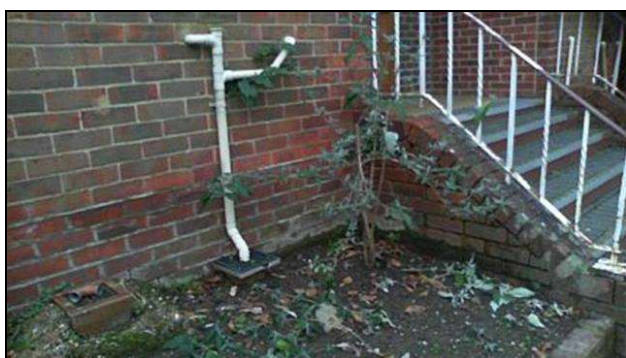
S1 - Buddleia

| Tree No. | Species | Age Cat | Approx. Height (m) | Distance to Building (m) * | Ownership | Action | Requirement |
|---|---|---|---|---|---|---|---|
| S1 | Buddleia | 1 | 1.2 | 0.4 | C - Insured | Action to avoid future risk | Do not allow to exceed current dimensions by way of regular pruning. |

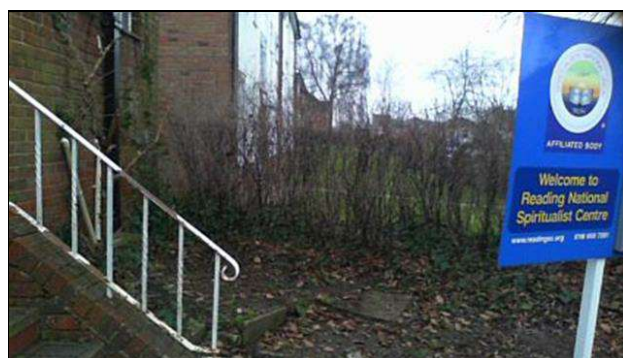
H1 - Snowberry

| Tree No. | Species | Age Cat | Approx. Height (m) | Distance to Building (m) * | Ownership | Action | Requirement |
|---|---|---|---|---|---|---|---|
| H1 | Snowberry | 1 | 2 | 0.5 | C - Insured | Action to avoid future risk | Remove section of hedge to achieve a minimum clearance of 2 m to the property. Balance to be maintained on a regular basis to ensure that current dimensions and influence are not exceeded. |

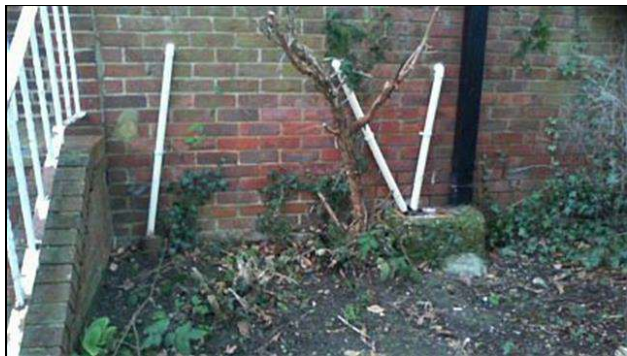
STG1 - Mixed species group

| Tree No. | Species | Age Cat | Approx. Height (m) | Distance to Building (m) * | Ownership | Action | Requirement |
|---|---|---|---|---|---|---|---|
| STG1 | Stump | 1 | 1.8 | 0.2 | C - Insured | Action to avoid future risk | Treat stump to inhibit regrowth. |

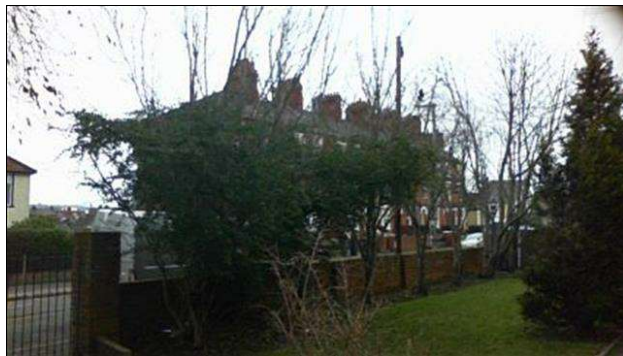
TG1 - Cherry

| Tree No. | Species | Age Cat | Approx. Height (m) | Distance to Building (m) * | Ownership | Action | Requirement |
|---|---|---|---|---|---|---|---|
| TG1 | Cherry | 1 | 9.2 | 8.2 | C - Insured | Action to avoid future risk | Do not allow to exceed current dimensions by way of regular pruning. |

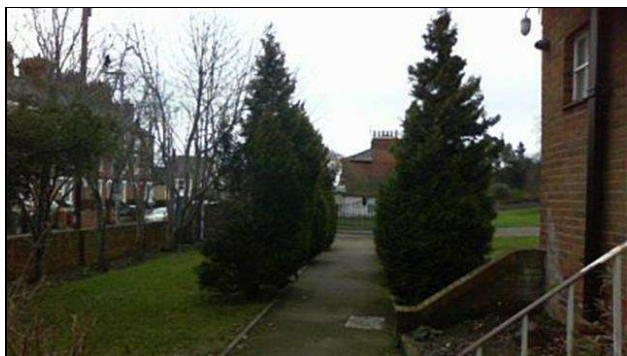
TG2 - Cypress

| Tree No. | Species | Age Cat | Approx. Height (m) | Distance to Building (m) * | Ownership | Action | Requirement |
|---|---|---|---|---|---|---|---|
| TG2 | Cypress | 1 | 3.8 | 2.8 | C - Insured | Action to avoid future risk | Remove nearest tree (to building) . Do not allow remainder to exceed current dimensions by way of regular pruning. |
