## Bat – Daytime Inspection Report

Montpelier Estates Ltd

Dellwood Hospital, Reading

Ref: 19-1293  
Version: V1  
Date: 14/10/2019

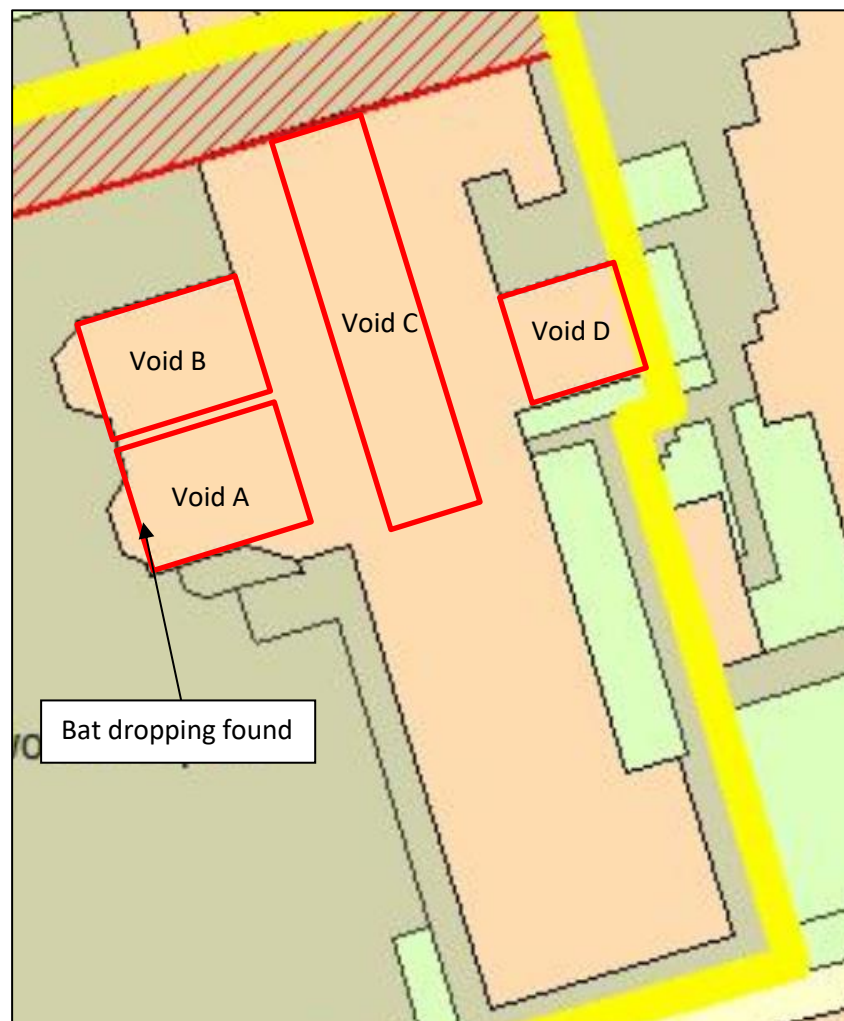
**Figure 2.** Void Plan (A – D)

- 3.17 The multiple pitched roof of the main building is split into four sections; these have been marked as Void A – D, as seen in **Figure 2** below. All other sections detailed in **Figure 2** are flat roofs with no voids to inspect.

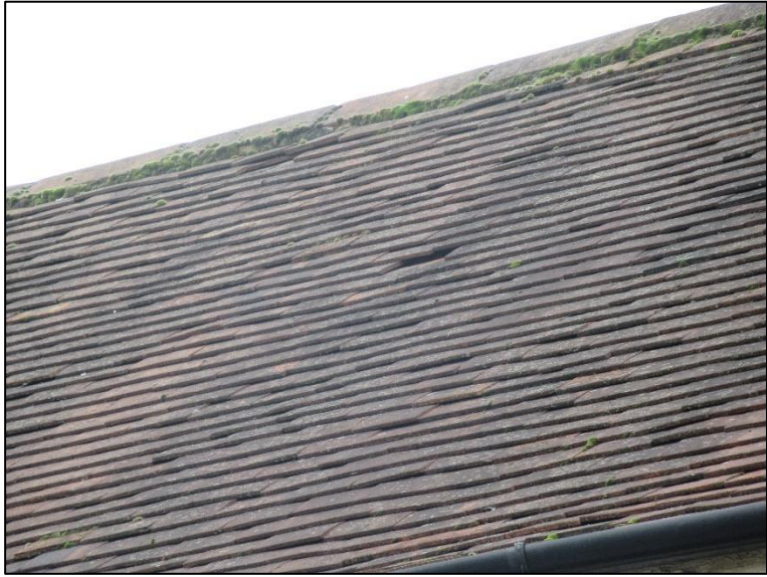
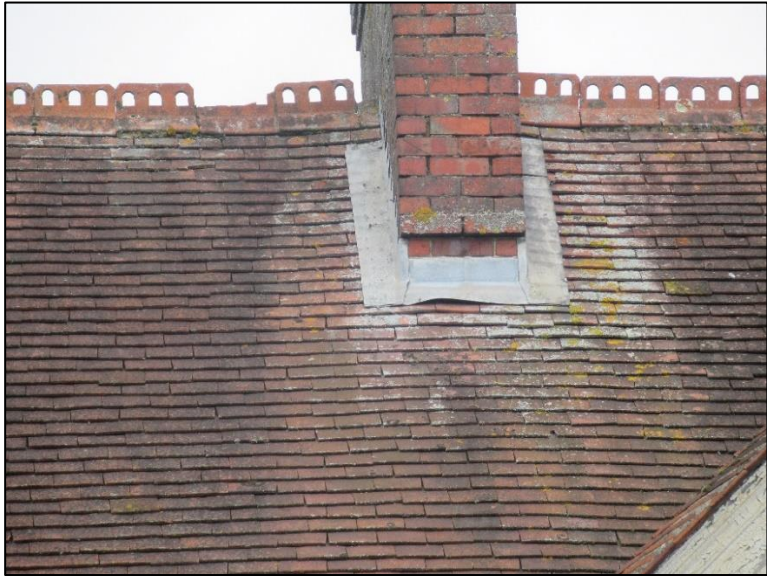
- 3.11 The roof of the main building displays multiple pitches and hip-junctions and is clad with clay tiles. Ornamental clay ridge tiles are also present. The roof itself appears structurally sound, however, slipped and missing tiles were noted, in addition to gaps underneath many of the ridge tiles. The east facing pitch features numerous missing tiles and is in poorer condition.

- 3.14 Two chimney stacks are present on the main roof and lined at the base with lead flashing. The flashing is loose and warped in places creating potential access into the void and for crevice-dwelling species such as pipistrelle. Flashing is also present underneath several of the gable windows providing more access points for bats.

| Features |
|---|
| <div data-bbox="400 313 1169 887">A photograph showing a steeply pitched roof covered in dark, weathered tiles. A black downspout is visible on the right side. There are several missing tiles, particularly along the ridge and in the upper left section, revealing the underlying structure.</div> <p data-bbox="580 887 1015 918"><b>Figure 3: Missing tiles on eastern elevation.</b></p> <div data-bbox="400 945 1169 1518">A photograph of a roof section featuring a brick chimney or gable end. The roof is covered in dark tiles. A metal lead flashing is visible around the base of the brickwork. There are noticeable gaps between the tiles and the flashing, and also between the ridge tiles themselves.</div> <p data-bbox="400 1523 1002 1554"><b>Figure 4: Gap under lead flashing and gaps under ridge tiles.</b></p> |

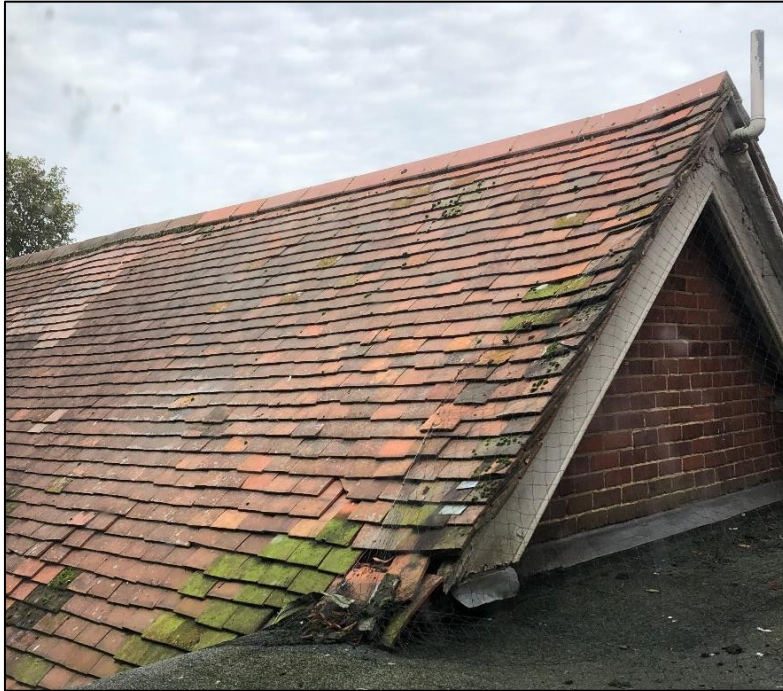
- 3.23 Void D was of a more complex construction supported by both timber and steel ties and struts. The roof was lined with bitumen felt which had several tears and sagged in places. Cobwebbing was present throughout the void, particularly at the gable ends and gable apex's. No evidence of bats was found.

Figure 5: Missing and slipped tiles on Void D.

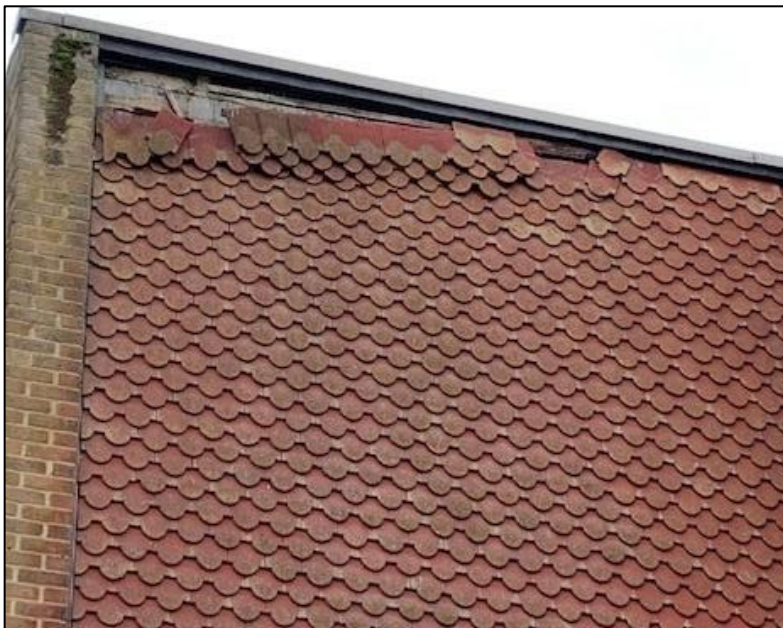
- 3.15 Several elevations are clad with clay hanging tiles, many of which are missing, dislodged or loose allowing for access across the wider elevation. A single blue tit was observed investigating gaps under hanging tiles on the northern elevation.

Figure 6: Slumped and broken hanging tiles on east elevation.

- 5.4 The Site has been shown to provide limited breeding opportunities for birds (possible swallow or swift and potentially blue tit). Therefore any destructive works to the building, such as removal of hanging tiles, should ideally take place outside the bird breeding season (March to August inclusive).
- 5.5 If in the event works need to proceed within this period then specialist advice from a suitable qualified ecologist should be sought. Typically removal of features which could be used by birds, during the bird breeding season would be informed by a pre-works nesting bird check by a suitably qualified ecologist.
- 5.6 It is also recommended that nesting opportunities are incorporated into the proposed plans. These should include:
  - X5 nest cups mounted at eaves level
  - X3 general purpose nest boxes mounted on retained and proposed trees

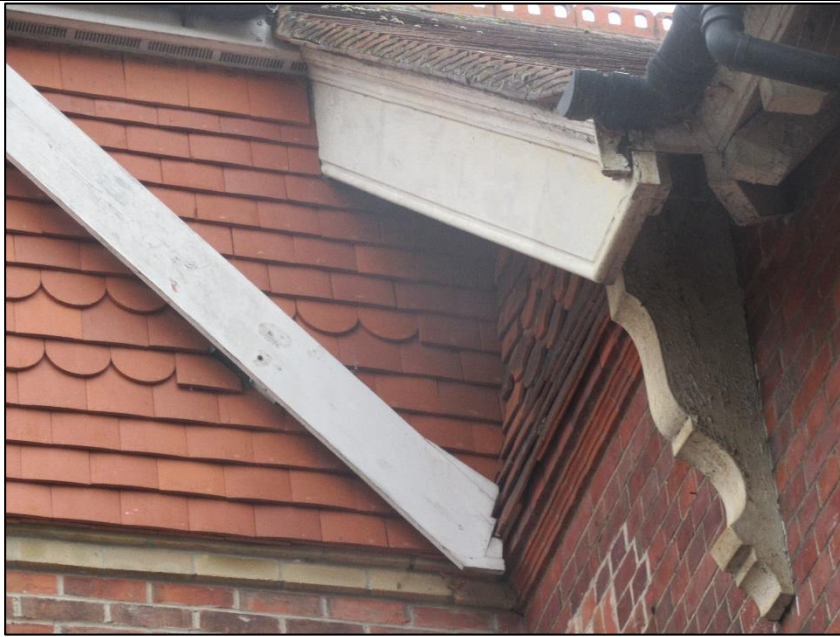
Figure 7: Gaps underneath tiles on north and west elevations.

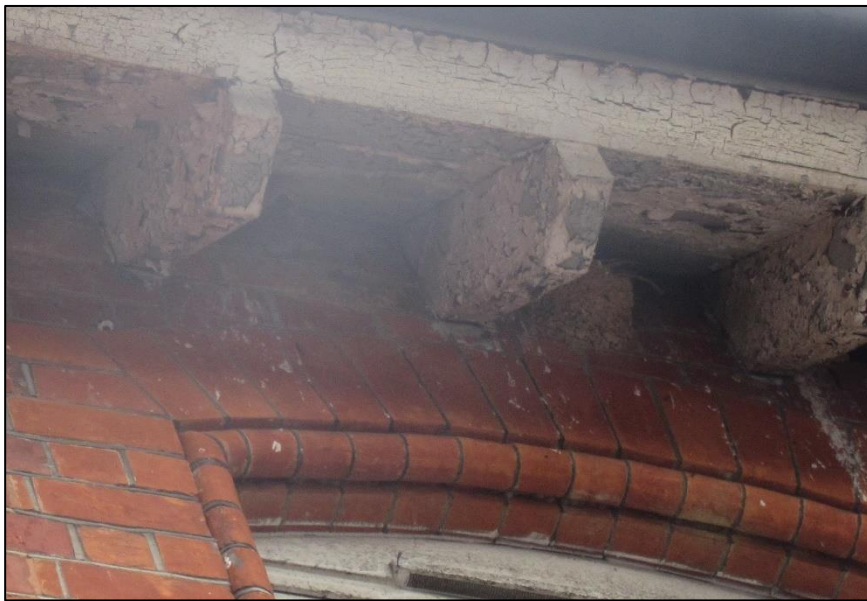
- 3.12 The eaves of the south-west and western elevation overhang significantly and the remnants of three swallow/swift nest cups could be seen at the apex on the southern elevation.

Figure 8: Indeterminate nest cups (x3) on southern elevation.

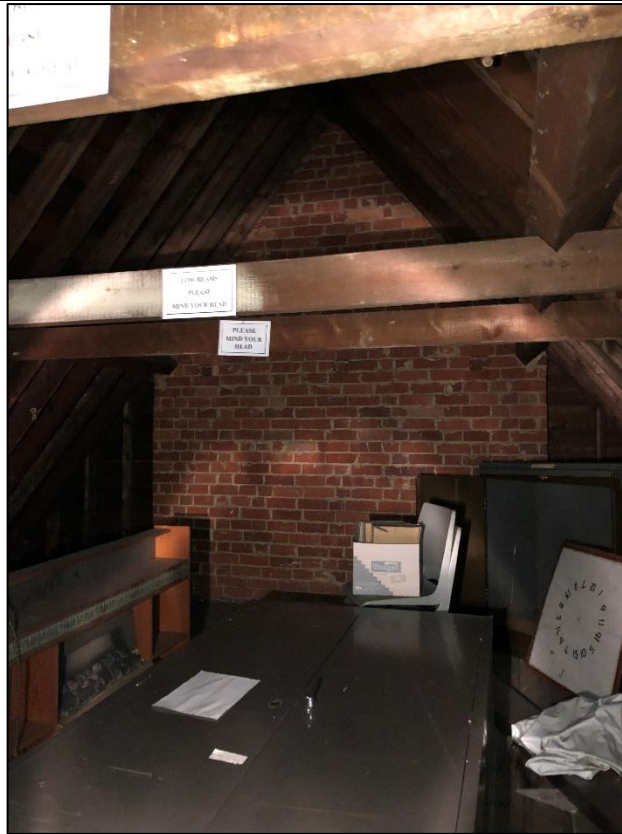
- 3.18 Void A is of simple construction with two timber support ties and a single timber ridge beam. The void is boarded out and used for storage; no joists are visible. The roof is lined with timber

sarking (underside of clay tiles not visible) which is well sealed. One small inactive wasps nest was found along the ridge beam and signs of minor water ingress were also noted. Cobwebbing was present but considered to be minimal.

Figure 9: Void A, boarded and used for storage

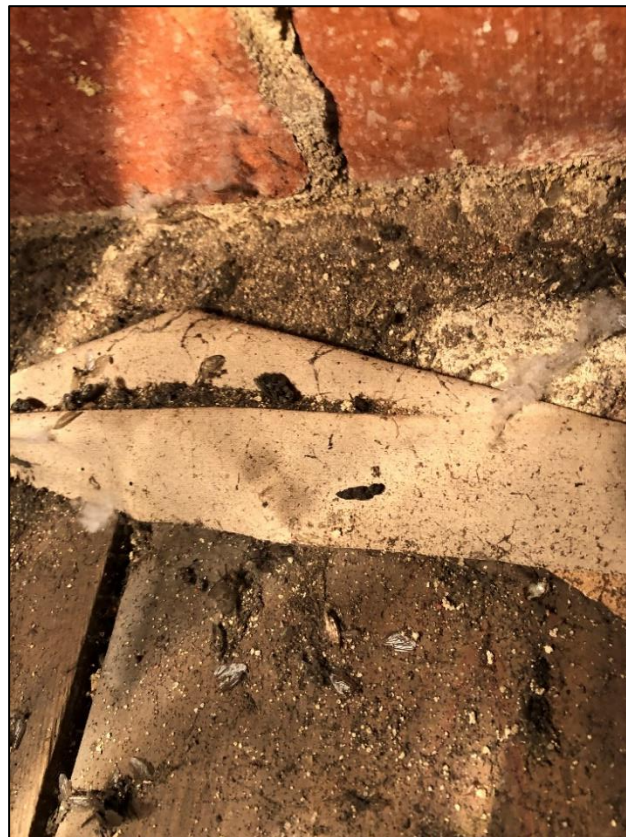
- 3.19 A single bat dropping was identified under the ridge at the western gable end and was similar in size and shape to a brown long-eared dropping.
- 3.20 Void B is of the same construction as Void A however, it was not fully accessible. A small room connected Voids A and B, with Void B having exposed rafters opening into the connecting area. These rafters were tightly spaced which did not allow for direct access into the void. The presence of bats, or evidence of bats could not be fully assessed.

- 3.24 In summary, the building offers a range of external and internal features with the potential to support roosting bats and has therefore been categorised as having High Suitability. The single dropping found in Void A also suggests that a bat has roosted within the smaller void at some point, therefore Void A can also be classified as a confirmed roost.

Figure 10: Bat dropping found under ridge in Void A

- 5.2 A series of three nocturnal dusk emergence / dawn re-entry surveys are recommended to assess the building to be affected by the proposals. Surveys will be undertaken in accordance with best practice guidance and can be undertaken between May and September, with the optimum survey period being between May and August. A minimum of three separate survey visits will be required, comprising of dusk emergence and dawn re-entry surveys. Surveys should be undertaken in good weather conditions and spaced apart by a minimum of two weeks.

- 5.3 If bats are found to be roosting within the building then it will be necessary to apply to Natural England for a European Protected Species Derogation Licence in order to demolish the building. Appropriate mitigation will be determined during the Licence application process.

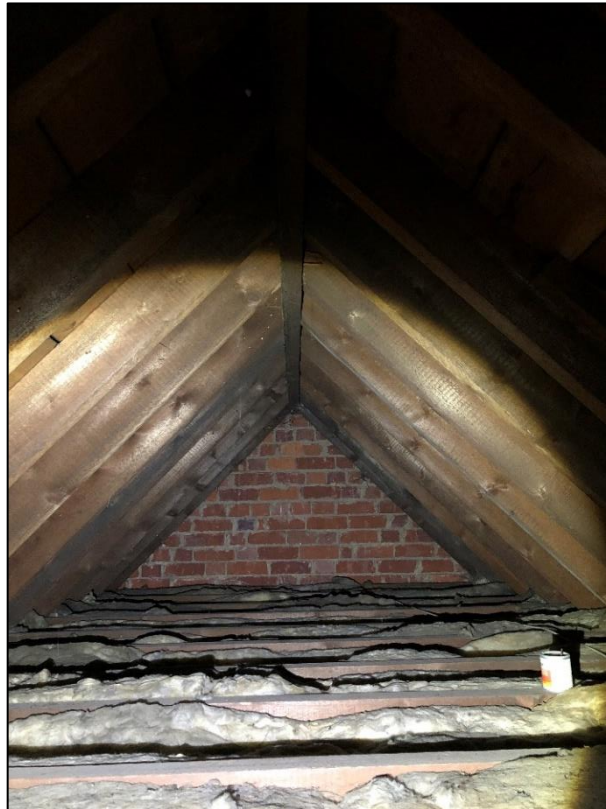
Figure 11: Void C

- 3.21 Void C ran along the centre of the building following the main ridgeline. The wider void had been converted, accommodating a third floor type loft conversion (office space). The remaining loft space was less than 1m in height and ran the length of the building. Due to the tight crawl space the void could not be accessed safely all the way along.

- 3.22 The void was cobwebbed, with heavy webbing along the main ridge. There was a thick layer of rockwool type insulation at joist level and the roof itself was lined by timber sarking, similar to Voids A and B. No evidence of bats was found.
