# TECHNICAL REPORT

Crawford Reference: SU1901098

[REDACTED]  
The Lodge  
77 Chazey Road  
Caversham  
Reading  
Berkshire  
RG4 7DU

## SUBSIDENCE CLAIM

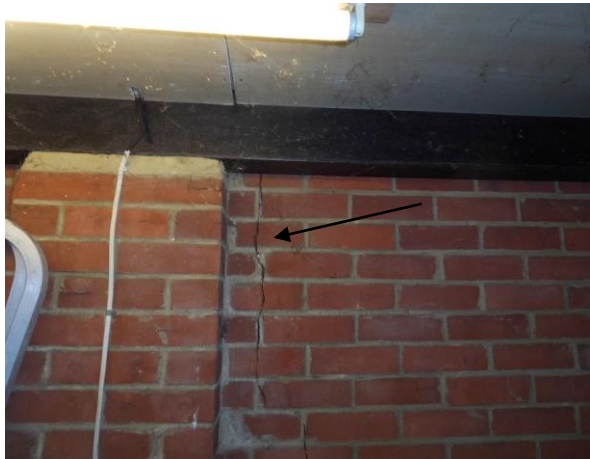
Detached garage-  
Vertical and stepped tapered cracking of up to 7mm was noted to the brickwork rear centre elevation of the garage.

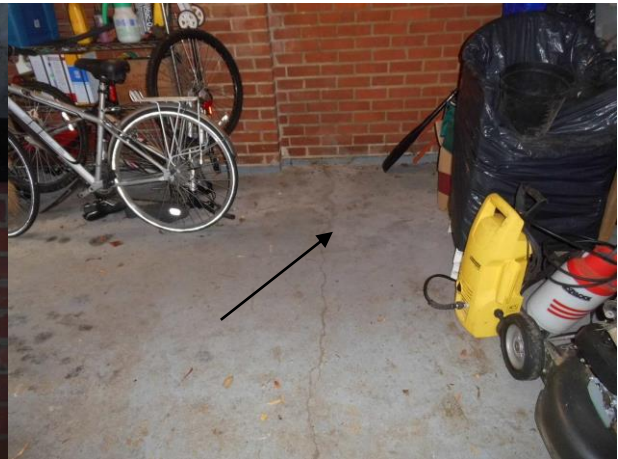
Detached garage-  
Front to rear to the centre of the garage is a crack to the concrete floor, with signs of a slope to the rear right corner, with maximum crack widths of 2mm.

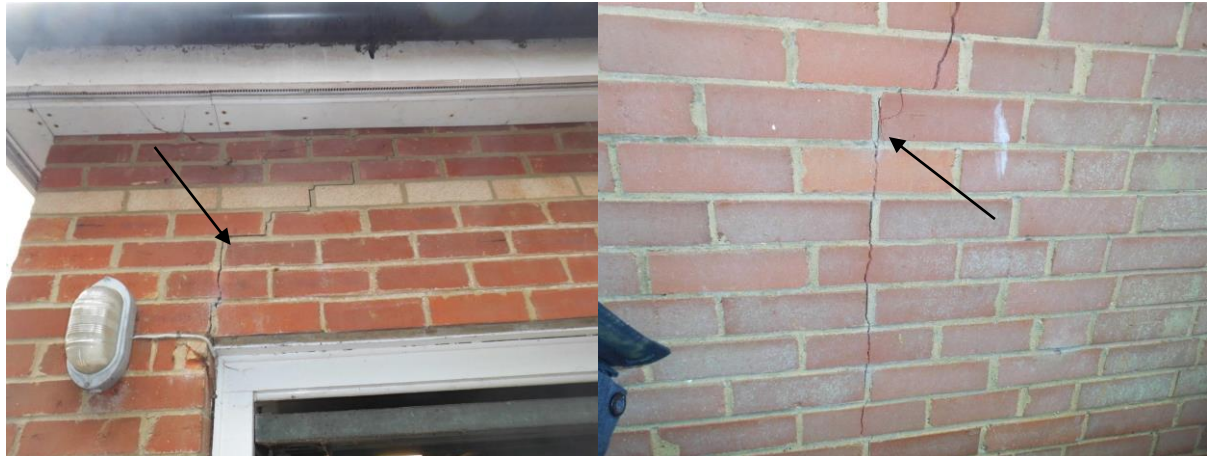
Detached garage-  
Stepped tapered cracking of up to 7mm was noted to the brickwork top left of the front garage door.

Detached garage-  
Vertical and stepped tapered cracking of up to 7mm was noted to the brickwork rear centre elevation of the garage.

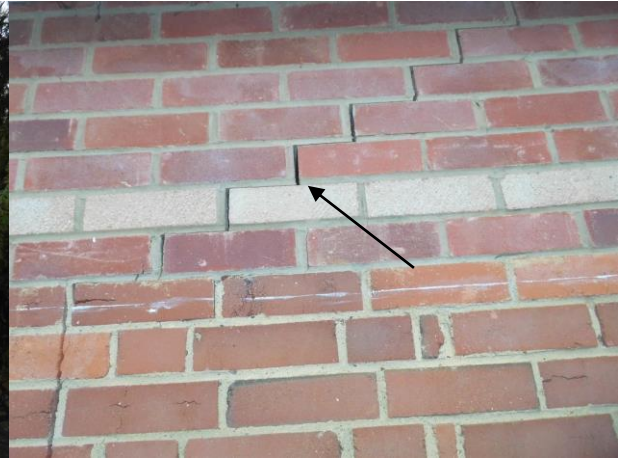
Detached garage-  
Vertical and stepped tapered cracking of up to 7mm was noted to the brickwork rear centre elevation of the garage.

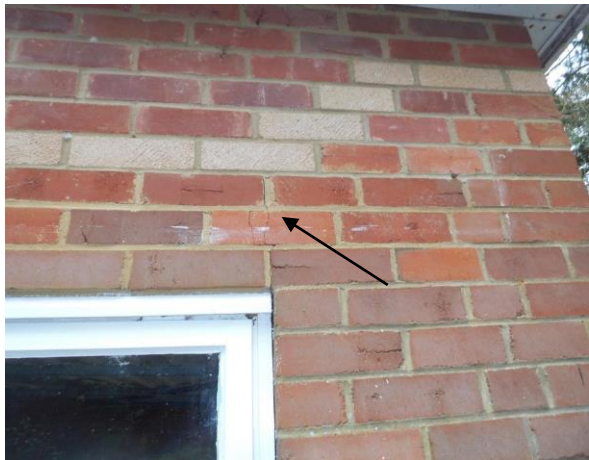
Detached garage-  
Stepped tapered cracking of up to 1mm was noted to the brickwork top right of the left hand front window.

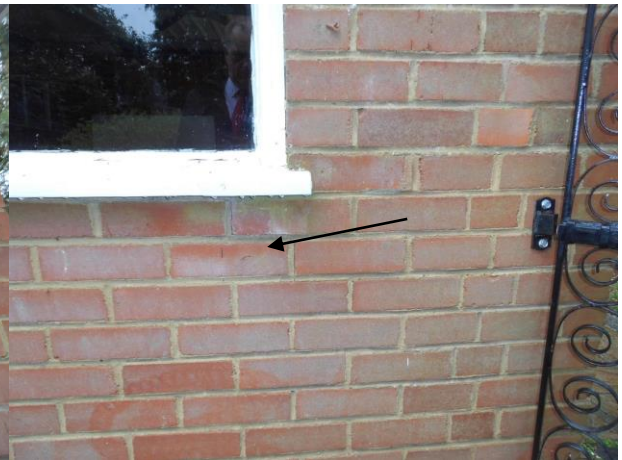
Detached garage-  
Stepped tapered cracking of up to 1mm was noted to the brickwork bottom right of the left hand front window.

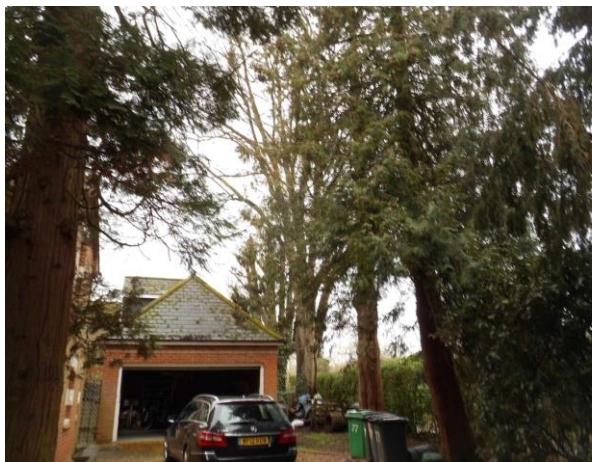
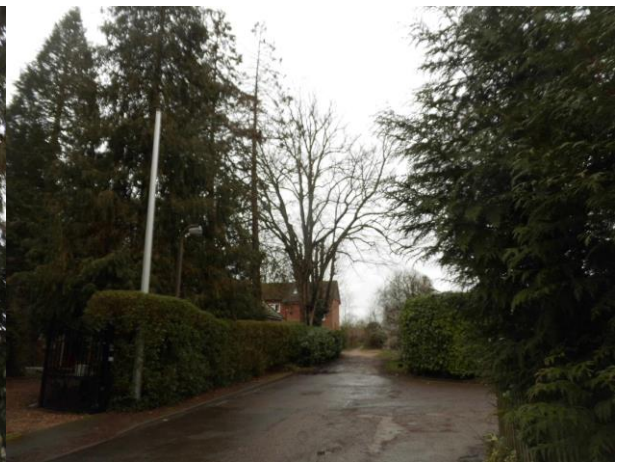
Possible offending trees.
