# ADDENDUM TECHNICAL REPORT

**Crawford Reference: SU1901098**

**The Lodge  
77 Chazey Road  
Caversham  
Reading  
Berkshire  
RG4 7DU**

**SUBSIDENCE CLAIM**

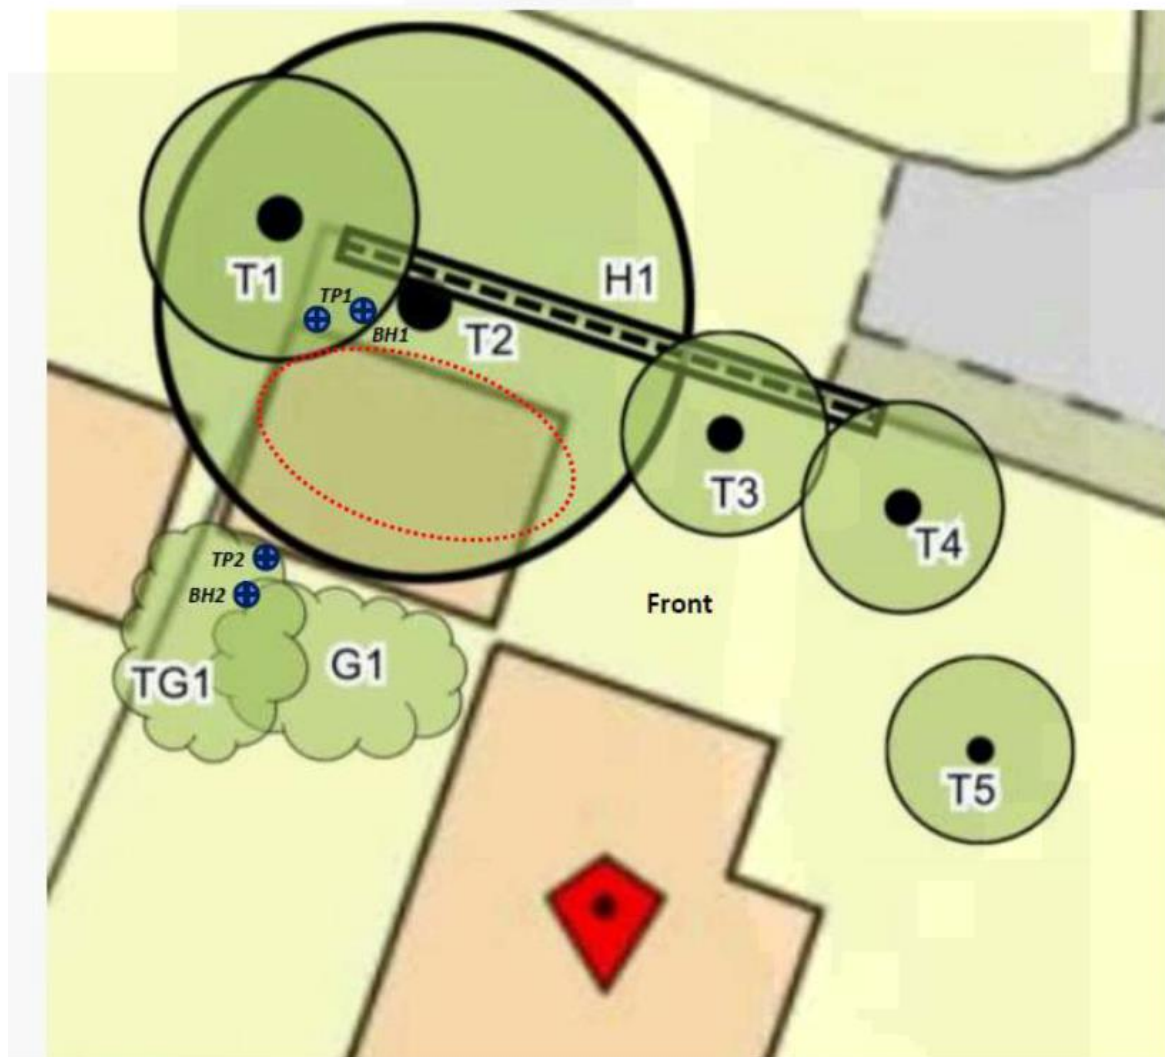
Plan not to scale – indicative only

Approximate areas of damage

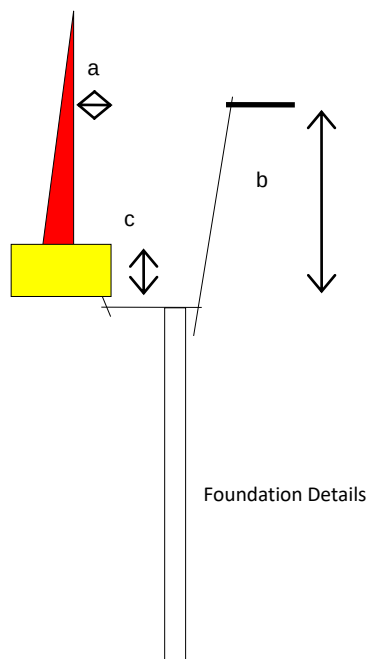
| No. | Borehole Depth | Footing (a) | Underside (b) | Thickness (c) |
| TH1 | 1200 mm | 0 mm | 300 mm | 300 mm |
| TH2 | 1800 mm | 0 mm | 300 mm | 300 mm |
