**Building on St John's Street  
Reading  
Berkshire**

# **Preliminary Bat Roost and Nesting Bird Assessment**

Ref: R2478/a

**February 2020**

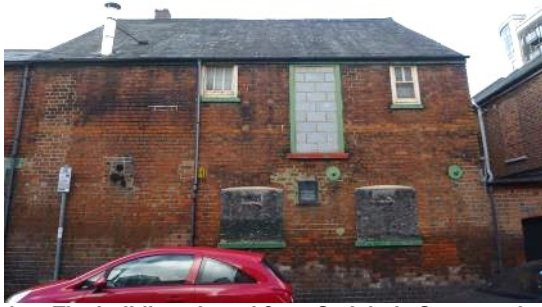
**3.2.1** The commercial building was of solid brick wall construction with sections with slate and corrugated sheet pitched roofs (**Photographs 1 & 2**). The slates covering the main roof at the northern end were all in situ and tightly fitted where visible (**Target note 1; Photograph 1**). There were gaps in the slates around a flue pipe on the front elevation (**Target note 3**). The corrugated sheets on the lower level roof were in place where visible also (**Photograph 2**). The mortar between the slates and brickwork of the main slate roof was intact (**Target note 4; Photograph 3**). Gaps were visible between the bricks and corrugated sheets at the building's southern end (**Target note 5; Photograph 5**). The barge boards at the roof line of the two roofs fronting St John's Street had gaps between them and the brickwork (**Target note 2; Photograph 6**). No evidence of bats or nesting birds was visible to the exterior of the building during the survey.

1. The building viewed from St John's Street to the east looking west.

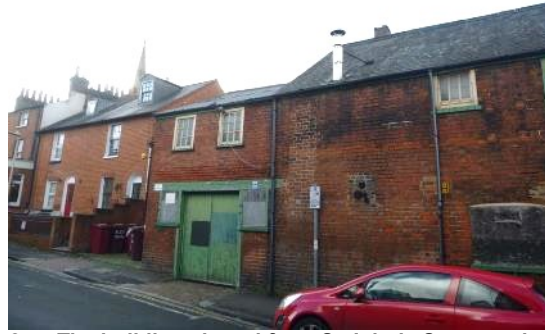
2. The building viewed from St John's Street to the east looking south west showing lower level corrugated sheet covered roof.

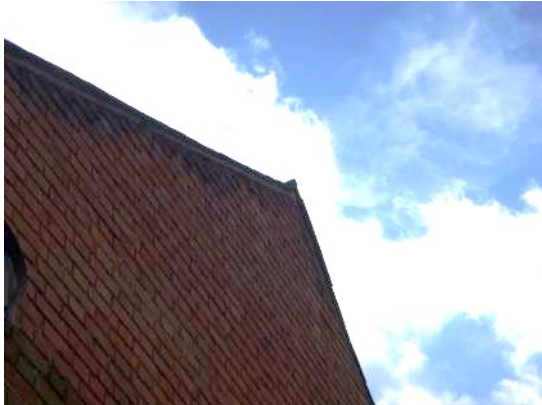
3. The intact mortar at the northern gable of the slate roofed part of the building fronting St John's Street.

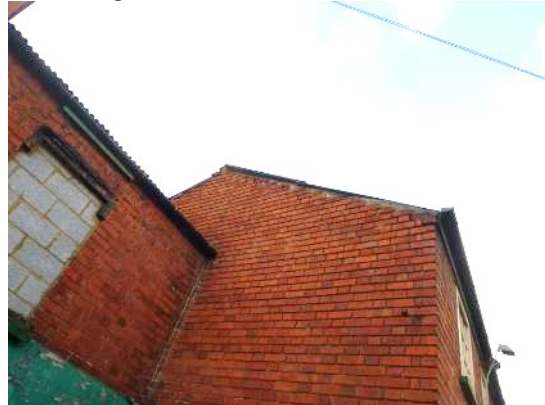
4. The southern gable end of the lower level, corrugated sheet roofed section of the building.

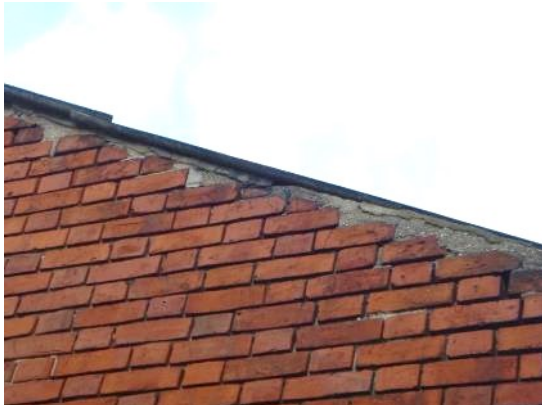
5. Gaps in the mortar between the sheet roof and brickwork.

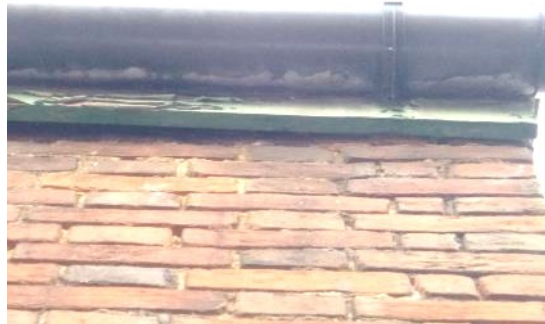
6. Gaps between the barge board and brickwork on the front (eastern) elevation of the slate roofed part of the building fronting St John's Street.

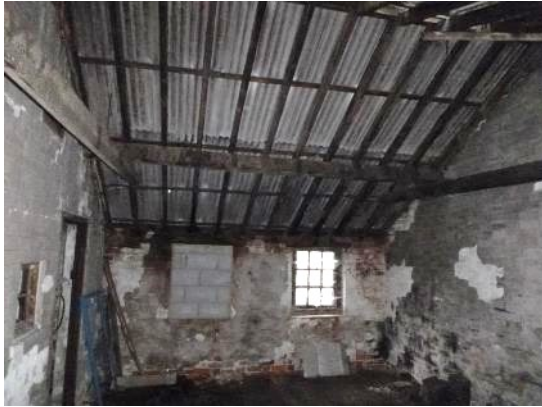
7. The corrugated sheet roof on the eastern side of the building.

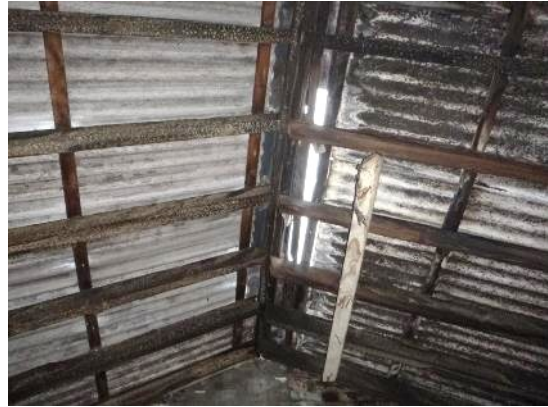
8. Gaps in the corrugated sheeting at the ridge.

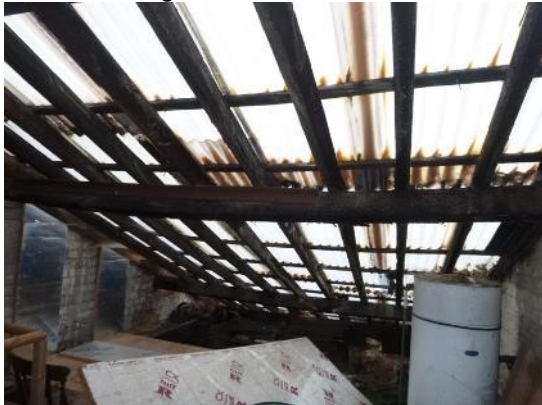
9. Corrugated sheet roof on the western side of the building.

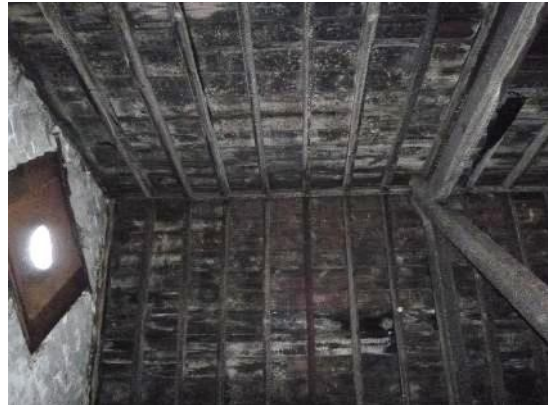
10. The timber sarking lining the slate roof on the building's eastern side.

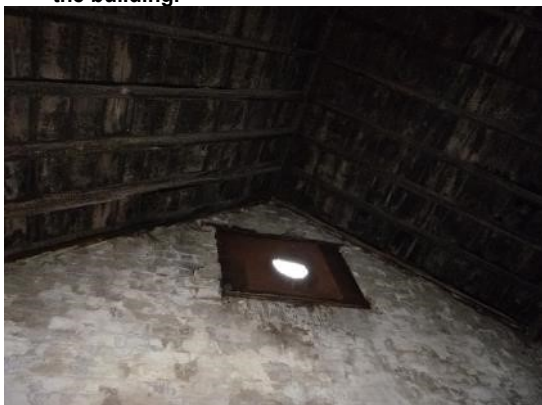
main slate roofed section on the eastern side had a circular opening to the exterior (**Target note 10; Photograph 11**). The eaves in all sections of the building were open to the barge boards at the roof line (**Target note 9**). A large water tank on a raised platform was situated within the room at the north western corner and there was an open space beneath (**Target note 8; Photograph 14**).

11. An opening to the exterior in the southern gable wall of the slate covered roof.

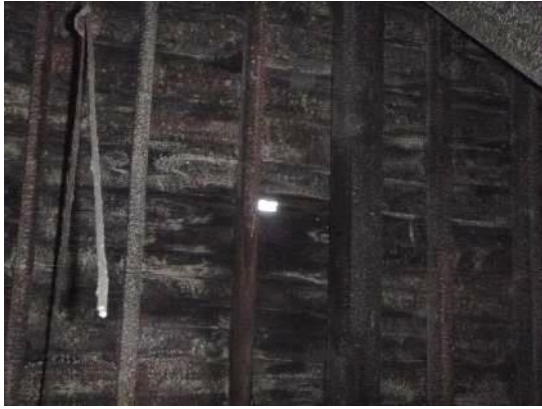
**13. Daylight visible through the sarking boards in the slate roof on the eastern side of the building.**

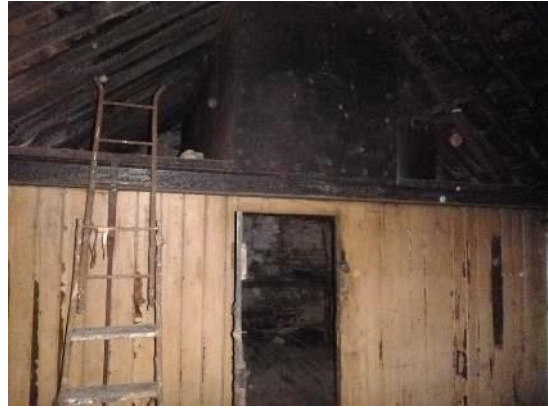
**14. The raised water tank and room beneath on the western side of the building.**

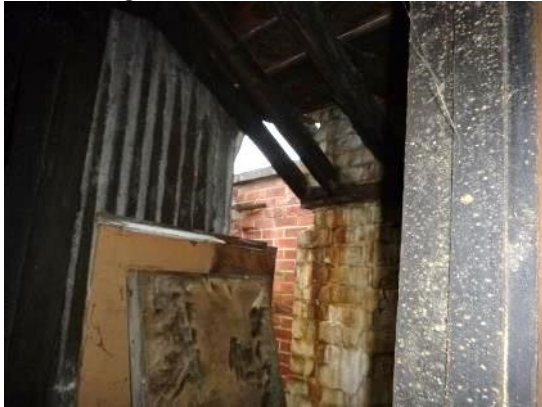
**15. An opening to the exterior at the building's south western corner.**

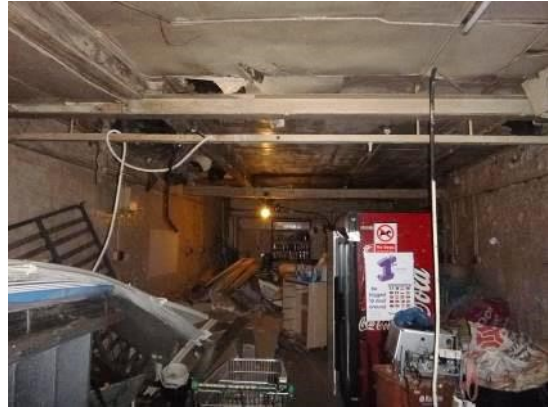
- 3.3.2** The building's ground floor comprised a large mostly open storage area with some smaller, enclosed rooms also (**Photograph 16**). The roof comprised plasterboard, which was sealed tightly to the painted walls.
- 3.3.3** No bats or evidence of the presence of bats or nesting birds was visible within the building during the survey.

**16. The storage space on the building's ground floor.**

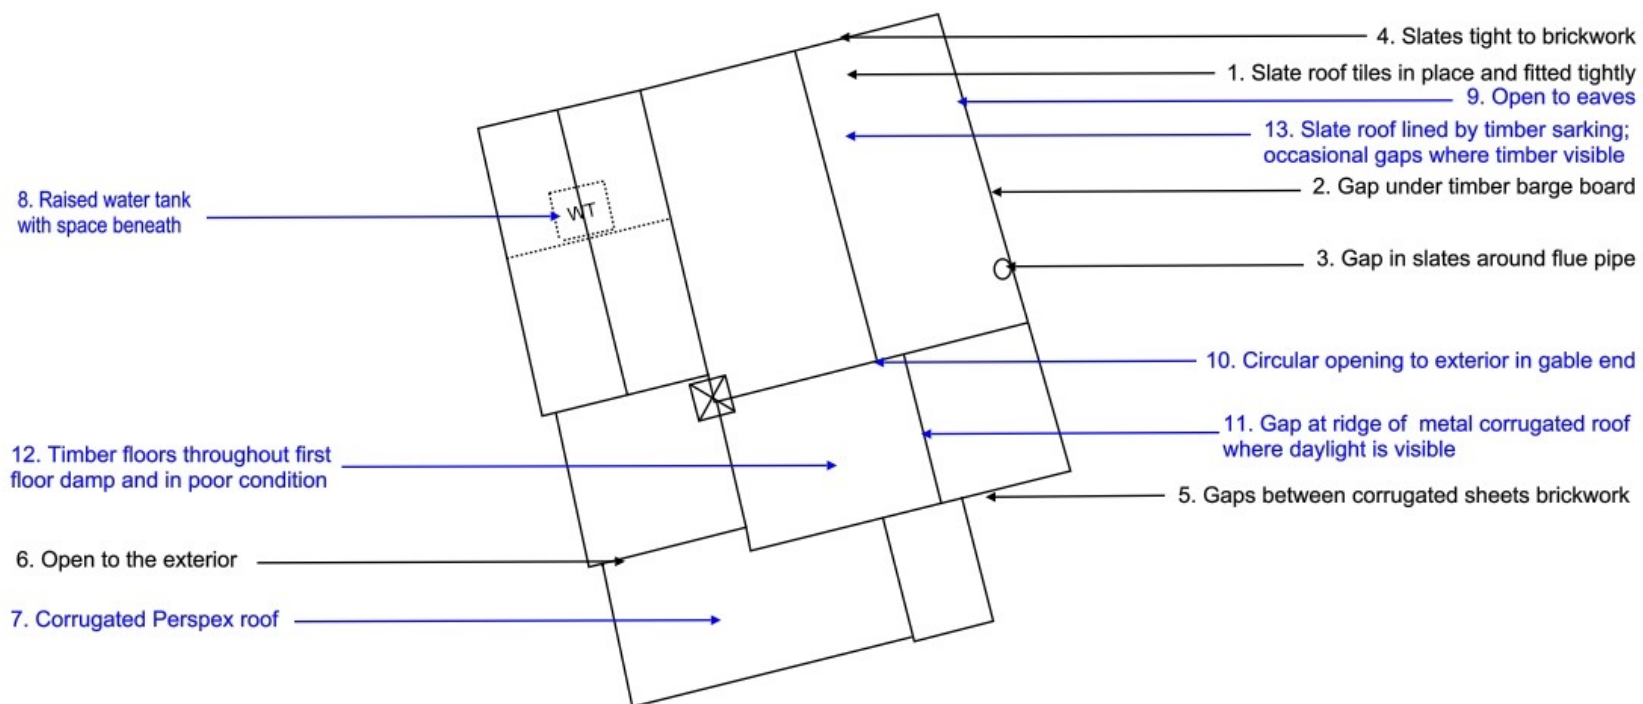
## APPENDIX 2 – PRELIMINARY BAT ROOST ASSESSMENT FINDINGS

**3.1.1** Photographs of the site are presented in **Appendix 1** and a plan of the external and internal survey findings with associated target notes is shown in **Appendix 2**. The survey findings from the exterior and interior of the building are described as follows:
