**68 Shinfield Road  
Reading  
Berkshire  
RG2 7DA**

# **Preliminary Bat Roost Assessment**

**Ref: R2508/a**

**May 2020**

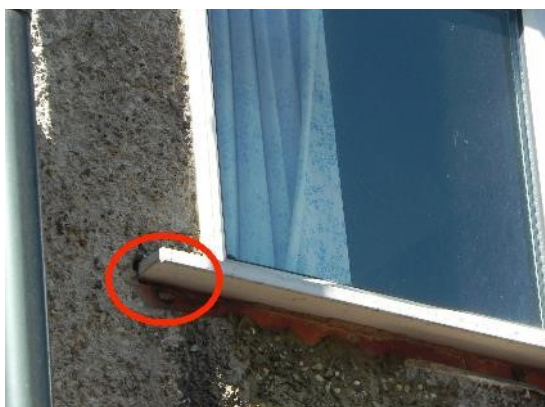
7. Gaps below and around windowsill on second-storey window (eastern elevation).

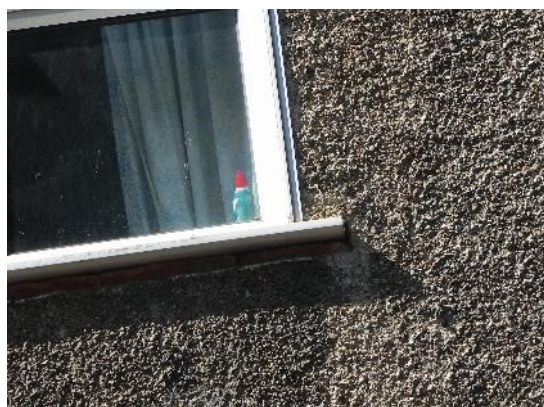
8. Gaps between second-storey windowsill, brickwork and mortar and pebbledash (eastern elevation).

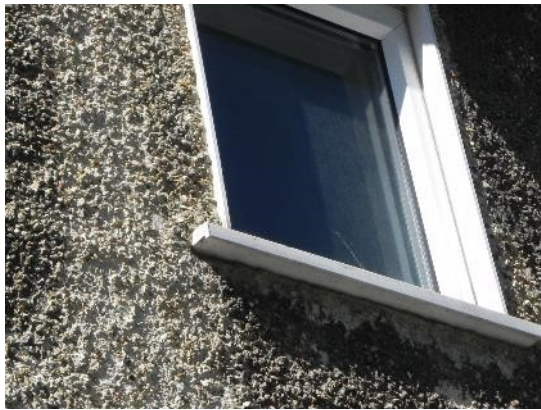
9. Gap between windowsill and pebbledash to second-storey window (eastern elevation).

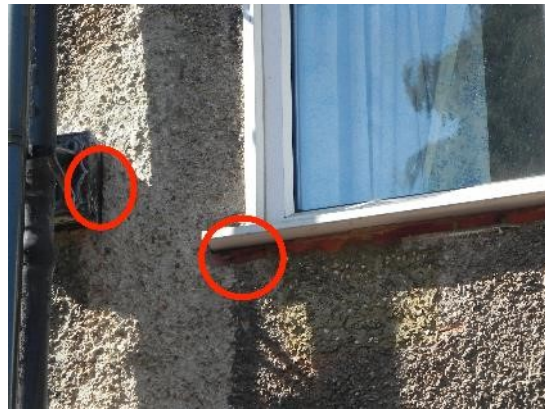
10. Gaps between downpipe fixture and windowsill and brickwork beneath to second-storey window (eastern elevation).

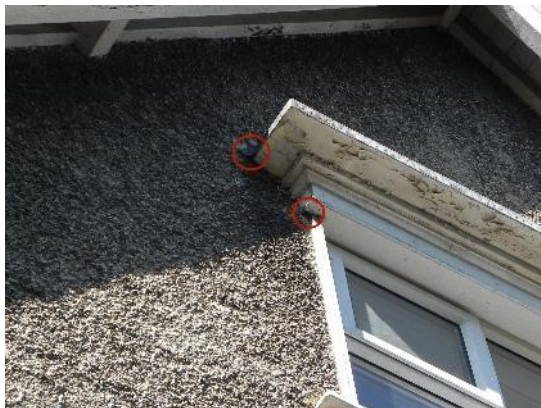
11. Gap to window edge and where flashing is loose (eastern elevation).

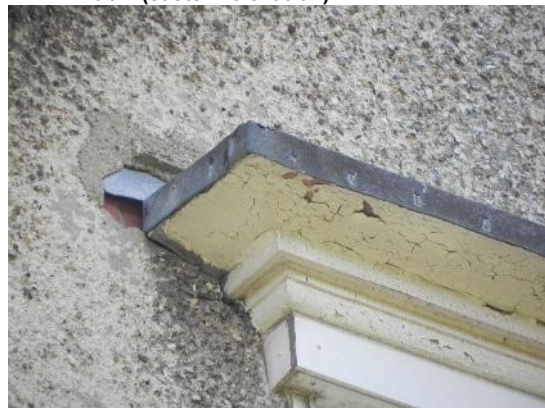
12. Crack in pebbledash creating gap between wall and gable window felt (western elevation).

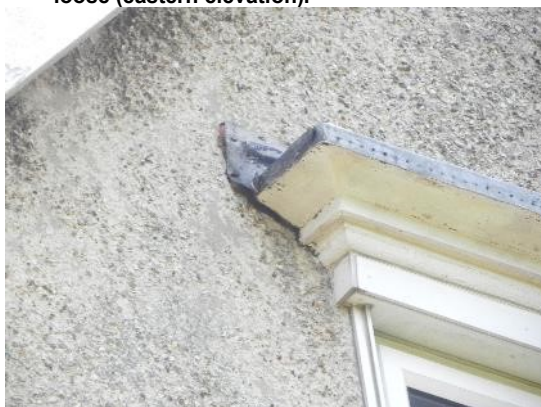
13. Further gap and cracked pebbledash area where felt for gable window meets wall (eastern elevation).

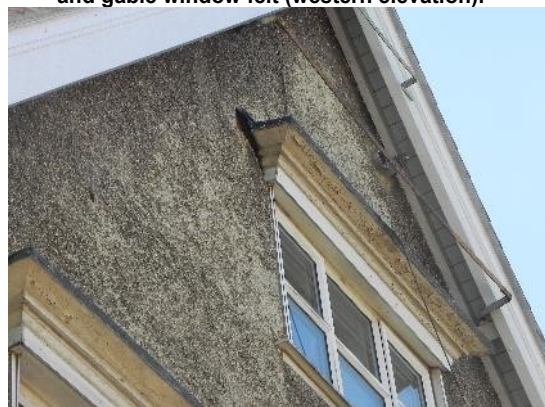
14. Large gap between gable window felt and wall (northern elevation).

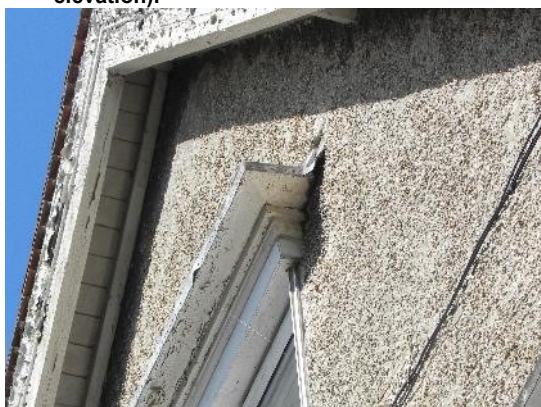
15. Gap between gable window felt and wall (eastern elevation).

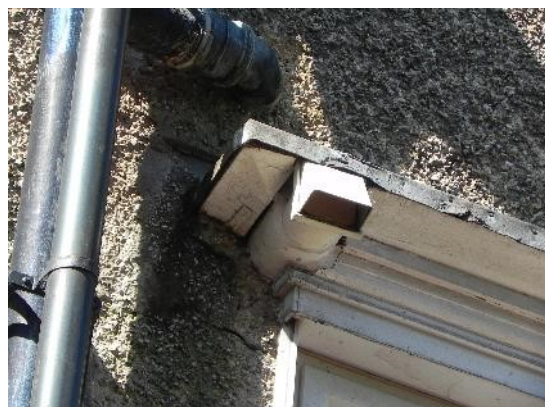
16. Gaps between flue, felt and roof to second-storey window (eastern elevation).

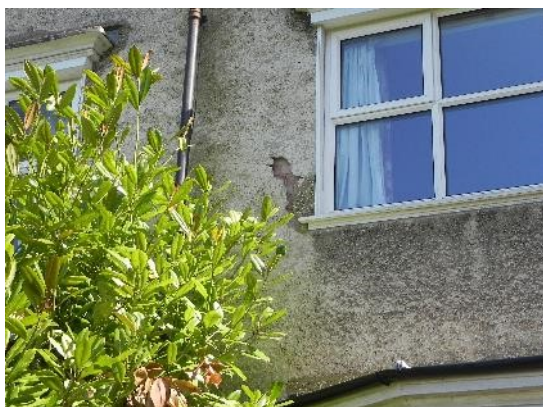
**17. Large area of pebbledash cracking near second-story window (western elevation).**

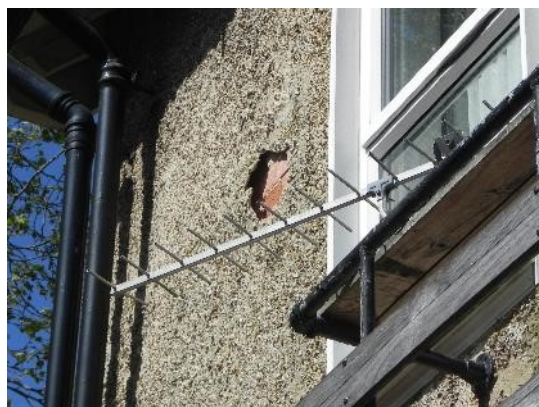
**3.2.2** The house's walls were of solid brickwork construction. The lower walls of the house had exposed brickwork, whilst the upper sections were covered with pebbledash render. Numerous gaps between windows and brickwork or pebbledash – there was one gap between downpipe fixture and pebbledash (**Photographs 7-11**) - and gaps created by areas of loose lead flashing or roofing felt not flush with windows or walls (**Photographs 11-16**), were observed on the western and eastern elevations, providing potential access and roosting opportunities for bats. Two large cracks in the pebbledash provided bats with potential roosting opportunities in the resulting gaps that remained between pebbledash and exposed brickwork: one crack was noted on the western elevation on the first floor and to the right of the central downpipe between the double ridged open gable roof (**Photograph 17**); another crack was noted on the southern elevation below the window adjacent to the first floor balcony door (**Photograph 18**).

**18. Large area of pebbledash cracking near second-storey window (southern elevation).**

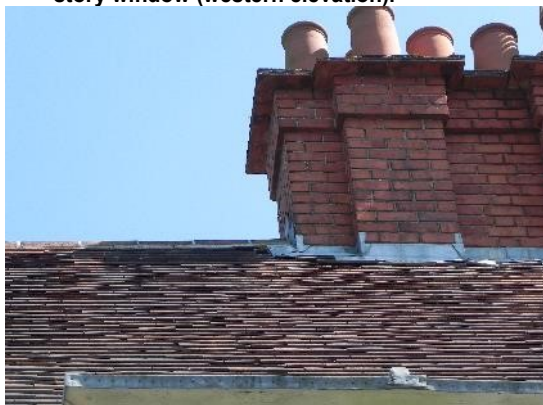
**19. Lifted and missing tiles near left chimney (western elevation).**

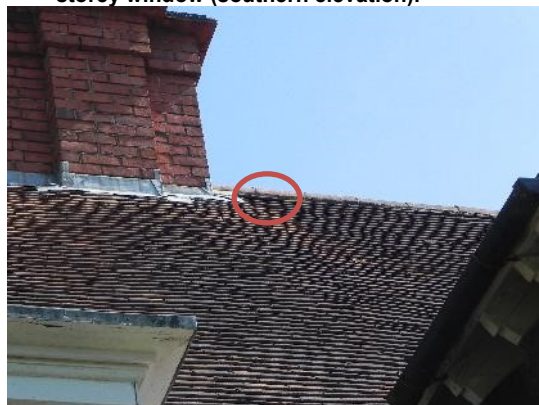
**20. Further missing tiles near left chimney and ridge tiles (western elevation).**

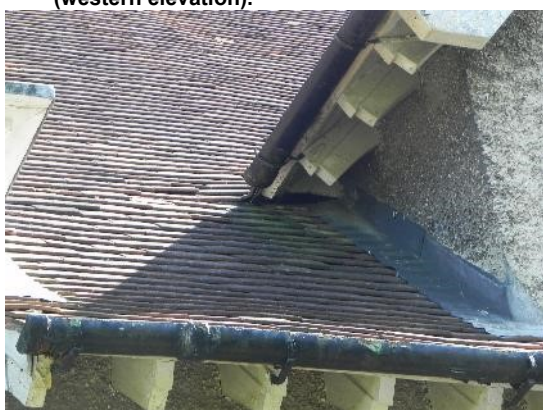
**21. Lifted tiles near gable (western elevation).**

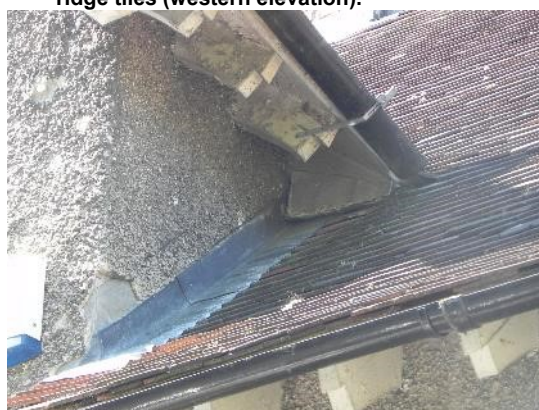
**22. Lifted tiles at end near gable (eastern elevation).**

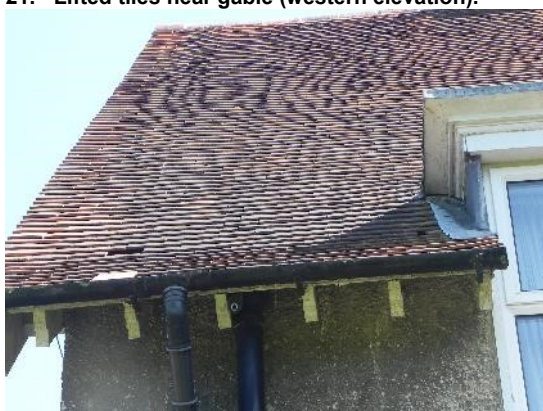
**23. Missing tiles (western elevation).**

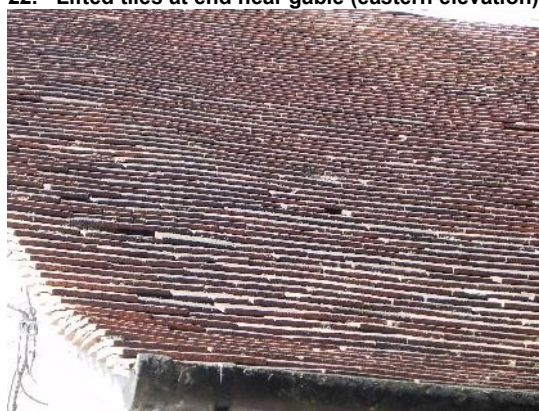
**24. Missing tiles above bay window roof (eastern elevation).**

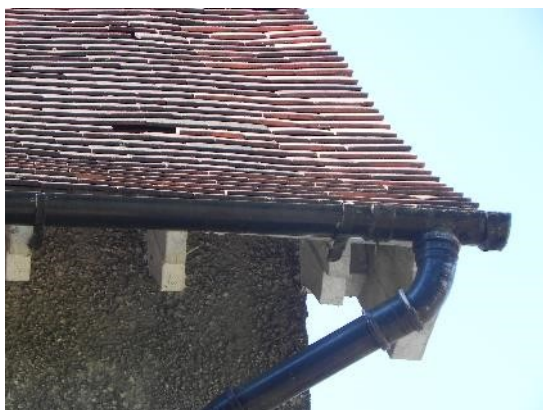
25. Missing and lifted tiles (eastern elevation).

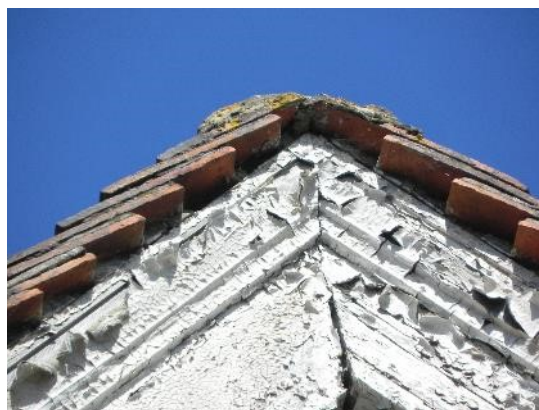
at and around the apex which provided potential bat access and roosting opportunities (**Photograph 26; Target note 4**). There was a gap to the northern gable between the soffits and wall (**Photograph 27; Target note 5**). The roof was covered with semi-circular clay ridge tiles, which had intact mortar and were heavily covered with moss - one cracked tile was visible however (**Photograph 28; Target note 6**). The eaves timbers were heavily weathered and paint was cracking on all sides. There was a gap at the gable end apexes but otherwise the mortar beneath the verge tiles was complete (**Photograph 29; Target note 7**). There were narrow gaps between the soffits and pebbledash render (**Photographs 30-31**). The two chimneys on the main roof presented potential access and roosting opportunities for bats via gaps between the lead flashings and roof tiles, and missing mortar between bricks (**Photographs 32-33**).

26. Gaps at and around gable apex where mortar between tiles has crumbled (southern elevation).

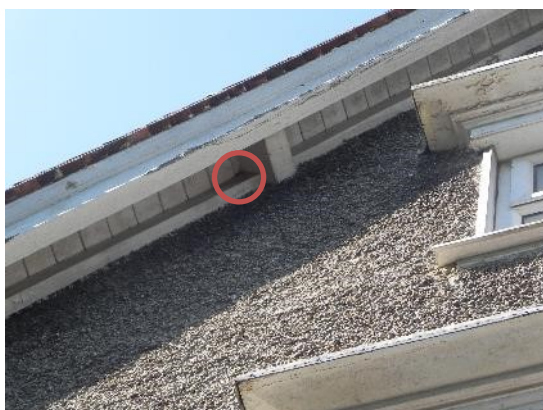
27. Gap to gable between soffits and wall (northern elevation).

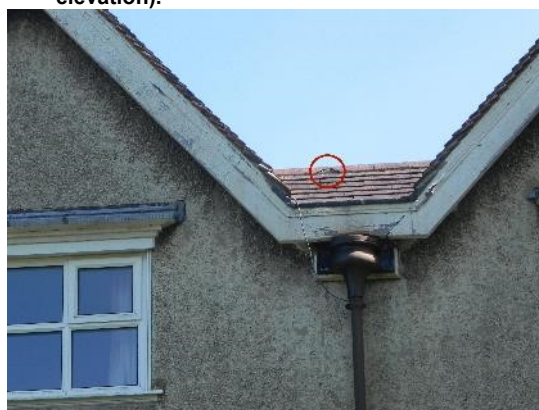
28. Cracked ridge tile from western view.

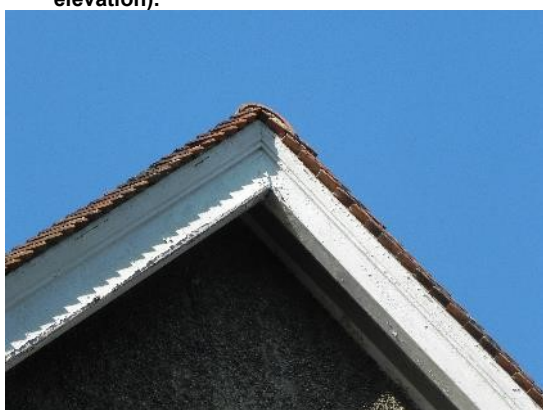
29. Gap to gable apex (northern elevation).

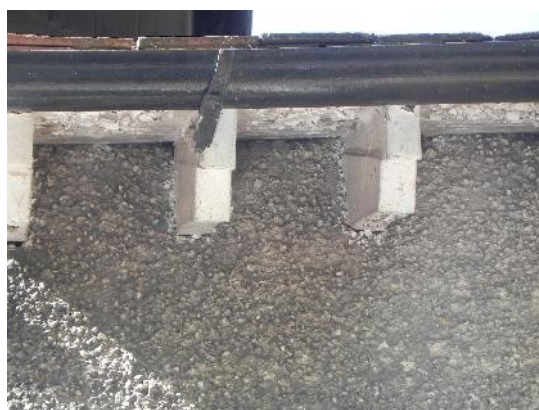
30. Slight gaps between soffits and pebbledash (northern gable end).

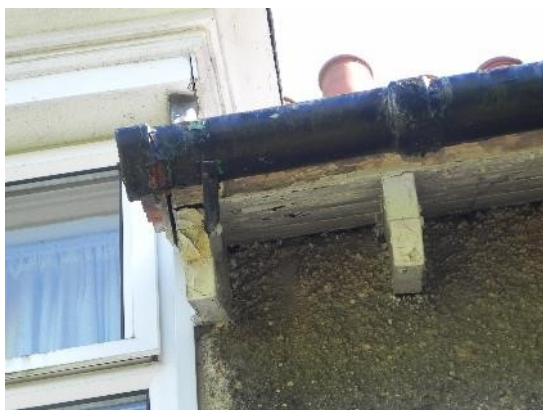
31. Slight gaps between soffits and pebbledash render (southern gable end).

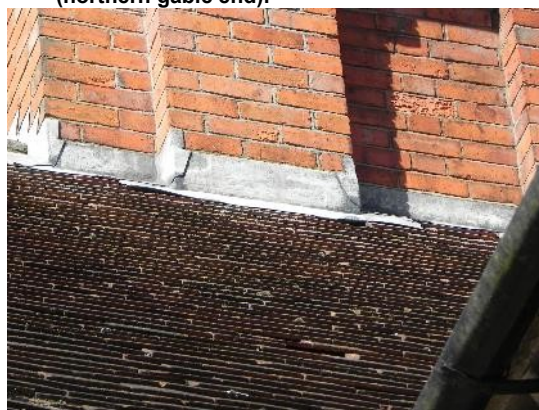
32. Lead flashing on chimney lifted (view from western elevation).

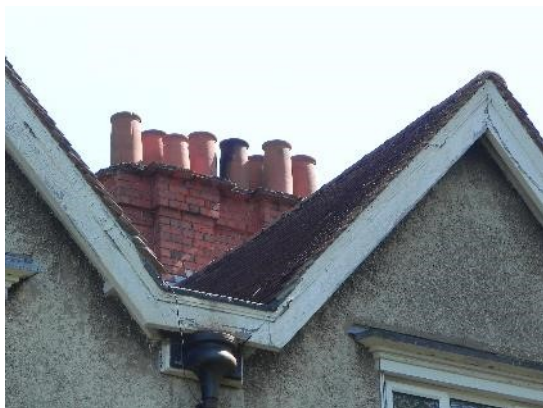
33. Mortar between chimney bricks missing in places (western elevation view).

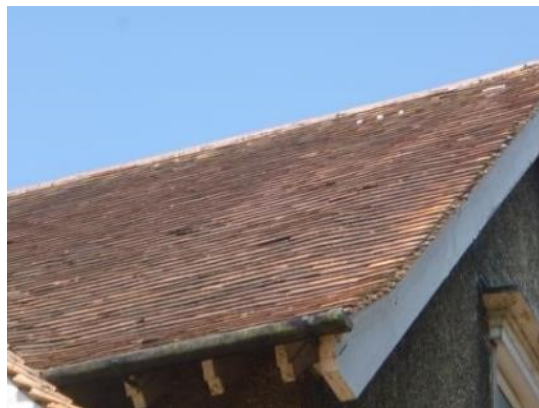
**3.2.4** Roof tiles on the roof's eastern elevation were lifted in many places, offering potential bat access and roosting opportunities (**Photograph 34**). The ridge tiles had no visible potential for bat access and roosting. At the eaves there were two gaps suitable for crevice-roosting bats to the central valley of the double open end gables: one gap between soffits above the black drainpipe; another directly behind the black drainpipe box where it met the pebbledashed wall and soffit above (**Photograph 35; Target note 8**). Furthermore, there was a gap between a gable soffit and tiles and lead flashing (**Photograph 36; Target note 9**).

34. Tiles lifted to gable (south-eastern elevation).

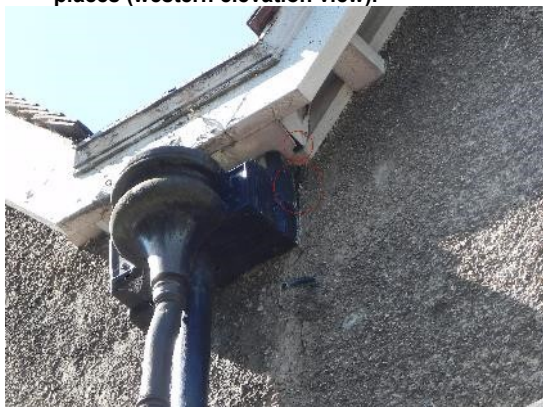
35. Gaps between downpipe fixture and wall and soffits to fascia joining western gable roofs (eastern elevation).

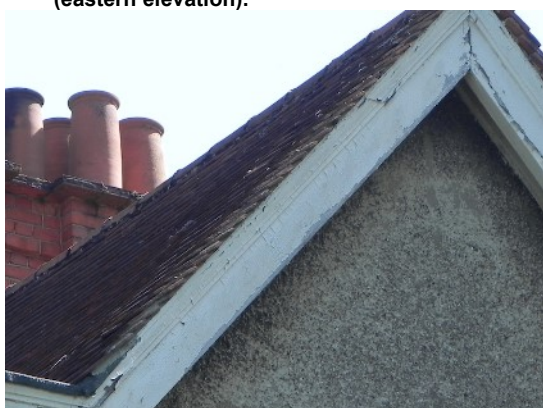
**3.2.5** The roof tiles on the western elevation were lifted in many places (**Photograph 37**). The ridge tiles were in place, with heavy moss coverage but no visible bat access potential

37. Lifted tiles (western elevation).

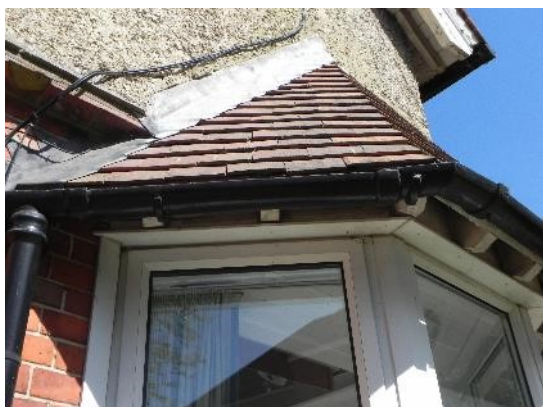
39. Tiles lifted to edge of bay window roof.

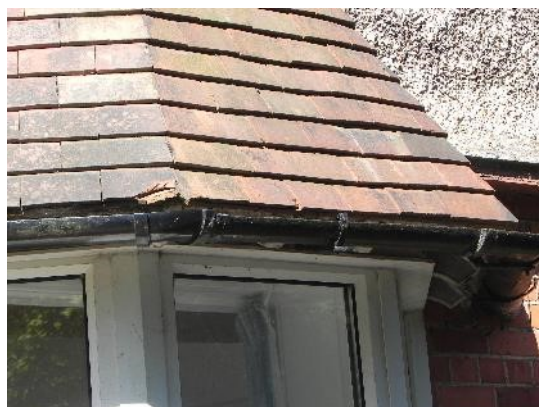
40. Tile cracked to edge of bay window roof.

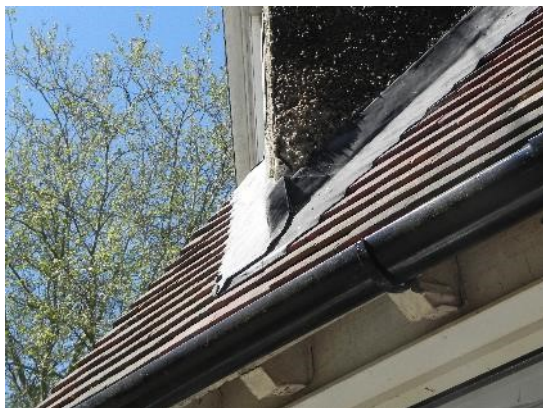
overlapped on the wall corner, providing access and roosting opportunities for crevice-dwelling bats (**Photograph 41**). The corner of the pebbledash wall directly above the area of central flashing was cracked, creating a small gap with potential for use by crevice-dwelling bats (**Photograph 42; Target note 11**). The eaves were in poor order overall, with heavy paint cracking narrow gaps between the soffits and the wall (**Photographs 43-45**).

41. Potential access through loose flashing if tiles beneath present gaps.

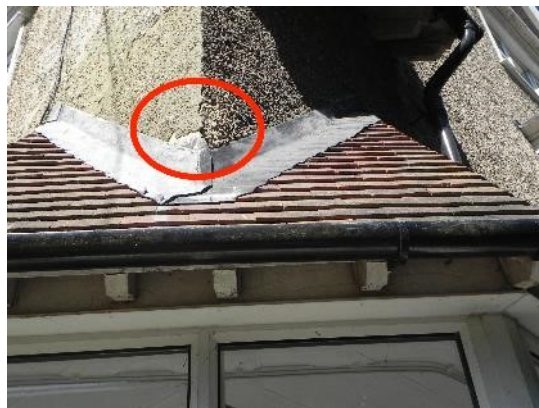
42. Crack in wall above bay window roof.

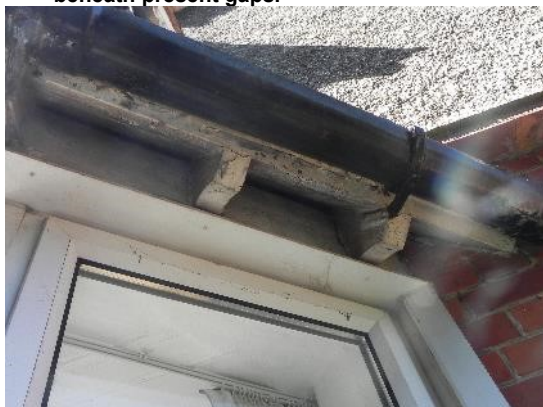
43. Gap between eaves and bay window.

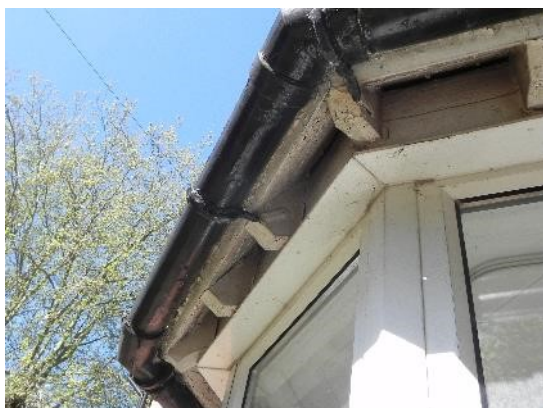
45. Further gap between eaves and bay window.

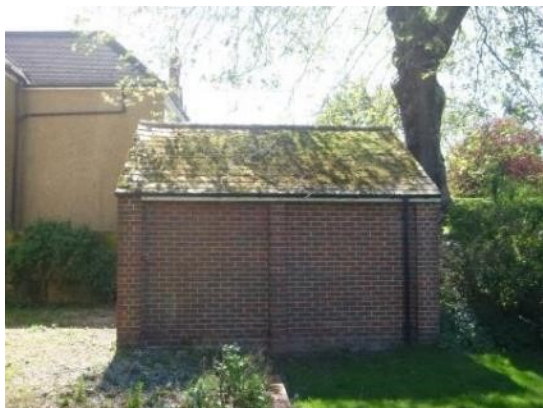
47. Garage roof (northern elevation).

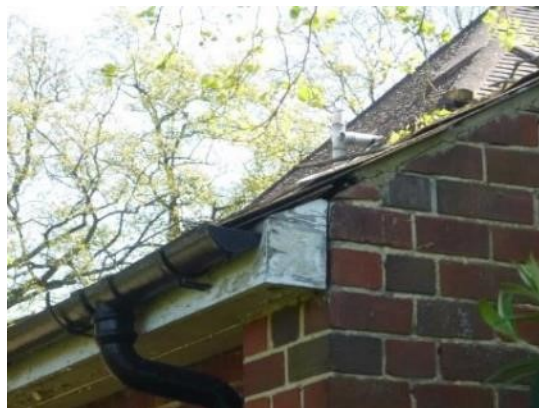
48. Gap in missing mortar to garage where brick wall meets roof (western elevation).

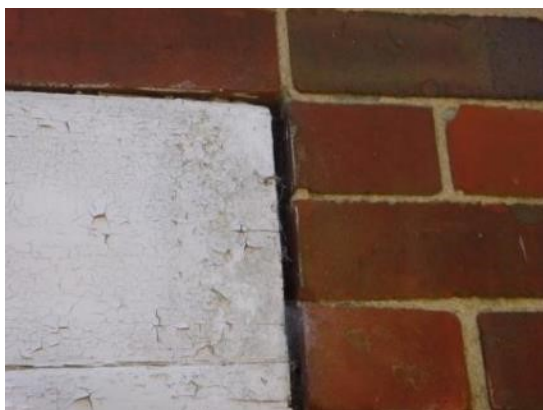
49. Gap between timber and brick to garage front (eastern elevation).

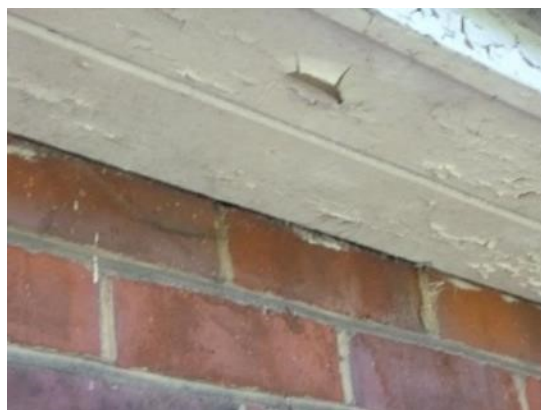
50. Narrow gap between the soffit and the wall (northern elevation).

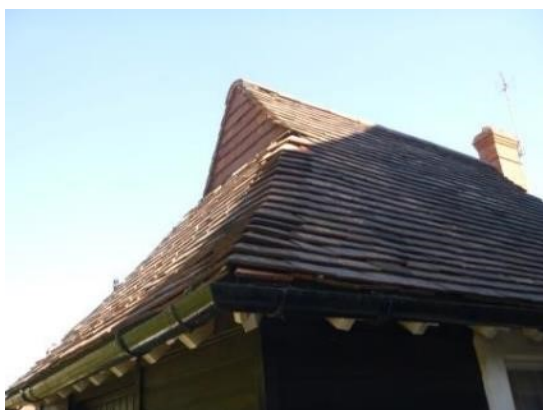
51. Shed tiles lifted down hip (south-eastern elevation).

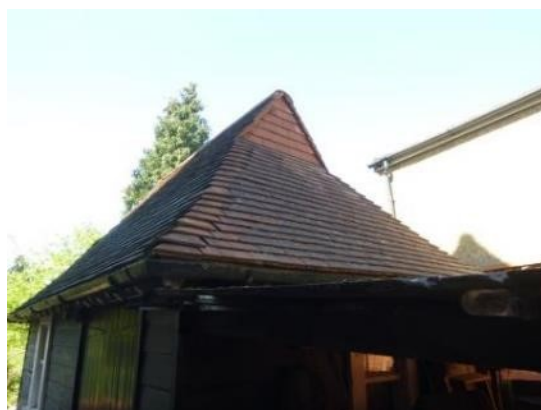
52. Shed tiles lifted down hip (south-western elevation).

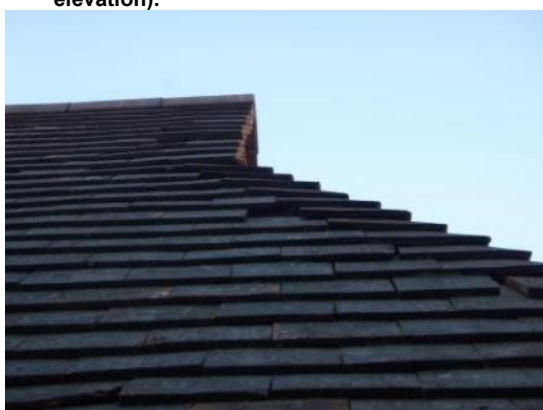
53. Shed tile missing near lifted hip tiles.

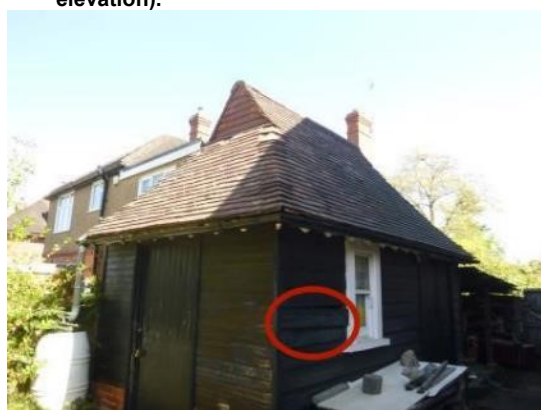
54. Loose feather boards to shed (south-western elevation).

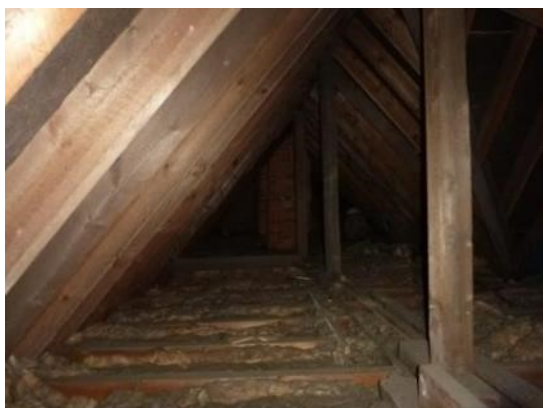
via two second floor loft hatches. The void had an approximate floor-to-ridge height of 1.5 metres and the roof was of 'cut and pitch' construction (**Photograph 55**). The roof was lined with horsehair felt and intermittent plastic sheeting covering some gaps, and the ridge was mostly cobwebbed and had signs of damp (**Photographs 56-58**). Gaps were present between bricks and timbers at all gables (**Photograph 59**). Most gaps at the eaves were filled with fibreglass; however, there were gaps at the chimneys between the timbers and bricks, and gaps between bricks and timbers at all gables (**Photograph 61; Target note 13**). The floor was boarded and had fibreglass insulation beneath (**Photograph 55**).

55. Internal roof space cut-and-pitch construction with fibreglass and boarded flooring.

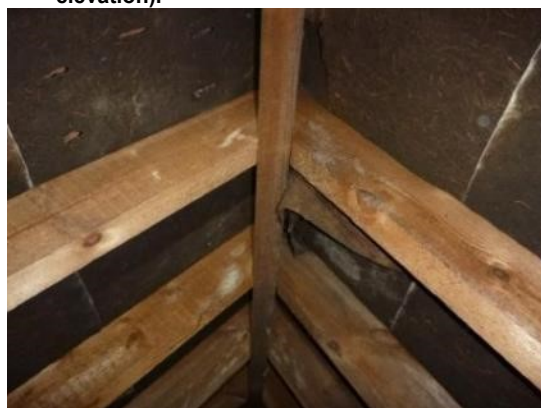
56. Internal roof space felt roof with timber beams.

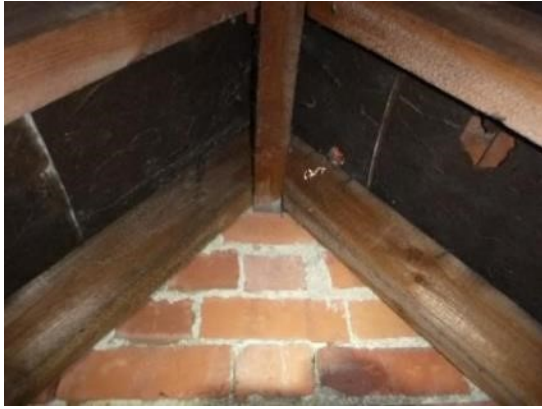
57. Internal roof space - signs of damp and cobwebs to ridge.

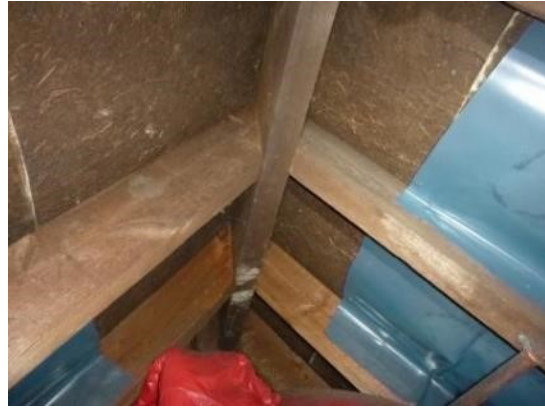
58. Internal roof space - sheeting covering gaps in felt.

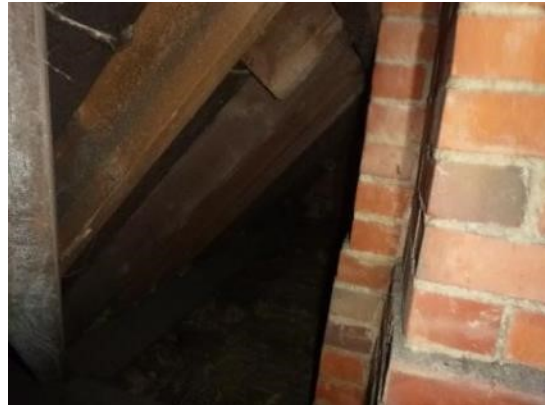
60. Narrow gaps either side of chimney/water tank.

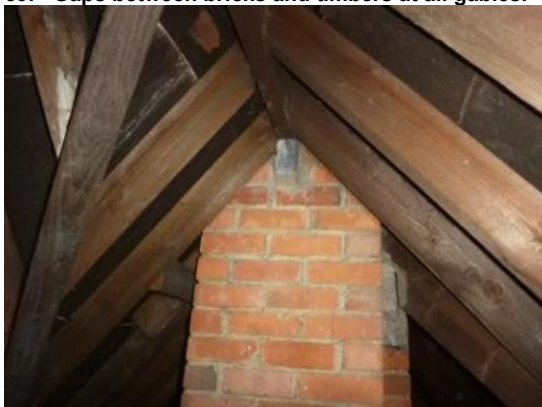
61. Gaps between bricks and timbers to internal roof space chimney.

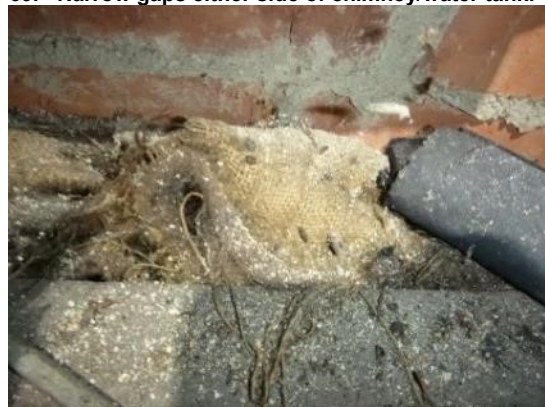
62. Medium-sized bat droppings on floor of roof space.

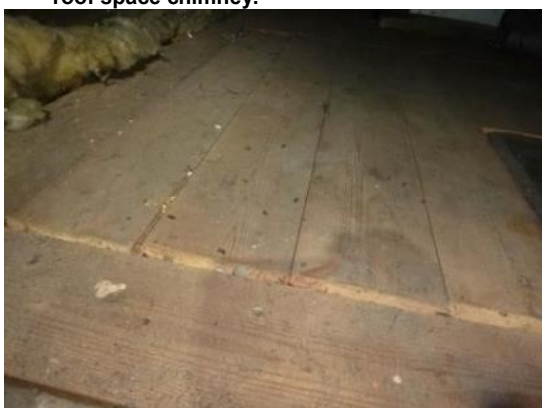
63. Further medium-sized bat droppings on floor of roof space.

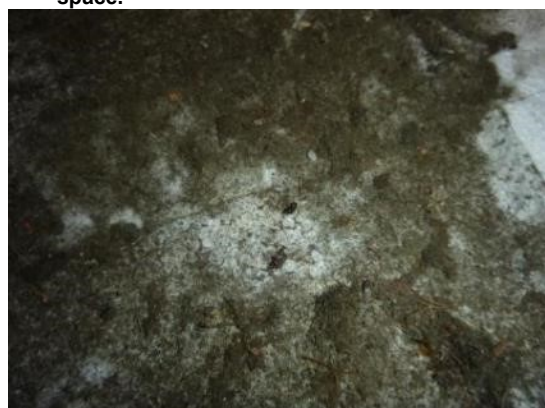
64. Further medium-sized bat droppings on floor of roof space.

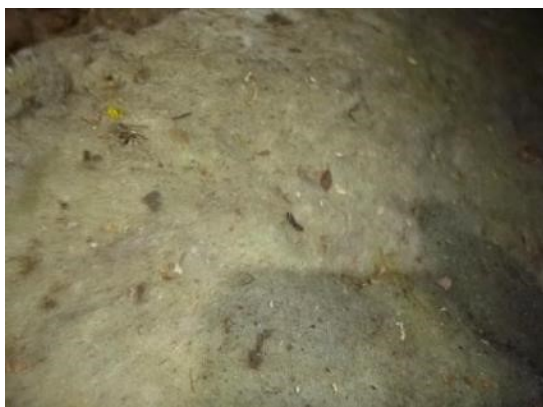
**65. Further medium-sized bat droppings on floor of roof space.**

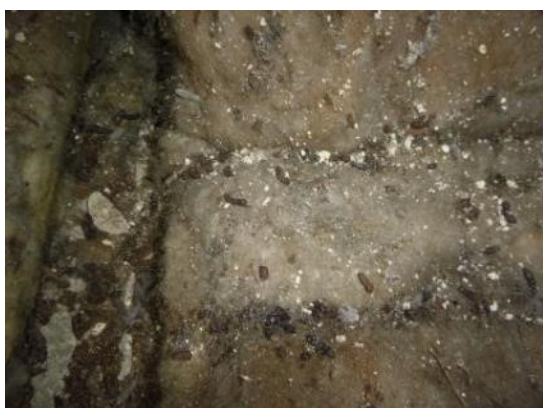
- 3.5.2** There were approximately 100 scattered medium bat droppings throughout the void, which were of a size and shape typical of long-eared bat species (*Plecotus* spp.). These droppings were found on fibreglass, floor boards and hanging from cobwebs on walls - four further medium-sized bat droppings were found toward the northern gable end: two on the loft hatch, one on the gable wall and one on floor boarding (**Photographs 62-68**). A concentration of 50-100 large bat droppings – of a size and shape most typical of serotine (*Eptesicus serotinus*) bats - were found on fibreglass at the south-eastern gable end (**Photograph 69**). No bats were visible in the void at the time of the survey.

- 4.1.3** The finding of a group of large bat droppings on fibreglass at the south-eastern gable end of the roof void suggests that the house likely supports roosting serotine bats. The number of droppings suggests that the house most likely supports a day and/or transitional roost for this species; however, further droppings may be trapped out of view and therefore the presence of a breeding roost cannot be discounted at this time. The serotine bat (*Eptesicus serotinus*) typically roosts in buildings with high gables, and serotine droppings are often concentrated at gable ends or around the chimney base (Collins 2016). The recorded distribution of serotine bats in the UK is heavily concentrated in the south of England and scattered throughout Wales, while scattered records are presented in the midlands and scarce records in the north of England (Joint Nature Conservation Committee 2019). Roosts supporting serotine bats are of low-moderate to moderate conservation importance (Mitchell-Jones 2004).

**69. Concentration of 50-100 large bat droppings on roof space flooring.**
