# 4 Downshire Square

## Bat Roost Assessment

**January 2020**

Report Ref: DFA20002V2

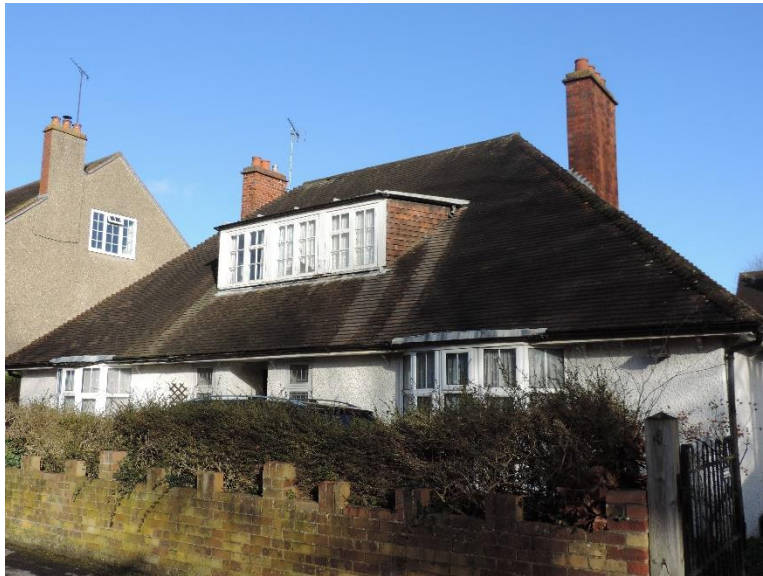
Plate 1. General view of the front of the dwelling.

- 3.2.2 The roof of the property comprises a hip roof with the ridge line running more or less north to south. Flat roofed dormer windows are present on both the front (western) and rear (eastern) aspects. Chimney breasts exit close to the ridge line at the either end of the roof. Hanging tiles are present around the dormer windows; there are no areas of weather boarding on any aspect of the dwelling. A detached garage, with a pitched roof, is present to the south of the house (Plates 1 – 3).

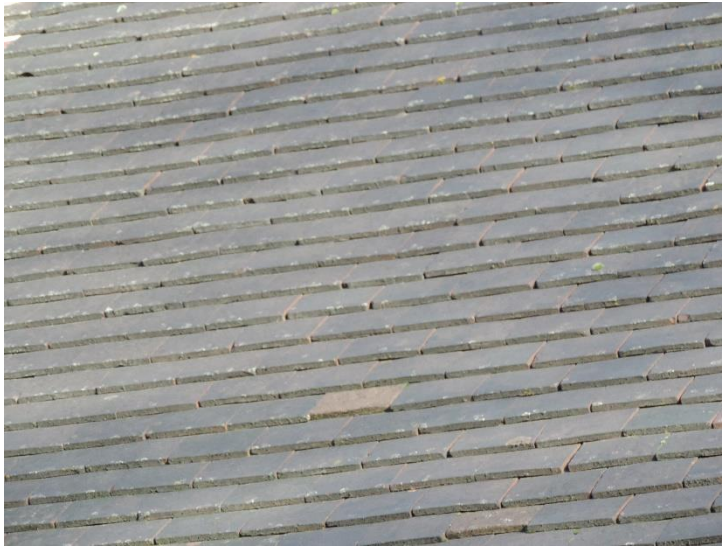
Plate 4. Typical view of roof tiles.

- 3.2.3 The roof of the house is finished with flat, interlocking clay tiles. The tiles are in moderate condition throughout, with no missing or broken tiles noted (Plate 4). There is the occasional small gap between some of the tiles, but none were deemed of sufficient size to allow bat ingress.

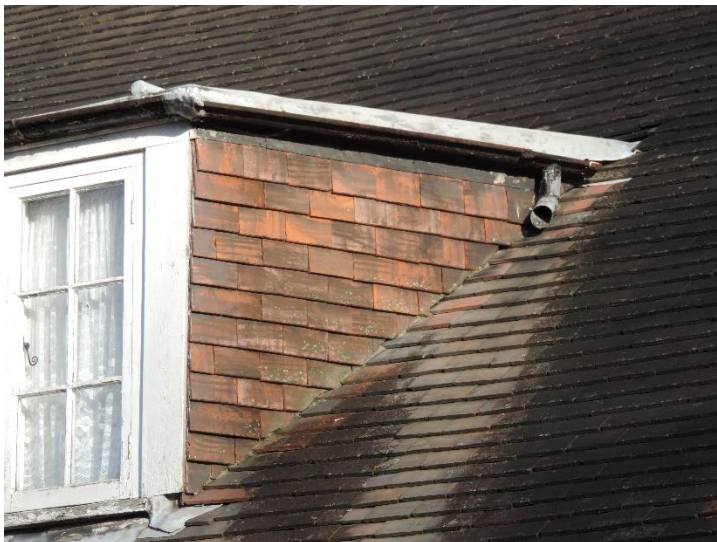
Plate 5. Typical view of the hanging tiles around the dormer window.

- 3.2.4 The hanging tiles around the dormer windows are also in good condition, with no loose or broken tiles present (Plate 5).
- 3.2.5 The wooden soffit and fascia boards are in moderate condition throughout. Polymer sealant is absent between the soffit and adjoining brickwork, however as the walls have been finished with render any gap is negligible (Plate 6).

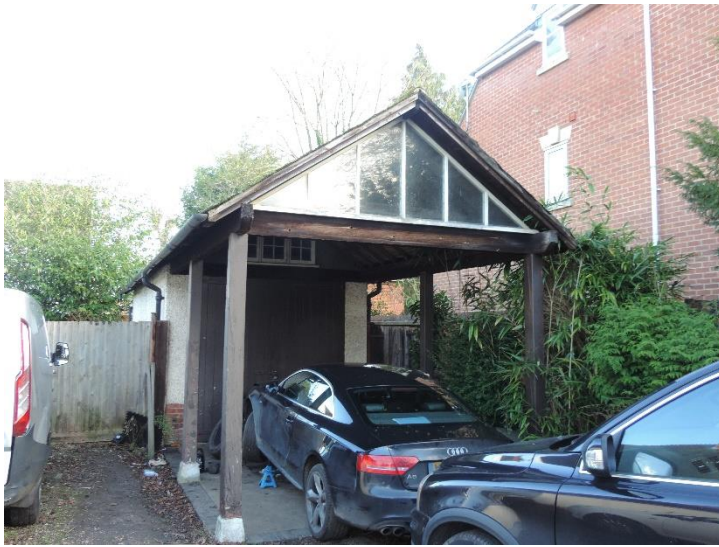
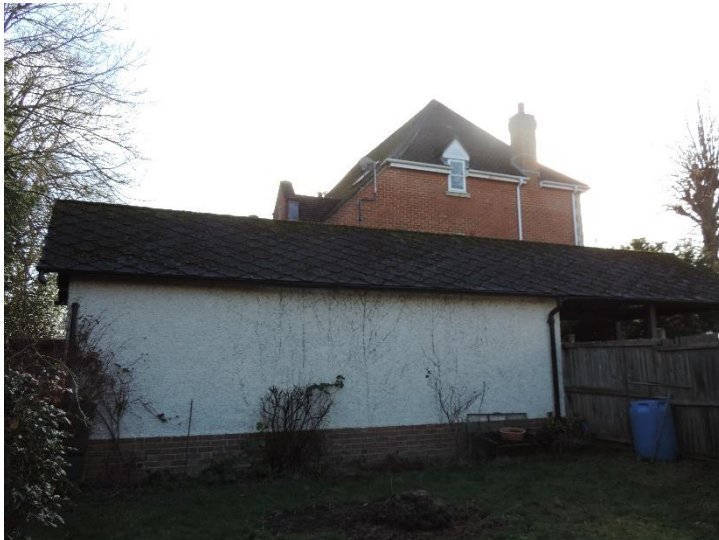
- 3.2.6 Externally, no ingress points were noted.
- 3.2.7 The trusses of the garage are open and exposed. Windows are also present on either gable end wall, illuminating the internal void space. The roof is finished with large felt tiles. Overall, the garage was assessed as having negligible potential to support roosting bats (Plates 7 - 8).

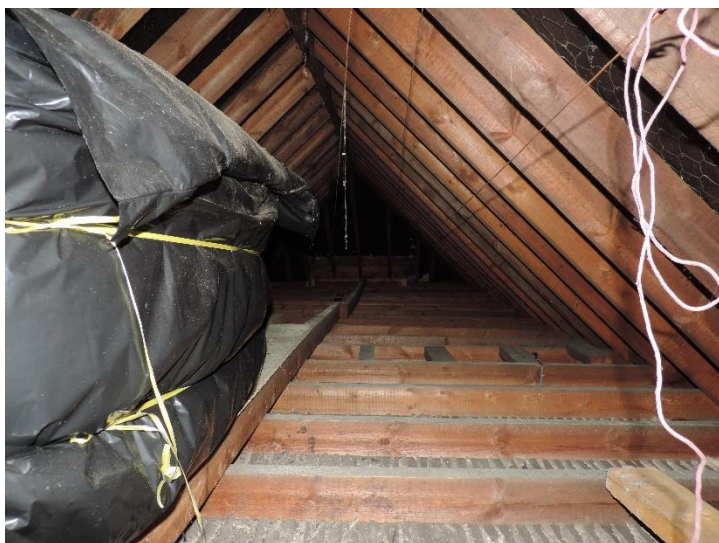
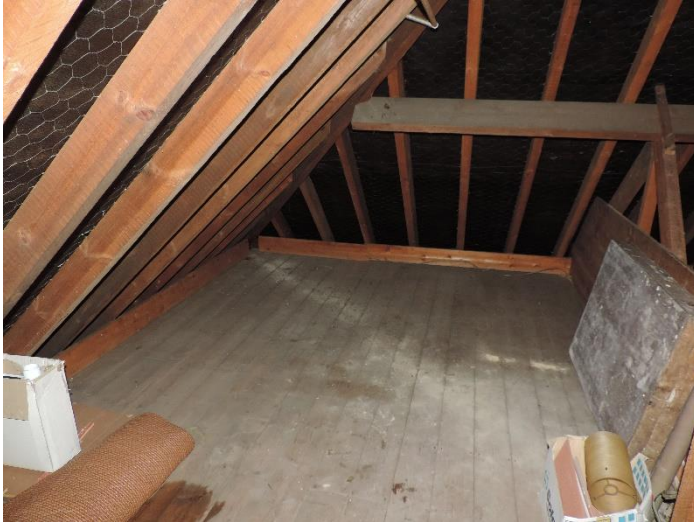
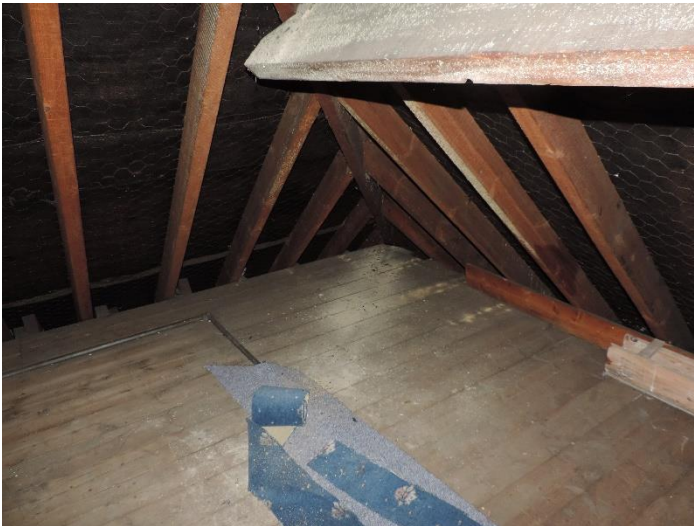
- 3.2.8 Internally, much of the void space is given over to habitable accommodation; a small attic space is present with additional accessible space within the eaves. The trusses of the voids space are of a simple design. Nail plates are absent at the major junctions, but any resulting gap is minimal. A moderate to heavy build-up of cobwebs was present around the junctions

and throughout the void spaces in general, suggesting a lack of bat activity (Plates 9 - 11). No staining or scratch marks were noted along any of the beams, and there was no evidence of feeding remains. No droppings were noted despite a thorough inspection and the distinct smell often associated with bat roosts was absent. The roof lining is intact.
