**2 Hewett Avenue  
Caversham  
Reading  
Berkshire  
RG4 7EA**

# **Preliminary Bat Roost Assessment**

**Ref: R2642/a**

**November 2020**

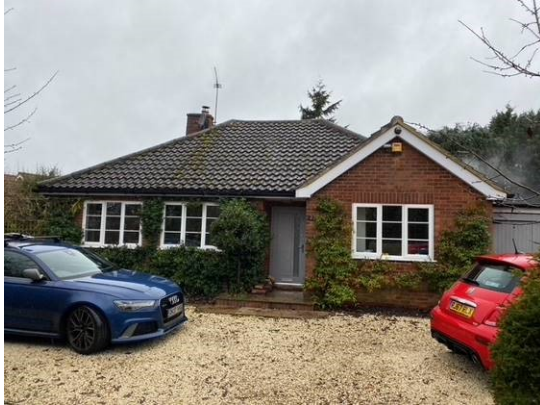
- 3.2.1** The chalet bungalow was of modern, brick cavity wall construction and had a hipped roof with front and rear pitched gable ends; a pitched roofed rear extension and two flat-roofed side extensions (**Photographs 1 & 2**).

1. Front of property viewed from east.

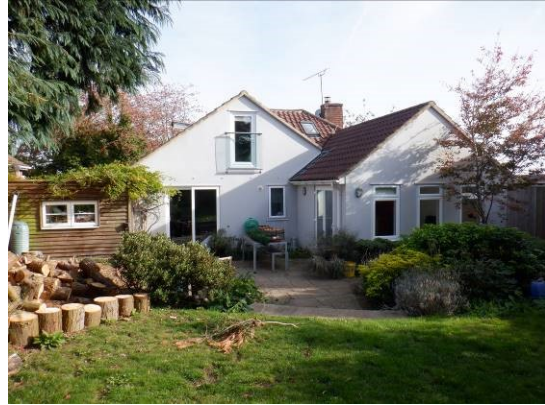
2. Rear of property viewed from west.

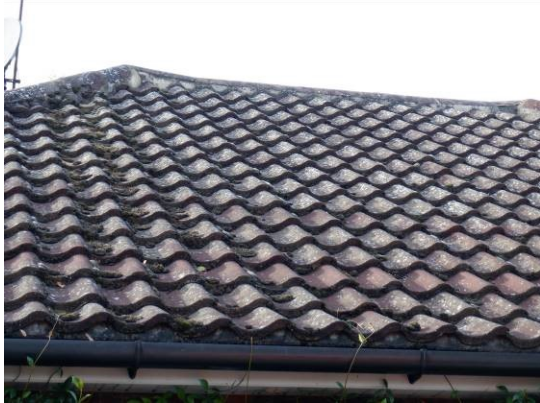
- 3.2.2** The hipped and pitched roofs were covered in concrete interlocking roof tiles, which were tightly fitted and uniform offering no visible ingress opportunities for roosting bats (**Photographs 3 & 4; Target note 1**). The ridge and hip tiles were securely mortared except for one missing piece of mortar on the southern elevation, which was closely inspected from a nearby roof light and showed no evidence of use by roosting bats (**Photographs 5 & 6; Target notes 2 & 3**). A slight gap under lead flashing around the chimney also lacked any signs of bats after close-inspection from the roof light (**Photograph 7; Target note 4**). The roof lights were all lined with tightly fitted lead flashing and had gaps under adjacent roof tiles that were deemed too open to provide optimal conditions for crevice-roosting bats (**Photograph 8; Target note 5**). The rear gable ends, including the extension, had intact verge mortar with undercloaking sitting tightly on top of the wall plates (**Photographs 9 & 10; Target notes 6 & 7**). The front gable had a narrow gap behind its uPVC soffit box that could be closely inspected from ground-level, which showed no indication of use by roosting bats (**Photograph 11; Target note 8**). Elsewhere, the uPVC soffit boxes were flush against the bungalow walls (**Photograph 12; Target note 9**).

3. Tight interlocking roof tiles (front elevation).

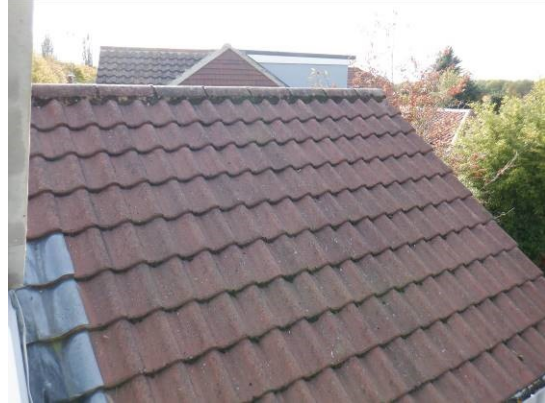
4. Tight interlocking roof tiles on rear extension (northern elevation).

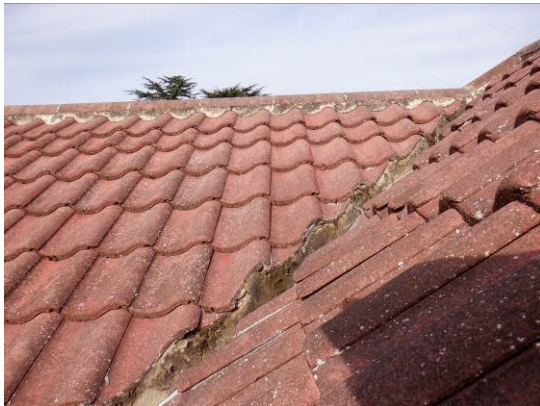
5. Securely mortared ridge tiles on rear gable end (southern elevation).

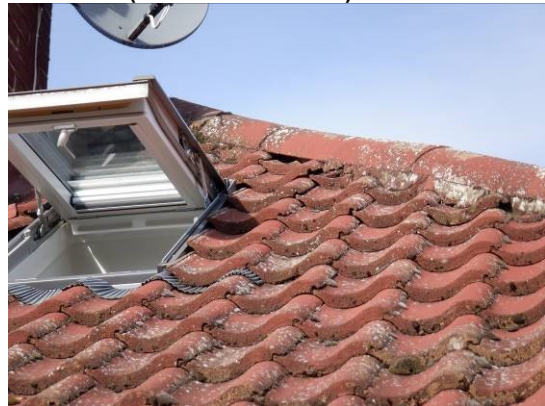
**4.1.2** Externally, the property had limited features suitable for use by crevice-dwelling species such as pipistrelle bats (*Pipistrellus* spp.), including: a piece of missing hip mortar, slightly raised chimney lead flashing and a narrow gap behind the uPVC soffit on the front gable end. The presence of bats in these few potential roost features identified during the survey could be ruled out by close inspection, which found no roosting bats present or evidence of past use (i.e. droppings).

6. Missing piece of hip mortar (southern elevation).

**4.3.1** In order to confirm the continued absence of bats, the potential bat roost features identified will be re-inspected by a licensed ecologist before the building work begins. Work to remove tiles will begin only once the licensed ecologist has confirmed there continues to be no signs of bats being present.

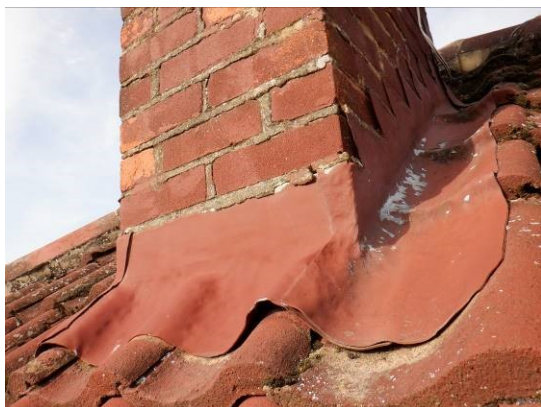
**7. Slightly raised lead flashing around chimney (southern elevation).**

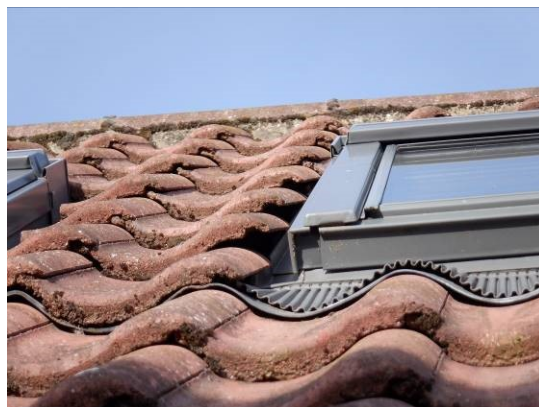
**8. Open gaps under roof tiles adjacent to roof lights (southern elevation).**

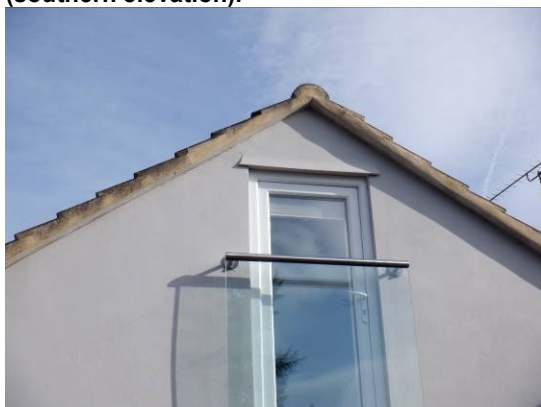
**9. Intact verge mortar on rear gable end (rear elevation).**

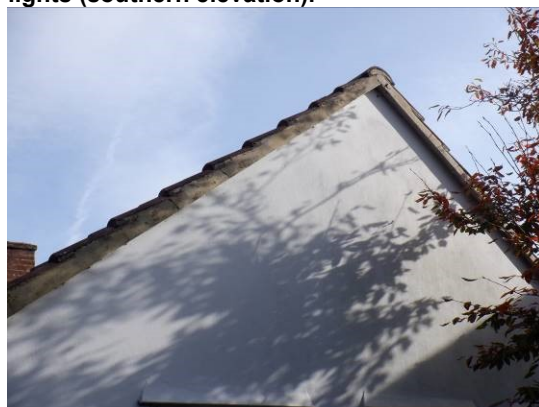
**10. Intact verge mortar on rear extension (rear elevation).**

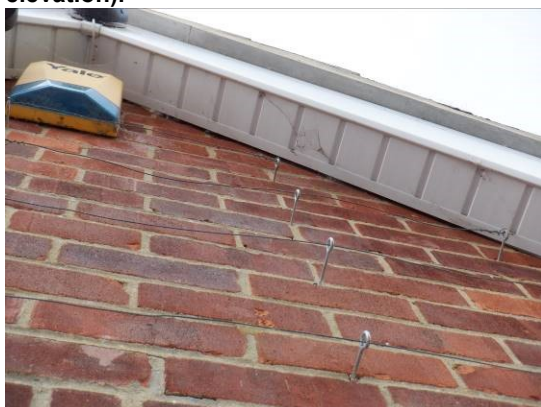
**11. Narrow gap behind uPVC soffit on front gable end (front elevation).**

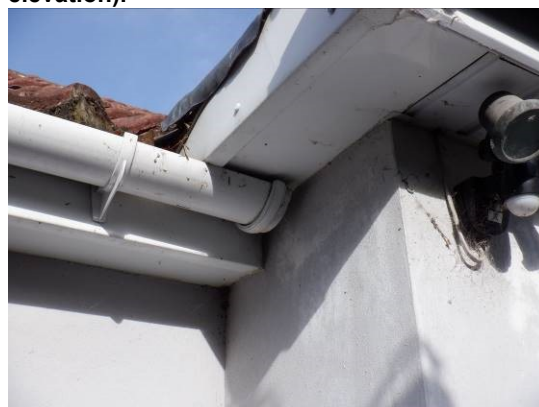
**12. Flush uPVC soffit boxes (southern/rear elevations).**

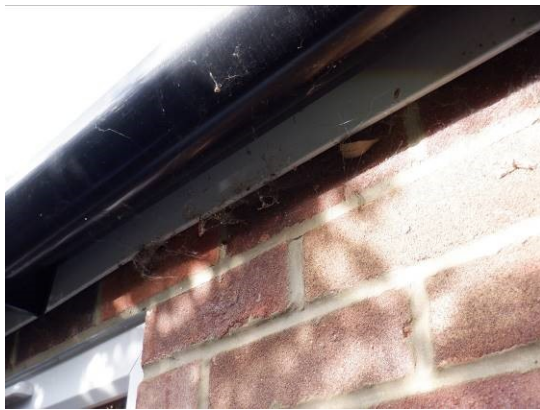
- 3.2.3** The southern side extension (utility room) had sealed bitumen roofing felt covering its flat roof with uPVC barge boards sitting flush against the walls (**Photograph 13; Target note 10**). The northern side extension (utility and garage) had a sealed bitumen flat roof and walls tightly clad with timber feather boards (**Photograph 14; Target note 11**). The timber around the garage door had weathered (**Photograph 15; Target note 12**). No evidence

**13. Flush uPVC barge board on side extension (southern elevation).**

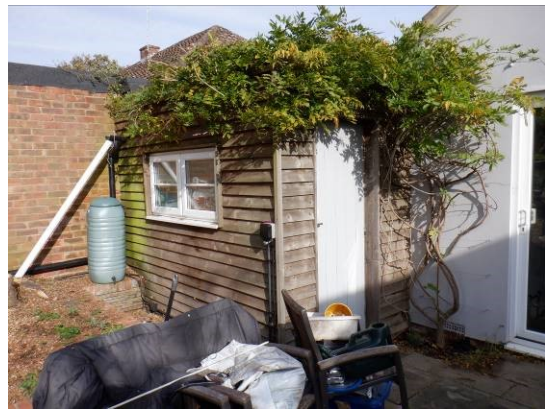
**14. Northern side extension (rear/southern elevations).**

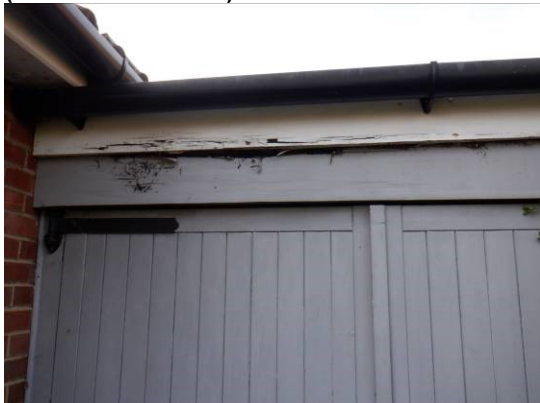
**15. Weathered timbers on front of garage (front elevation).**

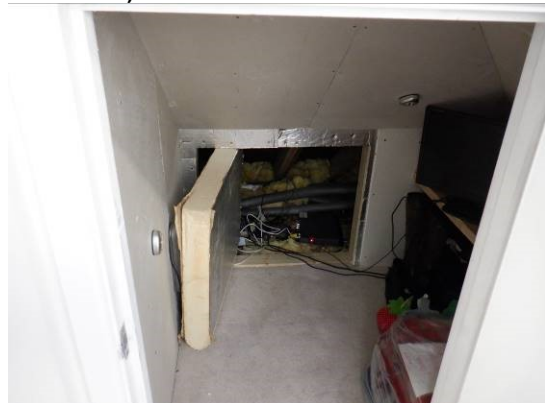
- 3.3.1** The roof void had been converted into living space (bedroom and en suite) but an eaves space remained and was accessible through a storage cupboard (**Photograph 16**). The space could not be fully explored because it was small (approximately 0.5-0.75 metres in height) and had pipework and cables running along the floor (**Photograph 17**). The roof was lined with bitumen-based roof lining but a small hole revealed baton and roof tile behind (**Photograph 18; Target note 13**). The floor was insulated with fibreglass that extended down the eaves to the soffits (**Photographs 19; Target note 14**). The internal walls had been insulated with foam insulation boards and the roof above was filled with fibreglass (**Photograph 20**). A breezeblock wall was visible at the start of the rear extension (**Photograph 21; Target note 15**).

**16. Access into eaves space through storage cupboard.**

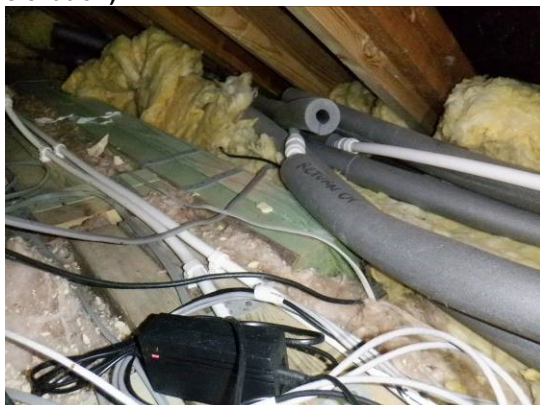
**17. Cables and pipework running through eaves space.**

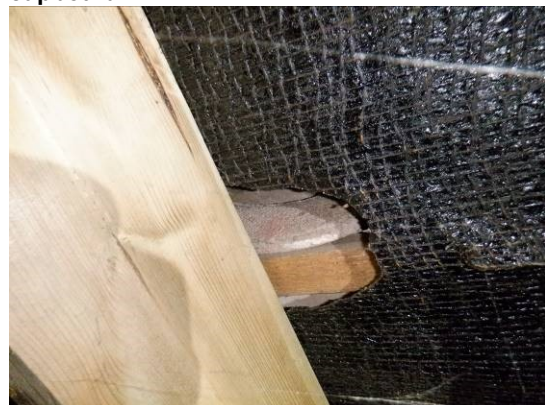
**18. Small hole in bitumen roof lining.**

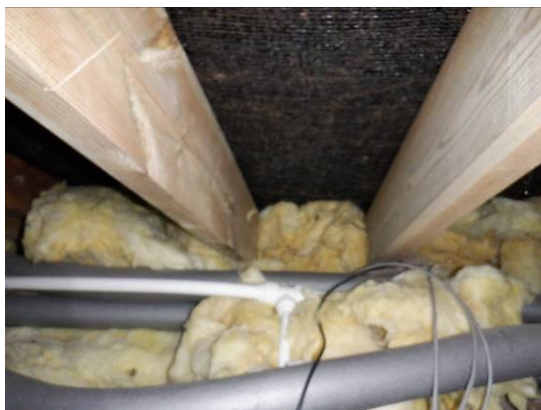
**19. Fibreglass insulation leading down into eaves.**

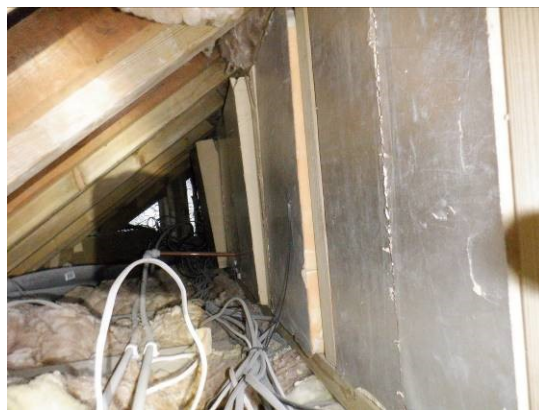
**20. Foam insulation boards.**

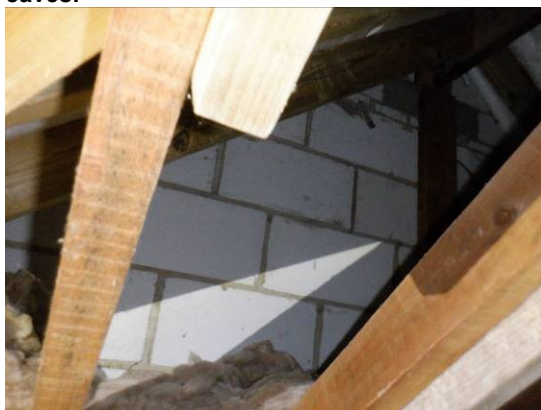
**21. Breezeblock wall at start of rear extension.**
