**After Dark  
112 London Street  
Reading  
Berkshire  
RG1 4SJ**

# **Updated Preliminary Bat Roost Assessment**

**Ref: R2429/a**

**December 2019**

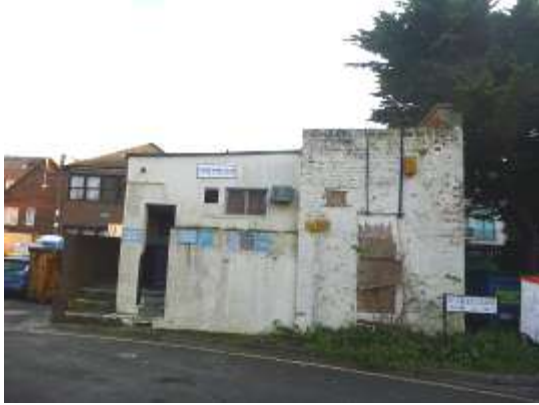
- 3.2.1** The building had three connecting roofs: a flat roof at the western end; a higher flat roof in the middle section; and a hipped roof at the eastern end of the building (**Photographs 1 & 2**).

**1. The western end of the building.**

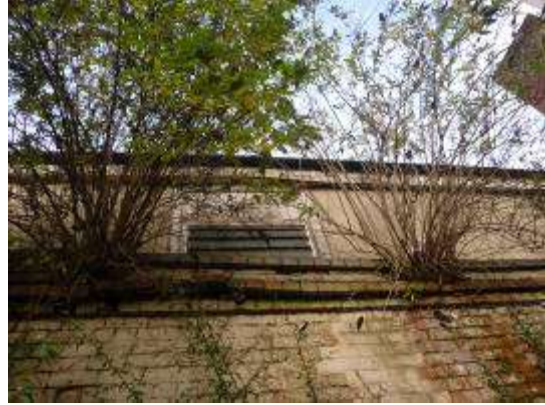
**2. The southern side of the building.**

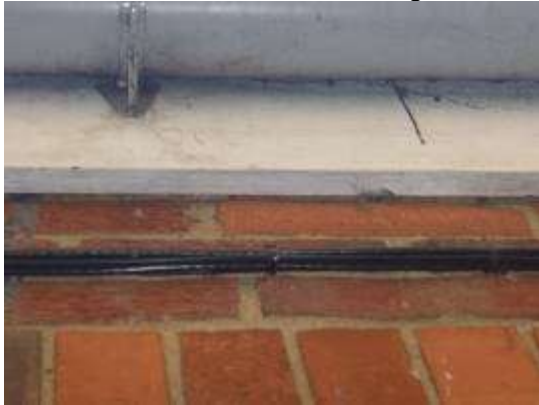
- 3.2.2** The flat elements of the roof were all tightly fitted and did not offer any roosting opportunities for bats (**Target note 1**). The barge boards at the eaves along the northern elevation of all roof sections of the building were, on the whole, fitted tightly to the brickwork (**Photograph 3; Target note 2**). There was the occasional narrow gap, and when inspected closely with a torch, this continued to reveal the gaps to be cobwebbed and they did not extend far enough to provide suitable roosting sites for bats (**Photograph 4; Target note 3**). A brick was missing above two of the ventilation bricks on the northern side of the building but these were blocked by guttering preventing easy access by bats (**Photograph 5; Target note 4**).

**3. The tight barge boards on the northern side of the building.**

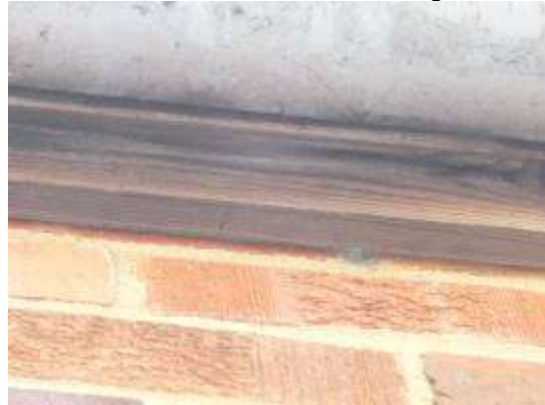
**4. The narrow gap behind the barge board in places.**

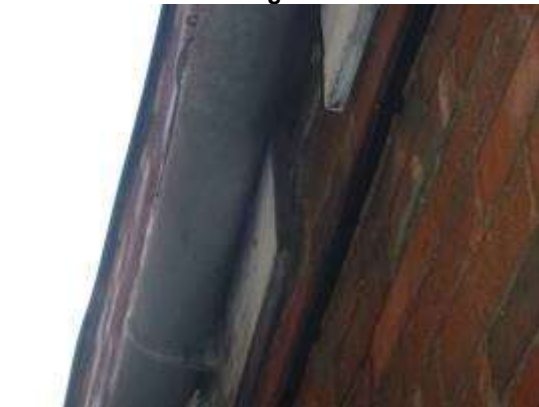
**5. The missing brick above the ventilation brick but guttering in the way of easy access.**

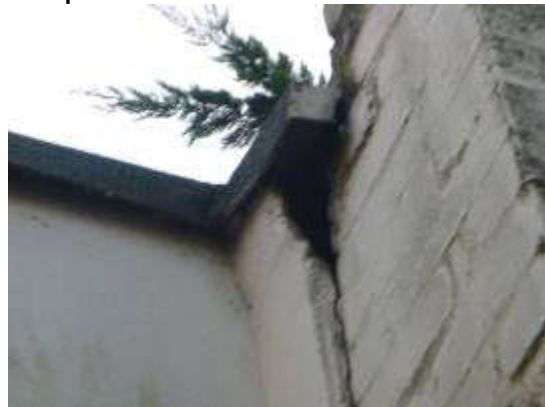
- 3.2.3** There was a large hole in the brickwork at the western end of the building but this was large and draughty and did not extend into suitable crevice opportunity for roosting bats (**Photograph 6; Target note 5**). The majority of the southern side of the building comprised of brickwork up to the roof and therefore there were no roosting opportunities for bats (**Photograph 2; Target note 6**). The wooden soffit box on the higher tiled roof was in poor condition and there were large gaps where the boards had started to rot but this was unsuitable for bats (**Photograph 7; Target note 7**).

**6. Large hole in the brickwork on the western side of the building.**

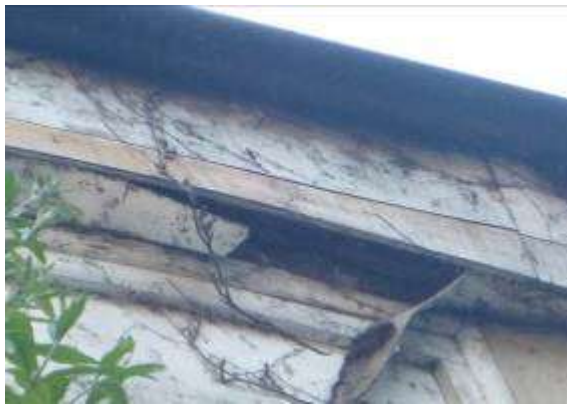
**7. The rotting wooden soffit box on the southern side of the hipped roof.**

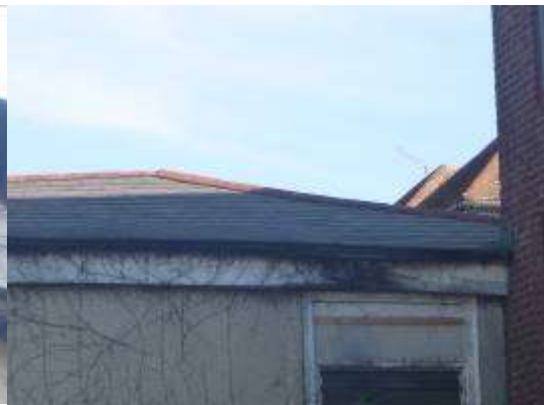
- 3.2.4** The slate roof tiles on the hipped roof remained flat and fitted tightly (**Photograph 8; Target note 8**). The mortar under the ridge and hip tiles continued to be in place offering no access opportunities for bats (**Photograph 8; Target note 9**). The roof was bowing on one side but this did not create any opportunities for bats.

**8. The flat slate roof tiles and mortared hip and ridge tiles.**

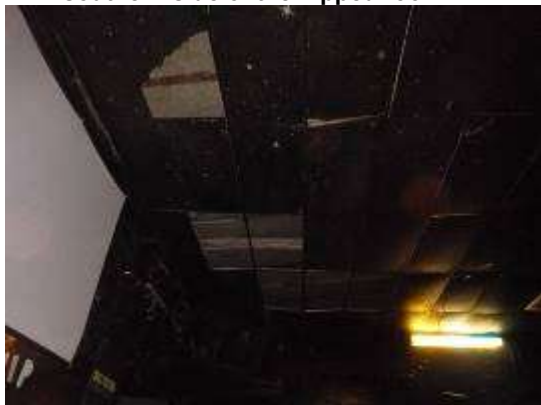
**3.3.1** The majority of the building was flat-roofed with no void spaces and internally the roof was very high with two false ceilings (**Photograph 9**). The roof space in the hipped roof could be surveyed in the north eastern corner where ceiling panels had been removed but a full inspection was not safe to carry out (**Photograph 10**). The roof was lined with tight wooden sarking and a nylon-style roofing felt, which was all intact from the survey viewpoint (**Photographs 10 & 11; Target note 10**).

**9. The interior of the building with high false ceilings.**

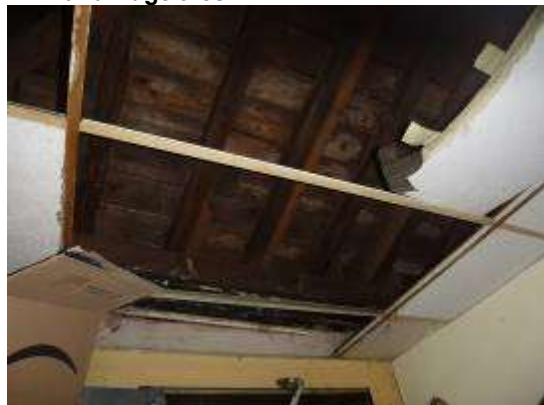
**10. The view of the underside of the roof space in the north eastern corner of the building.**

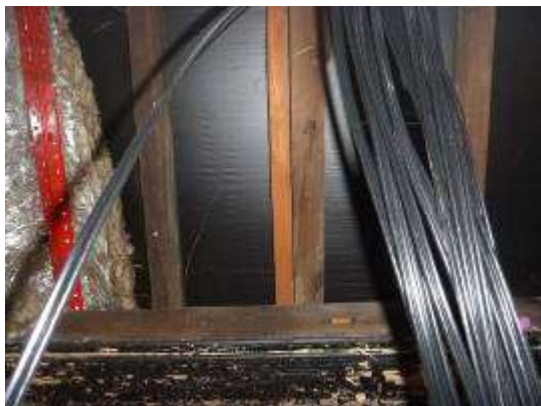
**11. The nylon-style roofing felt.**

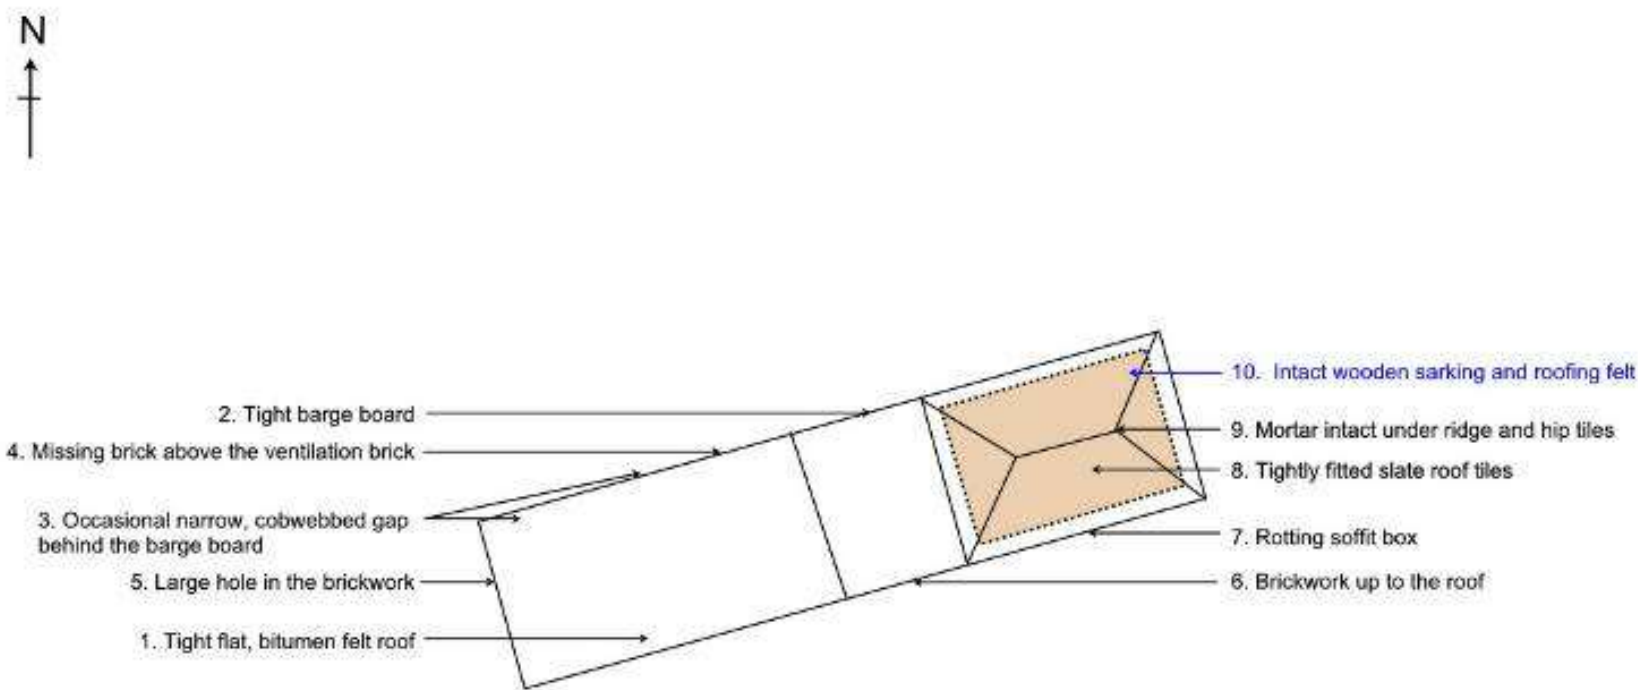
APPENDIX 2 – UPDATED PRELIMINARY BAT ROOST ASSESSMENT FINDINGS

- 3.1.1** Photographs of the site are presented in **Appendix 1** and a plan of the external and internal survey findings with associated target notes is shown in **Appendix 2**. The survey findings from the exterior and interior of the building are described as follows:
