# Bat Survey Report

Waterhouse Building, Reading School

Ridge and Partners LLP

October 2019

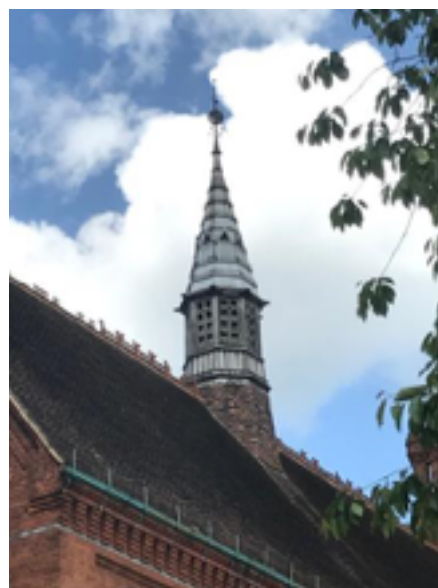
Photo 3 – Central tower with multiple lifted/missing hanging tiles

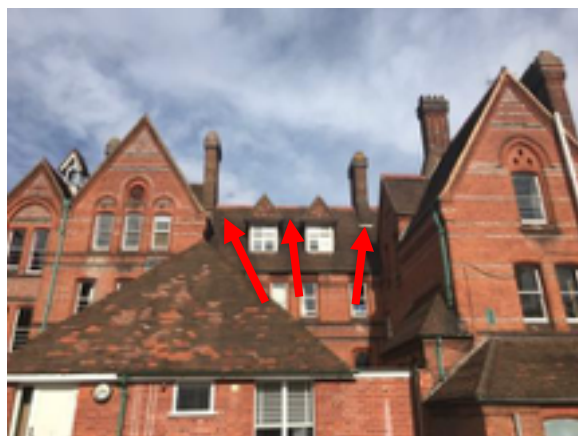
Two common pipistrelle bats were recorded emerging from the south east of the building, one from area A and one from area B (see map in Appendix 2 and Photos 6, 7 and 9 in Appendix 1). Although the exact roosting features could not be confirmed, due to the size and complexity of the building, there are multiple lifted and missing tiles in these areas. Foraging common pipistrelle activity was recorded between 19:56 and 20:05 along with one soprano pipistrelle pass and three noctule passes.

Photo 6 – Locations of potential roosts on southern elevation

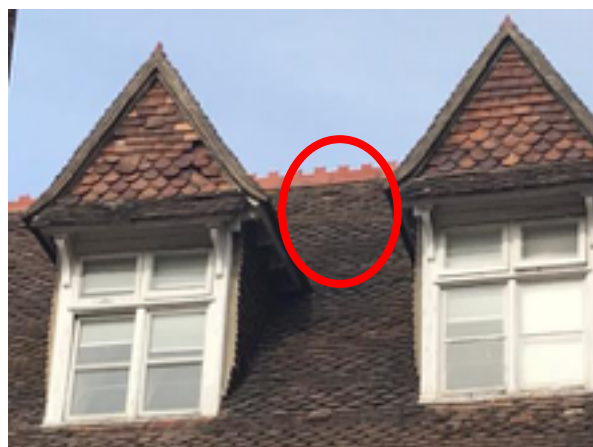
| Building | Location | Species | Species Value | Approx. number of bats | Roosts/ potential roosts | Geographic Frame of Reference |
|---|---|---|---|---|---|---|
| Waterhouse Building | South east of building, probably under lifted tile near ridge | Common pipistrelle | Common | 1 | Occasional day roost | 'District, local or parish' |

Photo 7 – Potential bat roosting location A

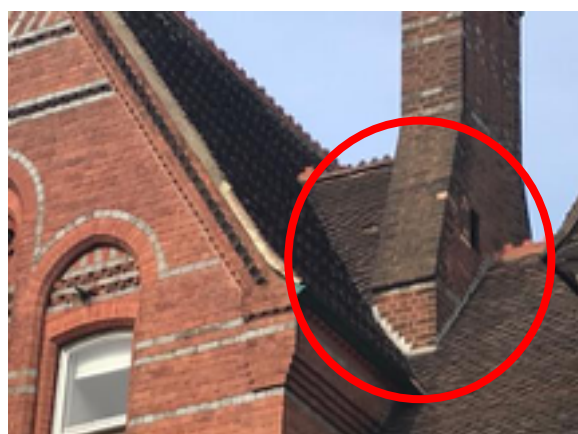
A single bat was recorded emerging from the south east of the building at area C however, no bat calls were detected therefore it was not possible to identify the species of bat. There are a number of lifted hanging tiles in this area (see Photo 8 in Appendix 1) however the exact roosting feature could not be confirmed. Moderate levels of bat activity were recorded with constant foraging common pipistrelle (between 19:11 and 19:53) and soprano pipistrelle (between 19:26 and 20:23) activity. Two noctule bat passes were also noted during the survey.

Photo 8 – Potential bat roosting location C

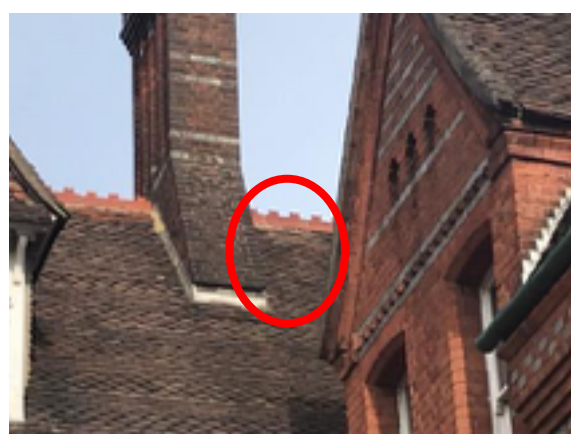
| Building | Location | Species | Species Value | Approx. number of bats | Roosts/ potential roosts | Geographic Frame of Reference |
|---|---|---|---|---|---|---|
| Waterhouse Building | South east of building, probably under lifted tile to east of chimney | Common pipistrelle | Common | 1 | Occasional day roost | 'District, local or parish' |

Photo 9 – Potential bat roosting location B

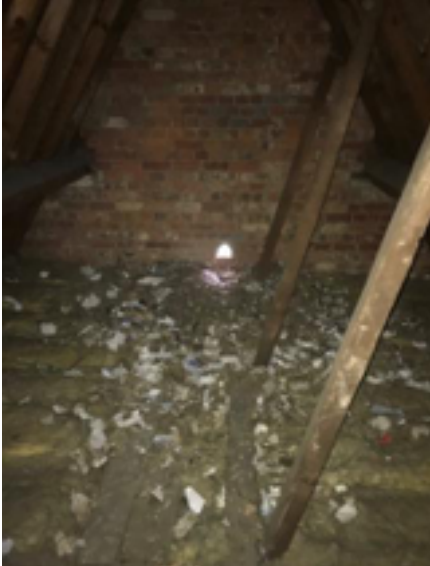
| <p>Photo 10 – Internal photo of loft void</p> | <p>Photo 11 - Internal photo of loft void showing hole into loft space and evidence of bird nesting</p> |

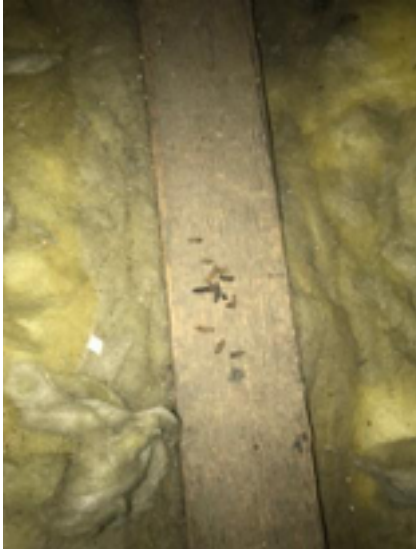
Bat droppings were recorded within loft voids 4, 6 and 7. The droppings appeared old and, due to conditions within the loft voids, could have been in situ for some time. It is considered likely that these droppings are from historic exploratory flight.

| <p>Photo 12 – Bat droppings recorded in loft void</p> | <p>Photo 13 – Internal photo of loft void</p> |

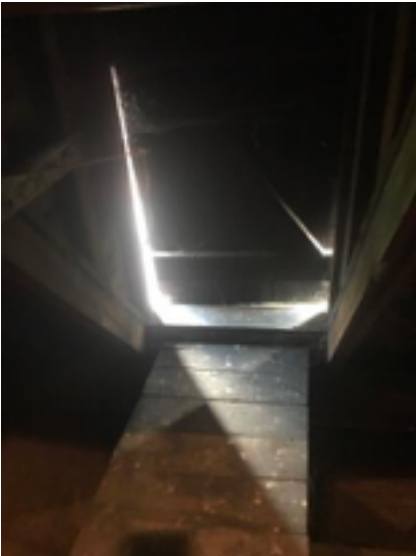
| <p>Photo 14 – Access hatch in Loft 4</p> | <p>Photo 15 - Internal photo of loft void</p> |

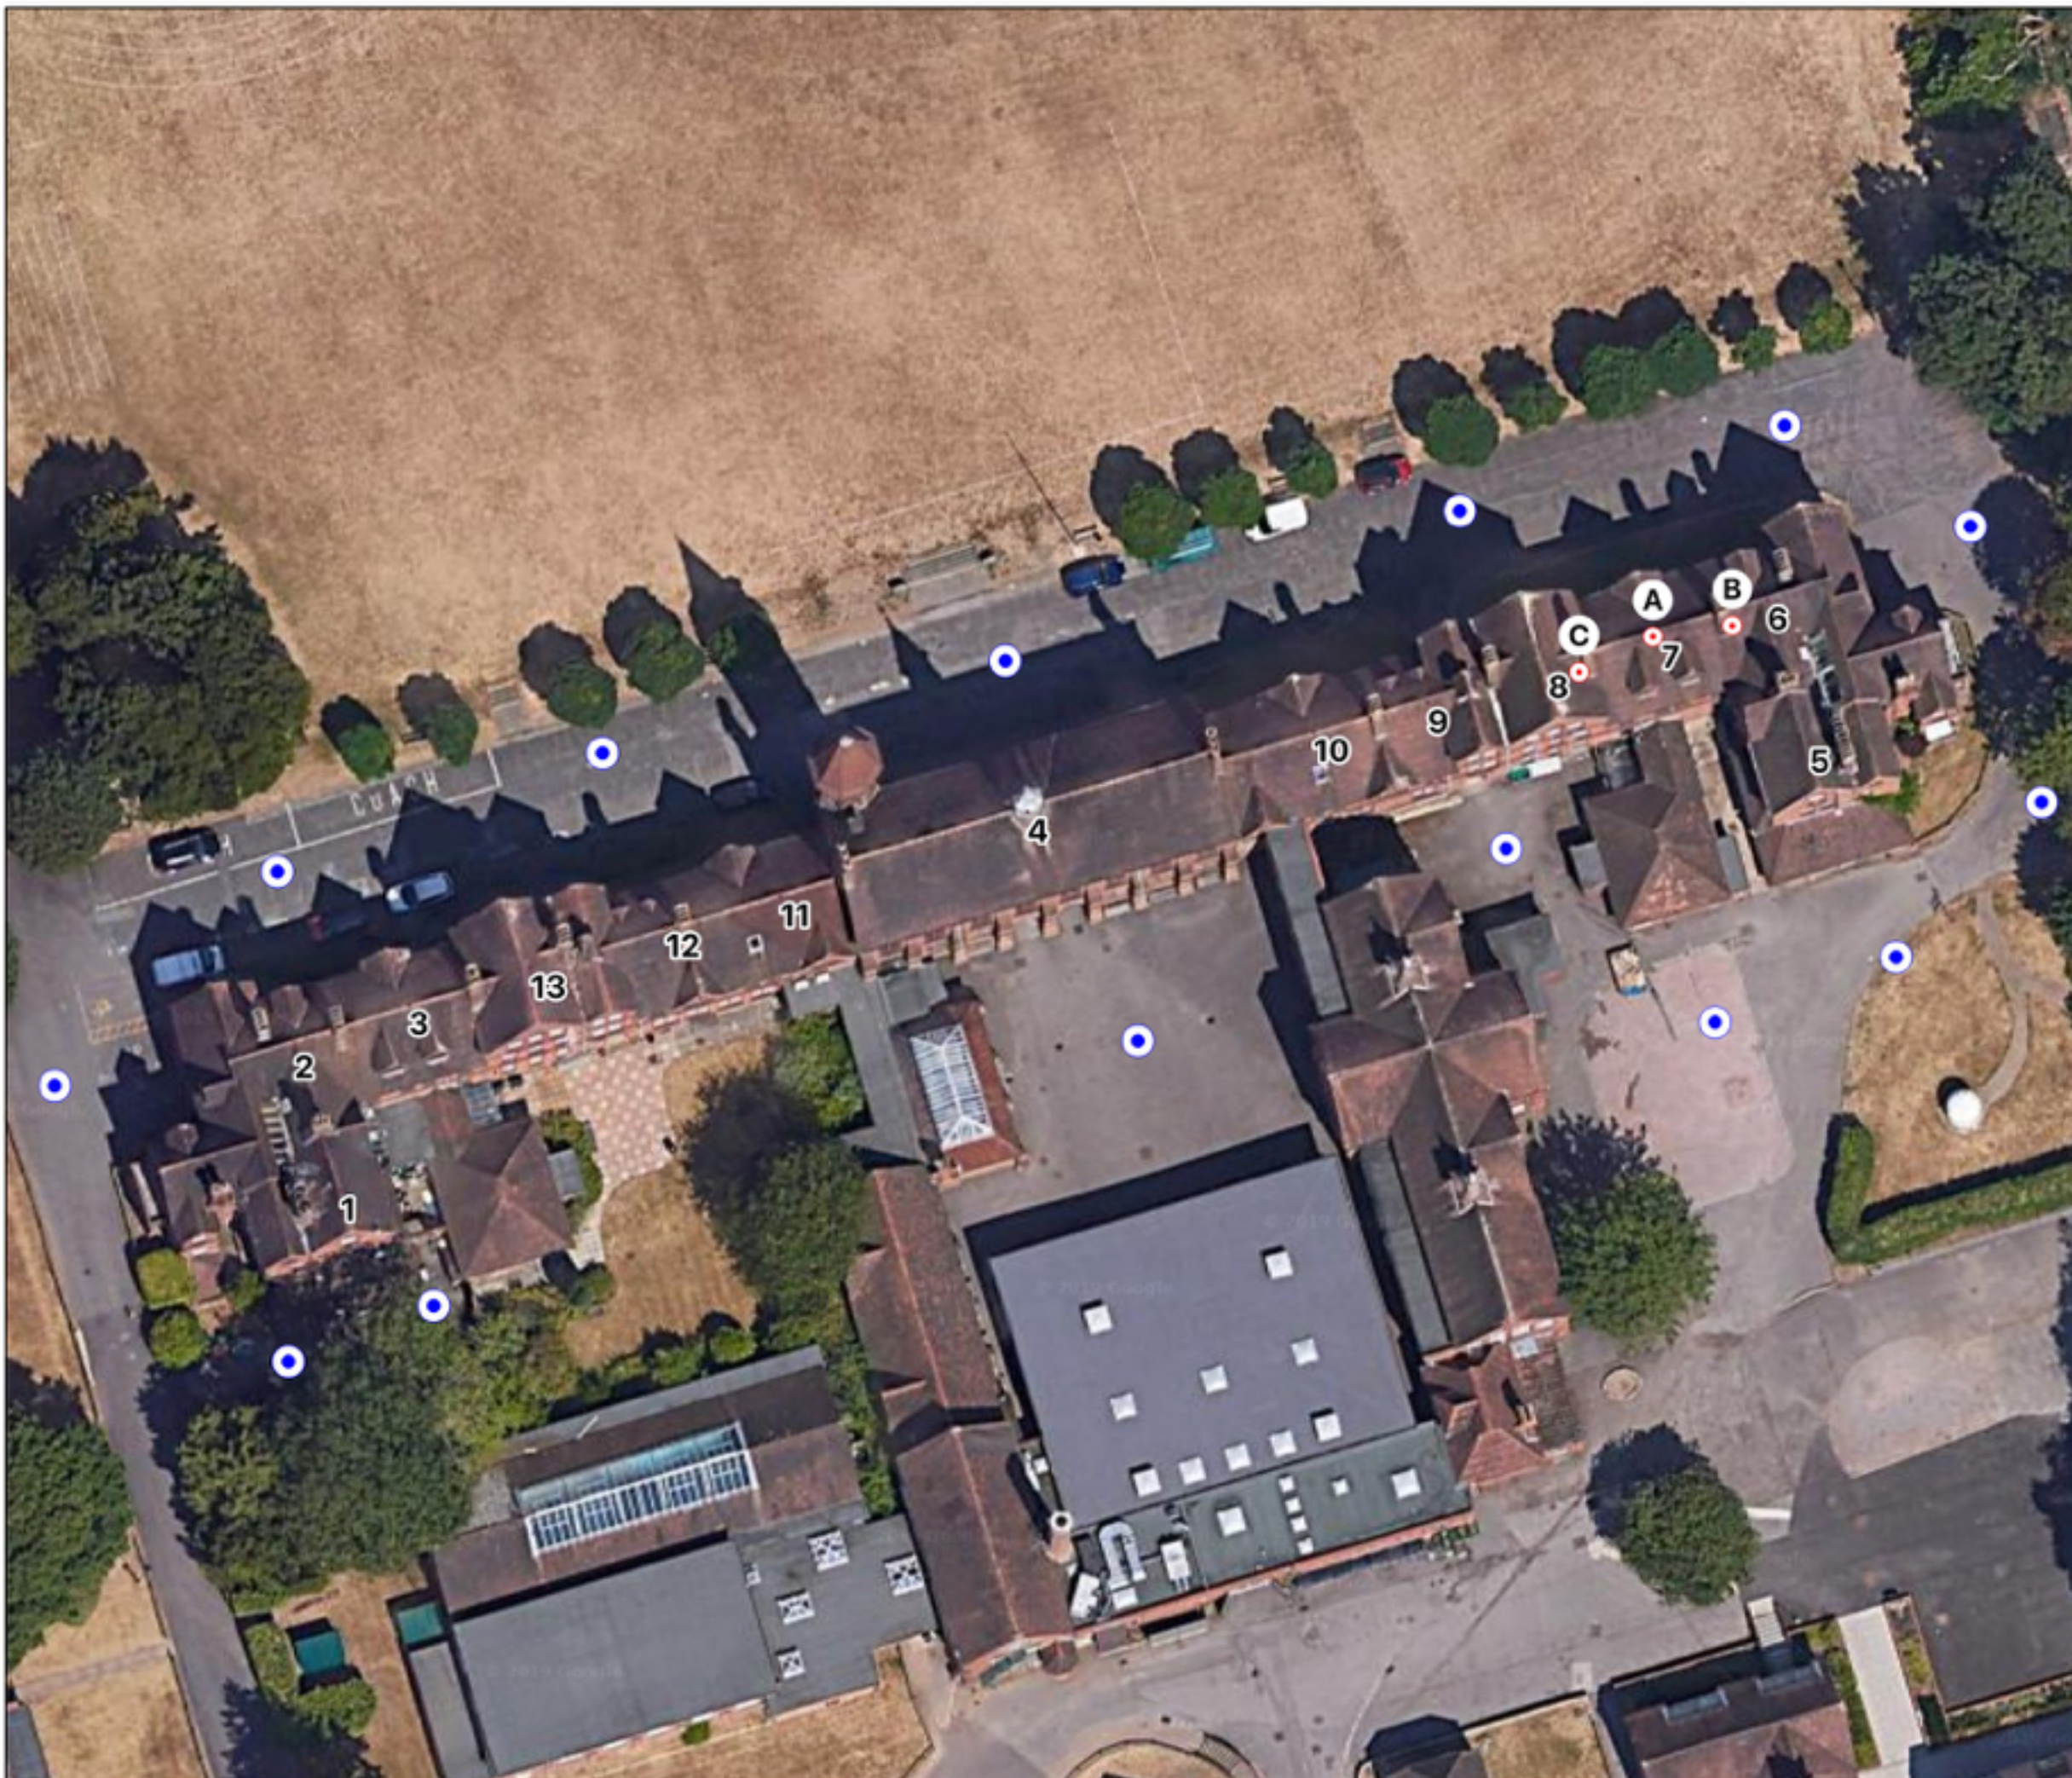
Two solitary common pipistrelle bats were recorded emerging from separate locations on the south east of the building on the 9<sup>th</sup> September, one emerged from near the ridge of the roof (area A on Map in Appendix 2) and another emerged to the east of the chimney (area B on Map in Appendix 2). A further unidentified bat emerged from the base of the chimney on the south east of the building (area C on Map in Appendix 2) on the 25<sup>th</sup> September. The bats emerged from under raised or missing tiles in these areas however, due to the size and complexity of the building along with lighting around the site, it was not possible to confirm the exact roosting features during the surveys.
