# Arboricultural Health & Safety Report

Land in the ownership of The Abbey School  
Kendricks Road  
Reading  
Berkshire  
RG1 5DZ

June 2019

Ref: 18053

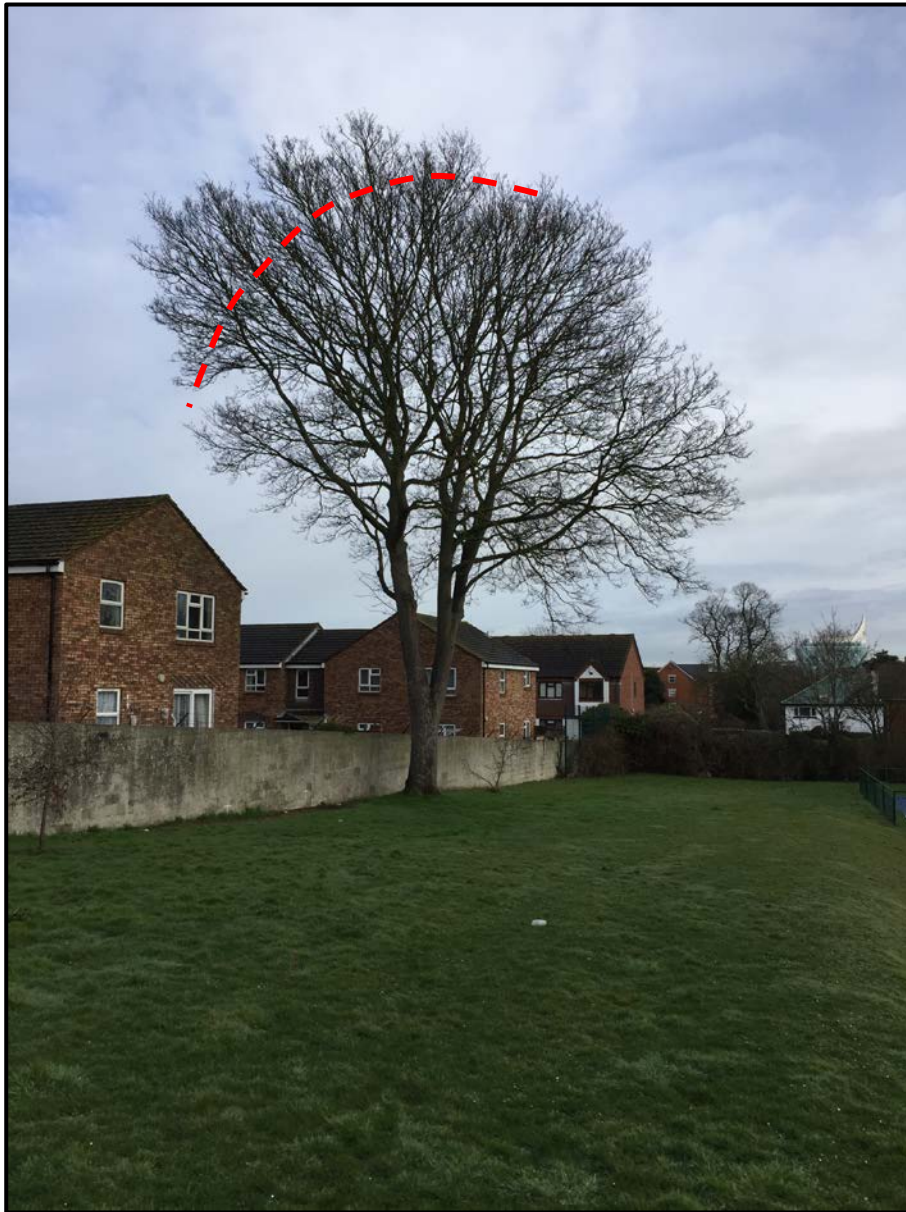
Photo 2 Tree T10 Hockey Pitches: Pruning Guidance

3.3.2 Two mature Sycamore trees are located adjacent to the north western boundary and have undergone previous crown lifting works. With regard to Tree T10, the canopy is starting to become over extended and is growing towards a number of offsite flatted properties. It is recommended to undertake selective canopy reduction works concentrating on the south western side of the canopy. Please refer to Photo 2, Appendix 5 for guidance. As a precautionary measure x 2 cavities require a climbing inspection to ensure no significant decay or defects are present.

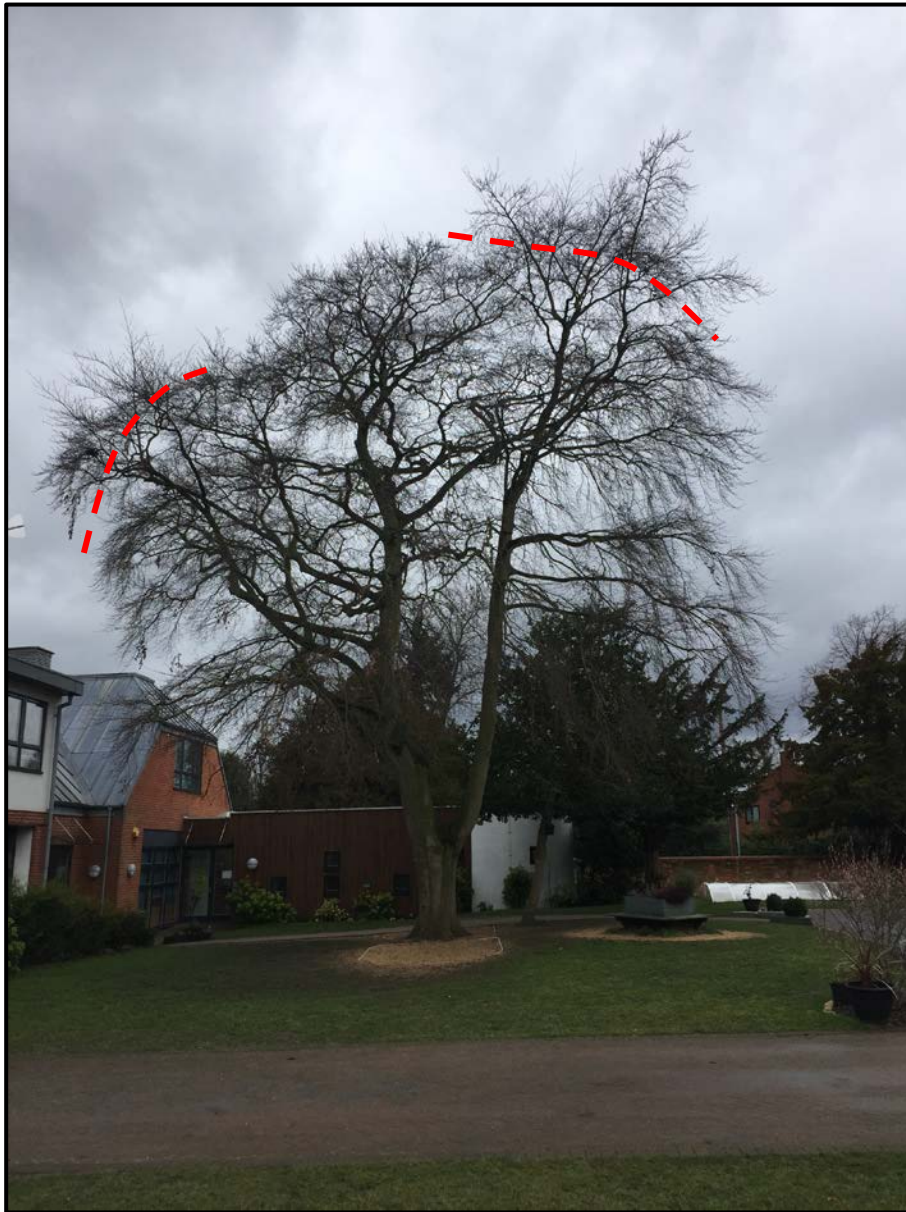
Photo 3 Tree T38 Kensington: Pruning Guidance

| Tree No. | Species | HT (M) | Age Class | Phys. Cond. | Branches | Leaf/Buds | Stem | Roots | Comment | Proposed Work | Priority | Next Survey (months) |
|---|---|---|---|---|---|---|---|---|---|---|---|---|
| T38 | Copper Beech | 17.5 | M | F | Old pruning wounds; Cobra Bracing; Minor deadwood | Normal | Bifurcated | No visual defects | X 2 at 2m agl- southern stem dominant - wide union present. Northern canopy starting to get over extended - recommend selective canopy reduction. | Prune | 3 Months | |
