## DESIGN & ACCESS STATEMENT – READING SCHOOL MAIN SCHOOL HALL DRY ROT REMOVAL

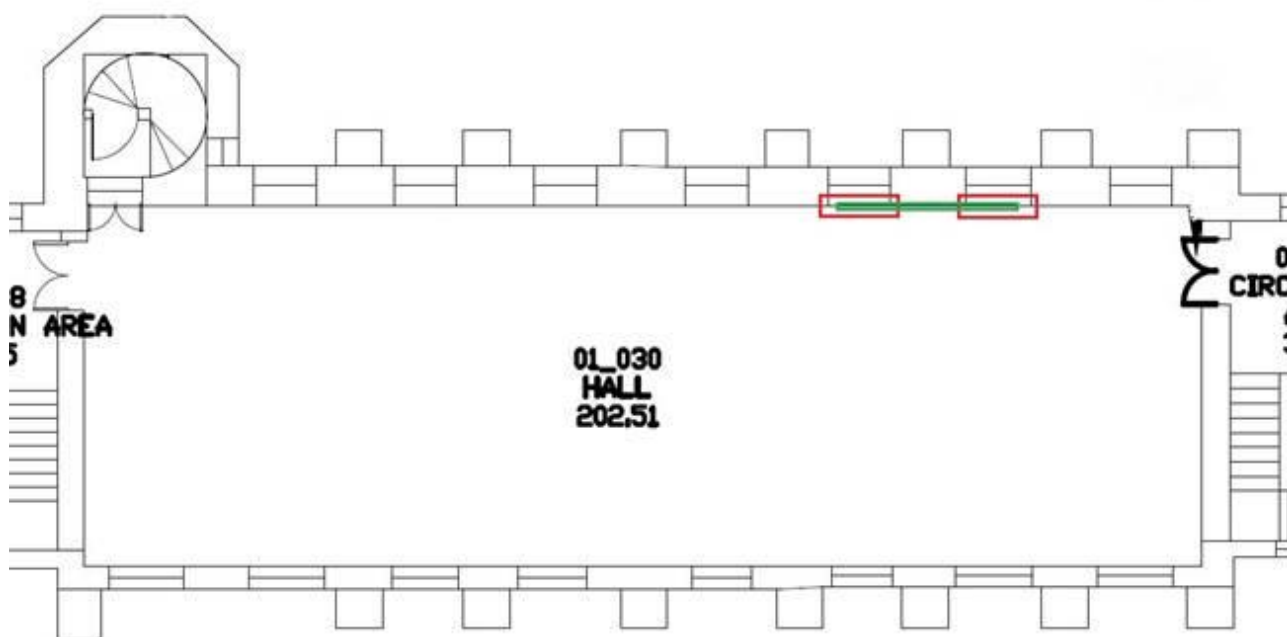
Two window boards and the section of skirting board below the windows were found to be severely decayed due to dry rot and beyond repair. The timber was removed to prevent further spread and loss of more building fabric. The plan below shows the location of the two affected window boards outlined in red and the section of skirting board in green.

*Figure 1: Location of decayed joinery.*

The proposal is to reinstate the decayed and unsalvageable window boards and section of skirting board. The new timber will be carefully selected and installed to match the pre-existing joinery in terms of species, appearance and dimensions.

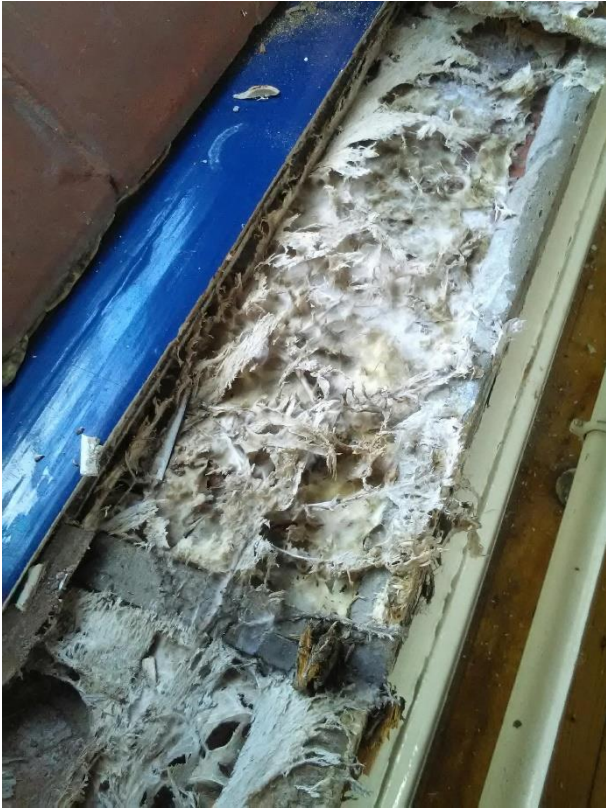
Significant dry rot was discovered to internal joinery within the first-floor main school hall. The affected area is to the front elevation centred around one external rainwater hopper and downpipe which has been leaking for some time, causing dampness internally.

*Figure 2: Exposed dry rot to window board 1.*

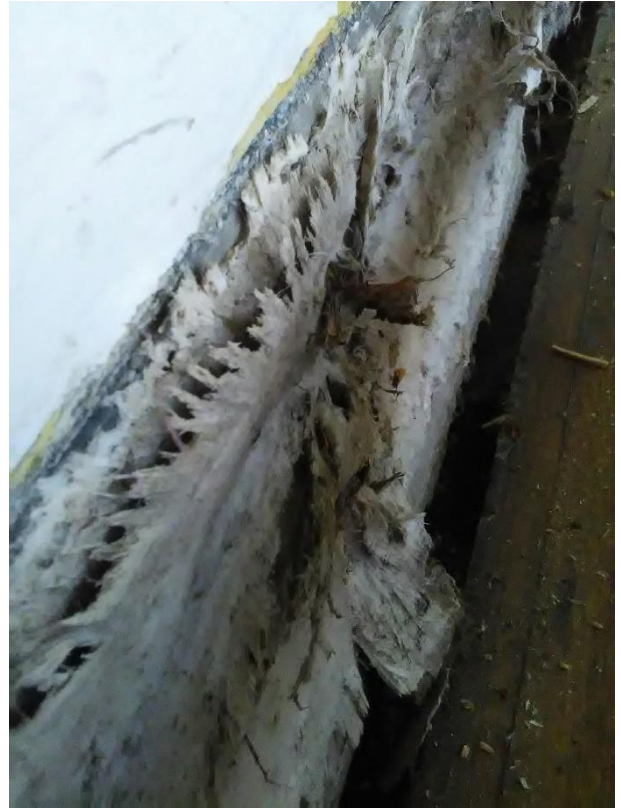
*Figure 4: Exposed dry rot to skirting board.*

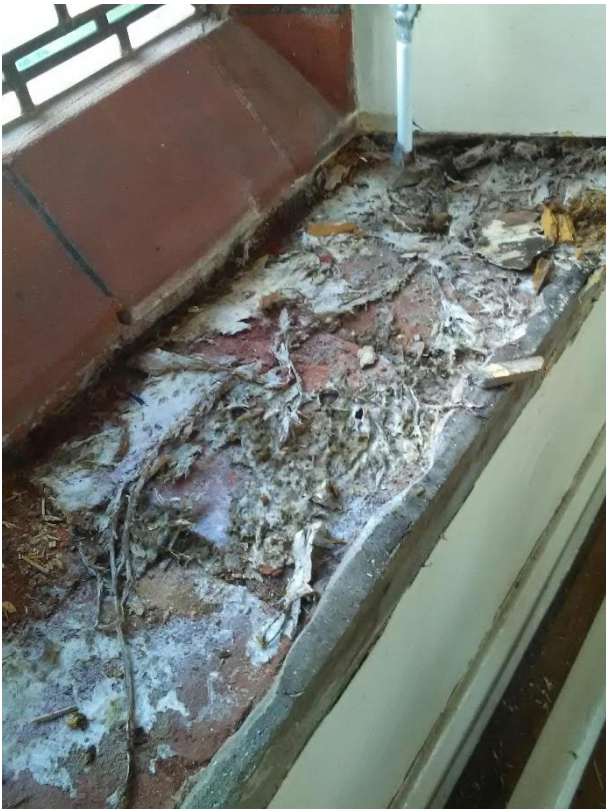
*Figure 3: Exposed dry rot to window board 2.*

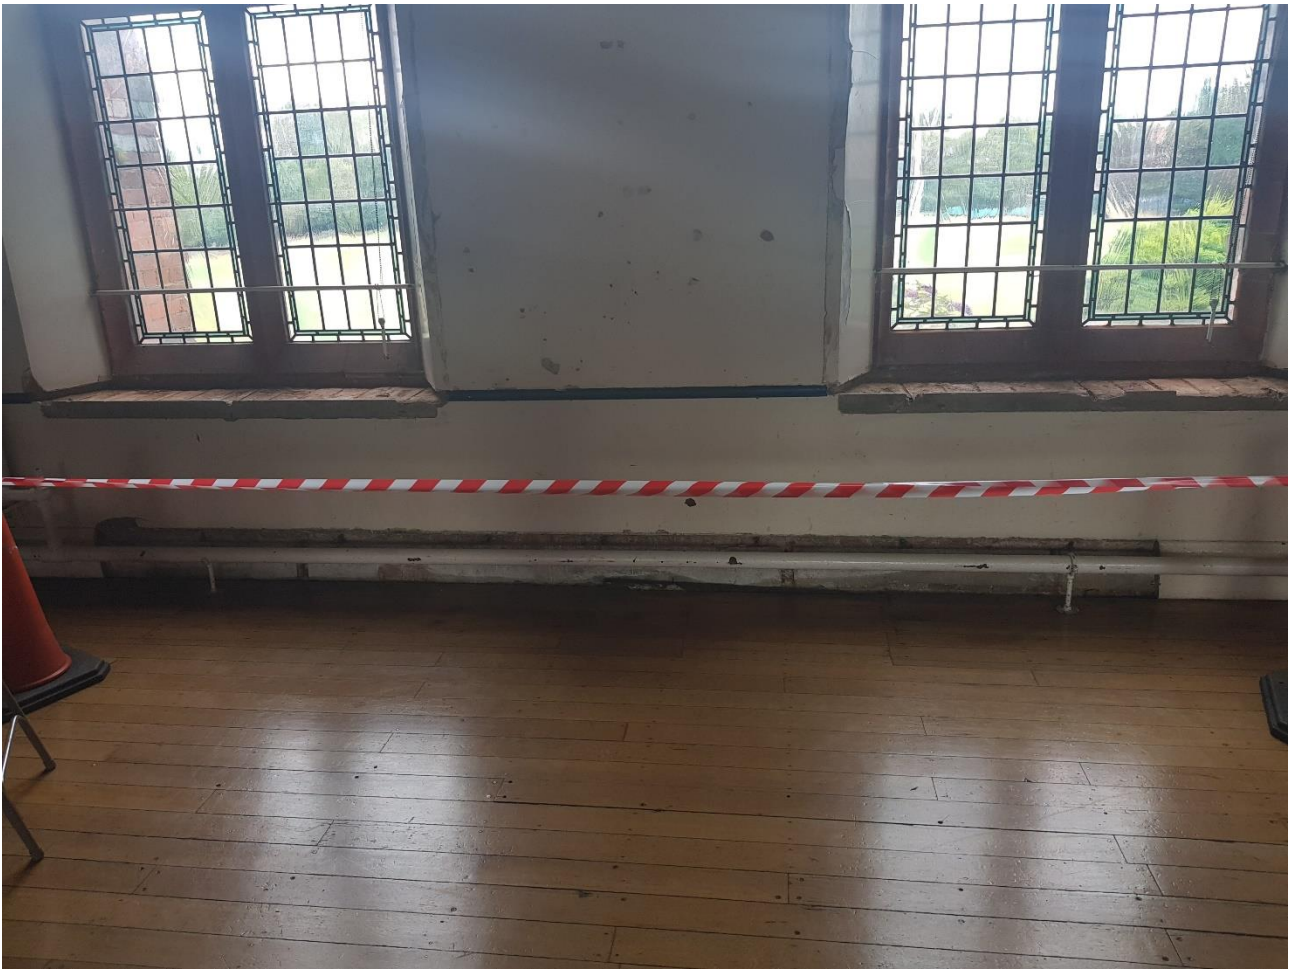
*Figure 5: Showing both windows following the removal of the decayed joinery.*
