**Subject:** FW: [EXTERNAL] 23316 Harris Arcade - 15 Friar Street

You asked us to inspect the flank wall of 15 Friar Street and to comment on the condition of the flank wall and attached chimney. We inspected on the 28<sup>th</sup> August and comment as follows:

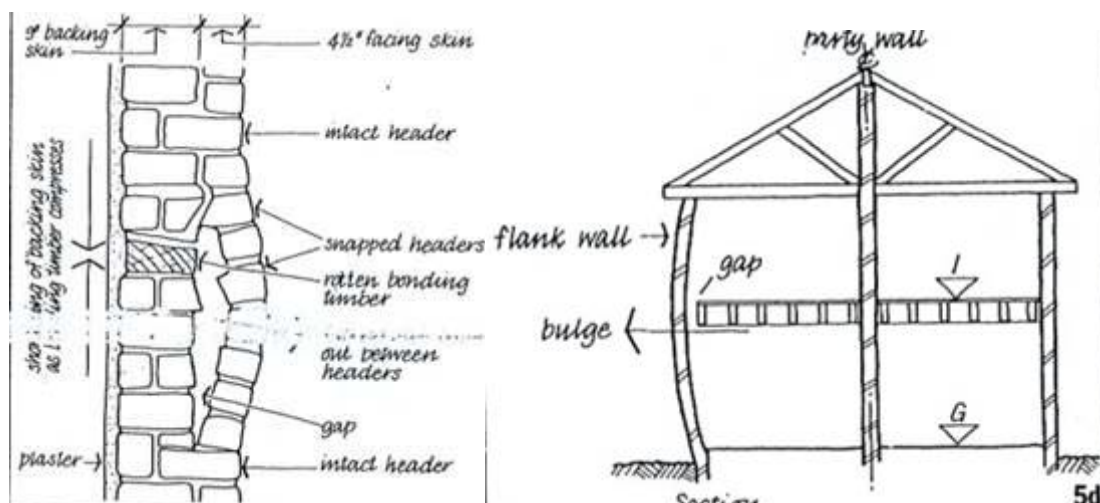
1.1.3 Sketches illustrating the wall movement:

- (a) Firstly, there is a localised outward bulge at the level where the roof meets the wall. We believe that this distortion is due to the deterioration of the embedded timber wall plate supporting the roof. Below is a sketch which illustrates this movement, although the sketch shows a gap forming in the wall, which may not be the case here.
- (b) Secondly, a large portion of this wall has bulged out. We believe that this is due to a lack of tie or restraint to the wall. Below is a sketch which illustrates this movement – the gap shown between the wall and the floor may not be present here.
- (c) Thirdly, there is a lean in the chimney.

- 1.1.4 The outward bulge of the wall and lack of tie / restraint may have resulted in the instability of the wall. We recommend that the condition of the timbers and tying provisions are investigated. This is likely to require intrusive investigations internally. The remedial works will depend on the findings of the investigation works. The lack of restraint also means that the chimney is unrestrained over a 2 storey height.
