Horse Chestnut  
Visual Tree & Climbing Inspection

Mr & Mrs Stowell

Site: Mulberry House, 20A Church Road, Caversham, RG4 7AD

Inspected on 18th September 2019

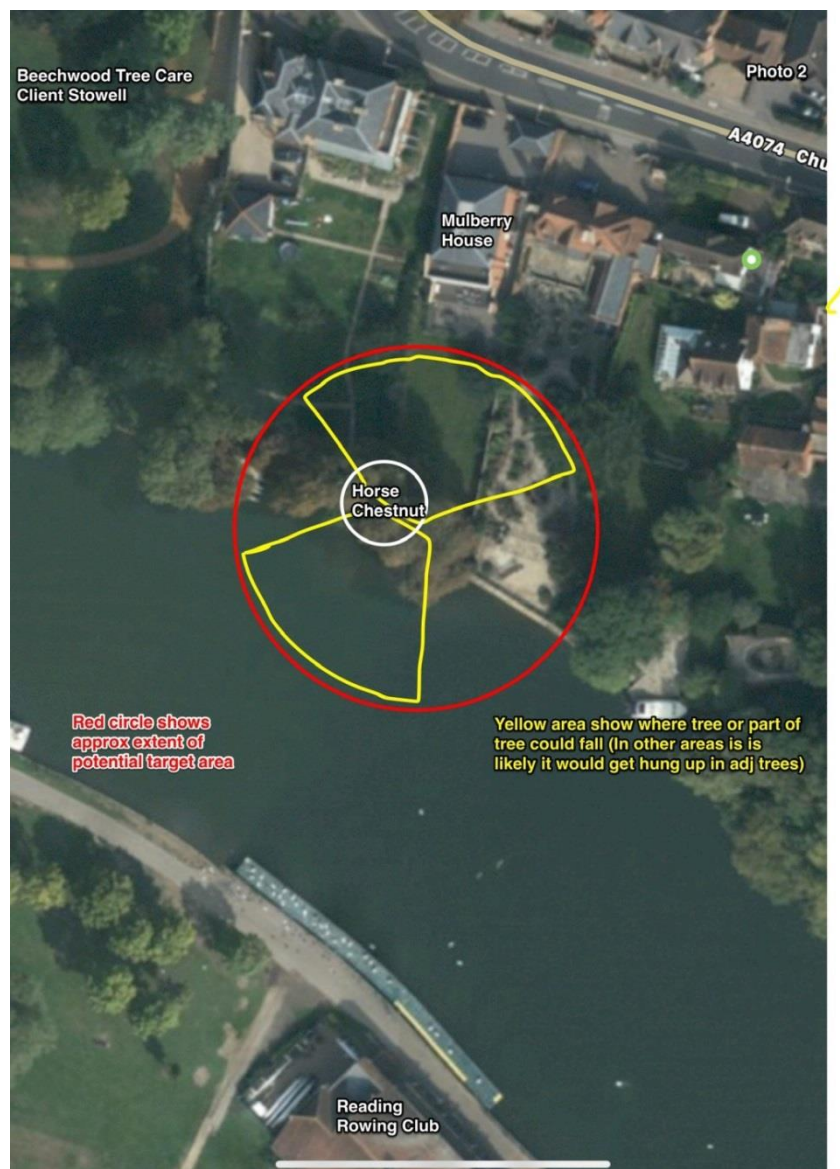
Photo 2 (picture of target area)

- The whole garden of Mulberry House is within the target area should the tree or a portion of it fail.
- Mr and Mrs Stowell has young children who frequently use the garden in all weathers.
- It is noted the river is effectively a public highway and boats frequently pass within falling distance of the tree.
- On the day of inspection it became clear that the rowers from Reading Rowing Club use the target area as a start point for rowing up the river. I observed rowers stopping in the target area and composing themselves before starting their row up river.
- Basically this area of the river is heavily used and a failure could lead to significant injury and/or damage to property.

I would classify the target area as medium use.

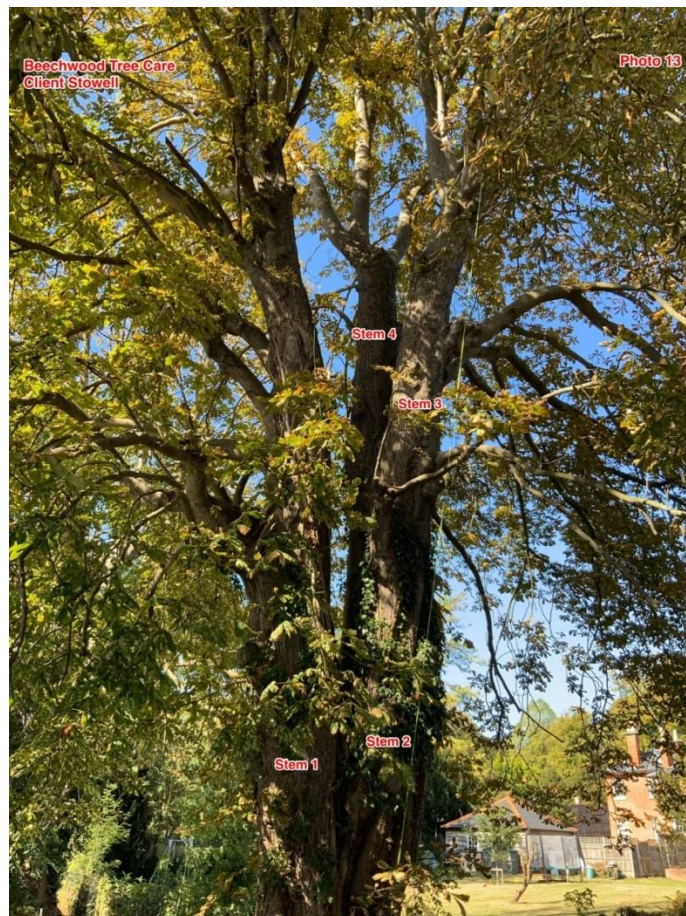
Photo 13 (picture of stems)

- The tree is approx. 20-22m tall (this is an estimated height).
- The tree shares a co dominant crown with the adj. Chestnut
- The tree is not in a great condition, the leaf size is small and yellowish in colour.
- The tree is heavily infested with leaf minor.
- There is significant amount of large diameter deadwood within the canopy over the decking.
- The main trunk forks into two at approx. 2m, forming a Southern stem (Stem 1) and a Northern stem (Stem 2).
- The Northern stem forks into two again with stems to South East (Stem 3) and South West (Stem 4)

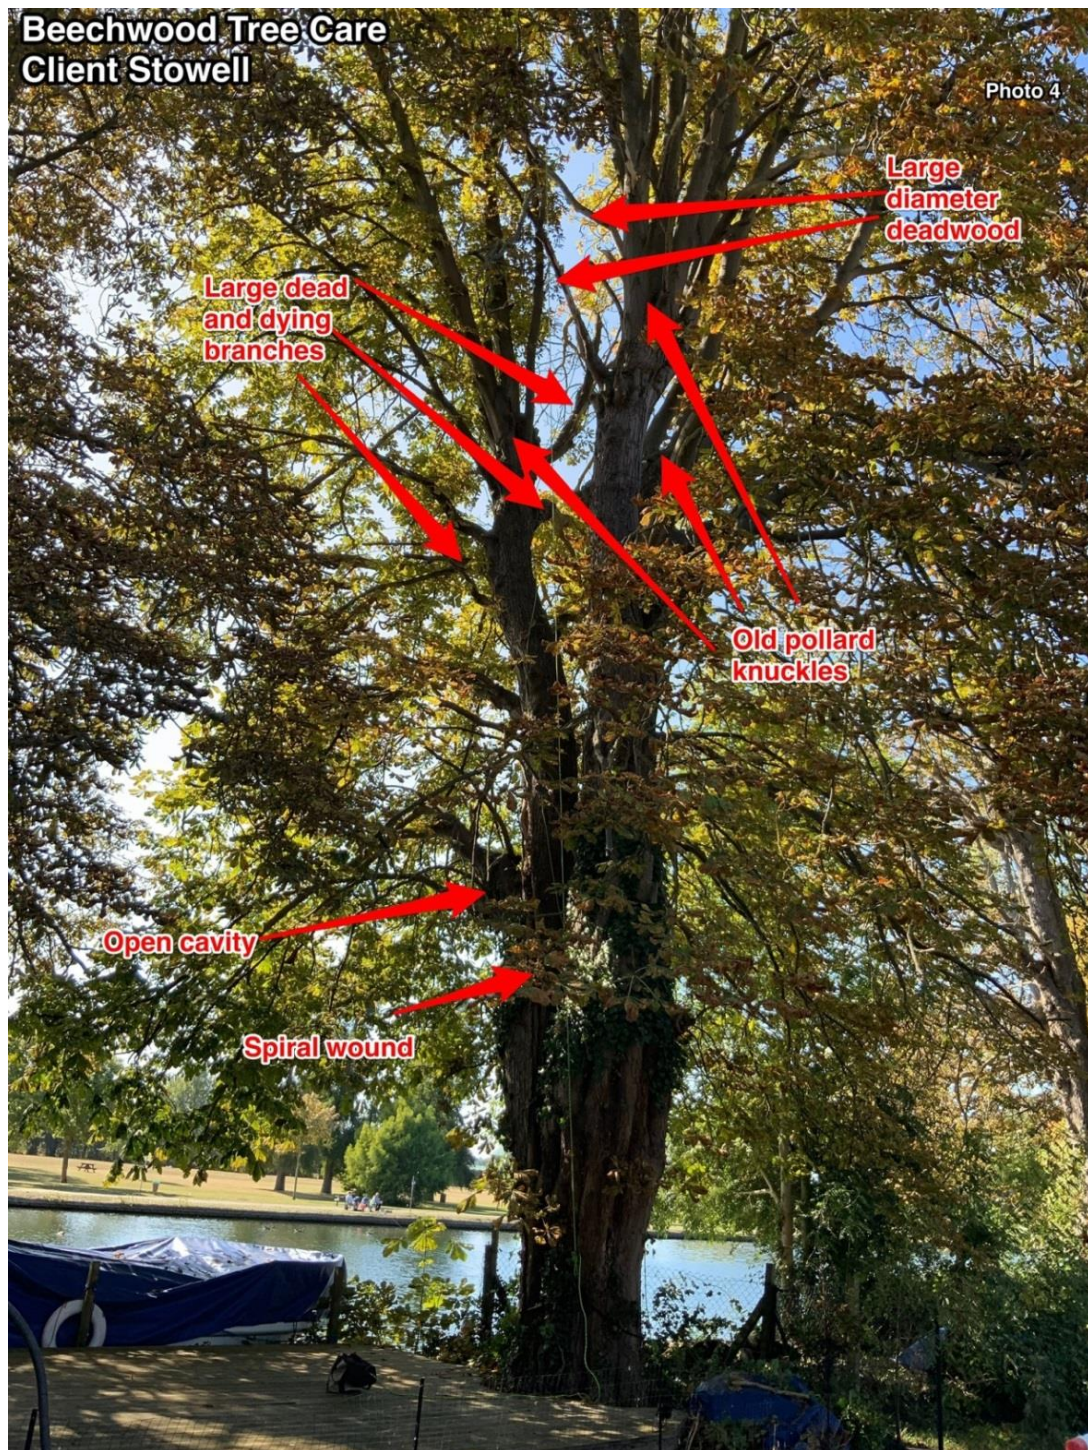
Photo 4 (picture of pollard points)

- Stems 1, 3 & 4 have all been historically pollarded/topped (photo 4) (These points are to be investigated for decay, dis-function and cavities).

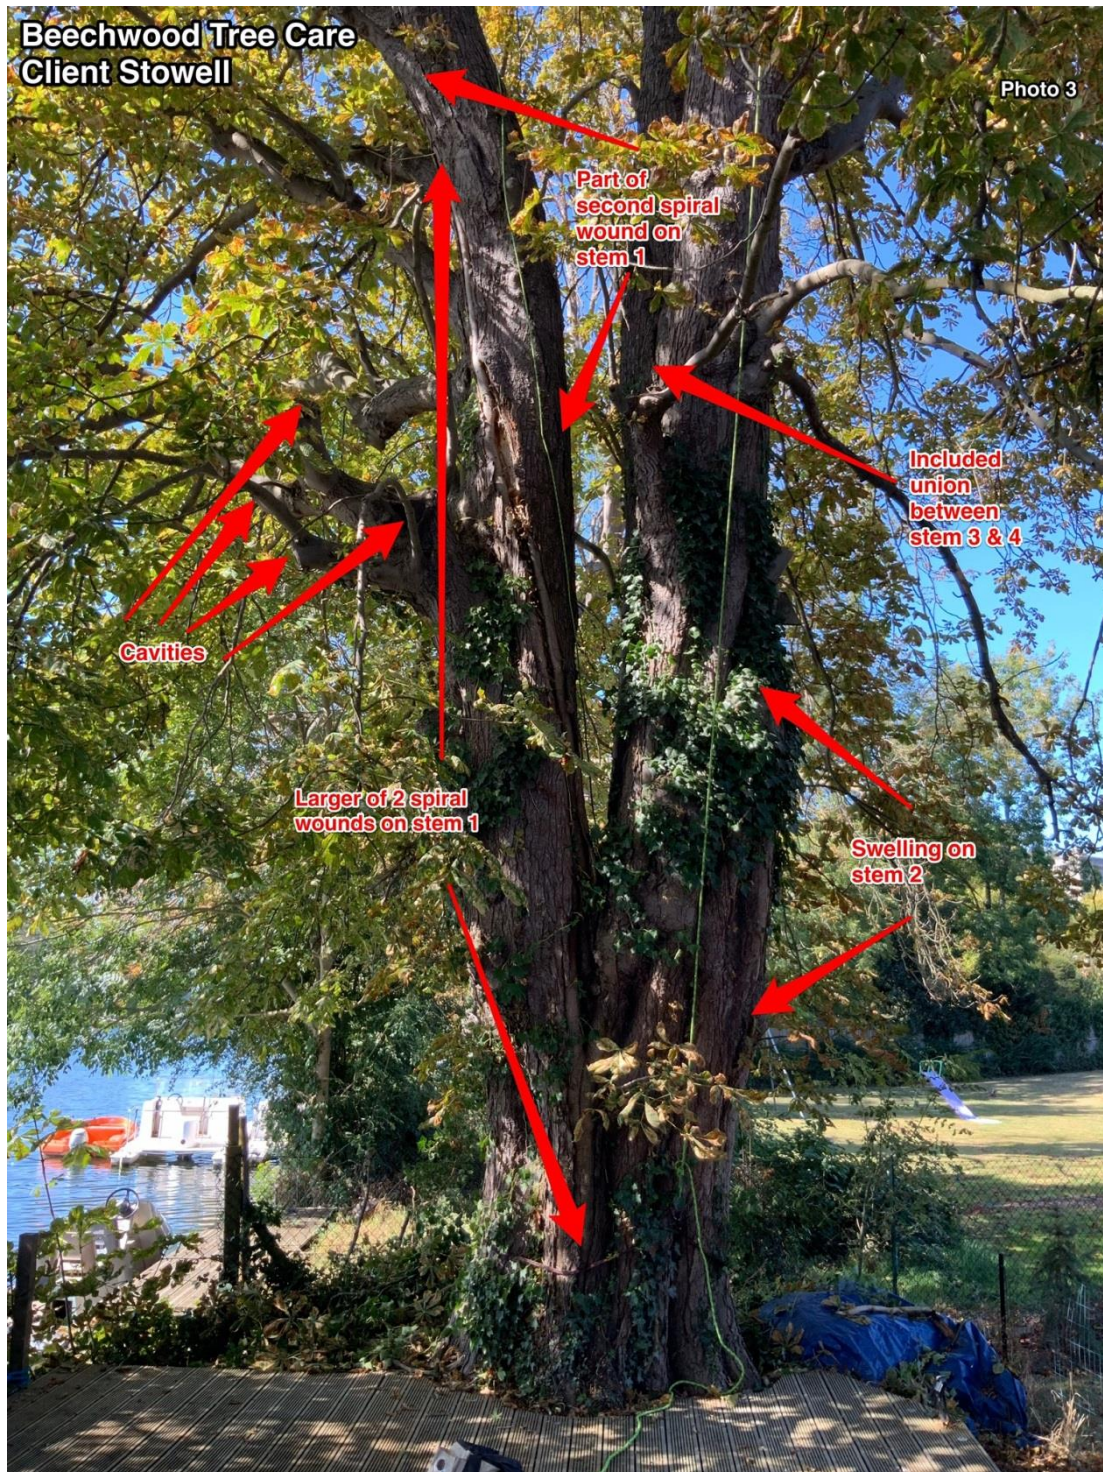
Photo 3 (picture of defects in lower section of stems)

- Stem 1 has a large open cavity on the river side, 3 large dead branches over the river and 2 wounds extend up the stem in a helical pattern (photos 3&4).

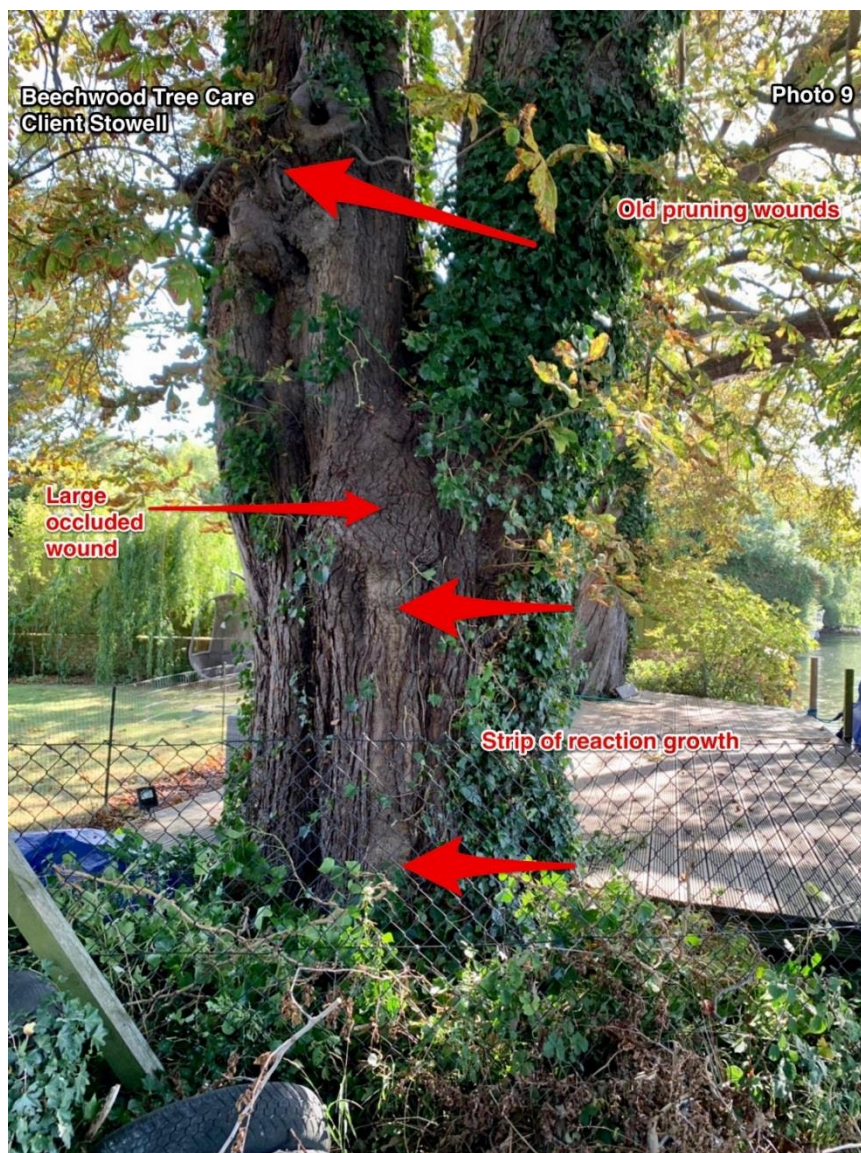
- On the east side of the main stem there is a large occluded wound and a strip of reaction growth (see photo 9)
- The lower section of the both stems 1 & 2 have numerous occluded wound from previously removed branches.

There are indications of a significant amount of dysfunctional and possibly decayed wood associated with previous damage and pruning.

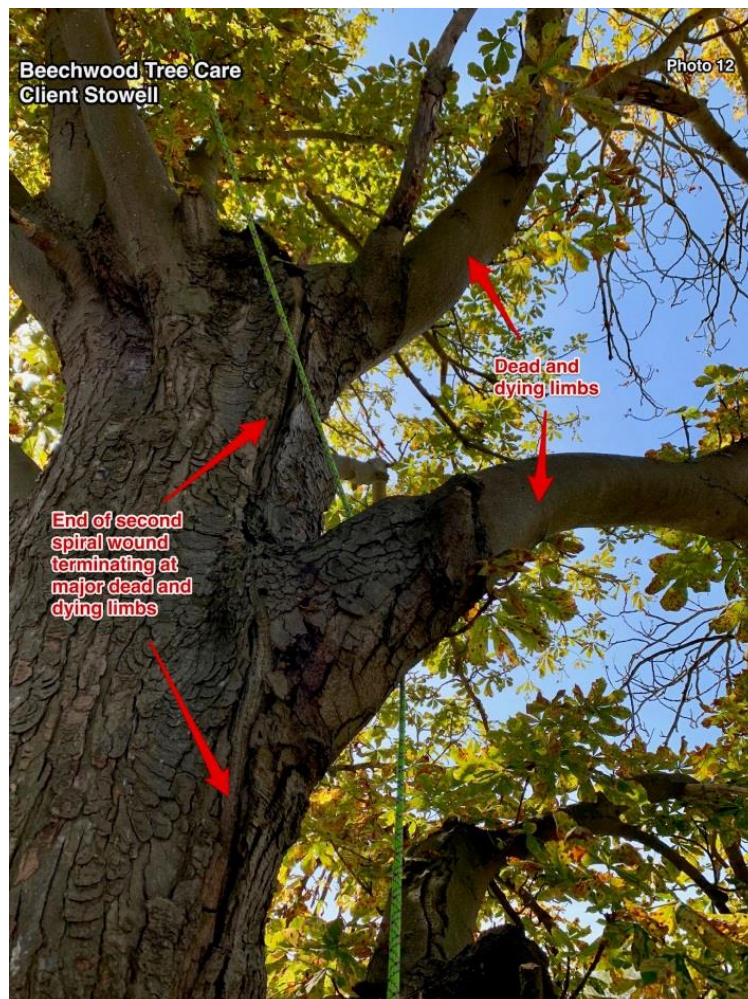
Photo 12 (picture of spiral wound connecting to large dead/dying limbs)

- The lower section has numerous occluded wound from previously removed branches.
- The stem has two significant wounds which run up the stem in a spiral pattern (photo 3).
- The first of these wounds links up with a significant cavity on the river side where a large branch has been historically removed (photo 5) and ends just below the pollard knuckle at the point where a large dead limb extends over the river. This limb has an open wound running along it.
- The second wound is not as large as the first and spirals up the tree in a pattern parallel to that of the first wound and ends at the pollard knuckle at the point where 1 large dead limb extends over the river and large portion of a second large limb is dead (photo 12). These branches have open wounds running along them. These branches emanate from the pollard knuckle.

There is a significant amount of dysfunctional and decayed wood to warrant concern that this stem or a large section of it could fail.

Remove major deadwood, i.e. branches over 50mm at source and over 300mm in length

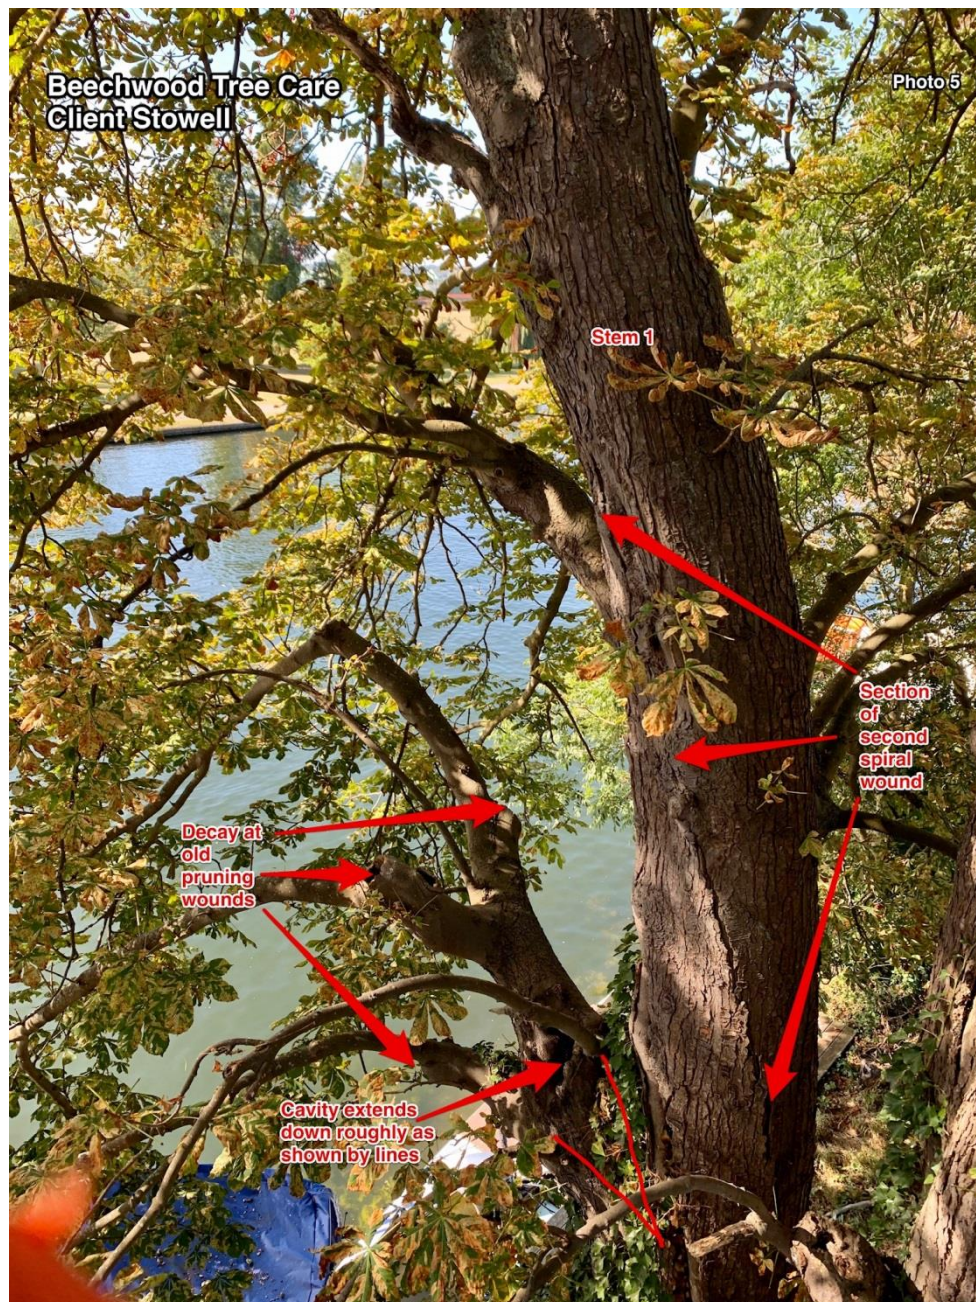
Photo 5 (picture showing areas of decay and cavity on river side, showing approx. extent of cavity)

- There is a cavity on the south side at a point where a large low limb has been removed. Cavity extends inwards and downwards at least 900mm and meets up with the first of 2 spiral bark wounds. There are 3 sizeable branches emanating from this stub all contain decay (see photo 5).

The cavity on the south side undermines the structural integrity of the branches emanating from around it.

Remove all lower branches from around the lower cavity.

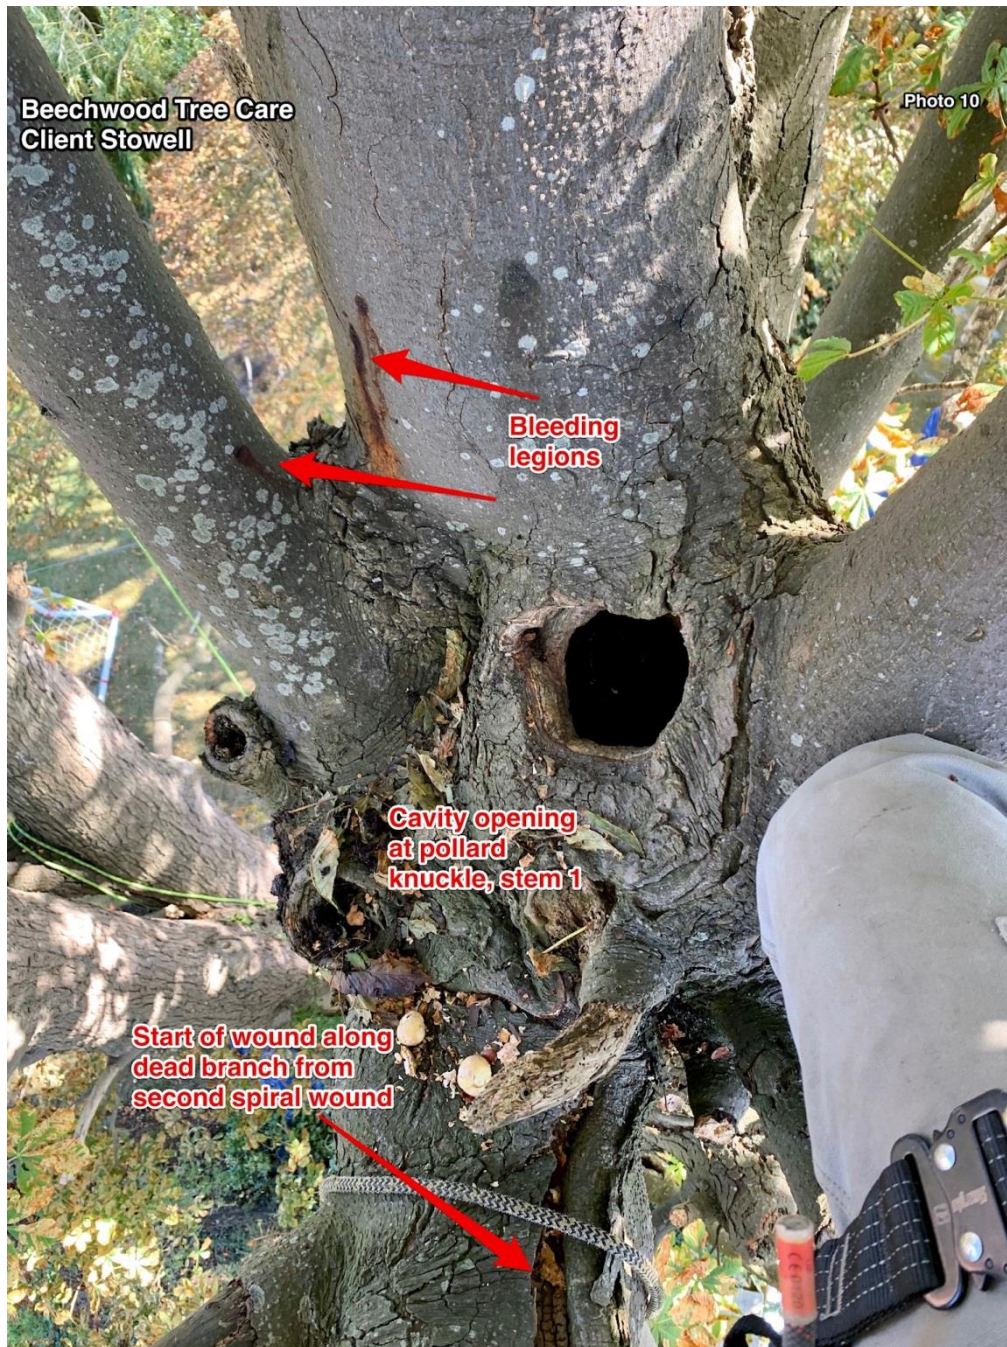
Photo 10 (picture of top of pollard knuckle on stem 1)

- The pollard knuckle has a large open cavity which extends down 400-500mm in cone like shape. This cavity was full of detritus, so it was hard to confirm the full size (photo 10).

The cavity at the pollard knuckle undermines the structural integrity of the stems emanating from the pollard knuckle.

Re pollard at previous pollard knuckle, leaving 100-150mm stubs to aid regrowth.

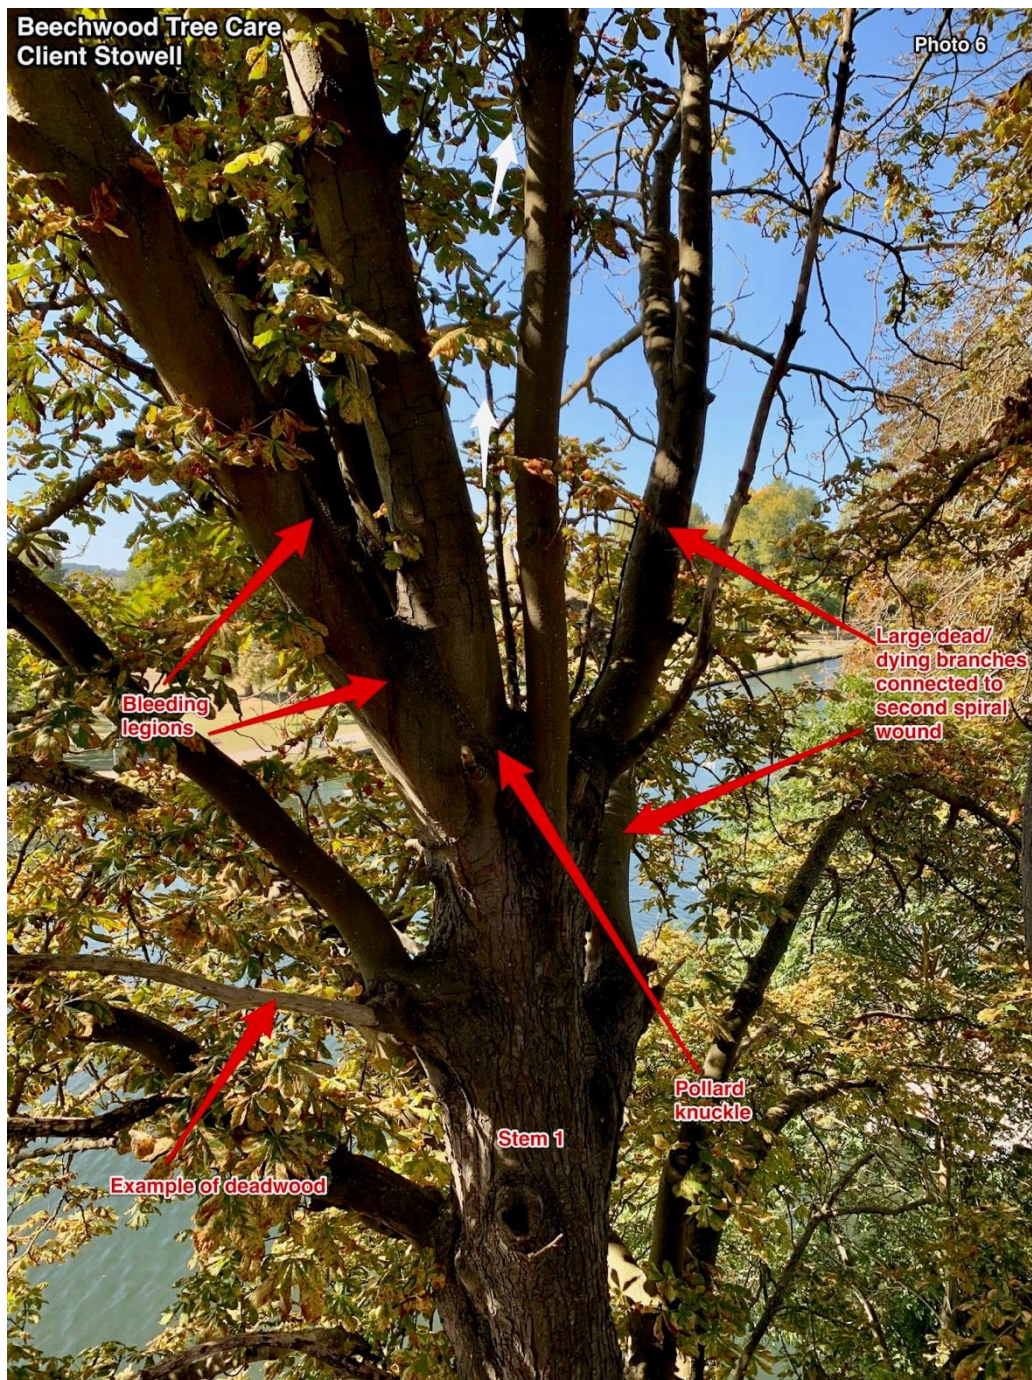
Photo 6 (picture of pollard knuckle on stem 1)

- Several of the stems emanating from the pollard knuckle have bleeding lesions (photo 6&10)

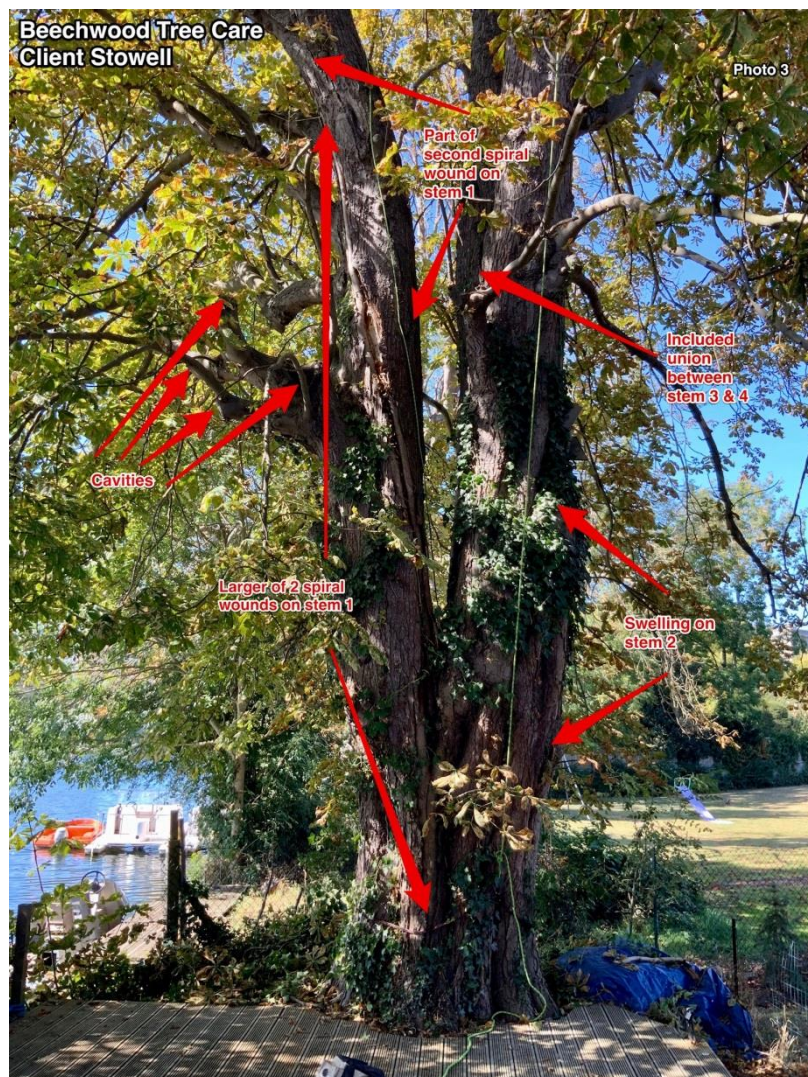
Photo 3 (picture of defects in lower stem)

- The lower section has numerous occluded wound from previously removed branches.
- The stem swells significantly and contains lots of areas of reaction growth (photo 3).
- There is a spiral wound, similar to the two on stem 1 but not as bad, which continues up stem 4 (photo 11).

There is an indication of a significant amount of dysfunctional and possibly decayed wood associated with previous damage and pruning.

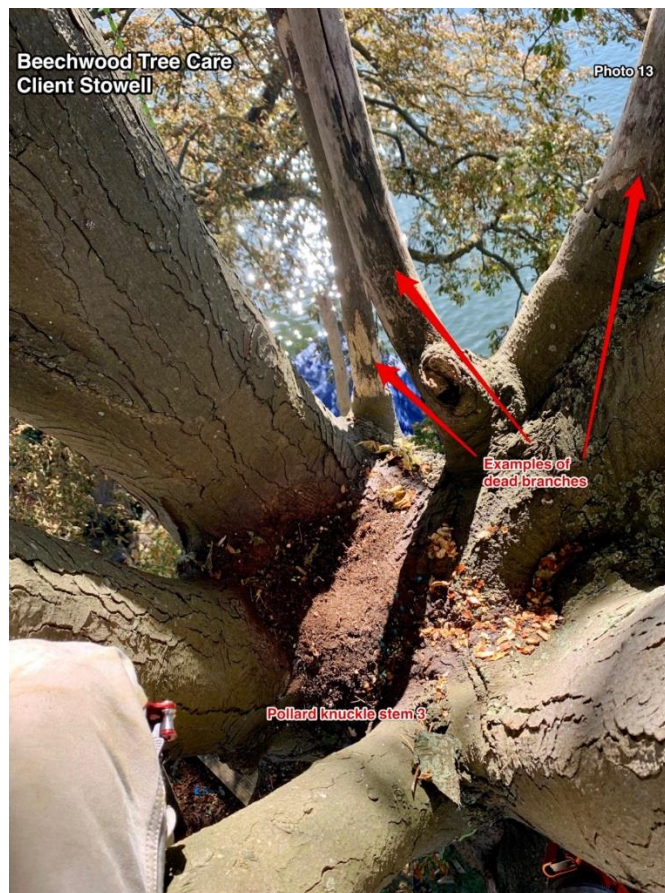
Photo 13 (picture of top of pollard knuckle on stem 3)

- There is a included union between this stem and stem 4 (photo 3)
- There are significant dead branches within the canopy.
- There was no notable decay or cavity at the pollard point however it should be noted that this is still a potential weak point (photo 13)

Whilst there are defects associated with this stem nothing, other than the deadwood, to warrant concern that this stem or part of it could fail. It should be noted that proposed pruning of stems 1 & 4 will open up this stem to new and significant wind loading, meaning failure is far more likely.

Re pollard at previous pollard knuckle, leaving 100-150mm stubs to aid regrowth.

Remove major deadwood, i.e. branches over 50mm at source and over 300mm in length.

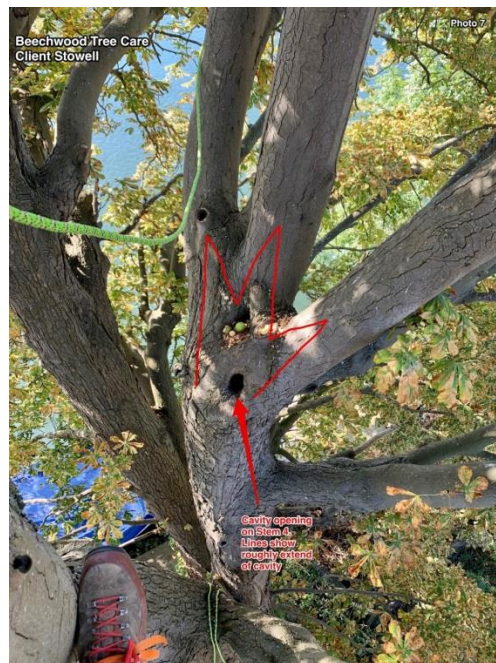
Photo 7 (picture of pollard knuckle on stem 4, showing the approx. extent of the cavity)

- There is a included union between this stem and stem 4 (photo 3)
- There is a similar spiral wound to the two found on stem 1, that leads to the pollard knuckle (photo 11)
- The pollard knuckle has a large open cavity which extends up the branches which emanate from the pollard knuckle. This cavity has a relatively small opening so it was hard to confirm the full size (photo 7).

The cavity undermines the structural integrity of the stems emanating from the pollard knuckle.

The significant extent of the cavity warrants concern that the stems above it could fail.

Re pollard at previous pollard knuckle, leaving 100-150mm stubs to aid regrowth.

Remove major deadwood, i.e. branches over 50mm at source and over 300mm in length.
