**Pavilion at Mapledurham Playing Fields  
Upper Woodcote Road  
Caversham  
Reading  
Berkshire  
RG4 7LB**

## **Preliminary Bat Roost Assessment**

**Ref: R2416/a**

**November 2019**

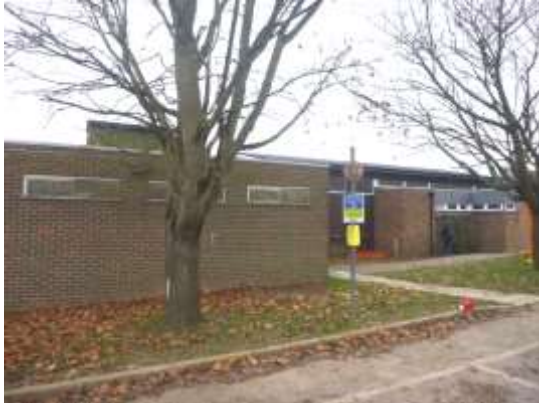
- 3.2.1** The pavilion was of simple brick wall construction with a part pitched roof with flat roofed extensions at either end of the building (**Photographs 1 & 2**).

**1. Front of the pavilion viewed from the north**

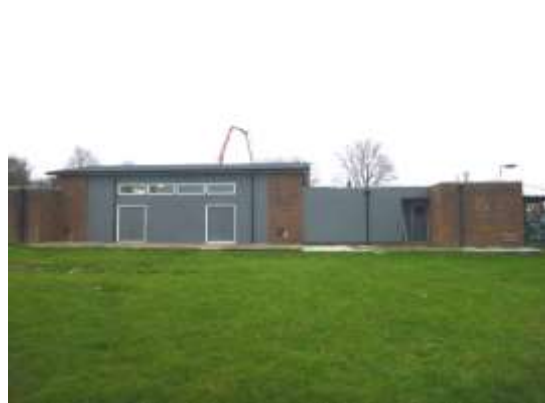
**2. Rear of the pavilion viewed from the south**

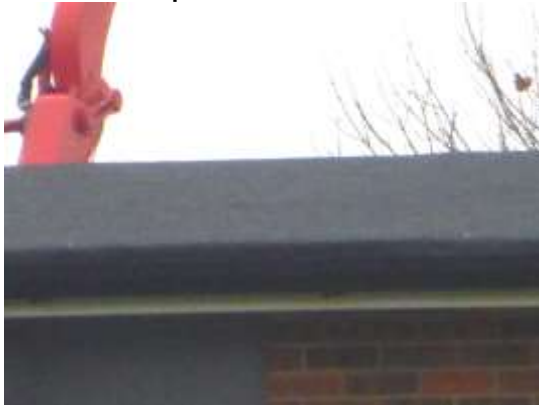
- 3.2.2** The main pitched roof was covered in bitumen felt, which was mostly flat and fitted tightly (**Photograph 3; Target note 1**). The soffits were tight at the eaves to the front and rear of the building (**Photograph 4; Target note 2**). The gable ends were clad with interlocking, flat vertical timber boards, which were tightly fitted at the east facing gable end, apart from superficial gaps behind the soffit which offered limited roosting opportunities for bats as further timber was visible behind (**Photograph 5; Target note 3**). A couple of gaps in the cladding were present at a low level close to the flat roof at the west facing gable end (**Photographs 6 & 7; Target note 4**). On close inspection with an endoscope there was no evidence of use by bats behind the cladding. The soffits fitted to the timber cladding had a very superficial; gap that provided no opportunities suitable for bats. The two flat roofs at either end of the building were lined tightly with bitumen felt with a layer of gravel on the top and a metal trim around the eaves (**Photographs 8, 9 & 10; Target notes 5 & 6**).

**3. The central pitched roof tightly covered with bitumen felt**

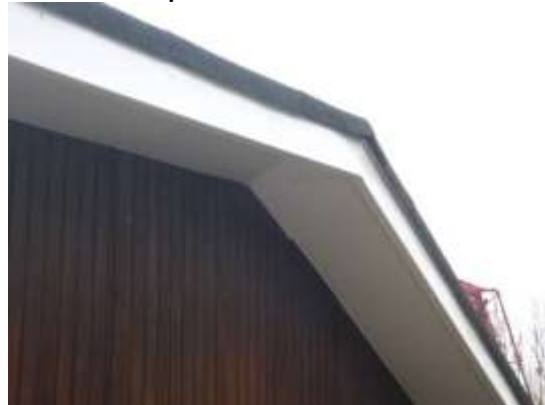
**4. Timber cladding tight at the eastern end of the pavilion. Further timber visible behind a gap between the soffit and the cladding.**

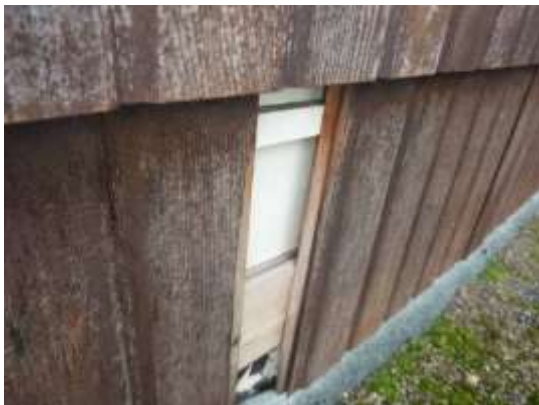
- 4.1.1** The pavilion had a few features of low potential for use by crevice-dwelling bat species such as the pipistrelles (*Pipistrellus* spp.) and/or small *Myotis* species including gaps behind the timber cladding on the west facing gable end, the gap behind the timber door frame, a gap behind a hanging tile, and gaps behind the boarded windows. On close inspection of all of these features, there was no evidence of use by bats. Furthermore, internally, no bat droppings were found inside the building, and therefore it is considered unlikely that the building supports roosting bats currently.

**5. Gaps where some of the timber cladding was missing at the western end of the pavilion**

- 4.3.1** The building work will be preceded by a repeat endoscopic inspection of the features with bat roost potential including the gaps behind the timber cladding on the west facing gable end, the gap behind the timber door frame, a gap behind a hanging tile, and gaps behind the boarded windows for the presence of bats by a licensed ecologist. In the unlikely event that bats are found, the work will begin only once a licensed ecologist has provided further written advice on how to proceed. At this point, a European Protected Species mitigation licence or confirmation of the site's registration under the Bat Mitigation Class Licence CL21 (if applicable) may be required to permit the work to continue lawfully.

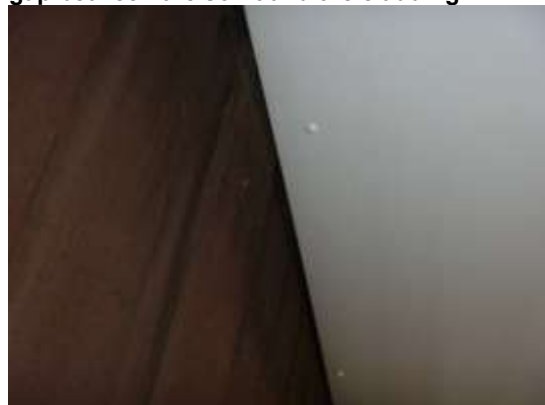
**6. Superficial gap between the cladding and the soffit at the western end of the pavilion**

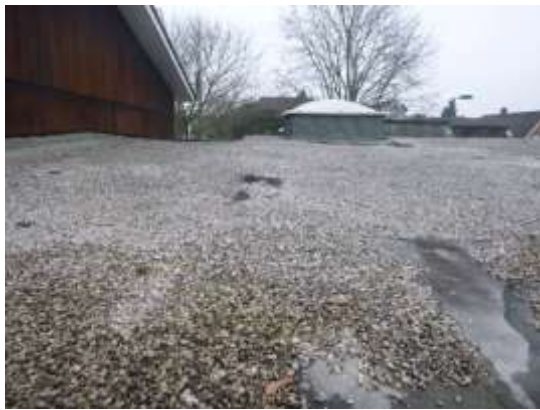
**7. Flat roof at eastern end of the building covered tightly with bitumen felt and gravel**

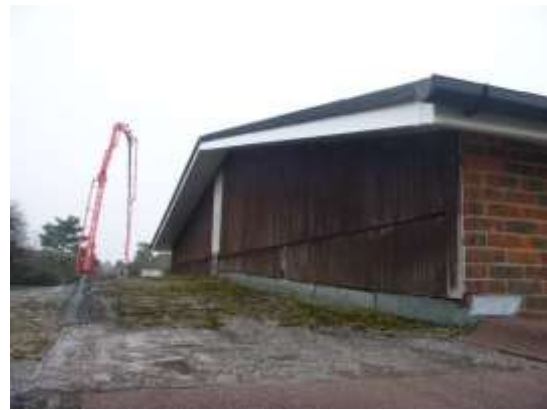
**8. Flat roof at western end of the building covered tightly with bitumen felt and gravel**

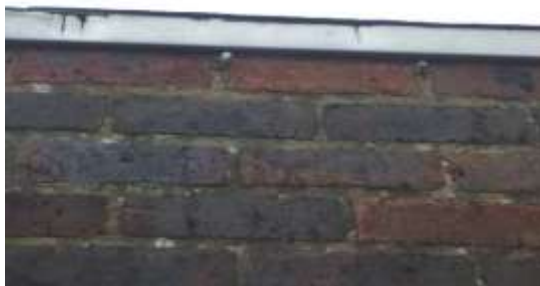
**9. Metal trim tight around the flat roof**

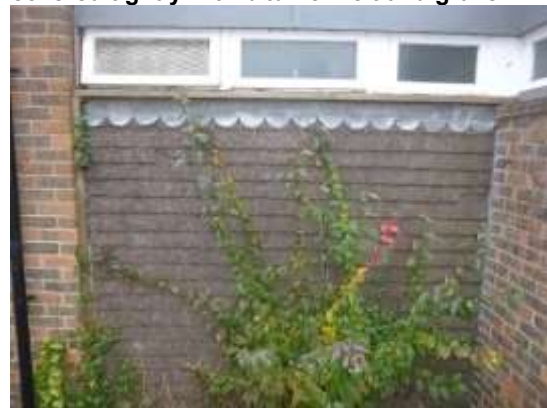
- 3.2.3** A couple of sections of the wall were clad with hanging tiles to the front (northern side) of the building and at the eastern end under a corrugated metal canopy (**Photographs 10, 11 & 12**). The hanging tiles were mostly tightly fitted, apart from one gap which was full of leaves to the front of the building, and where the lead flashing was loose or missing, which on close inspection showed no evidence of use by bats (**Target notes 7, 8 & 9**). Some other sections of the walls were covered with wooden boarding which was tightly fitted (**Photograph 13; Target note 10**). A gap was present behind a door frame and the brickwork at the western end of the building, which led into a crevice that on close inspection with an endoscope showed no evidence of use by bats (**Photograph 14; Target note 11**). There was also a small section of roof tiles which had gaps between them, which showed no evidence of use by bats and was also considered unsuitable as it was very open

**10. Hanging tiles at the western end to the front of the pavilion with vegetation covering some of the tiles**

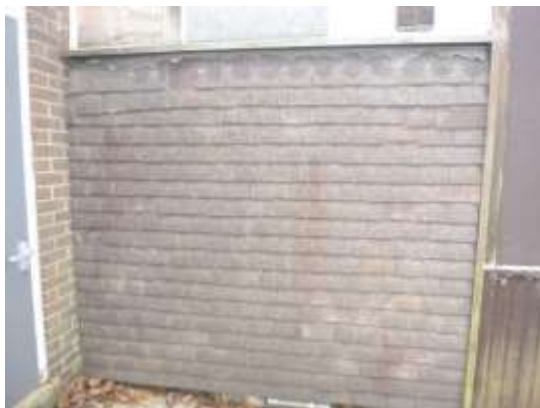
**11. Hanging tiles at the eastern end to the front of the pavilion with lead flashing missing and one lifted tile filled with leaves**

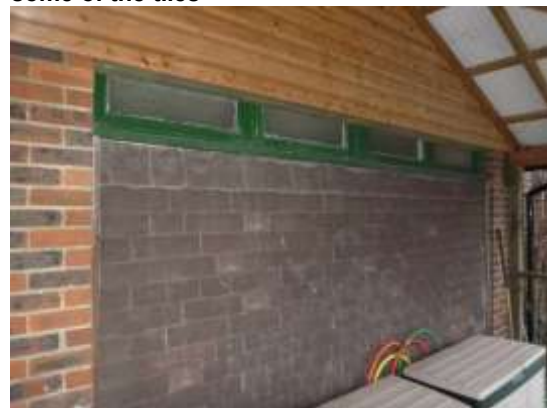
**12. Hanging tiles under the canopy to the eastern side of the pavilion**

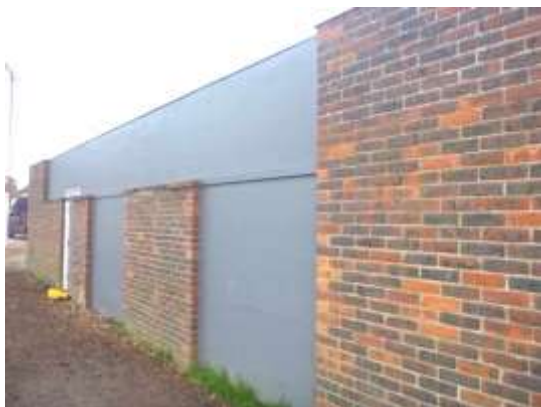
**13. Wooden boards covering parts of the pavilion**

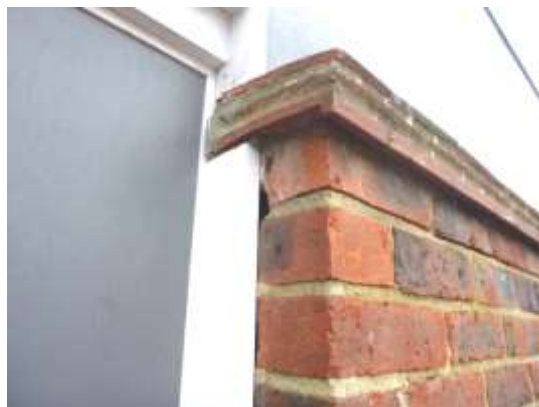
**14. Gap behind timber door frame at the western end of the pavilion**

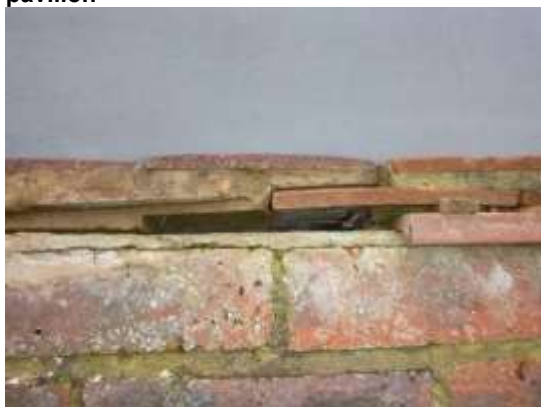
and did not lead into crevices (**Photograph 15; Target note 12**). Some of the windows had been boarded up, which were mostly tight apart from a couple of gaps to the front of the building where they were loose and between the glass and a section of cladding at the eastern end of the building, which were also checked with an endoscope and showed no evidence of use by bats (**Photographs 16 & 17; Target notes 13 & 14**).

**15. Gaps under a small section of roof tiles at the western end of the pavilion**

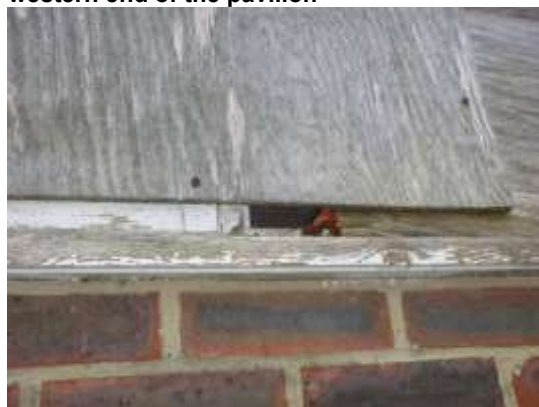
**16. Gap behind boarded window to the front of the pavilion**

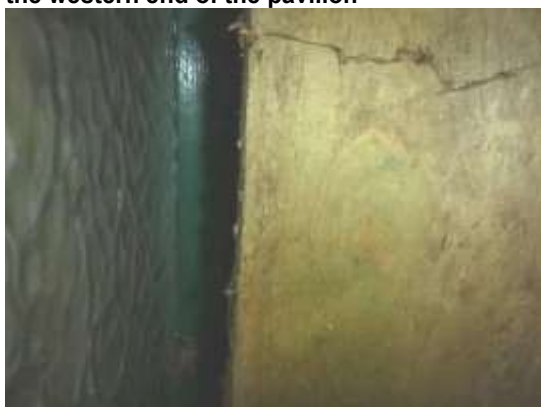
**17. Gap between glass and boarding covering the windows to the eastern end of the pavilion**

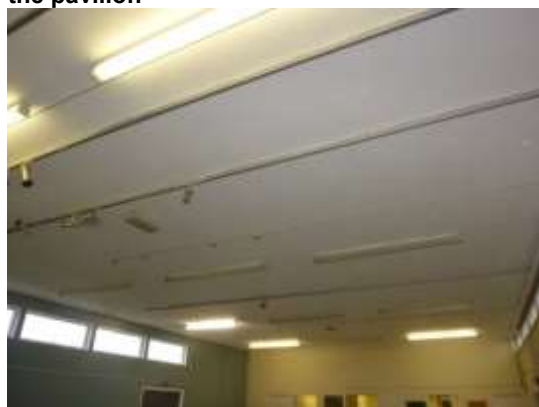
- 3.3.1** The pavilion had no roof spaces and all of the ceilings were plastered or boarded with no features suitable for roosting bats (**Photographs 18 & 19; Target note 15**). No signs of roosting bats were found in the pavilion during the internal inspection.

**18. Internal view of the main central pitched roofed section of the pavilion with no access to a roof space**
