### **Picus Sonic Tomographic Test Report** **13 Kendrick Road Reading.**

#### **1.6 T1 London Plane.**

#### **1.6 T3 Lime .**

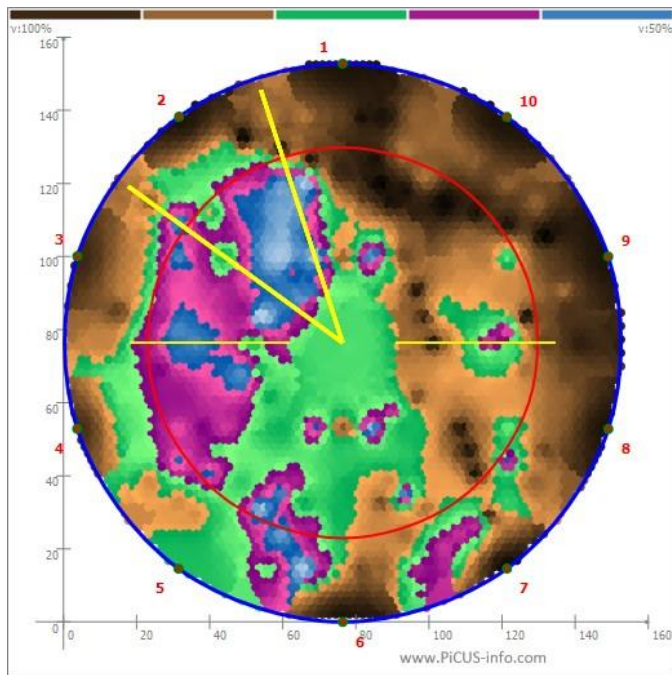
The measuring point readings give evidence of medium velocities overall show sound timber (see Picus sonic representation chart figure 2 and sonic tomographic image figure 1).

- **The resulting tomographic image shows altered timber in the lower stem/trunk area. Continue to monitor/ Remove Ivy completely from trunk and crown.**

- **The resulting tomographic image shows altered timber in the lower stem/trunk area. Continue to monitor/ Remove deadwood from the crown.**

Figure 1 Tomographic Images at 30cms Test 1 Plane and Test 2 Lime at 2m below.
