## INTRUSIVE SURVEY

Site Address: Queens Court, Reading RG1 7QF

Scope of survey: Remove panels and coping and assess secondary support, insulation and cavity barriers

Client: Hines PLC

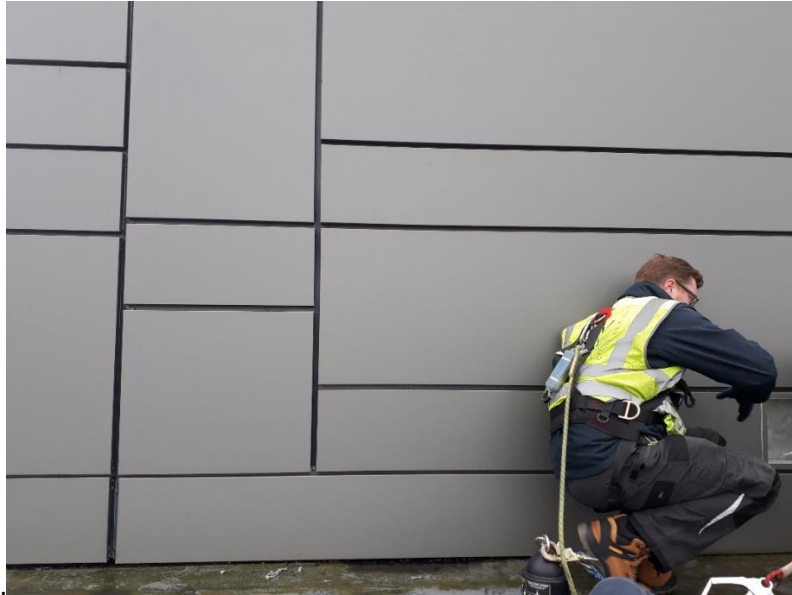
Photo of area prior to survey.

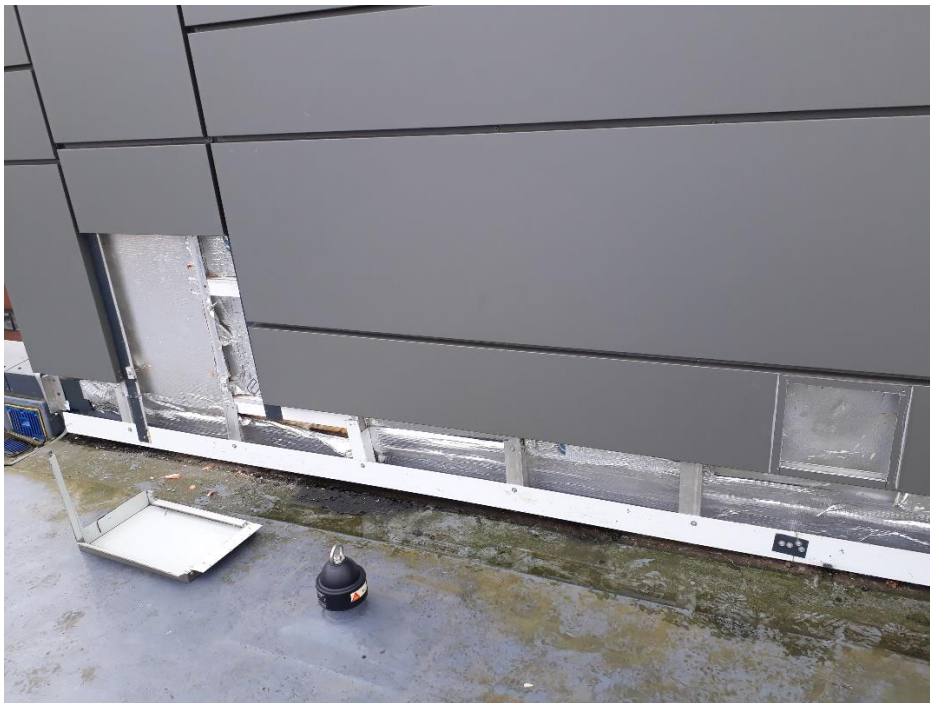
Panels removed A147, H103, H105, H107 and part H107 above.

The panels were observed to be ACM rainscreen panels with an approx. 30mm fold on the top edge and an aluminium angle sitting inside the bottom return. The panels H103 and H107 had a site made angle attached to either side.

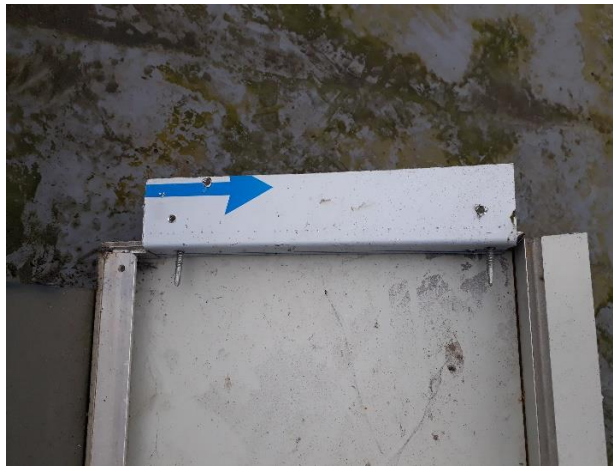
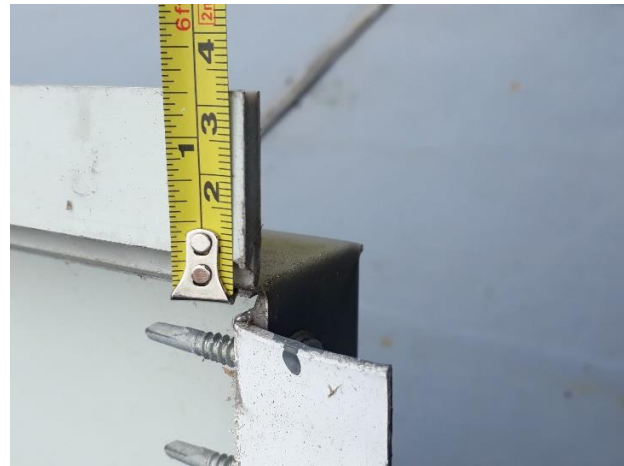
Panels H108 and H105 could not be removed as they were fixed on the top edge with rivets that sat underneath the panels above so no further areas could be exposed. Fixings along the folds were of random centres between 400mm - 650mm. The fixings were consistently self coloured dome head screws with sealing washers and appeared to be stainless steel. Rivets were also used in places.

The panels did not have any additional strengthening or anti-drumming features.

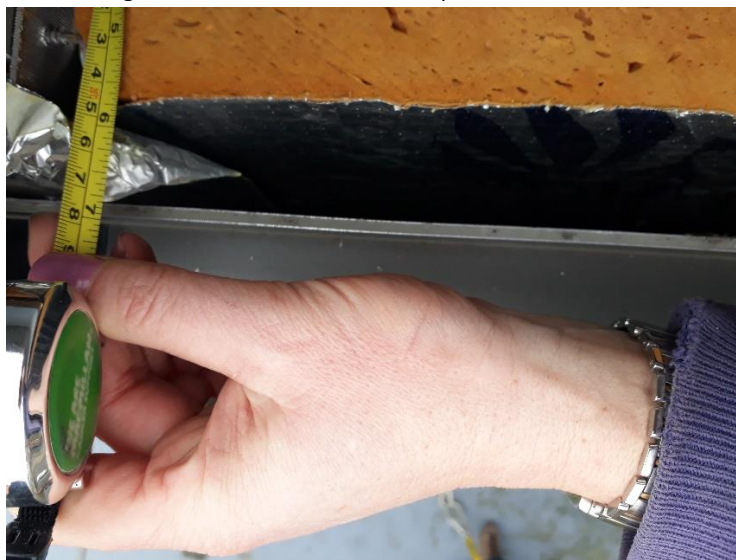
The existing external thermal insulation panels were observed to be 140mm Kooltherm K15 product by Kingspan.

The boards were observed to be installed with an insufficient number of fixings to secure the boards to the structure.

**It is recommended all insulation is installed as per manufacturers recommendations with at least 1 stainless steel anchor and washer per 1m<sup>2</sup> for fire safety and to maintain the correct air flow the cavity.**

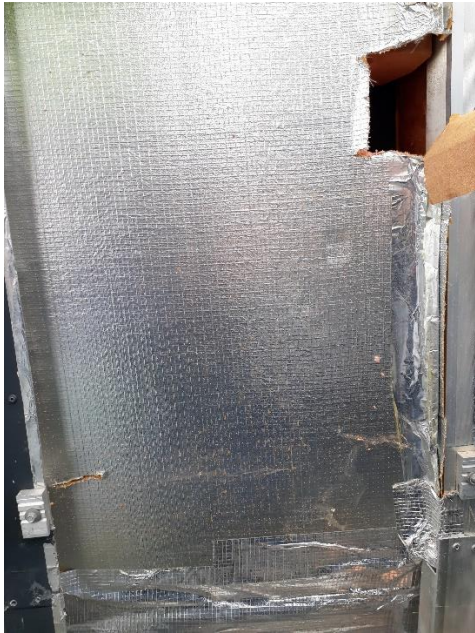
Where insulation anchors were present, there was one per board fixed with a plastic or nylon washer.

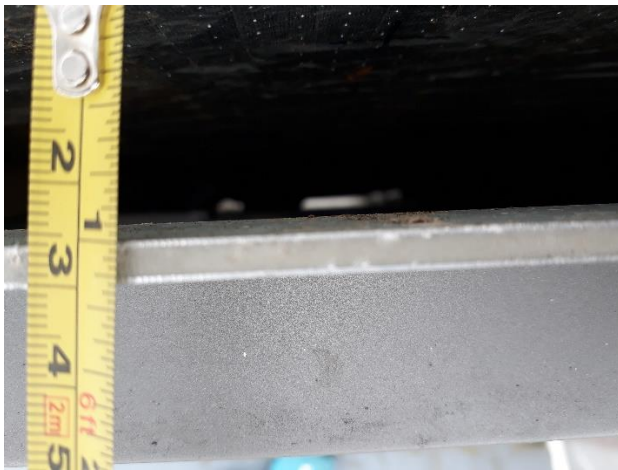
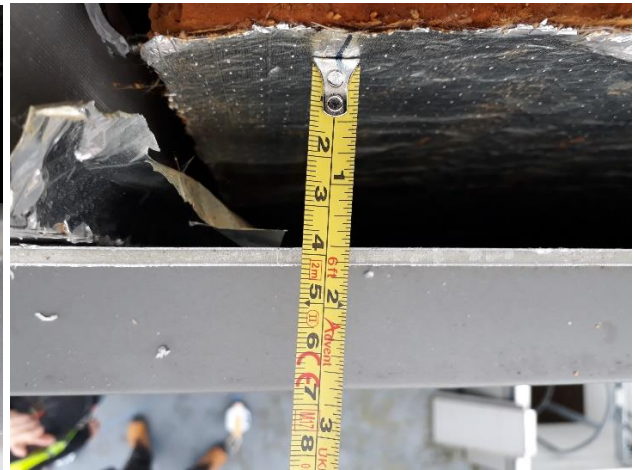
The insufficient fixings allowed the insulation to fall forward and the 40mm cavity was closed to approx. 25mm in places. See pictures below of the cavity with the insulation forward and then pushed back.

The insulation was originally taped to the carrier rails with silver foil tape but has subsequently come loose.

A minimum cavity depth of 25mm should also be observed throughout the rainscreen cavity including around heads and cills of the window openings and interface with copings and pressings.

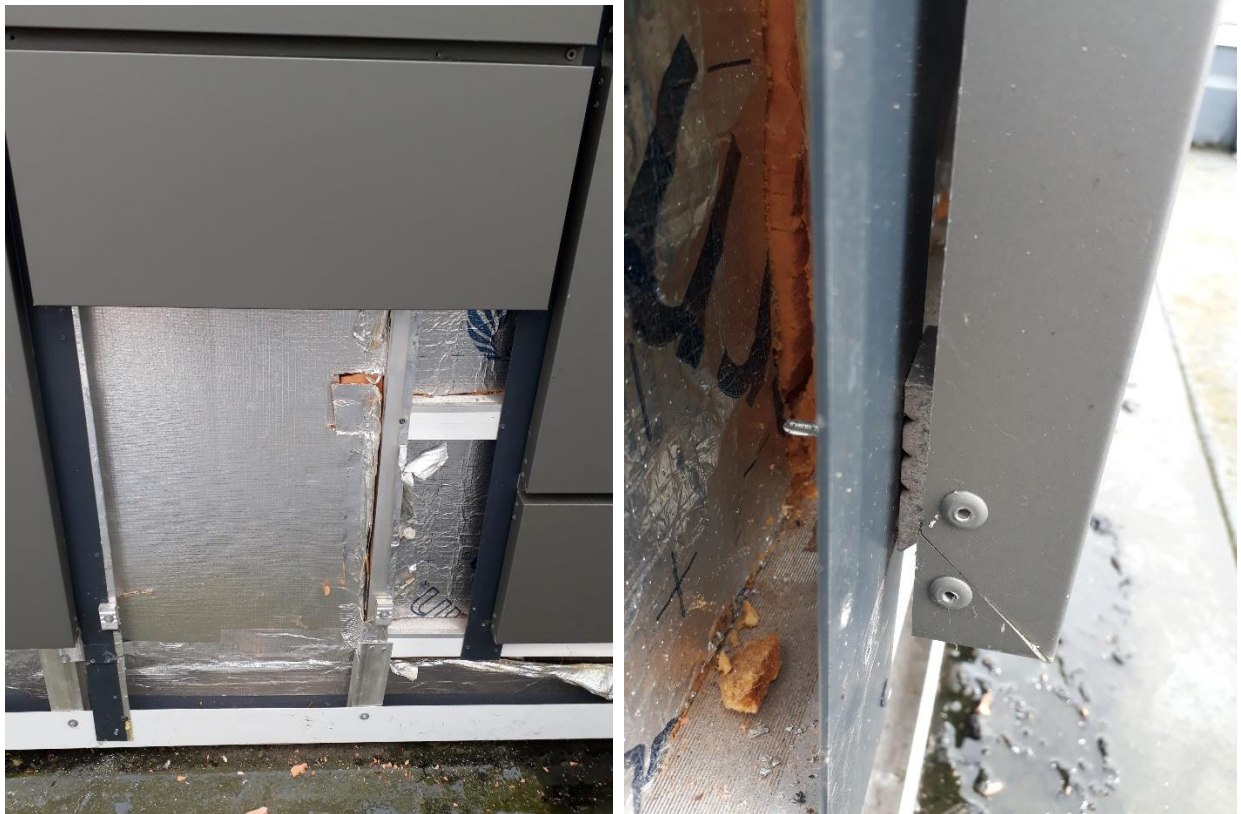
The panels edges did not always correspond with the carrier rails. The carrier rails had been extended with 2mm aluminum backing plates. The 2mm aluminum plate did not appear to be installed to negate deflection and may require an engineered solution.

**It is recommended that all secondary support system and replacement panels are designed so they are adequately fixed to the structure.**

**Minimum edge distances for fixing should be observed and thermal expansion should be allowed for at a minimum of 1mm per 1 linear metre.**

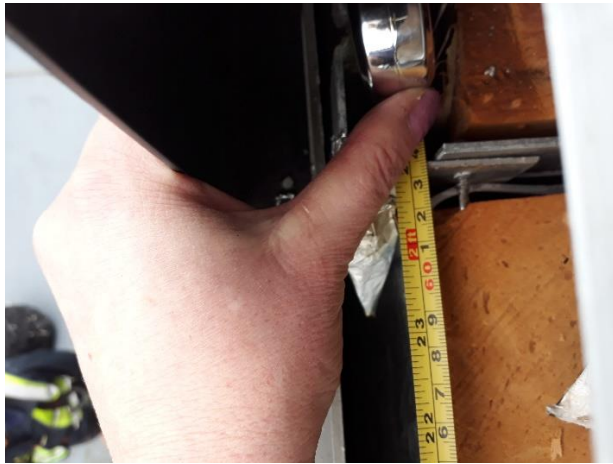
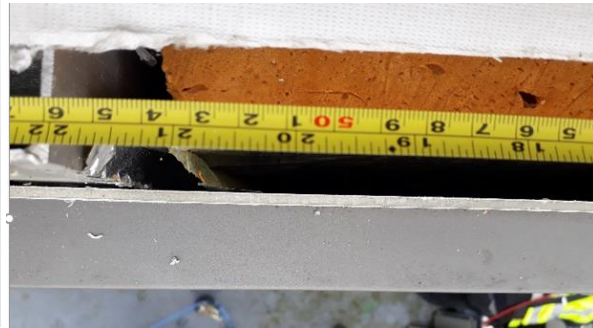
Carrier rails were 2.5-3mm aluminum fixed to 140mm helping brackets using 35mm hex head screws which appear to be stainless steel. The slotted retention bracket located at the lower portion of each panel appeared to be accurately located to ensure the panels were adequately retained. It was apparent that the carrier rails were fixed

at differing centres from 56cm to 64cm but we presume this is SFS structure. it is not evident whether the helping hands are fixed directly to the SFS structure.

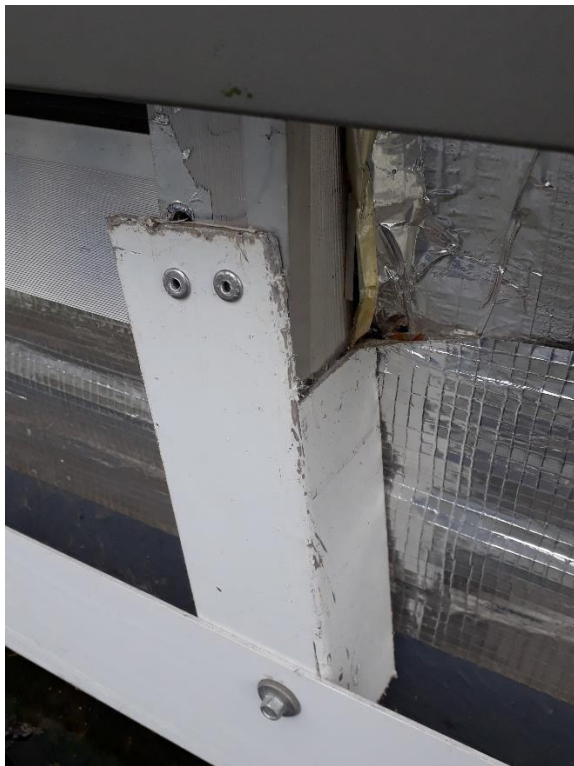
The carrier rails had been extended to carry the bottom panels with various pieces of aluminum and a combination of rivets and hex head fixings.

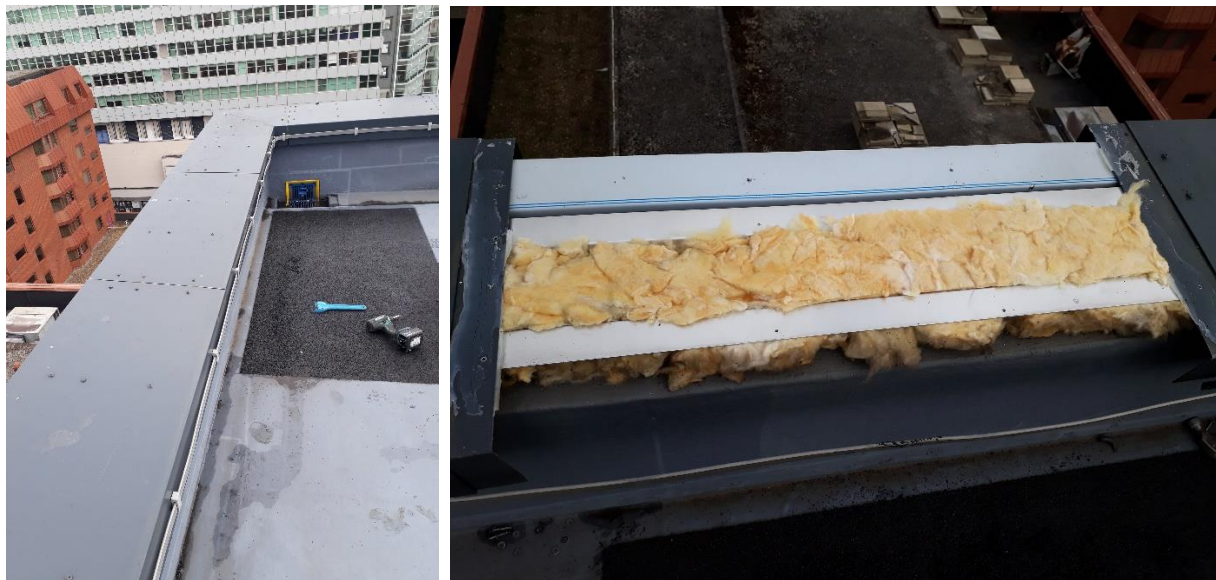
The coping removed was located on line of section D-D on drawing C3682-E039 above panels H100 & H101.

The copings appear to be 3mm aluminum faced fixed with dome head fixings with self seal washers which appeared to be stainless steel. They were installed on a continuous tray filled with rock wool over the roof membrane and on top of a 18mm plywood. The airgap appeared to be sufficient to allow air flow to ventilate the cavity as required. No insect mesh was present.

Numerous screws were raised from face of the coping. This could be due to thermal expansion, vibration or incorrect installation.

**It is recommended that the coping be checked and designed to accommodate thermal expansion.**
