## 5 DISCUSSION

### 5.2 Office Block - Spalling of concrete and reinforcement corrosion

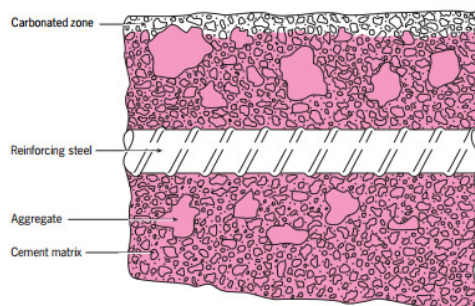
**Figure 3** Diagrammatic view of steel protected from carbonation-induced corrosion in partially carbonated concrete

- 5.2.1 The office block has concrete elements exposed on the external rear elevations. These exposed elements include lintols above windows and beams at floor levels. The beams are rendered.
- 5.2.2 In many cases, spalling of the concrete has occurred. The spalling of the concrete is due to the corrosion of the embedded reinforcement (or steel section), in turn occurring due to a process called 'Carbonation'. Carbonation occurs when the carbon dioxide in the atmosphere mixes with moisture and penetrates the concrete. When the carbonation front reaches the embedded reinforcement, the normal protective alkalinity of the concrete is neutralised. The reinforcement then corrodes, expands and causes the concrete cover to spall.
- 5.2.3 Below are sketches showing the carbonation process:

5.2.5 It should be expected that cracking and spalling will be ongoing as the carbonation process is also ongoing. Therefore, repairs will be necessary from time to time. The repairs will involve the removal of loose concrete, treatment of the reinforcement and the application of a repair mortar such as Fosroc Renderoc HB. To match the existing, a cosmetic render can be applied thereafter.

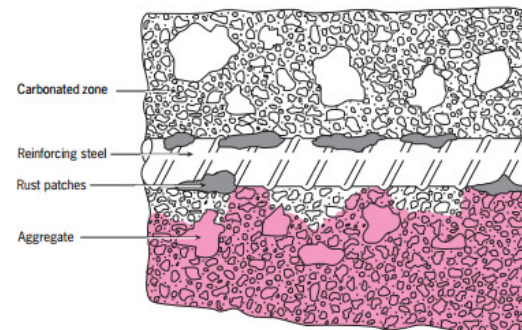
**Figure 4** Diagrammatic view of steel corroding in carbonated concrete

- 5.2.4 The beams appear to have been rendered, but the render has suffered from extensive cracking. The cracking may be due to shrinkage of the render, but where vertical, the cracking may also be due to the corrosion of the reinforcement links in the beams. Where the concrete and/or render have been repaired, cracking has occurred again in certain locations. In certain locations, the spalled concrete appears loose and needs to be dealt with urgently.

5.2.6 We also recommend that concrete tests, to include carbonation, chlorides and measurement of cover are undertaken in order to inform the future maintenance regime.

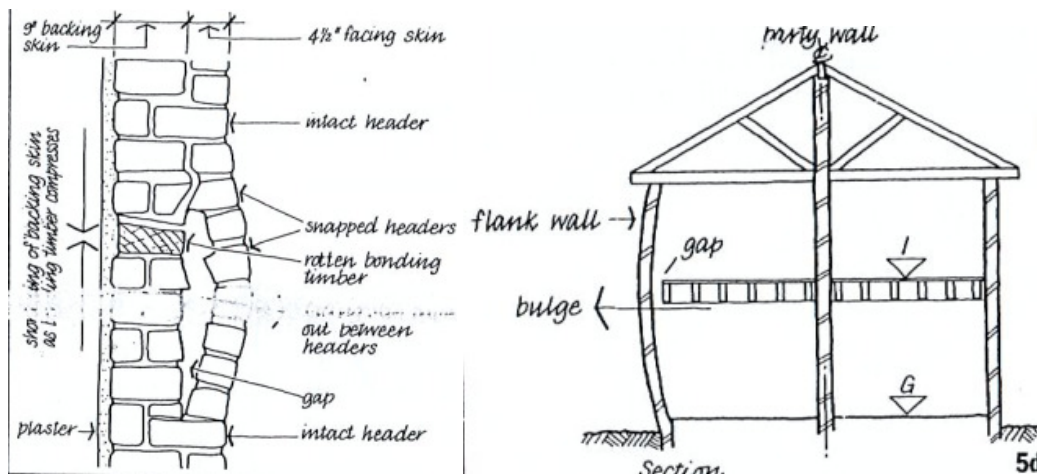
- 5.6.3 Sketches illustrating the wall movement:

- 5.6.1 This part of the building is occupied by a dental practice. The flank wall (east side) of the building at second floor and towards the front of the building has suffered from substantial outward movement.

- 5.6.2 We believe that there are two mechanisms in play:
- Firstly, there is a localised outward bulge at the level where the roof meets the wall. We believe that this distortion is due to the deterioration of the embedded timber wall plate supporting the roof. Below is a sketch which illustrates this movement, although the sketch shows a gap forming in the wall, which may not be the case here.

- Secondly, a large portion of this wall has bulged out. We believe that this is due to a lack of tie or restraint to the wall. Below is a sketch which illustrates this movement – the gap shown between the wall and the floor may not be present here.

- 5.6.4 The outward bulge of the wall and lack of tie / restraint may have resulted in the instability of the wall. We recommend that the condition of the timbers and tying provisions are investigated. This is likely to require intrusive investigations internally. The remedial works will depend on the findings of the investigation works.
