**PHASE 1 ENVIRONMENTAL INVESTIGATION  
NO 4178/19  
GARAGES AT 14-16, ELDON TERRACE,  
READING, BERKSHIRE  
FOR  
PROPOSED HOUSING DEVELOPMENT**

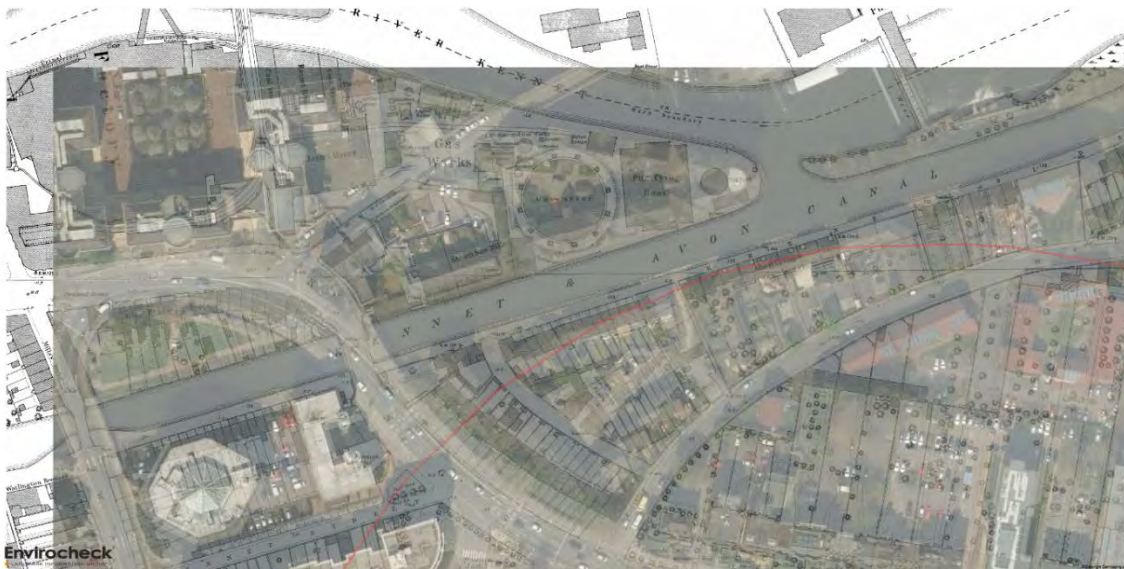
*Above, an overlay of the 1879 town map and a 2019 aerial picture of the gas works about 300m north west of the site.*
