**Happy Drains Ltd**

Ref C0010505

Date 29<sup>th</sup> May 2019

**Project Description:** General CCTV

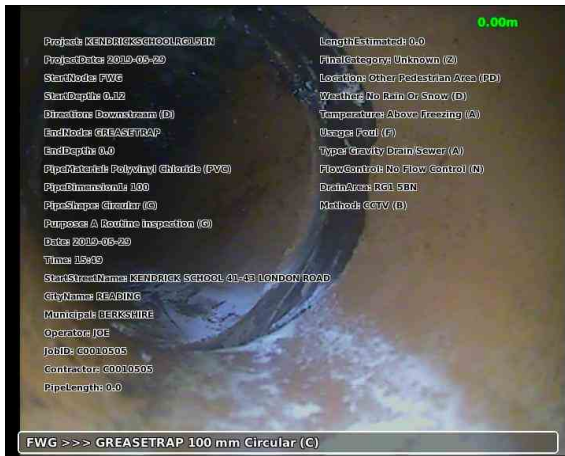
20190529-155231-snap0000.jpg, 00:00:02, 0.00 m  
Start node type, gully, reference number: FWG

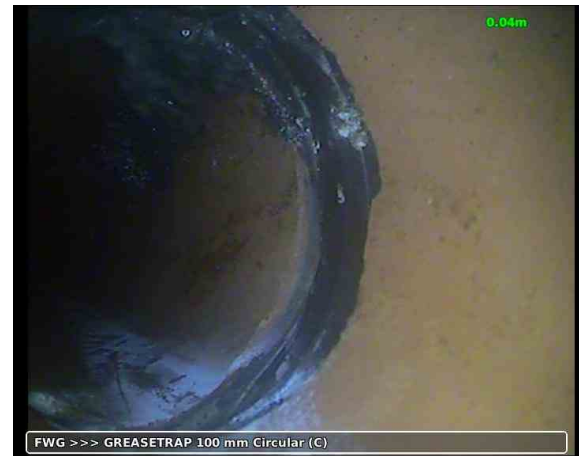
20190529-155231-snap0001.jpg, 00:00:15, 0.04 m  
Line deviates left

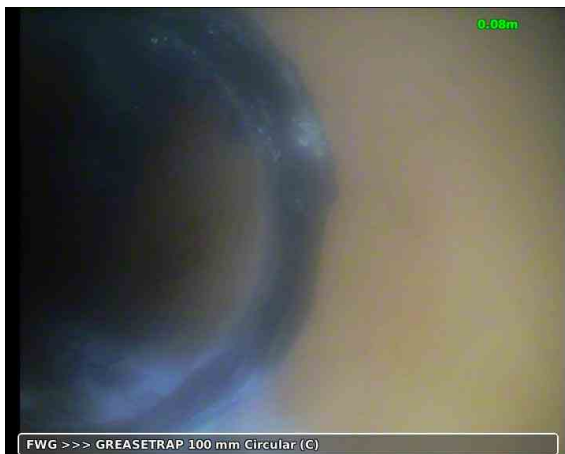
| No. | m+ | Code | Observation |
|---|---|---|---|
| 4 | 0.08 | SA | Survey abandoned, WOULD NOT TRAVERSE AROUND CORNER |

20190529-155231-snap0002.jpg, 00:00:40, 0.08 m  
Survey abandoned, WOULD NOT TRAVERSE AROUND  
CORNER

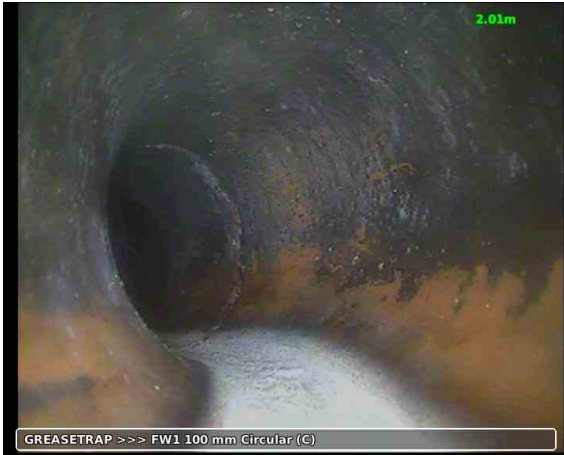
20190529-155647-snap0000.jpg, 00:00:19, 2.01 m  
Line deviates left

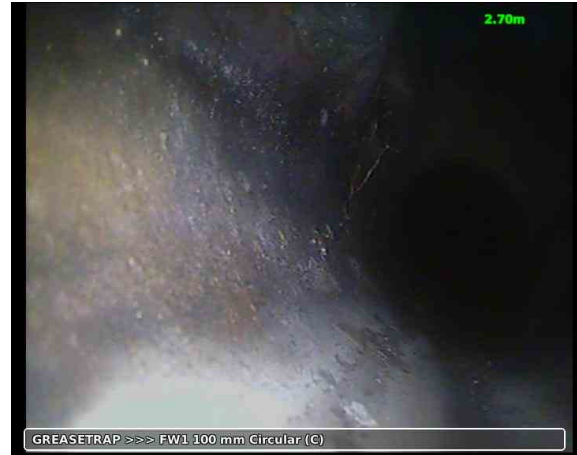
20190529-155647-snap0001.jpg, 00:00:28, 2.70 m  
Finish node type, manhole, reference number: FW1

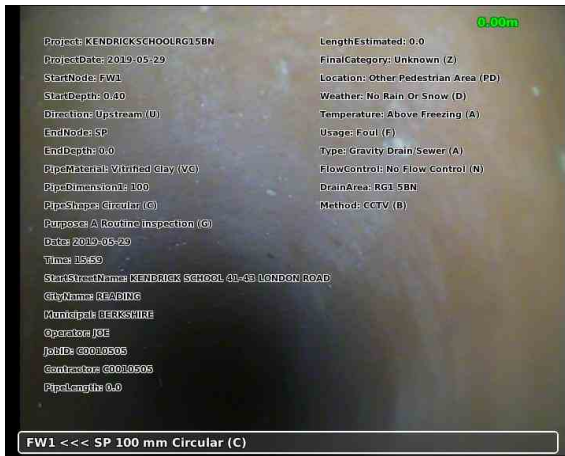
20190529-160652-snap0000.jpg, 00:00:01, 0.00 m  
Start node type, manhole, reference number: FW1

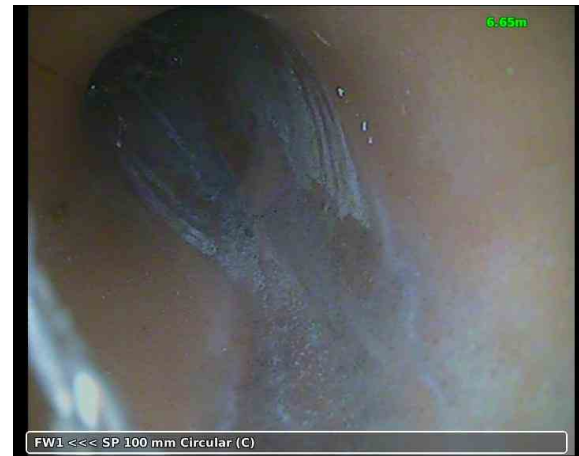
20190529-160652-snap0001.jpg, 00:00:32, 6.65 m  
Line deviates up

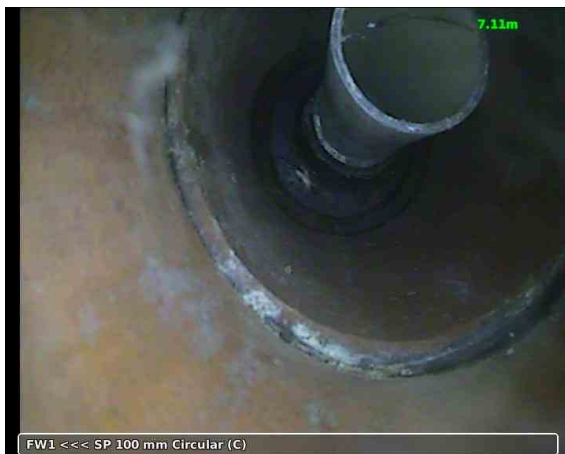
20190529-160652-snap0002.jpg, 00:00:40, 7.11 m  
Finish node type, manhole, reference number: SP

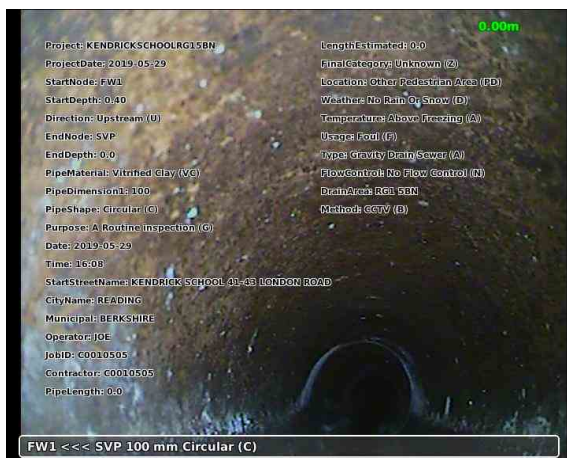
20190529-160922-snap0000.jpg, 00:00:01, 0.00 m  
Start node type, manhole, reference number: FW1

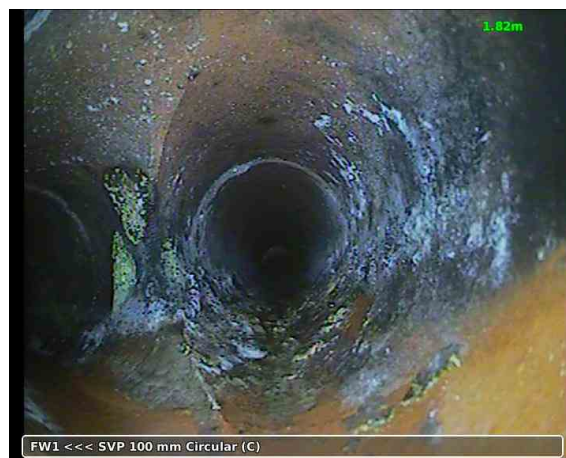
20190529-160922-snap0001.jpg, 00:00:13, 1.82 m  
Junction, at 09 o'clock, diameter: 100 mm

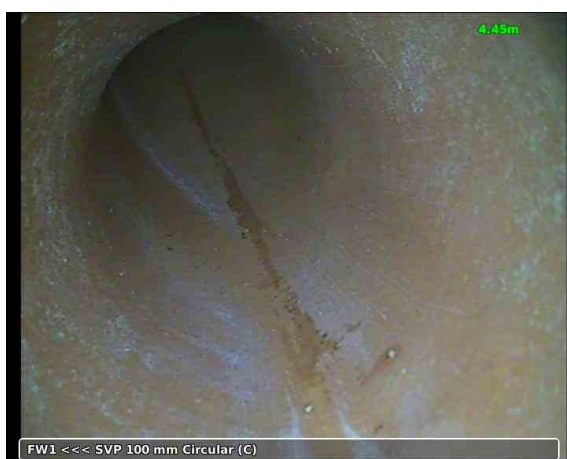
20190529-160922-snap0002.jpg, 00:00:31, 4.45 m  
Line deviates up

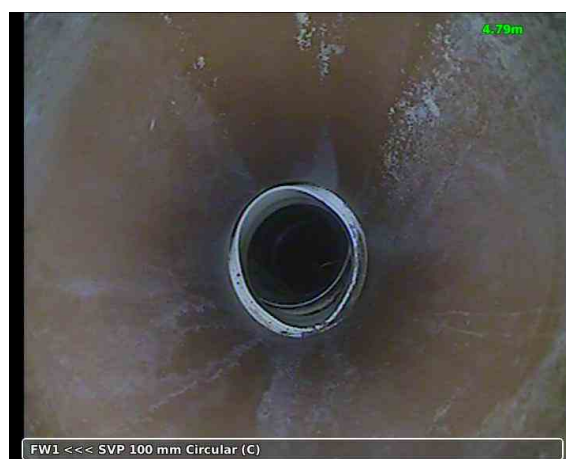
20190529-160922-snap0003.jpg, 00:00:37, 4.79 m  
Finish node type, manhole, reference number: SVP

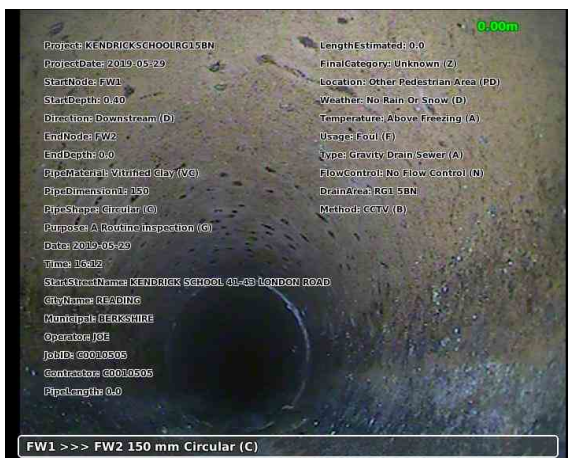
20190529-161316-snap0000.jpg, 00:00:01, 0.00 m  
Start node type, manhole, reference number: FW1

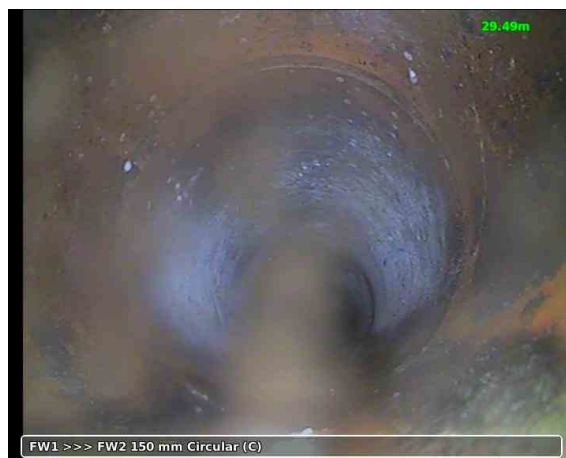
20190529-161316-snap0001.jpg, 00:01:19, 29.49 m  
Line deviates down

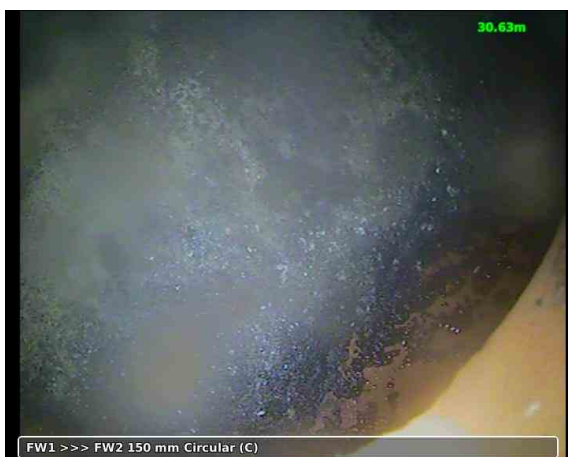
20190529-161316-snap0002.jpg, 00:01:30, 30.63 m  
Finish node type, manhole, reference number: FW2

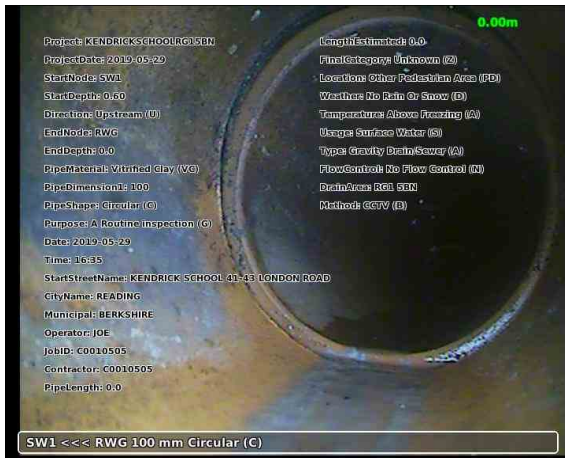
20190529-163553-snap0000.jpg, 00:00:00, 0.00 m  
Start node type, manhole, reference number: SW1

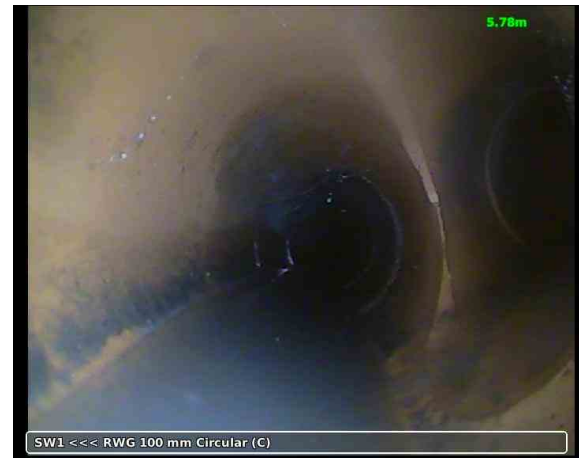
20190529-163553-snap0002.jpg, 00:00:35, 5.78 m  
Junction, at 03 o'clock, diameter: 100 mm, RWP

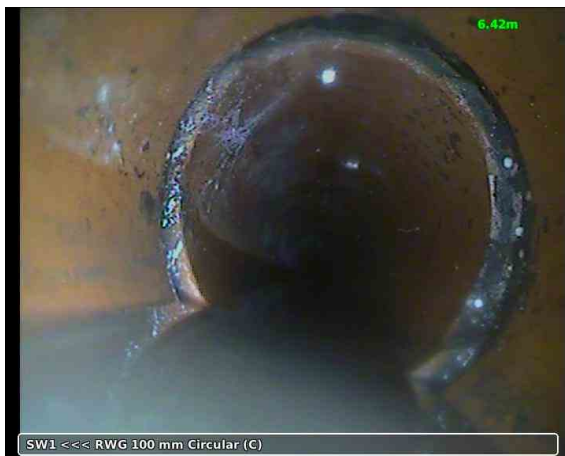
| No. | m+ | Code | Observation |
|---|---|---|---|
| 4 | 6.42 | JDM | Joint displaced, medium |

20190529-163553-snap0003.jpg, 00:00:54, 6.42 m  
Joint displaced, medium

**Repair 3)** – Section 6 - Install a 100mm diameter by 600mm long silicate patch repair at 6.4m upstream from Sw1 between Sw1 to Rwp

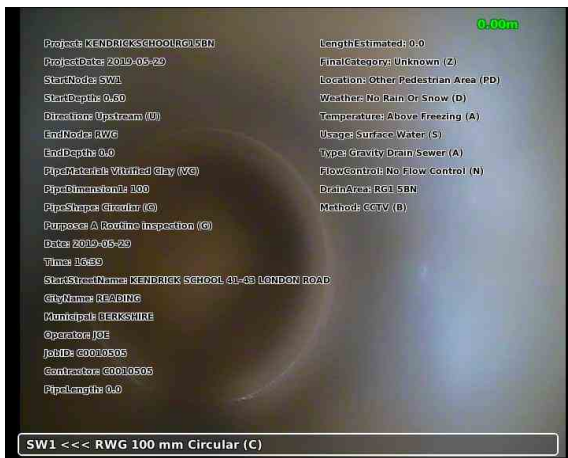
20190529-163921-snap0000.jpg, 00:00:01, 0.00 m  
Start node type, manhole, reference number: SW1

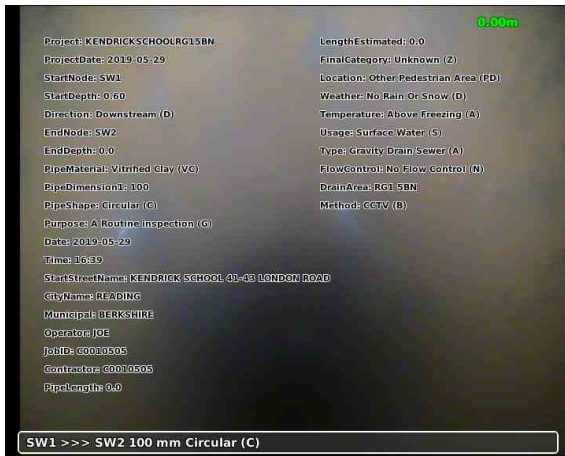
20190529-164119-snap0000.jpg, 00:00:01, 0.00 m  
Start node type, manhole, reference number: SW1

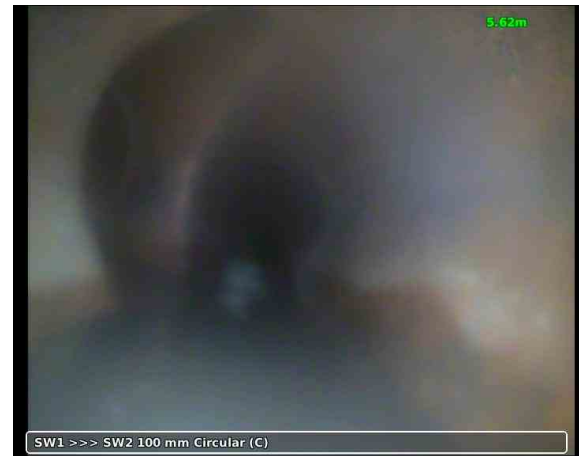
20190529-164119-snap0001.jpg, 00:00:22, 5.59 m  
Junction, at 09 o'clock, diameter: 100 mm

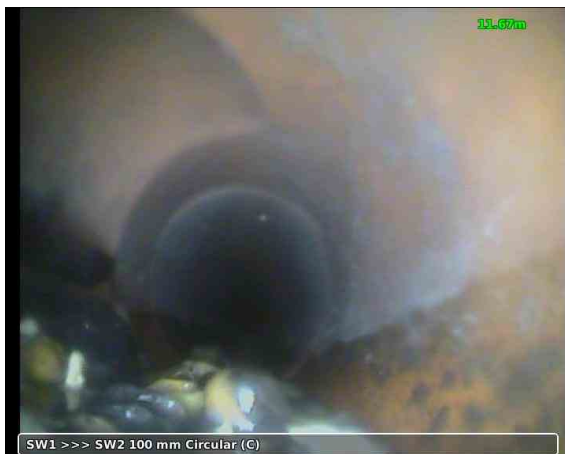
20190529-164119-snap0002.jpg, 00:00:48, 11.67 m  
Junction, at 09 o'clock, diameter: 100 mm

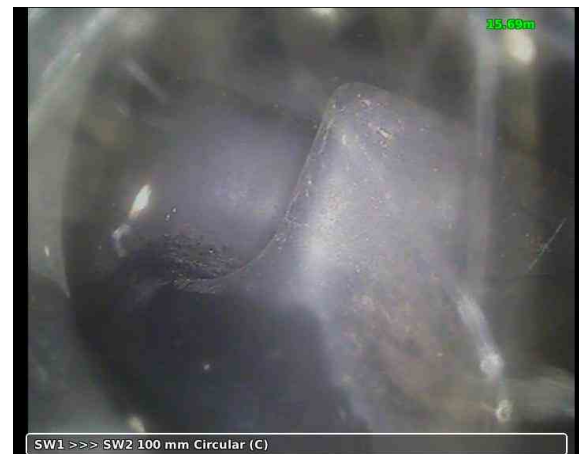
20190529-164119-snap0003.jpg, 00:01:08, 15.69 m  
Finish node type, manhole, reference number: SW2

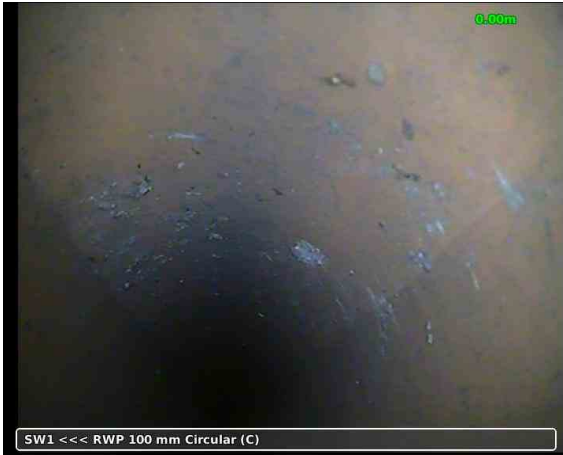
20190529-164610-snap0000.jpg, 00:00:02, 0.00 m  
 Start node type, manhole, reference number: SW2

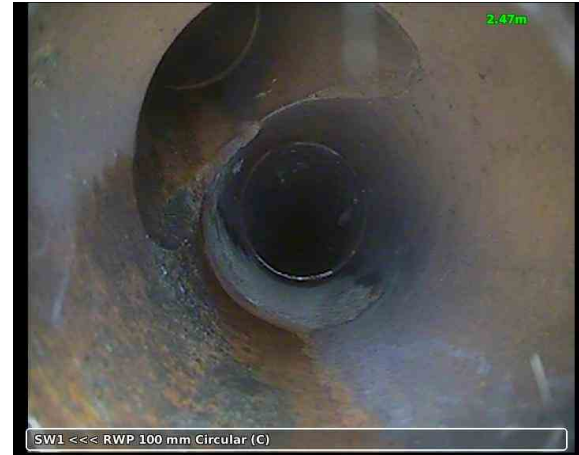
20190529-164610-snap0001.jpg, 00:00:19, 2.47 m  
 Junction, at 09 o'clock, diameter: 100 mm, RWG

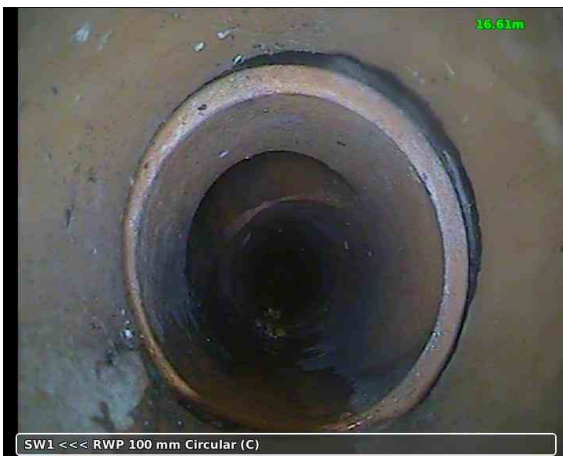
| No. | m+ | Code | Observation |
|---|---|---|---|
| 4 | 16.61 | JDM | Joint displaced, medium |

20190529-164610-snap0002.jpg, 00:01:05, 16.61 m  
 Joint displaced, medium

**Repair 4)** Section 9 - Install a 100mm diameter by 600mm long silicate patch repair at 16.6m downstream from Sw1 between Sw1a to Sw2

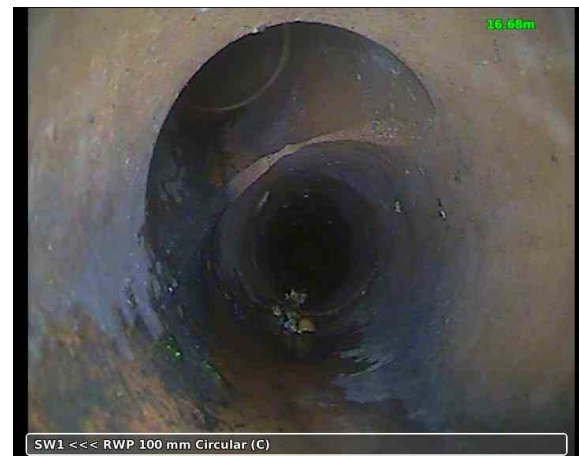
20190529-164610-snap0003.jpg, 00:01:17, 16.68 m  
 Junction, at 09 o'clock, diameter: 100 mm, RWG

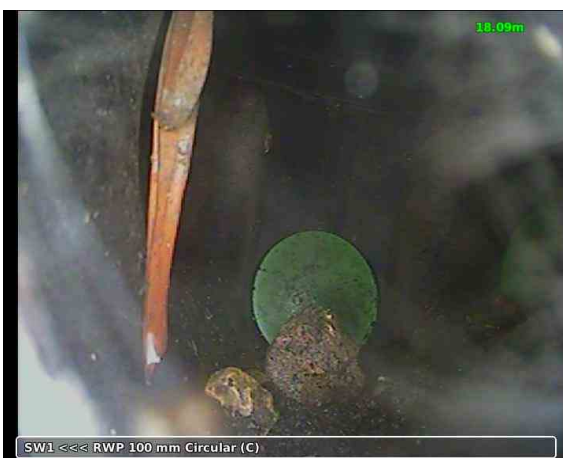
20190529-164610-snap0004.jpg, 00:01:41, 18.05 m  
 Finish node type, manhole, reference number: SW1A,  
 CONCELED CHAMBER

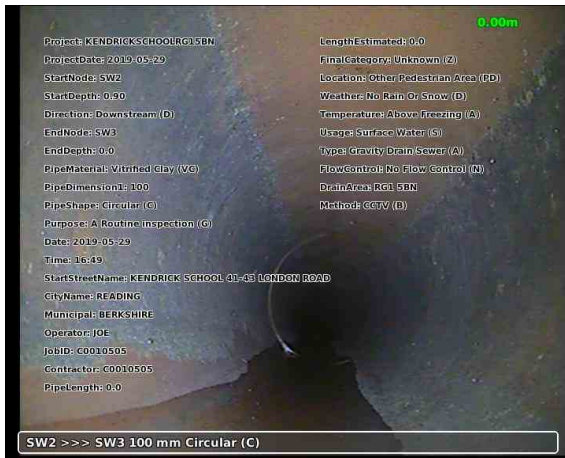
20190529-165059-snap0000.jpg, 00:00:01, 0.00 m  
Start node type, manhole, reference number: SW2

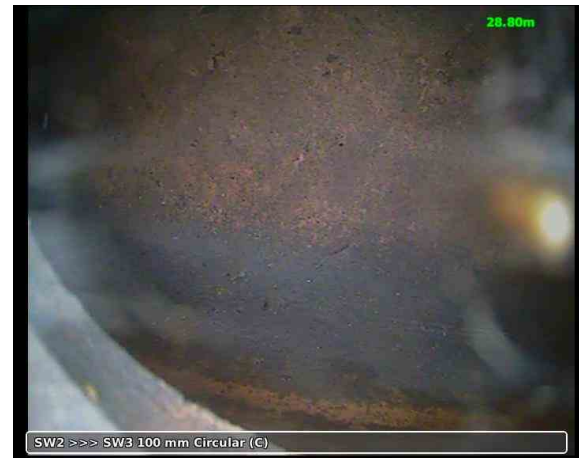
20190529-165059-snap0001.jpg, 00:01:04, 28.80 m  
Finish node type, manhole, reference number: JN
