# Clive Hudson Associates

Our ref: 195536/10, Eldon Road, Reading/Structural Repair Strategy Statement - Rev O  
Your ref:

### **Re: Structural Repair Strategy Statement – No. 10, Eldon Road, Reading**

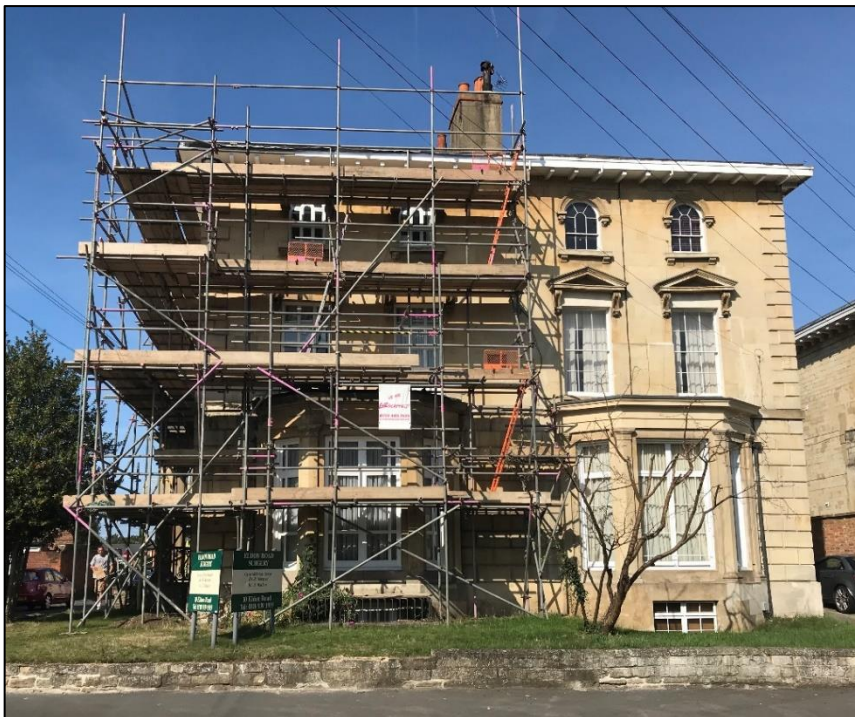
Figure 4. East elevation  
(Photograph taken on 22<sup>nd</sup>  
Aug 2019)

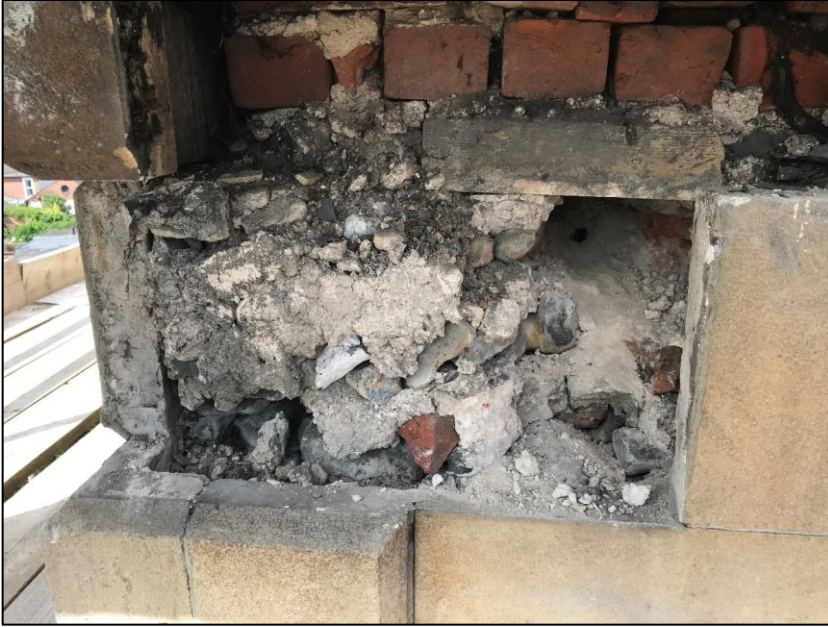
From the initial phase of opening-up works, it appears the ashlar outer skin relies solely on cross-bonded stone blocks for restraint, which is unusual and, in our opinion, is a poor detail. This method of restraint partially explains the structural movement observed. (Historically, ashlar stone outer skins were either tied back to the inner skin using iron cramps, or, relied on the inner face of the ashlar skin being undressed and of varying depths which formed a bond with the core.)

Figure 5.  
View of the rubble-stone /  
mortar core at high-level on  
the south-east corner.

While we are broadly in agreement with A F Jones's method of pinning the outer ashlar leaf to the core; our preferred method would be to use 8 or 10mm diameter stainless steel threaded anchors with washers and stone plugs, such as 8mm diameter CINTEC DRB sock anchors, rather than 'straight' threaded bars which are resin-anchored into the core.

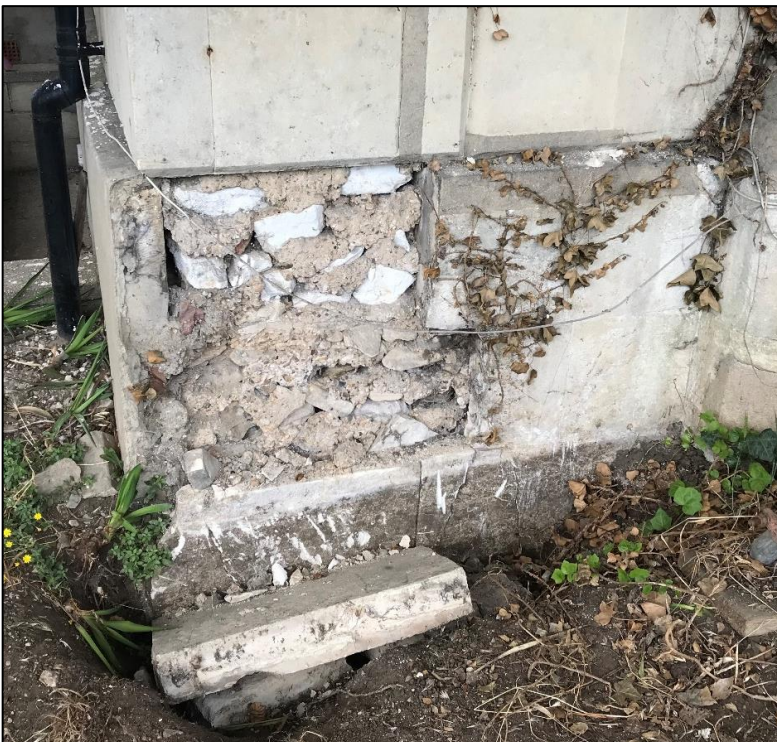
Figure 6.  
View of the stone /  
mortar core at low-level  
on the south-east corner.

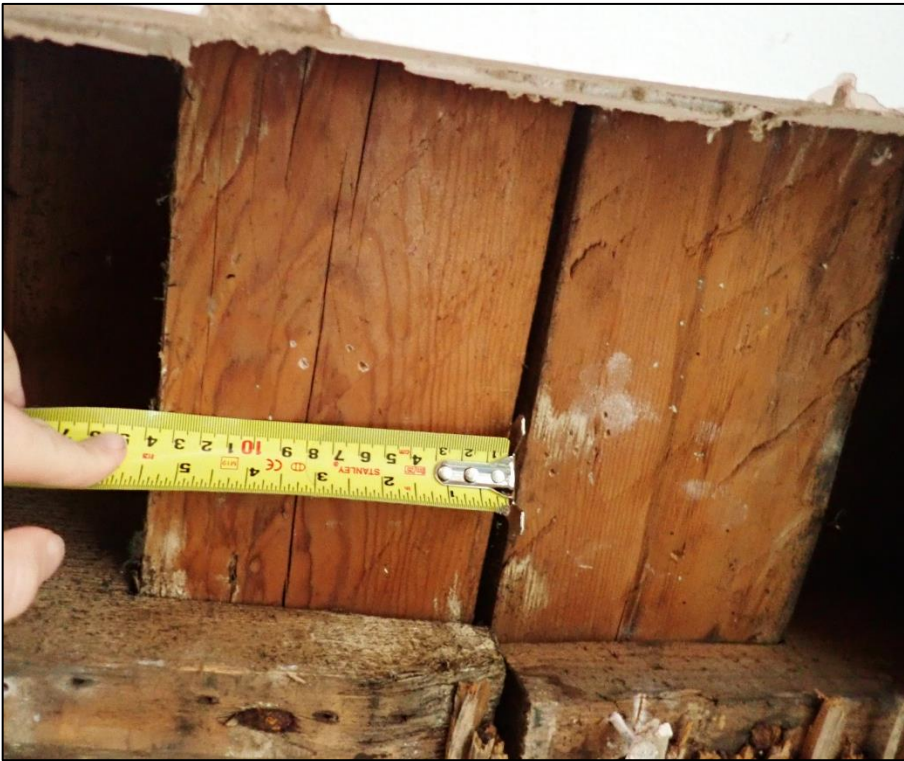
It is clear some of the movement observed in the stone outer leaf on the east elevation is due to the deflection of the 2 timber beams that span over the bay window aperture.

Opening-up works revealed the two timbers are each approx. 13" ½' deep x 5" ½' wide and are bolted together at approx. 46" centres. While no opening-up works have been undertaken on the second floor to confirm the presence of a relieving structure (timber beams), it is clear the beams are undersized for the loads which they have to support and span (approx. 4m). This is not only reflected in the preliminary calculations but in:

Figure 7.  
View of the underside of the timber beams which span over the bay window aperture (Note: plaster repairs have been undertaken to the ceiling in this location in the past).

Therefore, before undertaking the stone repairs to the east elevation, we would recommend the two timber beams are fully exposed / inspected, and an allowance is made for remedial works to strengthen / stiffen them.

Subject to the agreement with the Conservation Officer, one option could be to install a new steel beam below the existing timber beams, and, subject to calculations / inspection, to support this beam off the basement wall via steel posts.

If this is not considered acceptable, then another option could be, subject to calculations / inspection, to cut the ends of the existing floor joists / flat roof joists (where they are housed in the existing timbers) and to attach profiled steel plates / steel sections to the inner and outer faces of the two timber beams, before re-attaching the timber joists to the beam with site welded joist hangers.

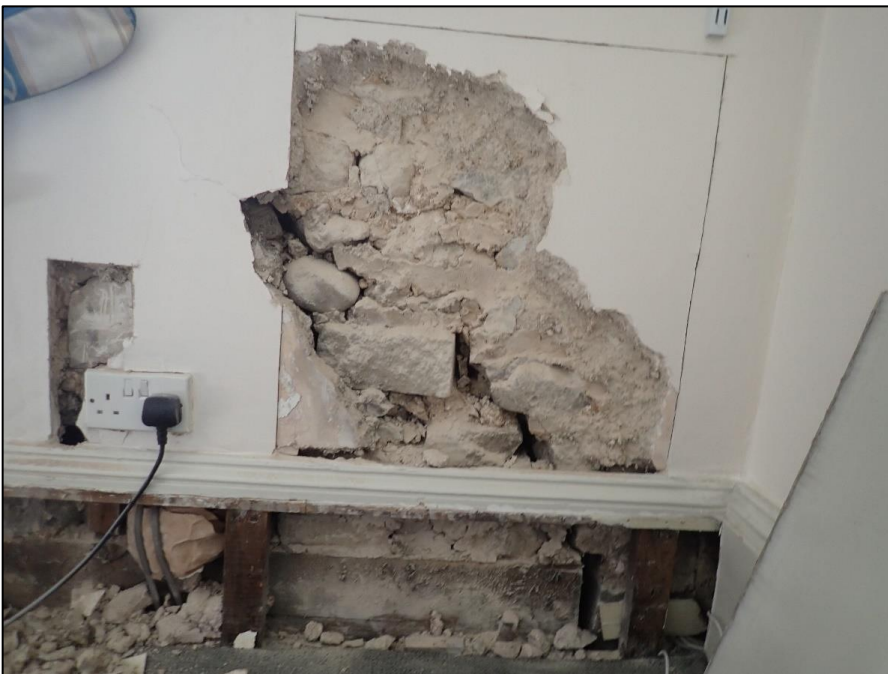
- the general unevenness (sagging) in the floors on the first and second floors in this location,
- a significant diagonal crack in the wall above the timbers on the right hand-side of the bay window, and
- a horizontal tapered split on the inner face of the inner timber beam.

This movement appears to be related to inherent structural defects associated with the nature of the construction, as similar movement is evident in the stonework above the bay window in No. 8. While we assume

Figure 8.  
Tapered diagonal crack in the wall above the right hand-end of the timber beam (on the 1<sup>st</sup> floor).

In addition, we would recommend stitching any vertical cracks with pairs of 2mm diameter stainless steel threaded bars resin-grouted into the horizontal mortar joints. We have used this successfully on other ashlar stone buildings, such as the Grade II listed, 17<sup>th</sup>-century, Old School Room in Uffington, West Oxfordshire.

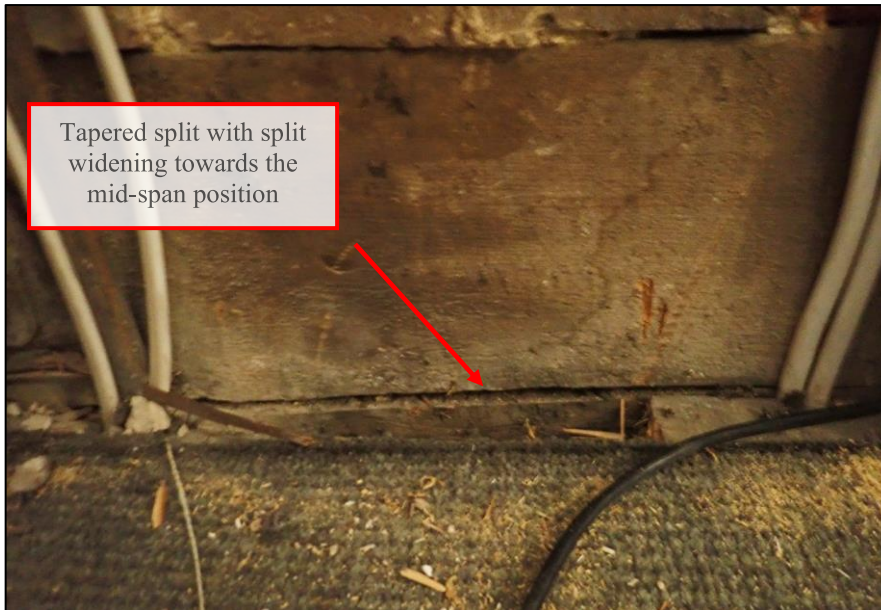
Figure 9.  
Tapered, horizontal split in  
inner face of inner timber  
beam
