## ARBORICULTURAL REPORT

Kendrick School  
41 London Road  
Reading  
Berkshire  
RG1 5BN

Sarah Duckworth  
DipArb(RFS), TechCert(ArborA), M. Arbor.A, BA (Hons)

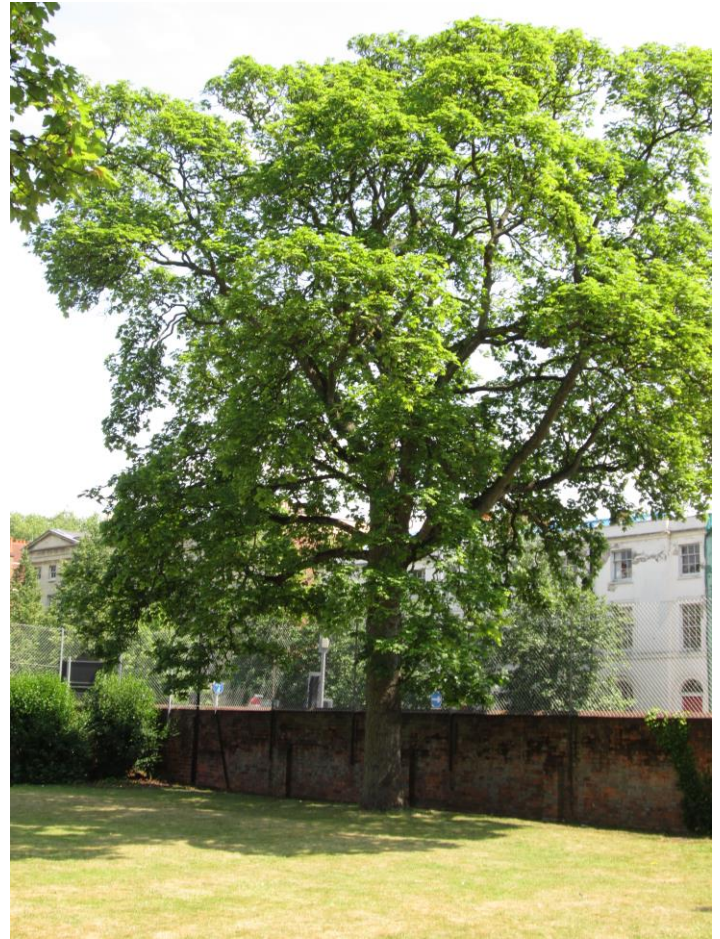
**T1 – Sycamore (*Acer pseudoplatanus*)**

**SITUATION** – Tree is growing in a compacted lawn area 1.9 metres from the boundary wall beyond which is the London Road.

**BASE** – The base is sound with no fruiting bodies or cavities evident. Hammer test is even and satisfactory. Some bark flaking around the lower trunk however there are no associated defects and it is likely to be caused by children.

**TRUNK** – Epicormic growth at 2 metres. The main stem forks at 4 metres. The branch union is open and satisfactory.

**CANOPY** – The canopy is broad and extends beyond the site boundary over the public highway. The foliage is chlorotic and sparse with windows through the canopy. Lower branch tips touching the perimeter fence. Mature epicormics sprouting on inner canopy. Aphids throughout canopy as usual for species.

**SUMMARY** – This is a significant tree in the local area growing adjacent to the public highway. The tree is structurally sound however it is showing signs of stress, nutrient deficiency and low vigour. In such a condition any major pruning works should be avoided and the epicormic growth retained to optimise tree health.

- **No tree pruning works identified at this time**
- **See Section 5 'Soil Improvement' for steps that can be taken to improve the overall health and condition of the tree.**

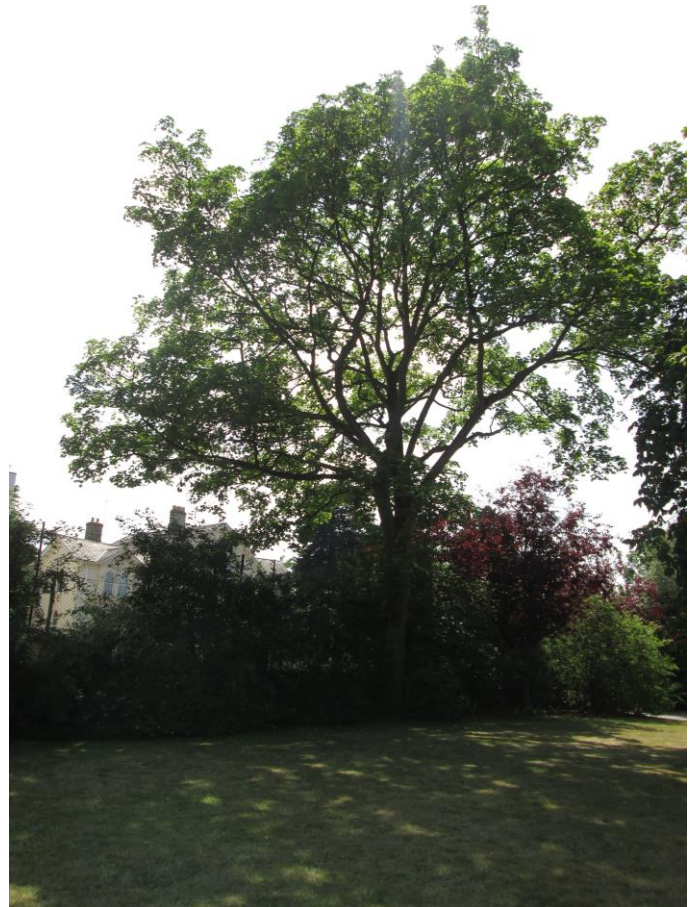
**T2 – Sycamore (*Acer pseudoplatanus*)**

**SITUATION** – Tree is growing in a shrub border adjacent to a compacted lawn area 1.6 metres from the boundary wall beyond which is the London Road.

**BASE** – The base is sound with no fruiting bodies or cavities evident. Hammer test is even and satisfactory. There is epicormic growth at the base of the tree and again at 2 metres up the main trunk.

**TRUNK** –Epicormic growth at 2 metres. Pruning cuts on main stem fully occluded. The main stem forks at 4 metres. The branch union is open and satisfactory.

**CANOPY** – The canopy is broad and extends beyond the site boundary over the public highway. The foliage is chlorotic and sparse with windows through the canopy. There is minor deadwood throughout the canopy with some apical dieback. There is a small dead hanging branch over the public highway – well lodged. Aphids throughout canopy as usual for species.

**SUMMARY** – This is a significant tree in the local area growing adjacent to the public highway. The tree is structurally sound however it is showing signs of declining health and low vigour caused by environmental stress and nutrient deficiency.

- **No tree pruning works identified at this time**
- **See Section 5 'Soil Improvement' for steps that can be taken to improve the overall health and condition of the tree.**

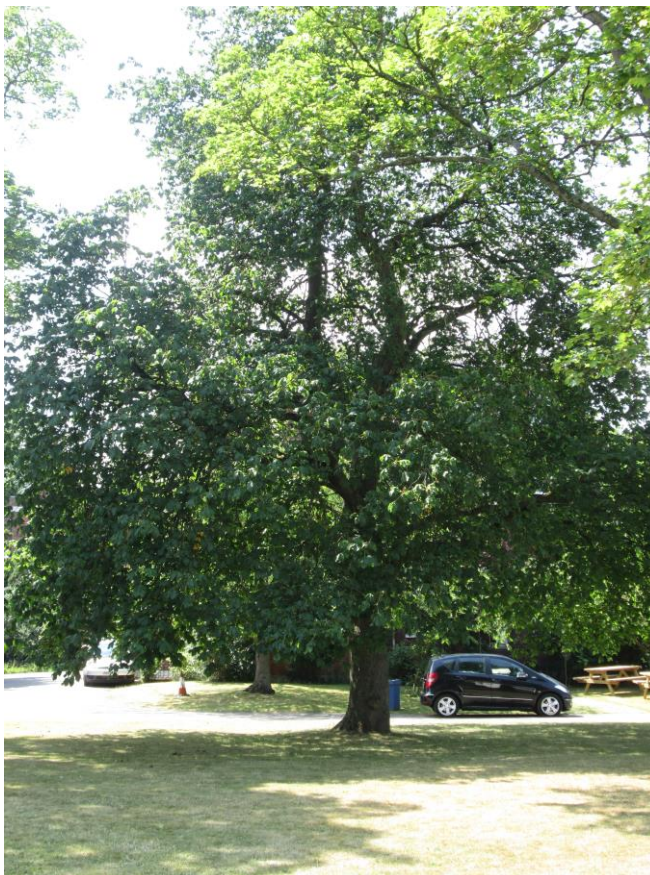
### **T3 – Red Horse Chestnut (*Aesculus x carnea* ‘*Briotii*’)**

**SITUATION** – Tree is growing in a compacted lawn area regularly used for sports and games.

**BASE** – The base is sound with no fruiting bodies or cavities evident. Hammer test is even and satisfactory. Warty boles on the lower trunk are a feature of the species and are not a concern.

**TRUNK** – Main stem divides into 3 with two large side branches at 3 metres and again into 3 similar sized large branches at 6 metres. The lower branch union is open; some bark inclusion, condition satisfactory. The upper union has lost a small area of bark associated with the branch fork which is worth further investigation.

**CANOPY** – The canopy is low and broad with slightly lower leaf density in the upper canopy. Several lower branches have been cut back in the past and grown on. One lower lateral extending north west has a bud proliferation (witches broom) on the upper side of the branch near the reduction point and a small cavity associated with an earlier pruning cut nearer the trunk. This limb also has dense terminal growth. There are numerous small splits in the bark, on the trunk and main branches in the upper canopy, not unusual for the species and indicative of growth and good vigour.

**SUMMARY** – This is a significant tree for the school growing in the well-used lawn area. The tree condition is satisfactory but the defects on the lower lateral branch with its profuse end growth is a cause for concern and work should be undertaken to reduce the load of the branch.

- **Crown lift lower branches to give 2.5 metres clearance.**
- **Reduce extended lower lateral (growing towards T5 (northwest) and with ‘witches’ broom’) by 2 metres. Selectively thin reduced terminal branches on this limb by 25-30% to reduce end weight.**
- **Inspect upper branch form during the course of these works where a small area of bark is missing from the union at 6m.**

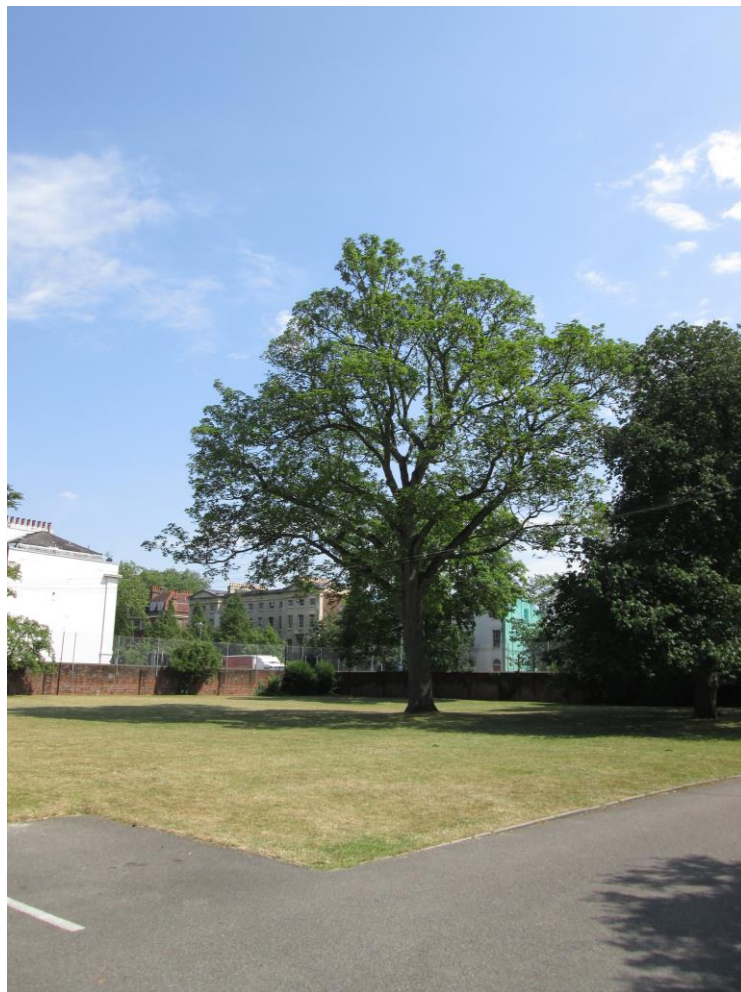
### **T4 – Sycamore (*Acer pseudoplatanus*)**

**SITUATION** – Tree is growing in the centre of a compacted lawn area regularly used for sports and games, 9 metres from T3.

**BASE** – The base is sound with no fruiting bodies or cavities evident. Hammer test is even and satisfactory. Surface lawnmower damage to large root (600 long and 150 wide) 250mm from base of tree.

**TRUNK** – Main stem has no notable defects, all historic pruning cuts fully occluded, branch forks all satisfactory.

**CANOPY** – Various pruning cuts on branches in canopy partially occluded with some cavities within. Foliage is sparse and chlorotic with windows through the canopy. Apical (tip) dieback throughout canopy. Some vertical epicormic growth on larger branches. Moderate sized dead limb on south west size of canopy towards T3.

**SUMMARY** – This is a significant tree for the school growing in the well-used lawn area. The tree is structurally sound however it is showing signs of stress, nutrient deficiency and low vigour. In such a condition any major pruning works should be avoided and the epicormic growth retained to optimise tree health.

- **Remove moderate sized dead limb on south west size of canopy towards T3**
- **See Section 5 ‘Soil Improvement’ for steps that can be taken to improve the overall health and condition of the tree.**

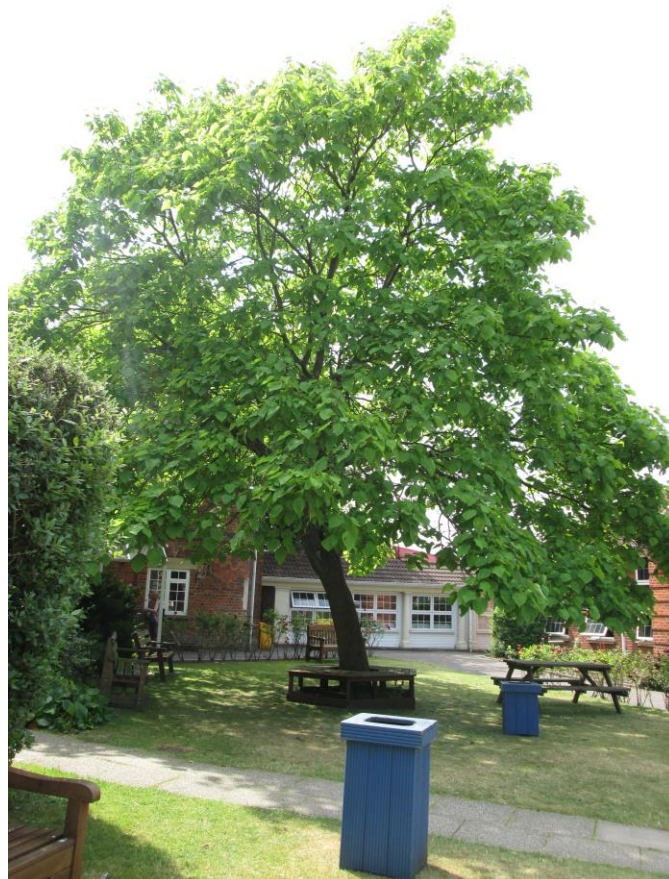
### **T5 – Indian Bean Tree (*Catalpa bignonioides*)**

**SITUATION** – Tree is growing a small area of lawn surrounded by paths and adjacent buildings. There is a circular bench around the base of the tree and high pedestrian occupancy.

**BASE** – The base is sound with no fruiting bodies or cavities evident.

**TRUNK** – Main stem has slight helical growth on the lower stem and leaning to the south west. Canopy is upright therefore the lean is not a concern at this time. The stem bifurcates at 2.5m with a close fork and some included bark. There is also a branch stub at this point which has been reduced and there is a tear on the lower part of the stub. This could be the tidying up of a broken branch? Regenerative growth on the upper side of the branch stub.

**CANOPY** – Minor deadwood throughout the central canopy. Foliage even density; slightly chlorotic. No major deadwood.

**SUMMARY** – This is a high amenity tree for the school growing in high occupancy area of the school. The tree is structurally sound however it is showing signs of nutrient deficiency.

- **No works identified**

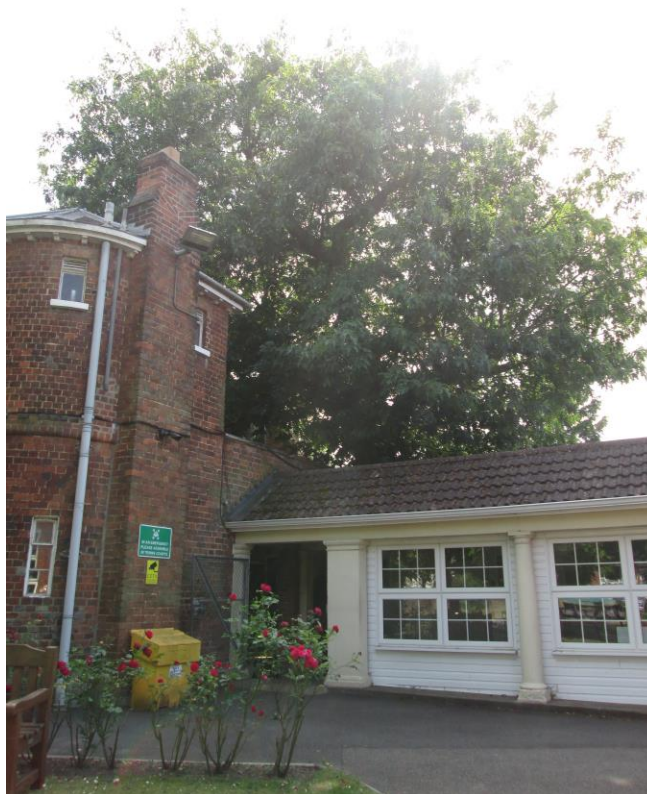
**T6 – Pin Oak (*Quercus palustris*)**

**SITUATION** – This interesting feature tree is growing in a particularly constricted area 1.78 wide and 4.8 long, surrounded by brick walls or buildings on all sides. The undeveloped area immediately to the base of the tree has been laid with tarmac and is used for storage. To the east of the tree beyond the school boundary is the carpark for the adjacent Dentist's surgery.

**BASE** – The base is visually sound with no fruiting bodies or cavities evident. Hammer test is even but difficult to interpret as the sound echoes in the confined space. Epicormics on the main trunk from 1m.

**TRUNK** – Epicormics on the main trunk from 1m. Stem leaning to the south and touching the capping bricks at the top of the wall which appear to have been repaired. The tree has been substantially reduced in the past and a new canopy formed from regenerative and epicormic growth. Branch fork obscured by vegetation.

**CANOPY** – Some chlorotic foliage but otherwise satisfactory. No major deadwood. Canopy touching the buildings on all sides. Foliage even density; slightly chlorotic. Reduction points obscured by vegetation.

**SUMMARY** – This is an interesting feature tree for the school which is growing and thriving in particularly inhospitable conditions. The tree is in a sheltered location but the canopy is coming into contact with property in many areas. The nearest undeveloped area is over 7m from the base of the tree within the school and 9.5 metres to the west within the adjacent property. The tree trunk is touching a wall and may already have caused damage and will become a greater concern as the trunk increases in diameter. An assessment of the structural integrity of the wall is outside of the remit of this tree report.

- **Reduce canopy by 2-3m back to pruning (or topping) points taking care not to damage any pollard knuckles.**
- **Selectively prune foliage elsewhere to give clearance to property where possible and remove epicormic growth from the underside of the large scaffold growing south over the stairwell.**
- **Inspect branch union during the course of these works.**

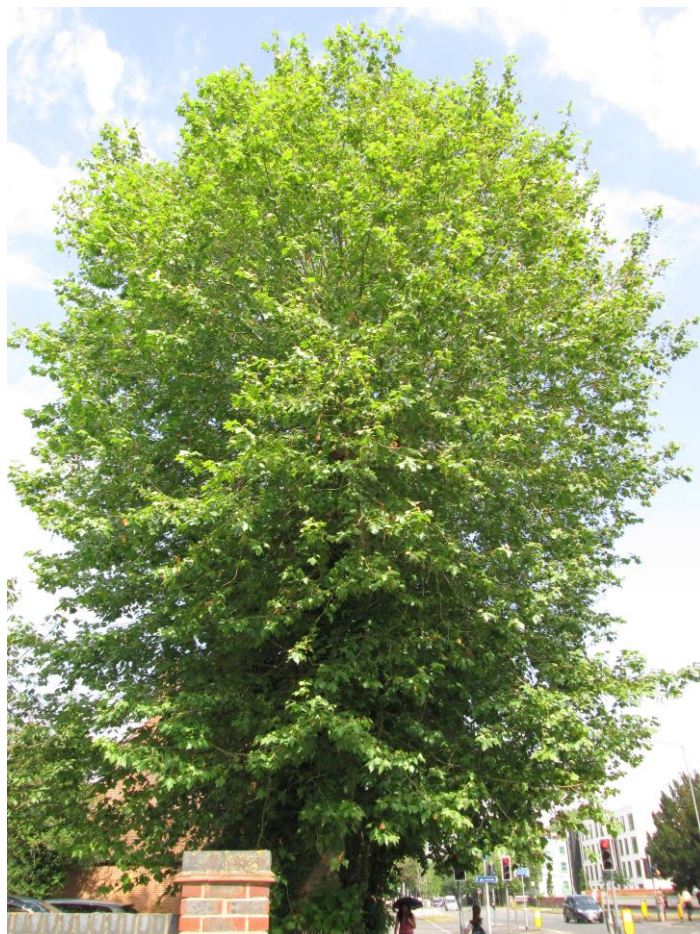
**T7 – London Plane (*Platanus x hispanica*)**

**SITUATION** – Very large tree growing in a small grass strip at the front of the school between a parking area and the public highway.

**BASE** – There is dense ivy growth on the lower and main trunk which hampers a full inspection. In addition there are metal railings along the south side of the base. The gap between the railings and the Plane tree is blocked with litter, leaves and a shrubby Hawthorn. Where the base can be seen it is in a satisfactory condition with no obvious defects or cavities.

**TRUNK** – Deeply fluted in parts and densely covered in ivy. Branch union at approximately 3 metres obscured by ivy.

**CANOPY** – Tree has been managed as a pollard in the past with the formation of good pollard knuckles. Regeneration from these points is up to 8 metres long. No major deadwood. Small broken branch at ground level. Foliage good and evenly distributed with some Anthracnose (*Apoignomonina veneta*) evident on the leaves. Canopy growing over the highway and public footpath.

**SUMMARY** – This is a very large significant tree growing adjacent to the highway. It is healthy and sound and with no obvious structural defects. The tree has been managed as a pollard in the past and will need to be pollarded in the future on a regular basis to maintain the tree and prevent major branch failure.

- **Sever ivy with hand tools and remove around stem to a height of 1m.**
- **Reduce canopy back to previous pruning cuts taking care not to damage any pollard knuckles (approximately 6-8m).**
- **Reduce epicormic growth on main stem back to trunk.**

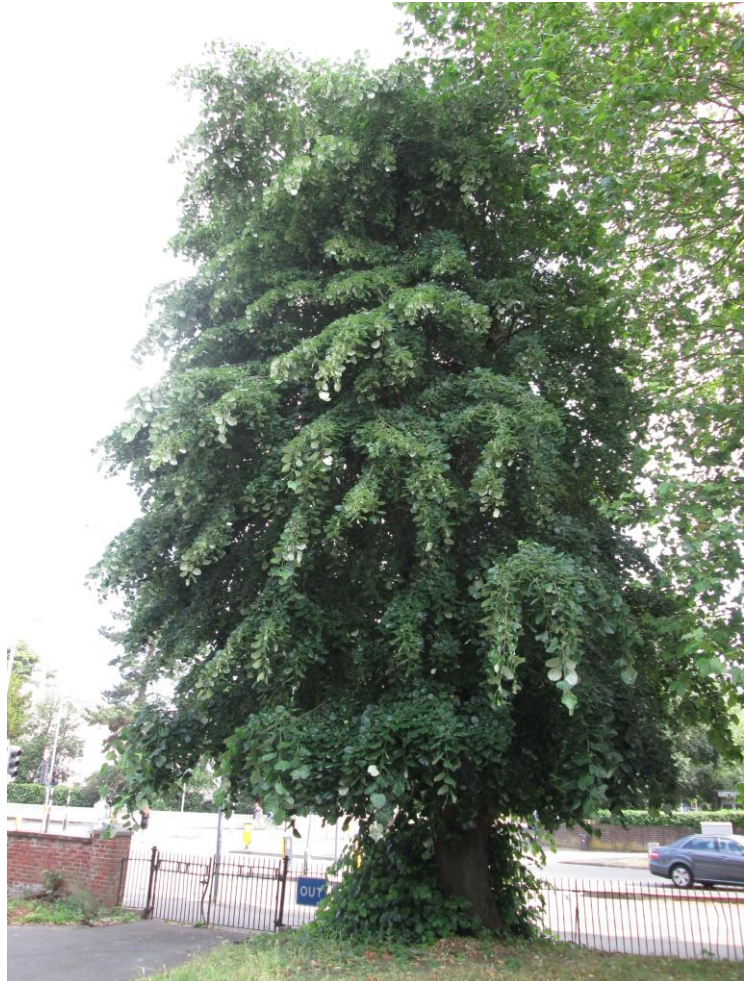
**T8 – Weeping Silver Lime (*Tilia tomentosa*  
'Petiolaris')**

**SITUATION** – Large tree growing in a small grass strip at the front of the school between parking areas and the public highway.

**BASE** – Prolific epicormic growth at the base hampers a full inspection. In addition there are metal railings along the south side of the base. Where the base can be seen it is in a satisfactory condition with no obvious defects or cavities.

**TRUNK** – Twin stem from 4 metres with a tight fork and some included bark. This is not unusual for the species and not a concern at this time. Tree has been pollarded in the past and also topped at 10-11 metres creating large wounds.

**CANOPY** – Tree has been managed as a pollard in the past with the formation of some pollard knuckles. Regeneration is between 6-8 metres long. No major deadwood. Aphids on leaves and Horse Chestnut scale (*Pulvinaria regalis*) on younger branches, both insects very common on Lime.

**SUMMARY** – This is a very large significant tree growing adjacent to the highway. It is healthy and sound. The tree has been managed as a pollard in the past and has been topped, therefore the canopy will need to be reduced on a regular basis in the future to maintain a compact canopy and prevent major branch failure.

- **Reduce epicormic growth at the base and lower trunk of the tree with hand tools.**
- **Reduce canopy back to previous pruning cuts taking care not to damage any pollard knuckles (approximately 6-8m).**

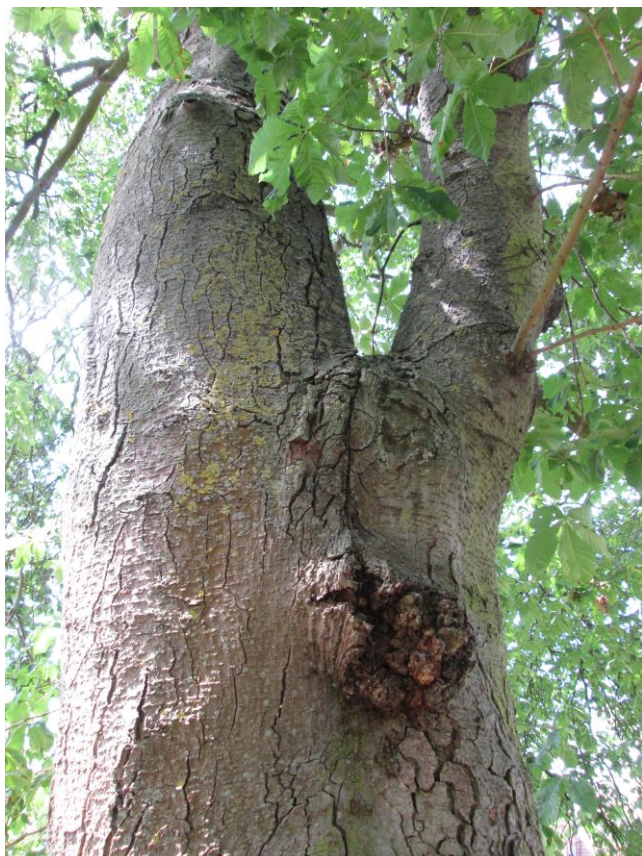
A. T3 - Close up of lower branch fork.

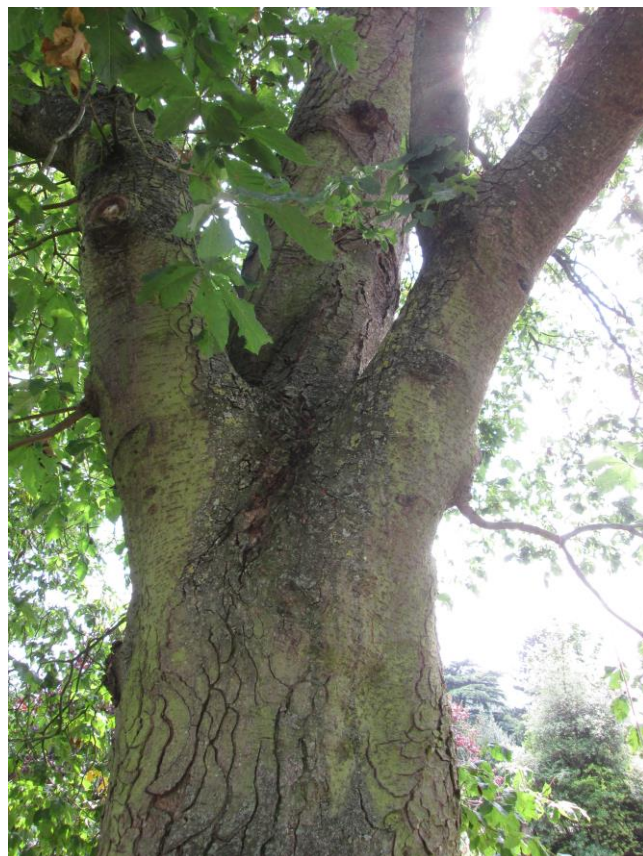
B. T3 - Other side of lower branch fork.

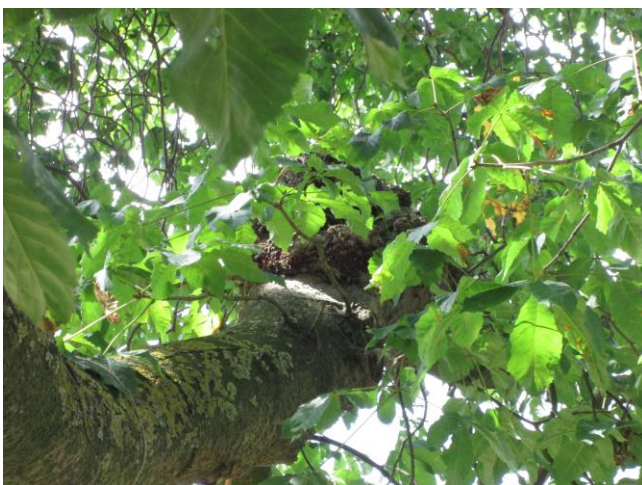
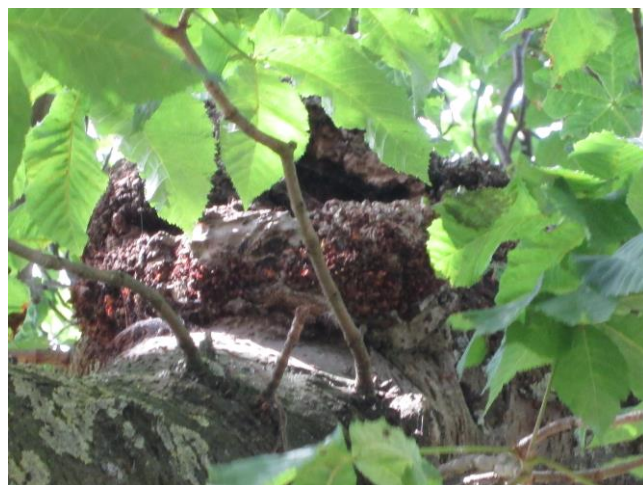
C. T3 - View of witches' broom on lower branch.

D. T3 - View of witches' broom on lower branch.

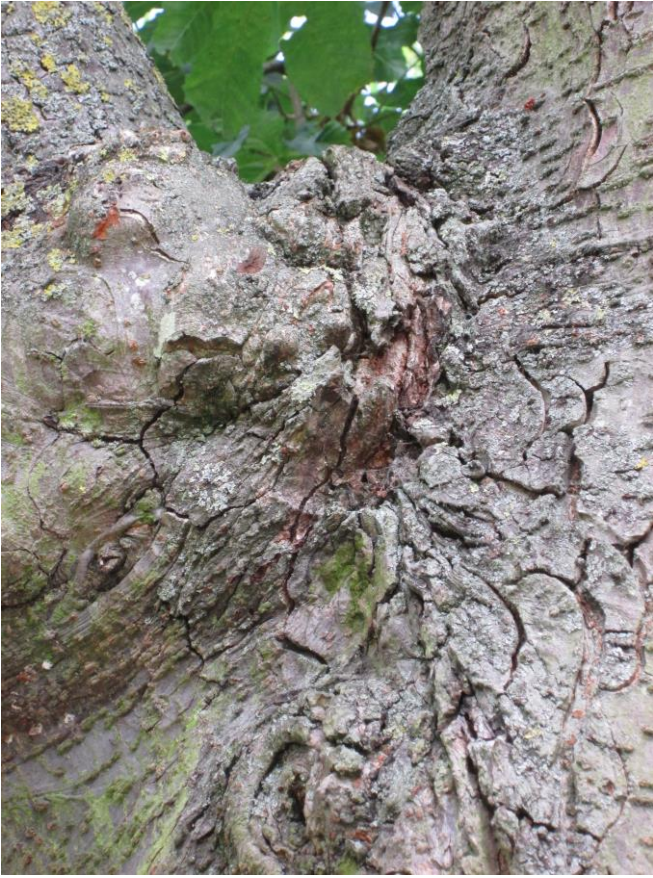
E. T3 - Upper branch union close up

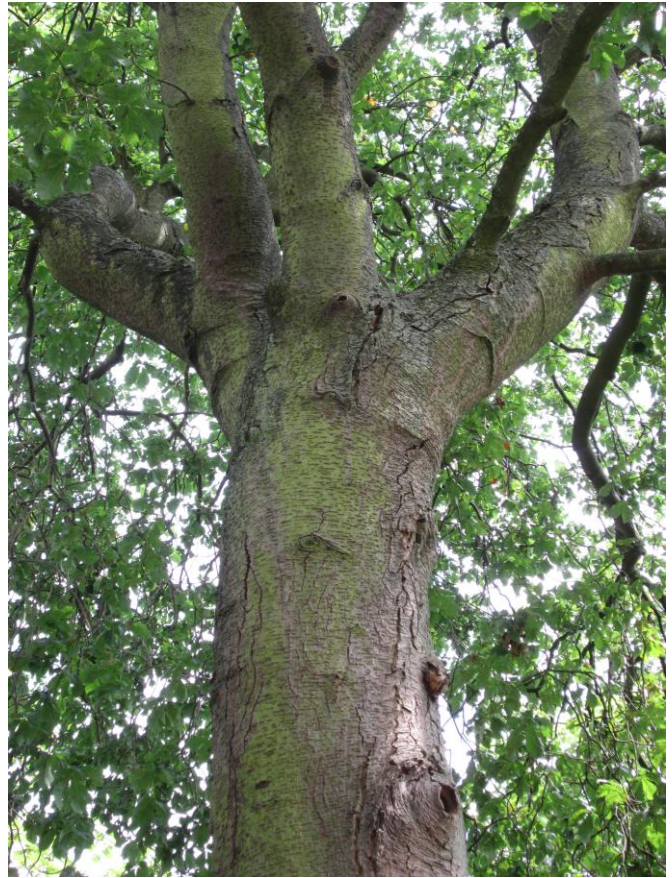
F. T3 – Upper branch union

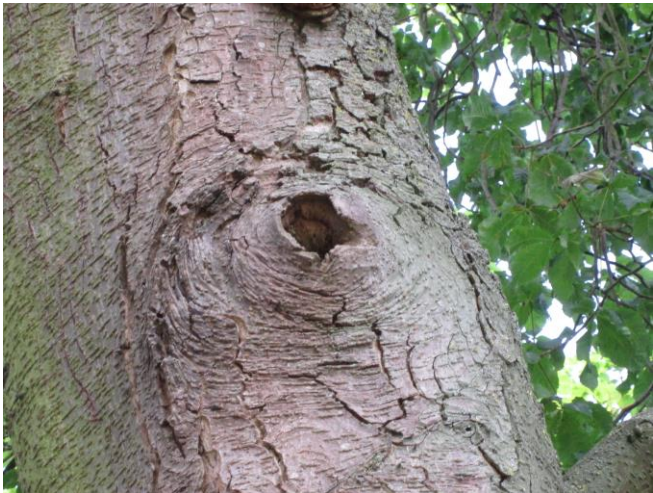
G. T3 – Small cavity on main trunk

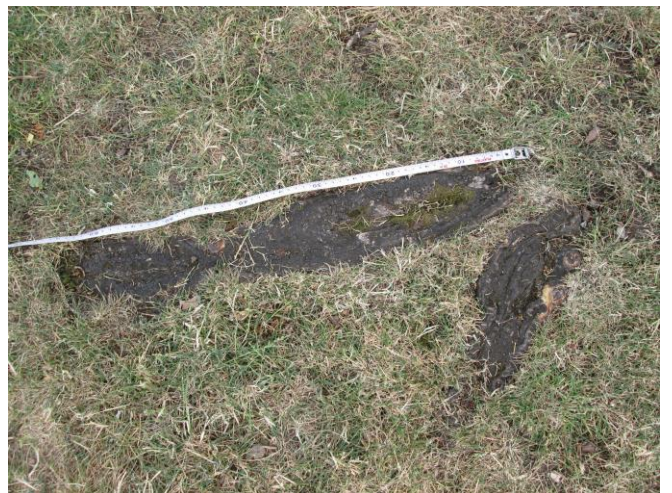
H. T4 – Lawnmower damage to surface roots

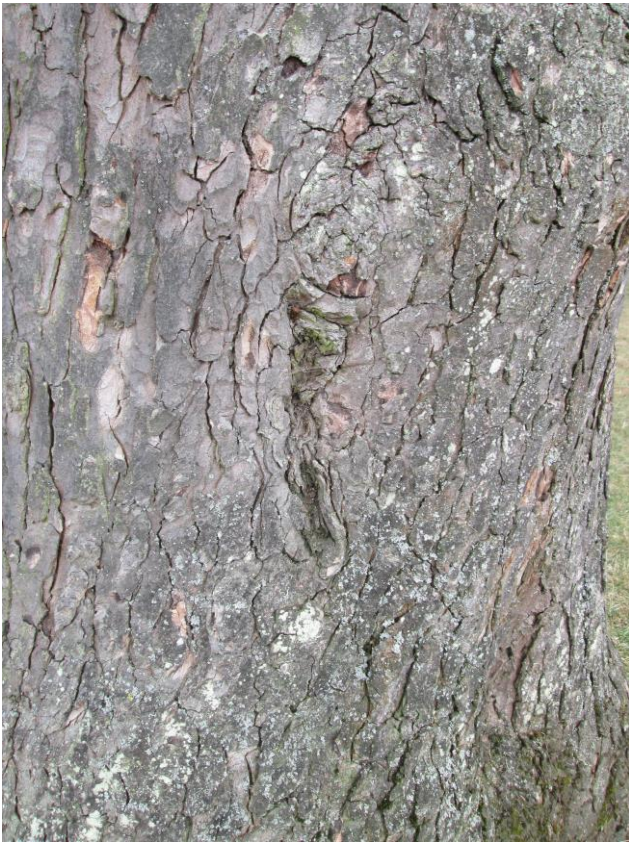
I. T4 – Occluded wound on lower trunk

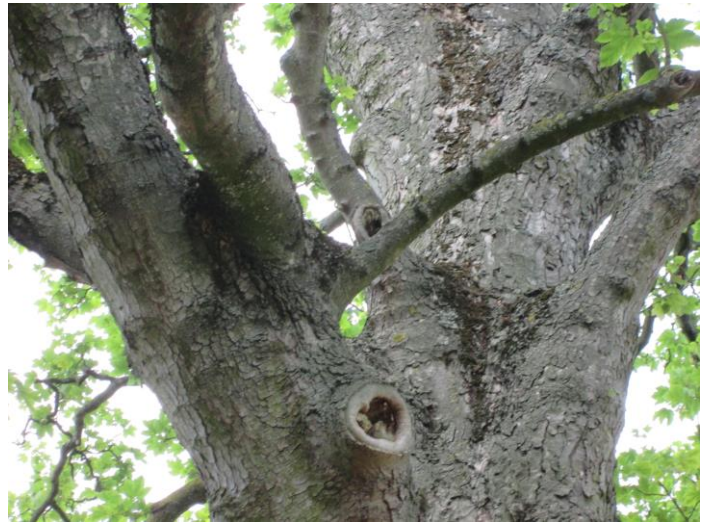
J. T4 – Partially occluded pruning cuts in canopy

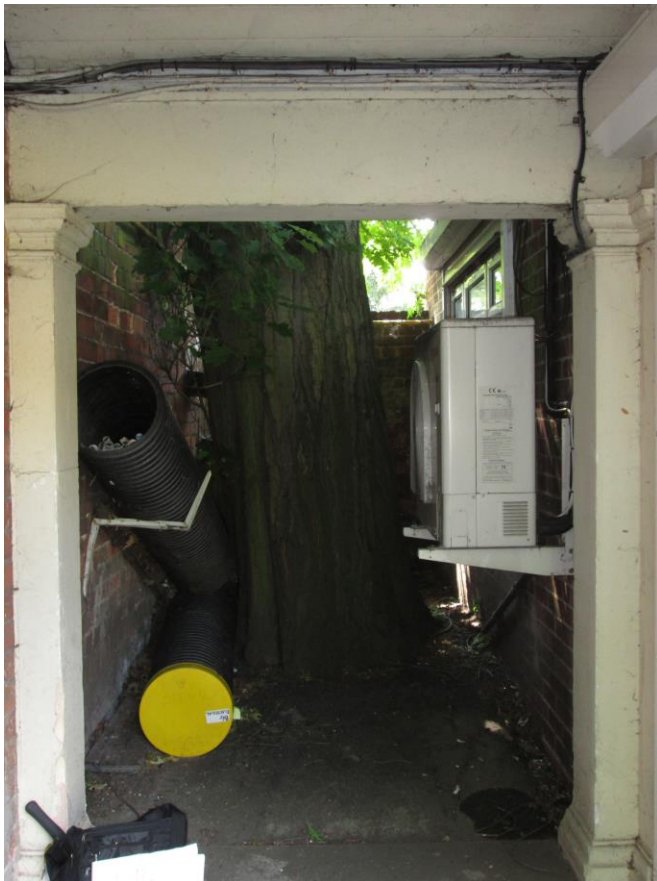
K. T6 - Lower trunk

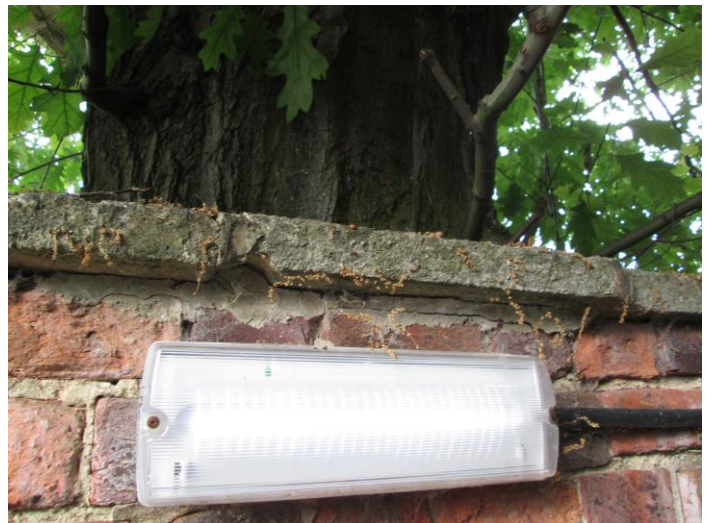
L. T6- touching adjacent brick wall.

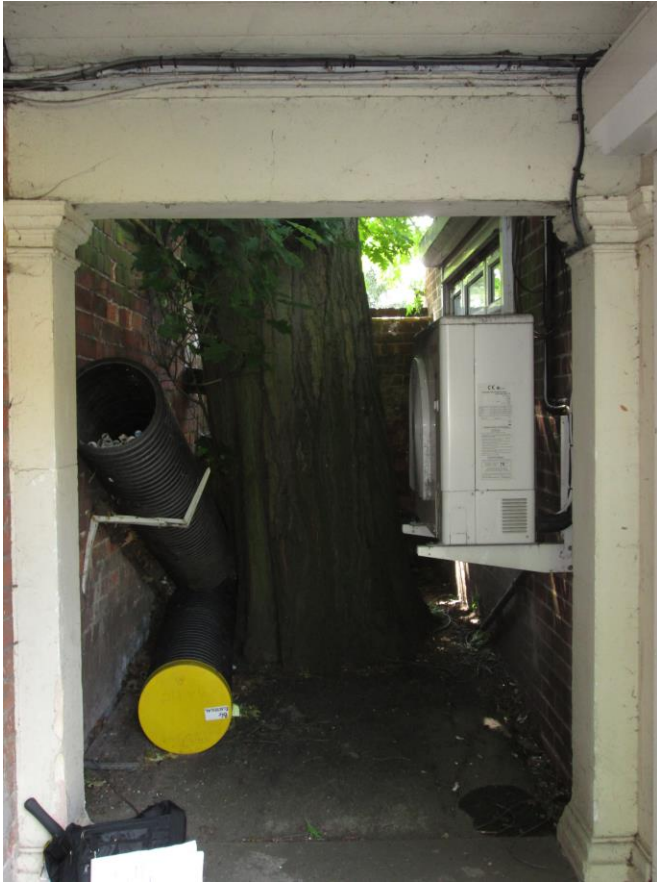
M. T6 – Lower trunk

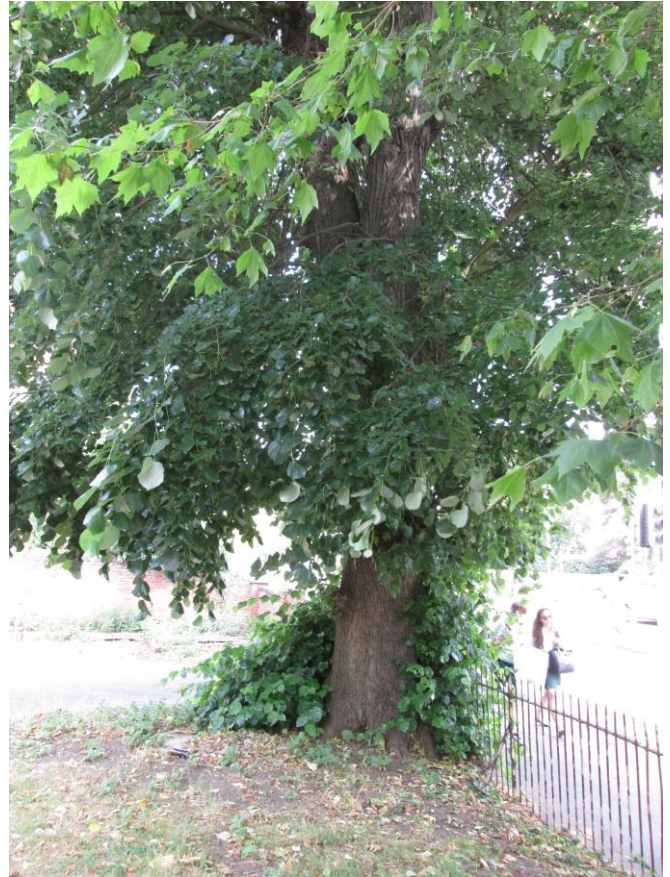
N. T8 – Epicormic growth at base.

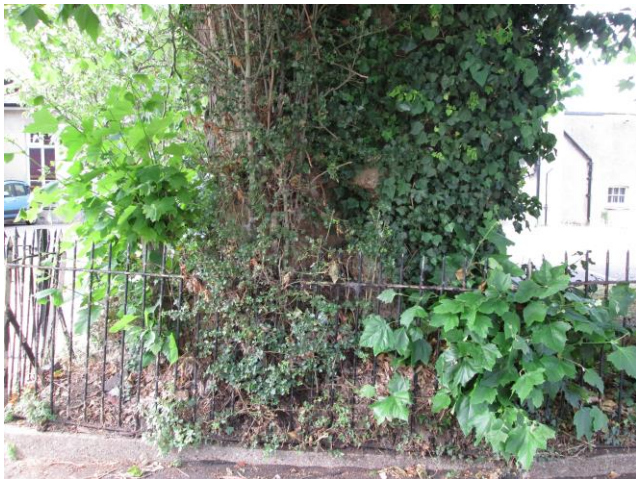
O. T7 – Ivy clad base and adjacent railings.
