**5 Woods Road  
Caversham  
Reading  
Berkshire  
RG4 6NA**

# **Preliminary Bat Roost Assessment**

**Ref: R2426/a**

**December 2019**

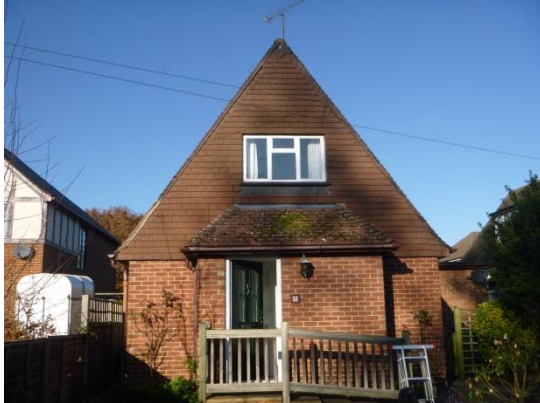
**3.2.1** The chalet bungalow was of brick construction and had a pitched roof covered in aggregate roof tiles with a single-storey side extension, rear conservatory and front porch (**Photographs 1 & 2**).

1. Front of the chalet bungalow viewed from the southeast.

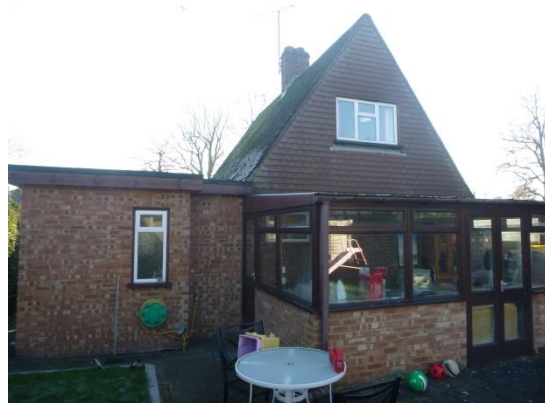
2. Rear of the chalet bungalow viewed from the north.

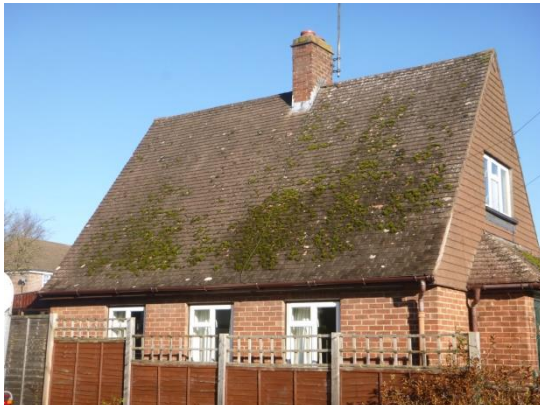
**3.2.2** The roof tiles on the pitched roof were mostly flat, tight and covered in moss (**Photograph 3; Target note 1**). There were however, several gaps under lifted roof tiles around the chimney and under uneven verge tiles at the gable ends offering potential access and roosting opportunities for bats (**Photographs 4 & 5; Target notes 2, 3 & 4**). The chimney possessed suitable bat access points beneath overlapping sections of lead flashing, and where a roof tile and mortar were missing at the ridge (**Photographs 6 & 7; Target notes 5 & 6**). The verge mortar at the gable ends was reasonably intact (with one repointed section) except for a few gaps at the front gable end where the mortar had cracked (**Photograph 8; Target note 7**).

3. Overlapping roof tiles mostly flat, tight and moss-covered (southwest elevation).

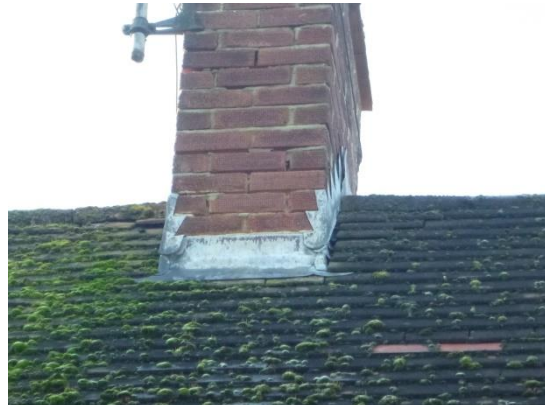
4. Gaps under roof tiles next to chimney (northeast elevation).

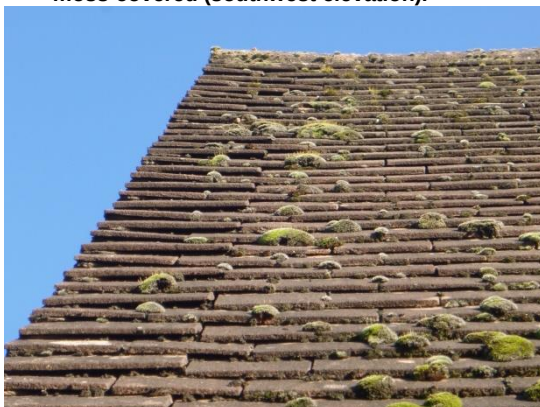
5. Gaps under verge tiles at northwest-facing gable end (southwest elevation).

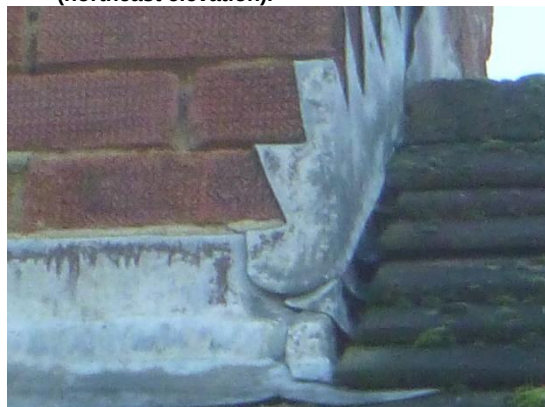
6. Gaps under overlapping lead flashing around chimney (northeast elevation).

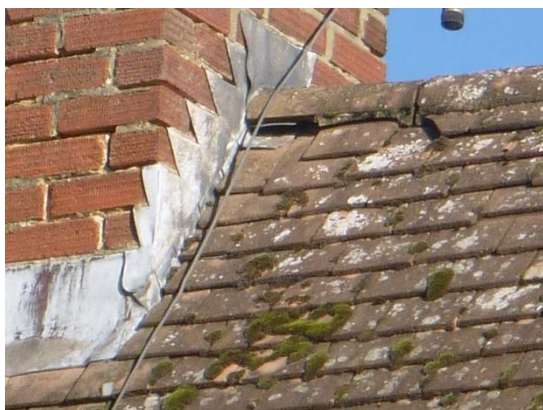
7. Missing roof tile and mortar at ridge next to chimney (southwest elevation).

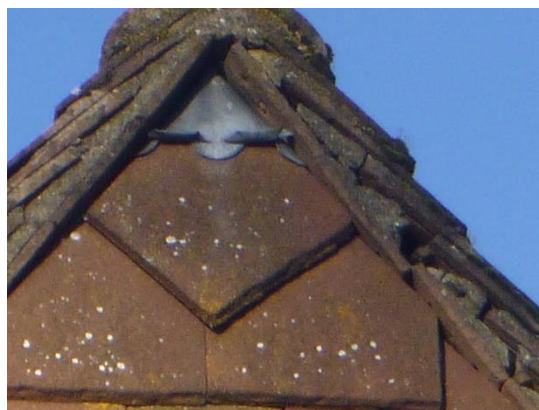
8. Cracks in verge mortar at front gable end (front elevation).

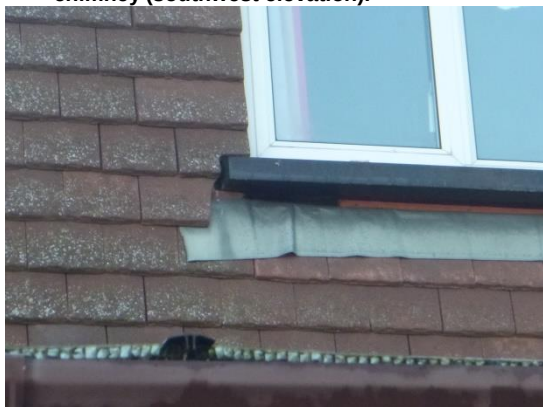
**3.2.3** The gable ends were clad in aggregate hanging tiles that were mostly flat and tightly fitted but with occasional gaps that had potential to be exploited by bats that typically occupy crevice-roosts. In particular, there were gaps behind the tiles around the rear window ledge (and frame), and between the tiles and verge undercloaking (**Photographs 9 & 10; Target notes 8 & 9**). A gap was also present at the eaves where the timber soffit did not sit flush against the brickwork (**Photograph 11; Target note 10**).

9. Gap behind hanging tiles around window ledge (rear elevation).

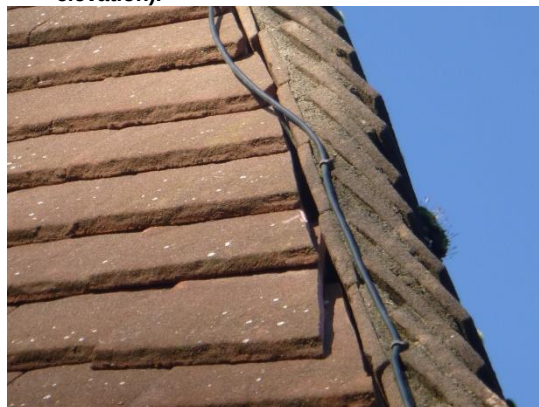
10. Gaps between hanging tiles and verge undercloaking (front elevation).

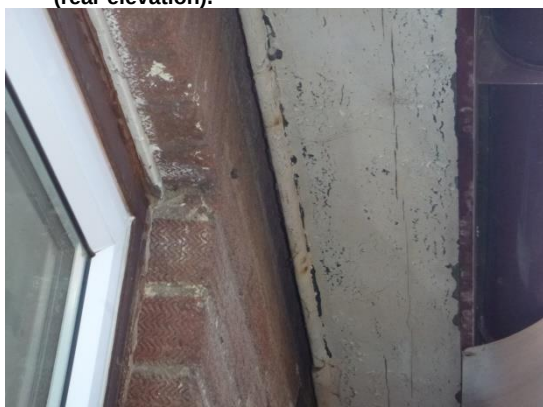
11. Gap between soffit and brickwork (northeast elevation).

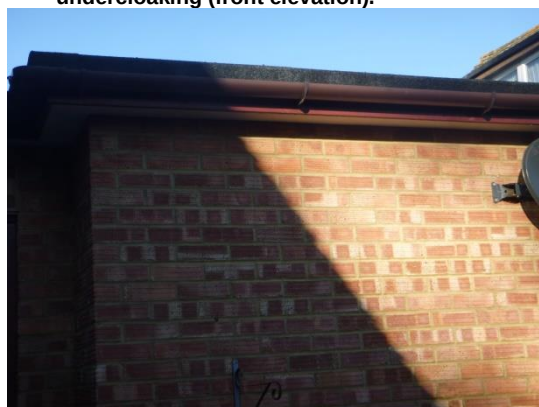
**3.2.4** The single-storey side extension had a tightly fitted bitumen flat roof and a timber soffit box that sat reasonably firmly on the wall plate (**Photograph 12; Target notes 11 & 12**). The rear conservatory had a sloping uPVC roof that was unsuitable for use by roosting bats (**Photograph 13; Target note 13**). The front porch had flat roof tiles and securely mortared hips; though a gap was present behind the lead flashing lining the junction with hanging tiles

12. Tight bitumen flat roof on single-storey side extension (front elevation).

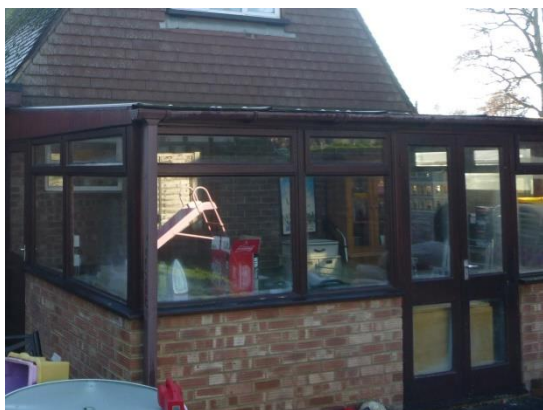
13. Sloping roof on rear conservatory (rear elevation).

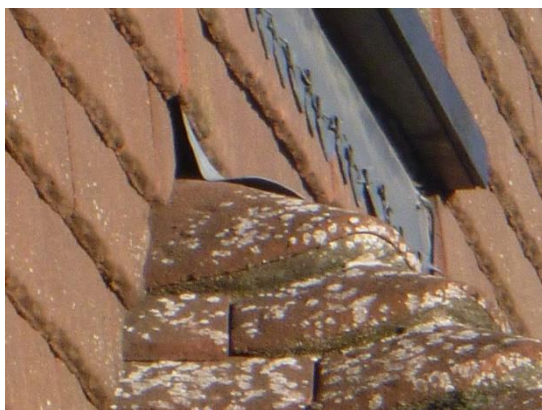
**(Photograph 14; Target note 14).**

14. Gap under lead flashing lining top of porch roof (front elevation).

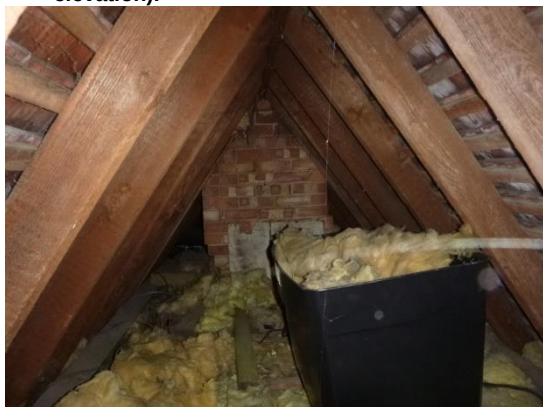
- 3.3.1** The roof void covered the two-storey footprint of the chalet bungalow and was split into two spaces either side of the chimney, both accessible via a loft hatch (**Photographs 15 & 16**). The void had an approximate floor-to-ridge height of one metre and was of 'cut and pitch' roof construction. The roof was unlined and the ridge was lightly cobwebbed which can suggest a lack of bat activity at the ridge (**Photograph 17; Target note 15 & 16**). The floor was insulated with fibreglass and squares of fibreglass insulation were present inside the eaves (**Photograph 18; Target note 17**). Daylight was visible beneath roof tiles in proximity to the gable ends but both ends were thickly cobwebbed and had numerous old wasp nests (**Photograph 19; Target notes 18 & 19**). The gable ends were lined with plastic sheeting and insulated behind with Celotex foam insulation (**Photograph 20; Target note 20**). The chimney was heavily cobwebbed and lead flashing was visible in the roof (**Photograph 21; Target note 21**). Holes in the chimney brickwork had been covered with metal mesh and timbers (**Photograph 22; Target note 22**).

15. Roof void viewed from northwest (rear) gable end.

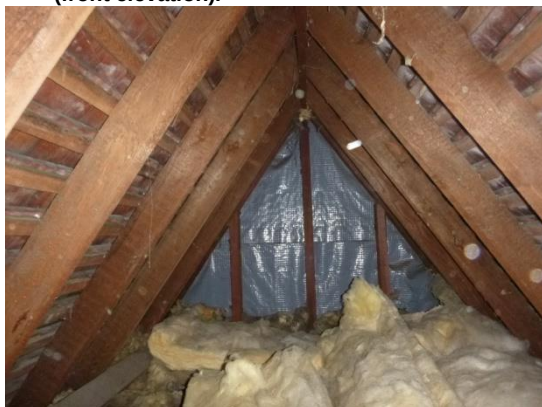
16. Southeast (front) gable end viewed from centre of roof void.

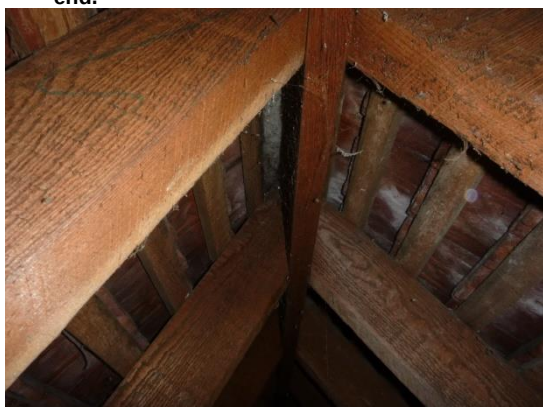
17. Unlined roof with lightly cobwebbed ridge.

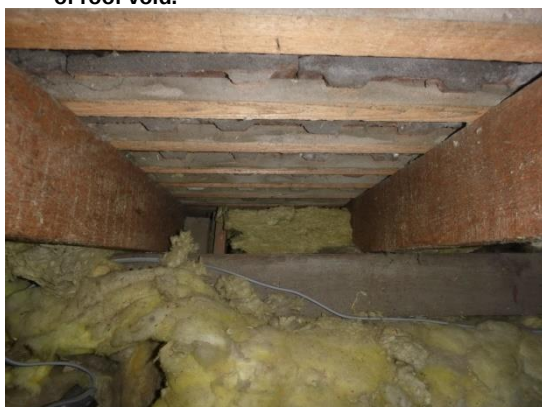
18. Square of fibreglass insulated inside eaves.

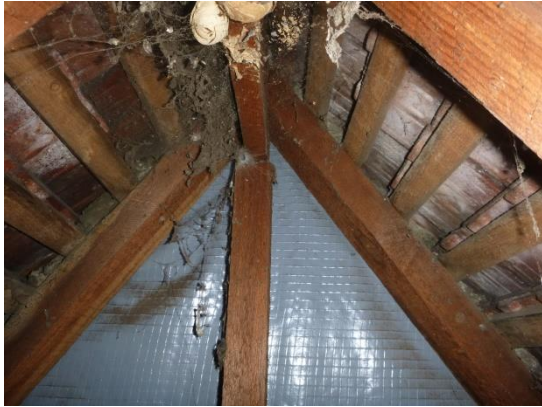
19. Thickly cobwebbed southeast (front) gable end.

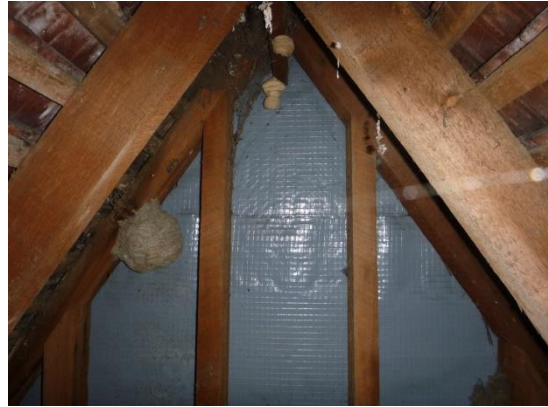
20. Plastic sheeting at gable ends with Celotex insulation behind.

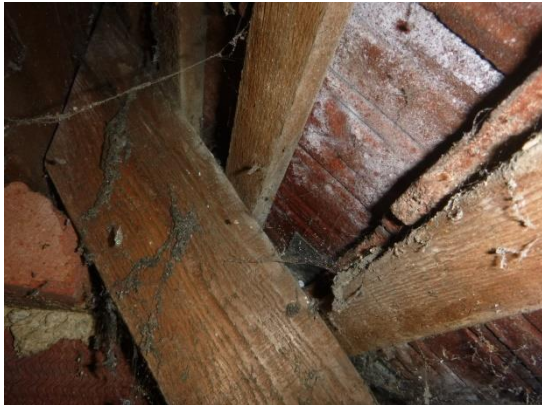
21. Lead flashing visible in roof around chimney.

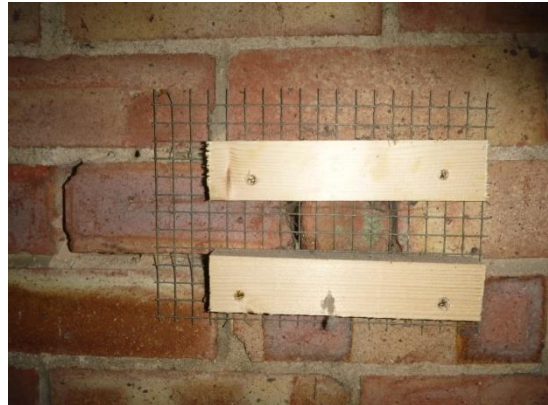
22. Metal mesh and timber over holes in chimney brickwork.
