# Initial Bat Assessment

## 1 Jesse Terrace

Reading  
Berkshire  
RG1 7RS

Dr Stacey Dawn Waring  
18-035-IBA  
October 2018

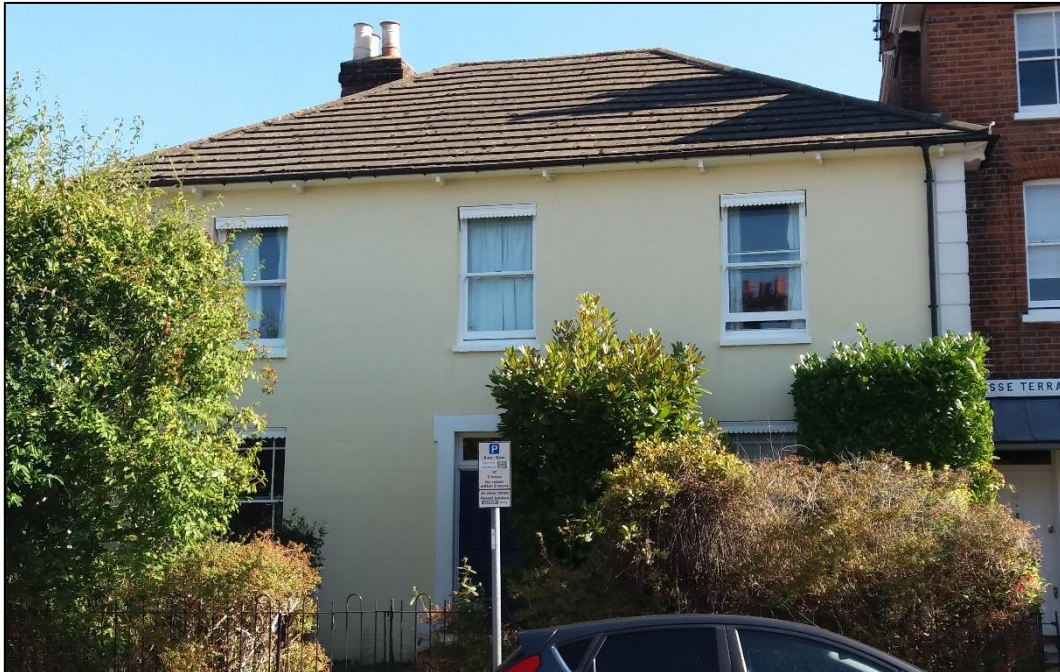
**Figure 2 - Front (western) elevation of 1 Jesse Terrace**

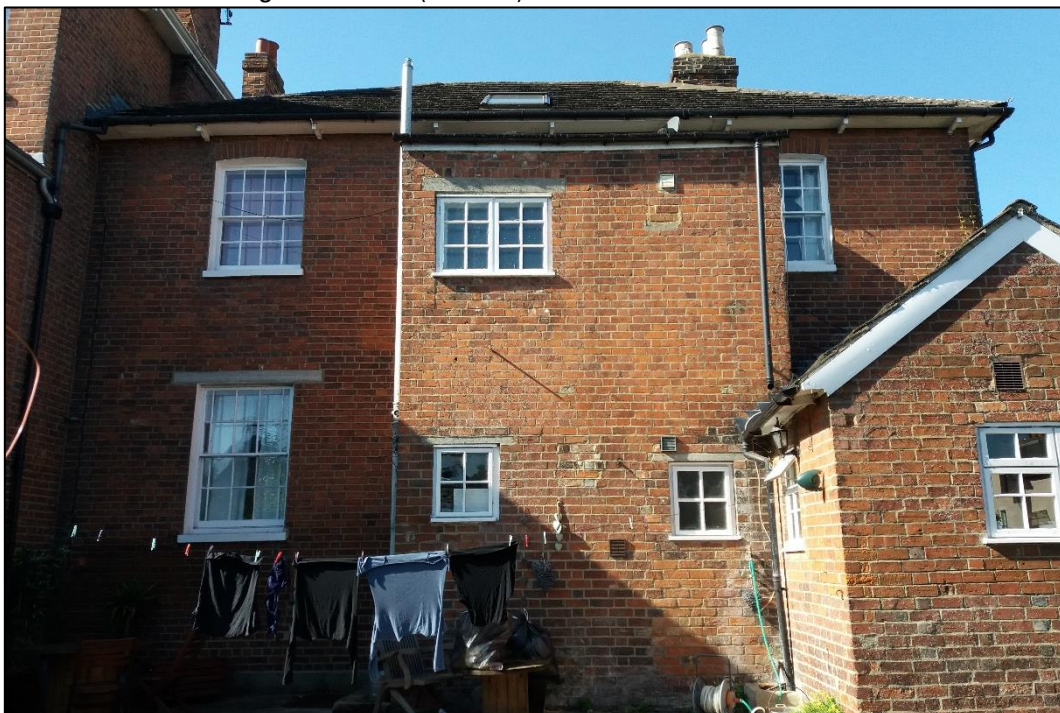
**Figure 3 – Rear (eastern) elevation of 1 Jesse Terrace**

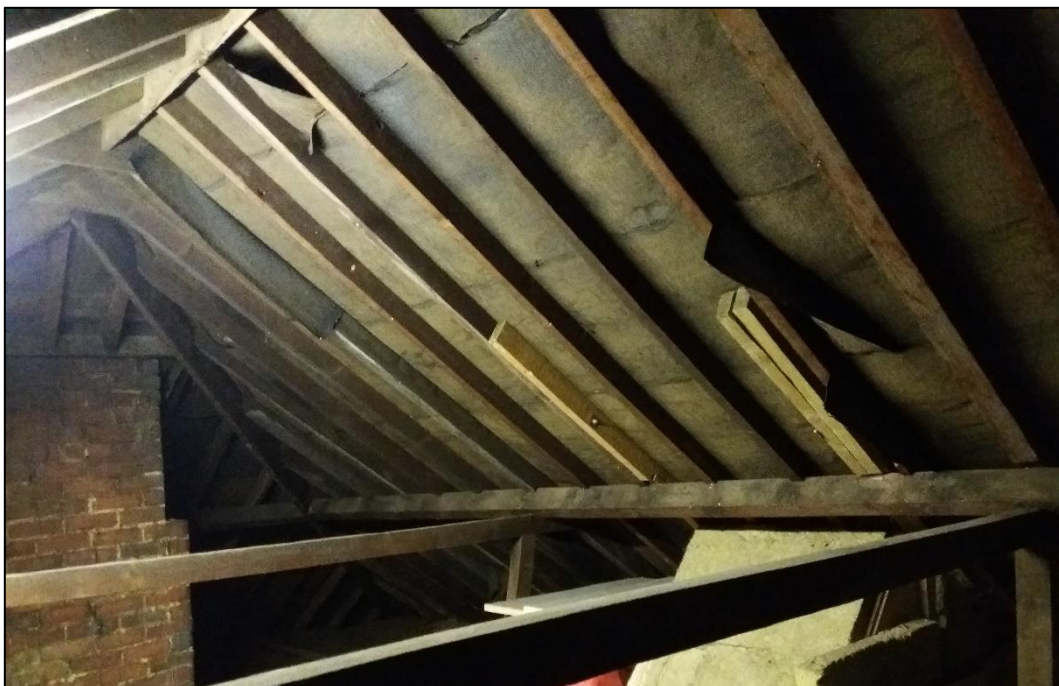
The property had a single roof void accessible through a loft hatch in the ceiling. The roof void was simple in design and was approx. 3m high at the ridge throughout (Figure 4). Underlay, in the form of bitumen felt, was present beneath the concrete tiles. The bitumen felt was in poor condition with numerous rips, tears and gaps (Figure 4). In some sections, the underlay was missing, and the underside of the interlocking tiles could be seen from within the void (Figure 5). These sections of missing underlay, increase draughts and the fluctuation of microclimate changes within the roof void, which reduces the suitability for void dwelling bats. Further gaps were present at the ridge where the underlay overlapped. Here there were signs of water ingress (Figure 6), suggesting the conditions would not be suitable for hibernating bats.

**Figure 4** – showing lack of underlay and slates with light entering though gaps (bottom left)

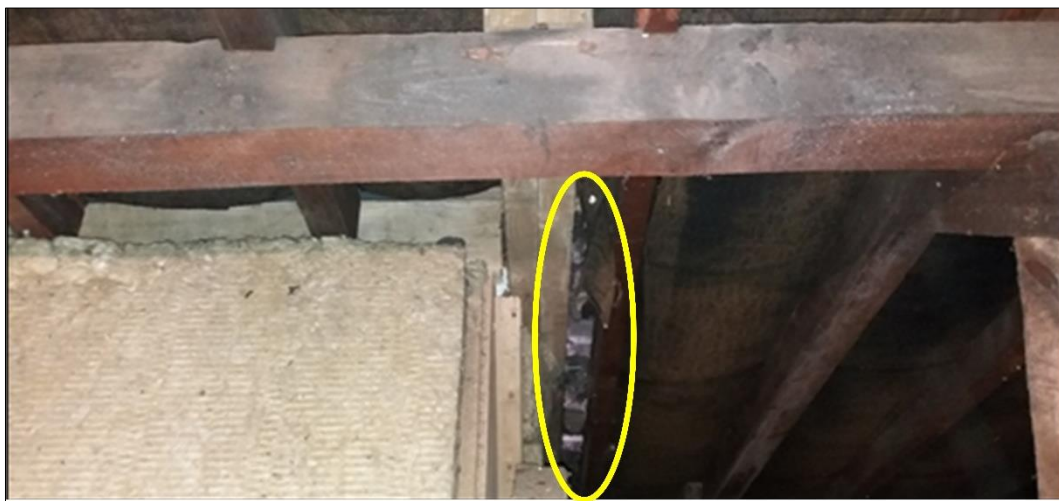
**Figure 5** – showing damaged slates, gaps at ridge and signs of damp

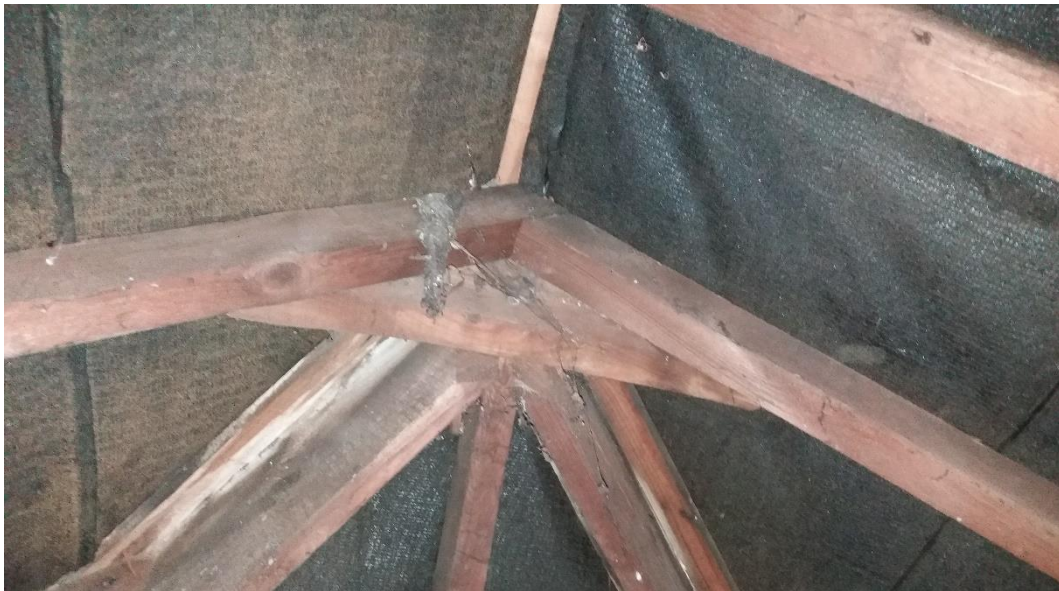
**Figure 6** – showing overlaps, dampness and high level of cobwebbing at ridge

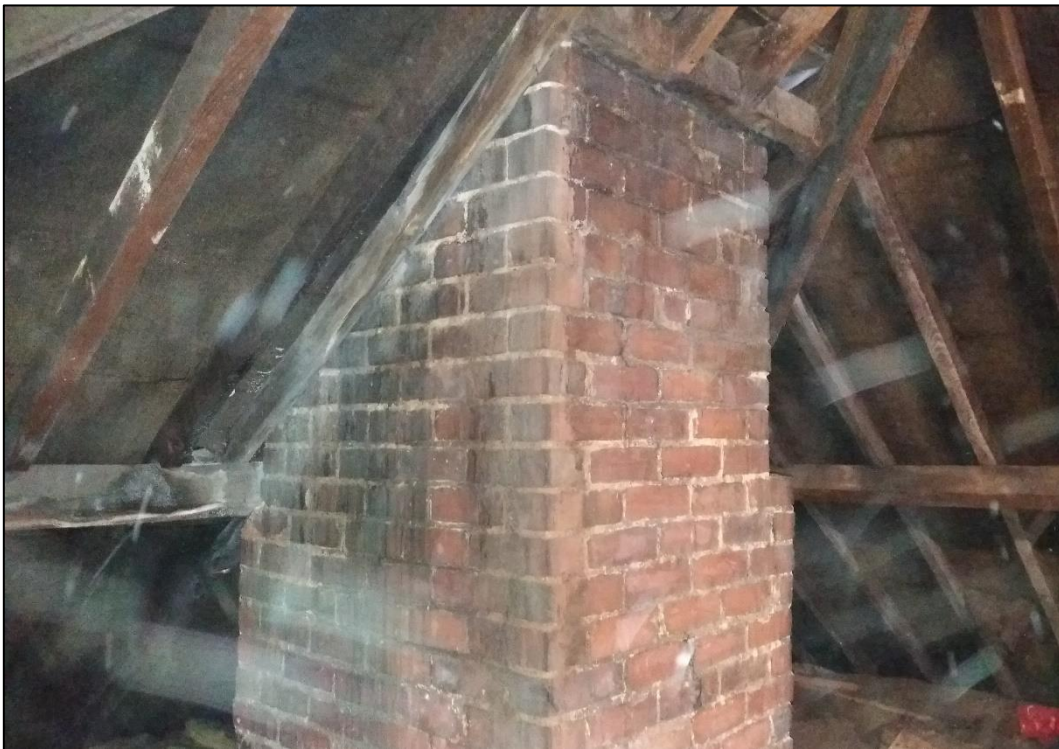
There was a high level of cobwebbing throughout the void, suggesting nothing had been using the void for flight in recent times. The chimney stack was in fair condition (Figure 7) with no gaps in the brickwork, although numerous damp patches on the brick work would suggest some external repairs are needed. Internally the brickwork on the wall plates, was taller than the lowest part of the roof (Figure 8). Here the eaves had been sealed off with sections of timber, to form sealed soffits. This would make accessing the roof via the eaves more difficult. The building has solid wall construction, thus there

**Figure 7** – showing good condition of brickwork on chimney, but signs of staining through damp

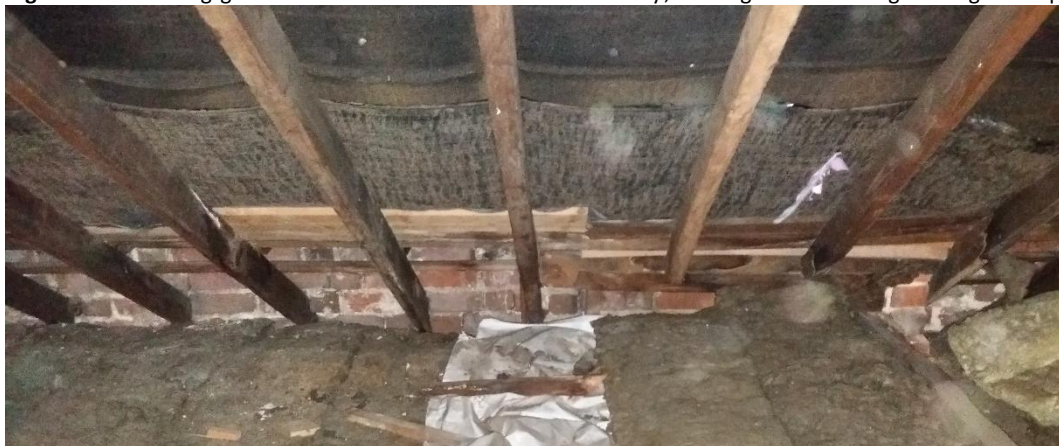
**Figure 8** – showing the wall-plate extending into the roof void, separating roof and eaves

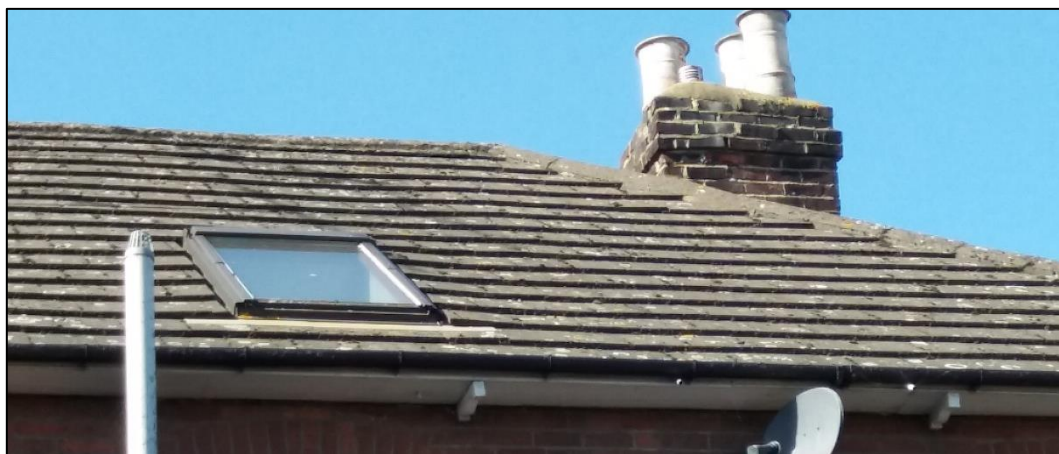
**Figure 9** – roof showing good condition of main and ridge tiles

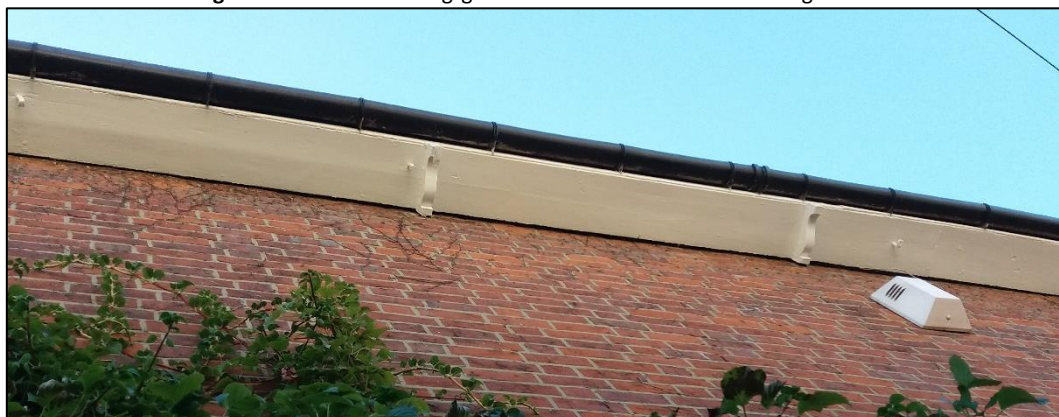
**Figure 10** – Image showing boxed eaves, with gap between wall and timber on rear elevation

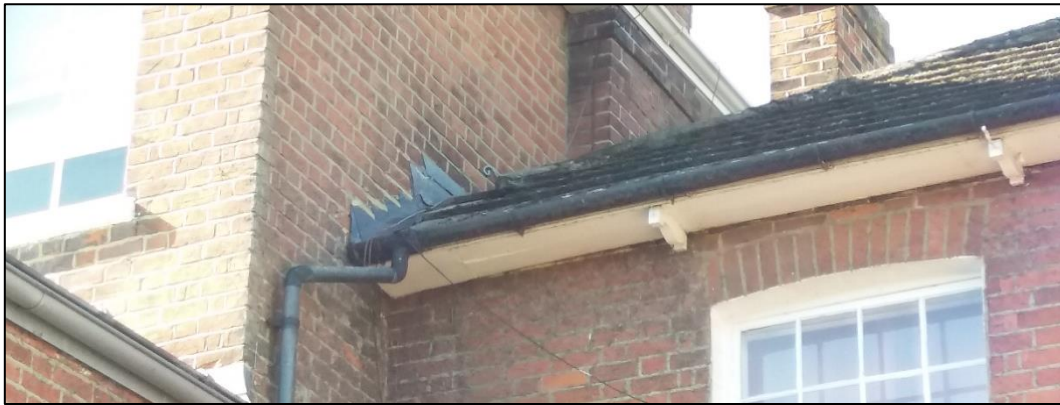
**Figure 11**– roof tiles, boxed eaves and flashing between the two buildings

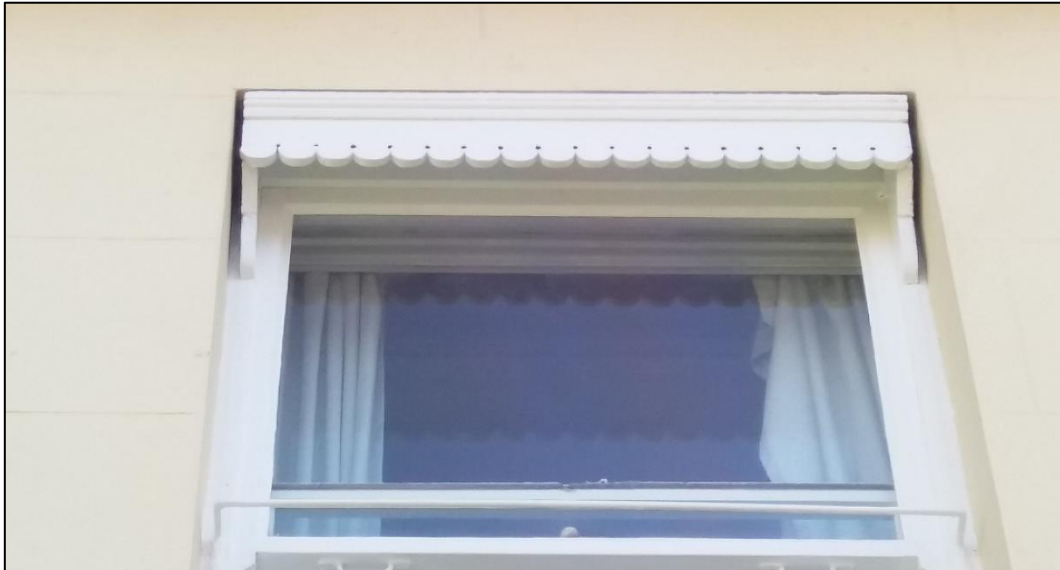
**Figure 12**– showing crevices between wall and window lintel on front elevation
