**Tree condition assessment**

**Walnut Cottage, 10 Shepherds Lane,  
Caversham, Reading, RG4 7JH**

Reference: J1159  
February 2019

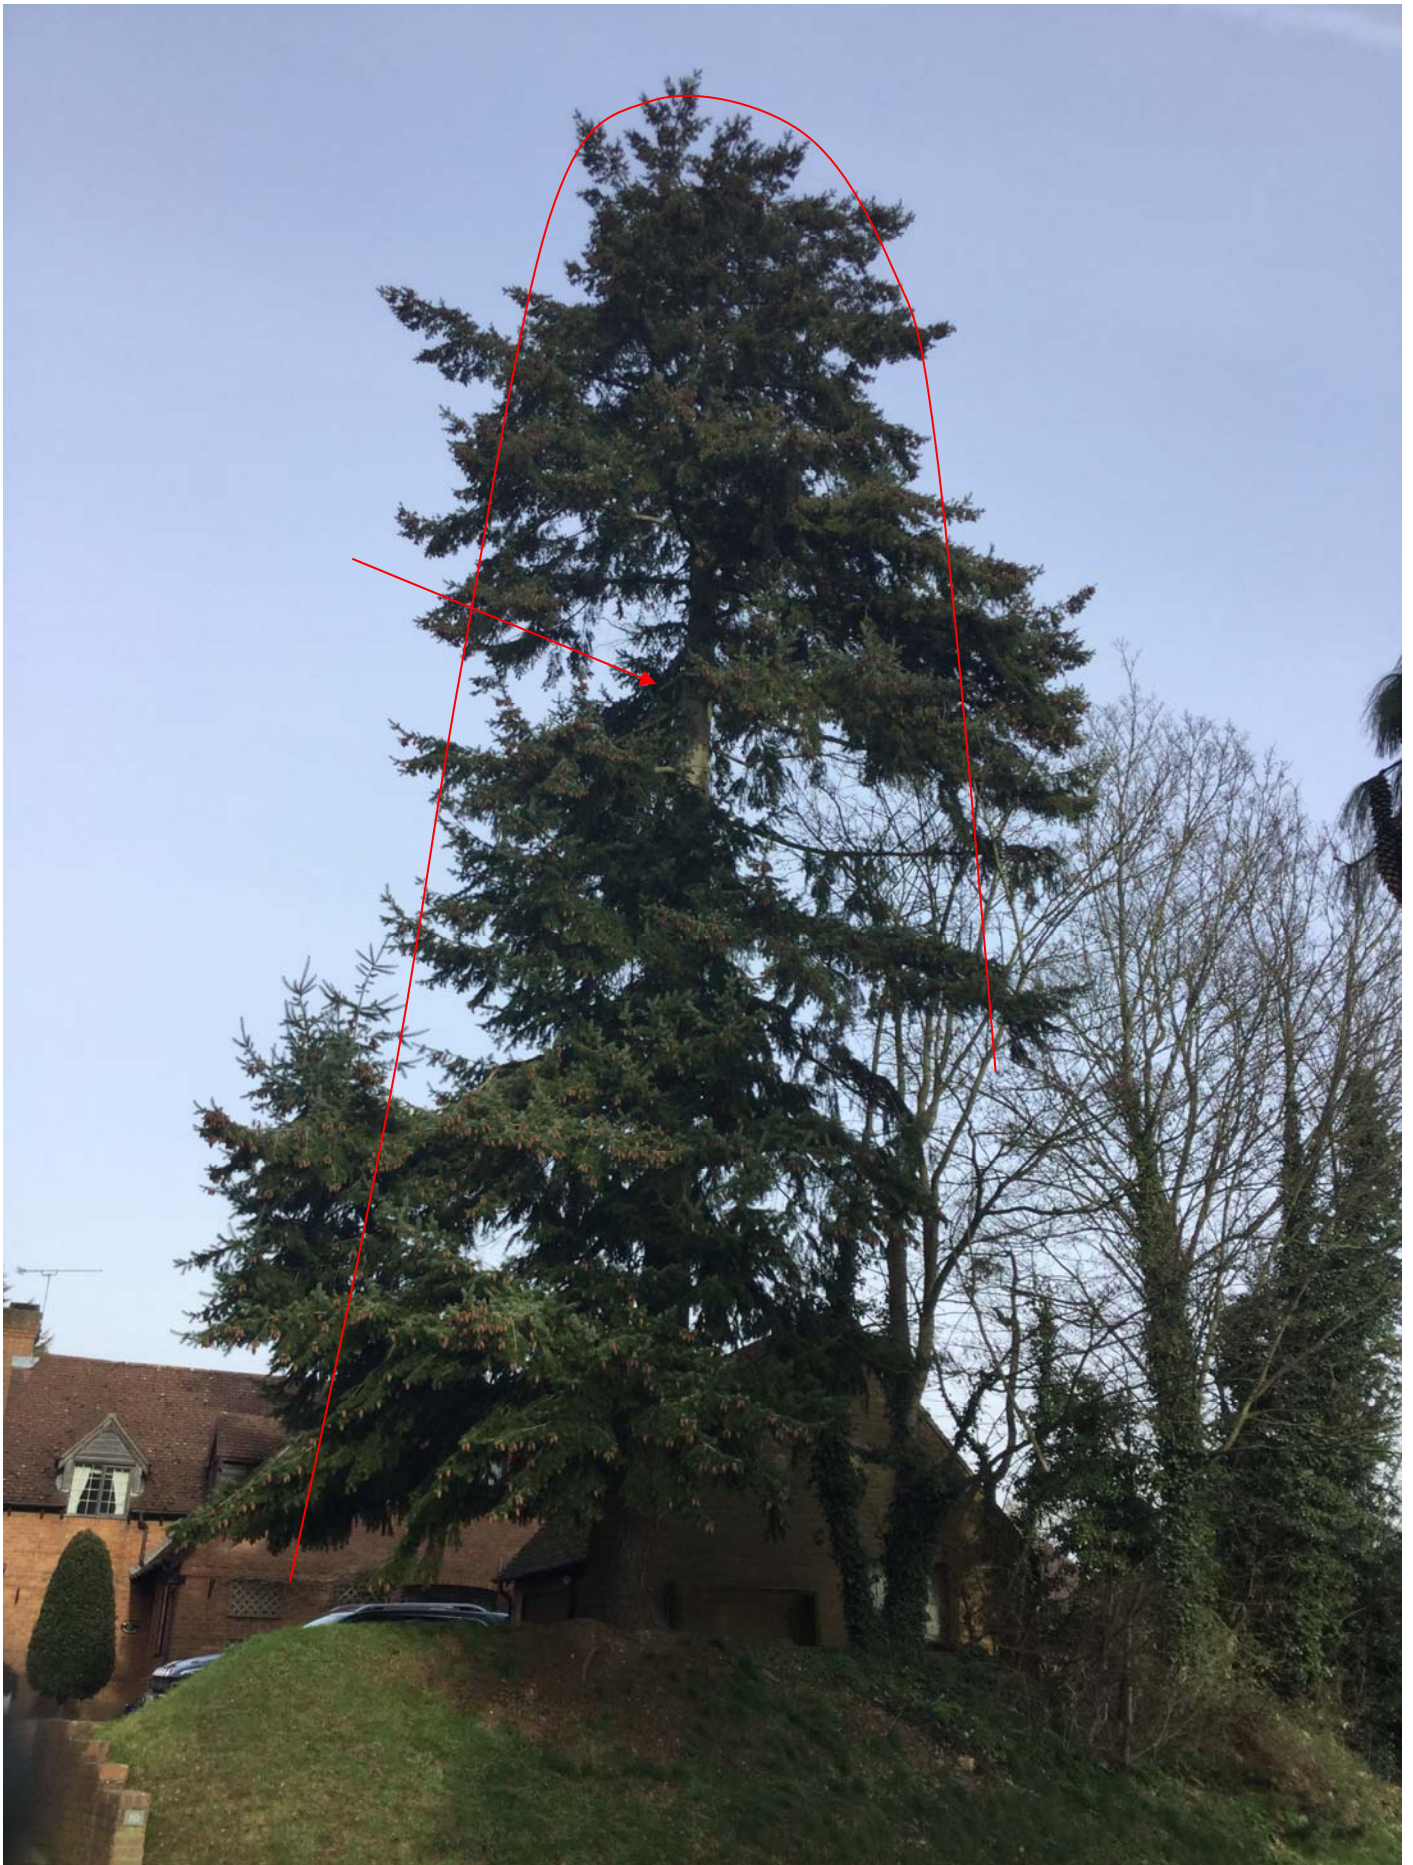
| No | Species | Height (m) | Crown spread (m) | | Age class |
|---|---|---|---|---|---|
| Physiological: Fair<br>Structural: Fair<br><br>Good vitality although slightly sparse and yellowing foliage in upper canopy.<br>Numerous leaders developing in upper canopy.<br>Twist in stem at c14m commensurate with historic damage to leader at that height and subsequent regrowth.<br>Numerous and frequent branch failures throughout, both historic and recent (including 1 branch c70mm diameter at c17m on East side and 1 branch c100mm diameter at c6m on West side) more frequent than typical for the species<br>New leader developing at c3m on West side.<br>Twist in lower stem at c2m with visible adaptive growth on underside.<br>On top of embankment.<br>Occasional roots exposed on embankment. | | | | | |

SAL1 T1 Douglas Fir with red line indicating anticipated selective tip reduction works. Twist in upper stem identified by red arrow.

| <p>1. Selective tip reduction of c40 overlong lateral branches all round to give a final height of 21m and 5m radial branch spread. Reason: to reduce potential for additional branch failures.</p> <p>2. Remove branches at c3m on West side over 150mm diameter. Reason: to remove developing new leader over adjacent access road.</p> <p>OR</p> <p>3. Remove tree. Reason: unsuitable tree species due to its condition, elevated on embankment and exposed position, limited rooting area, proximity within falling distance to footway, carriageway, dwelling, garage and car parking.</p> |

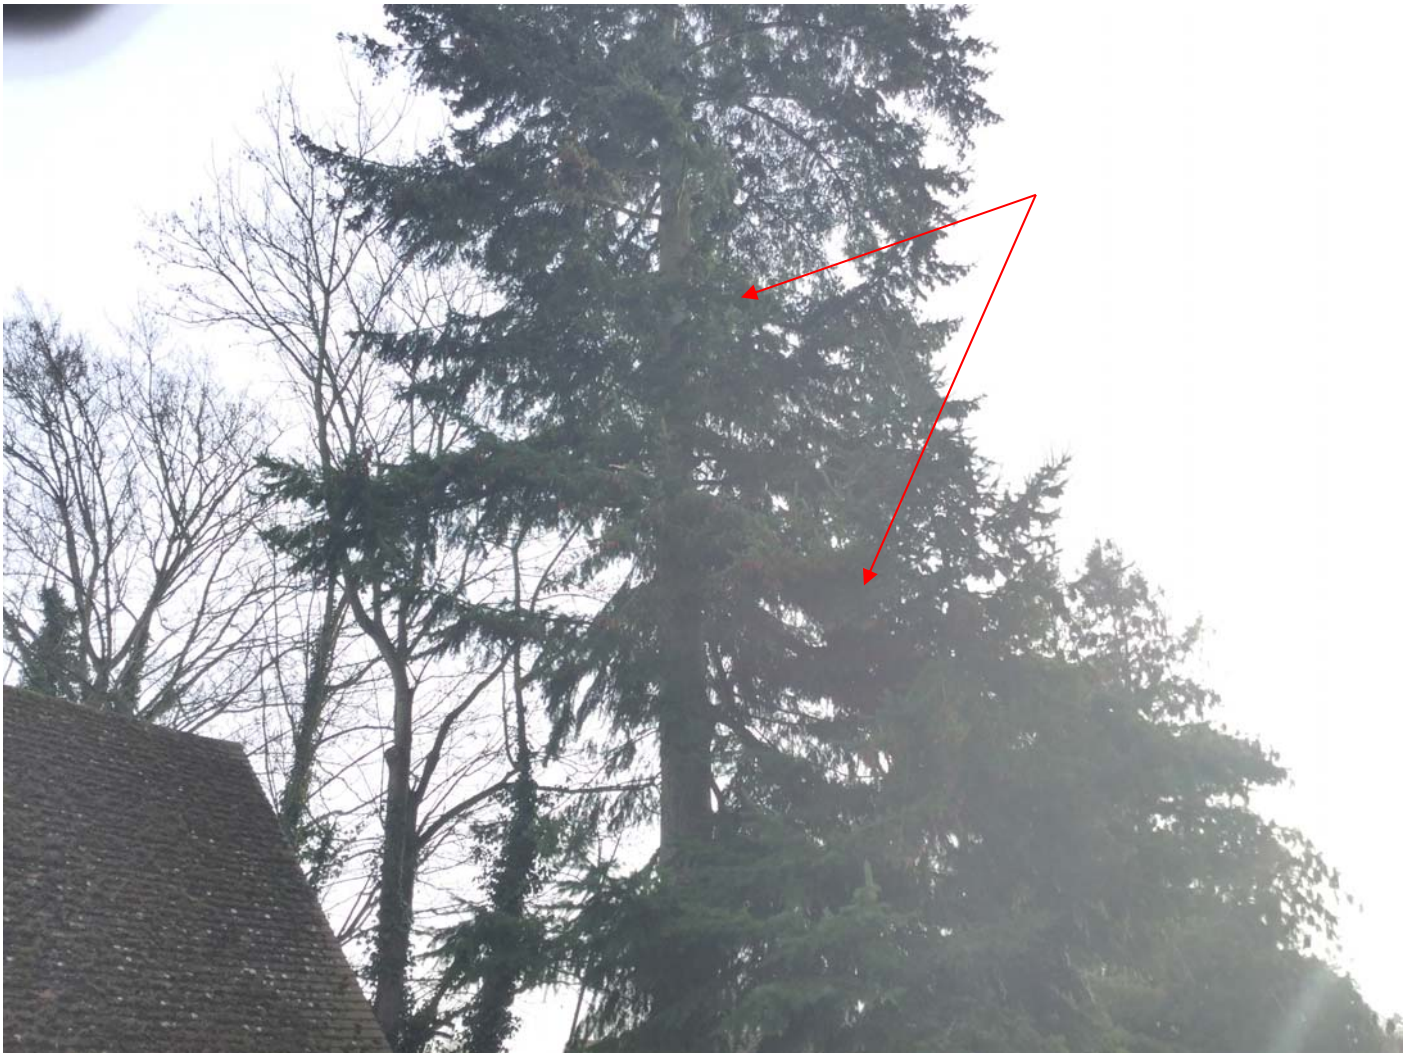
SAL 2 Approximate position of recent branch failures identified by red arrow.

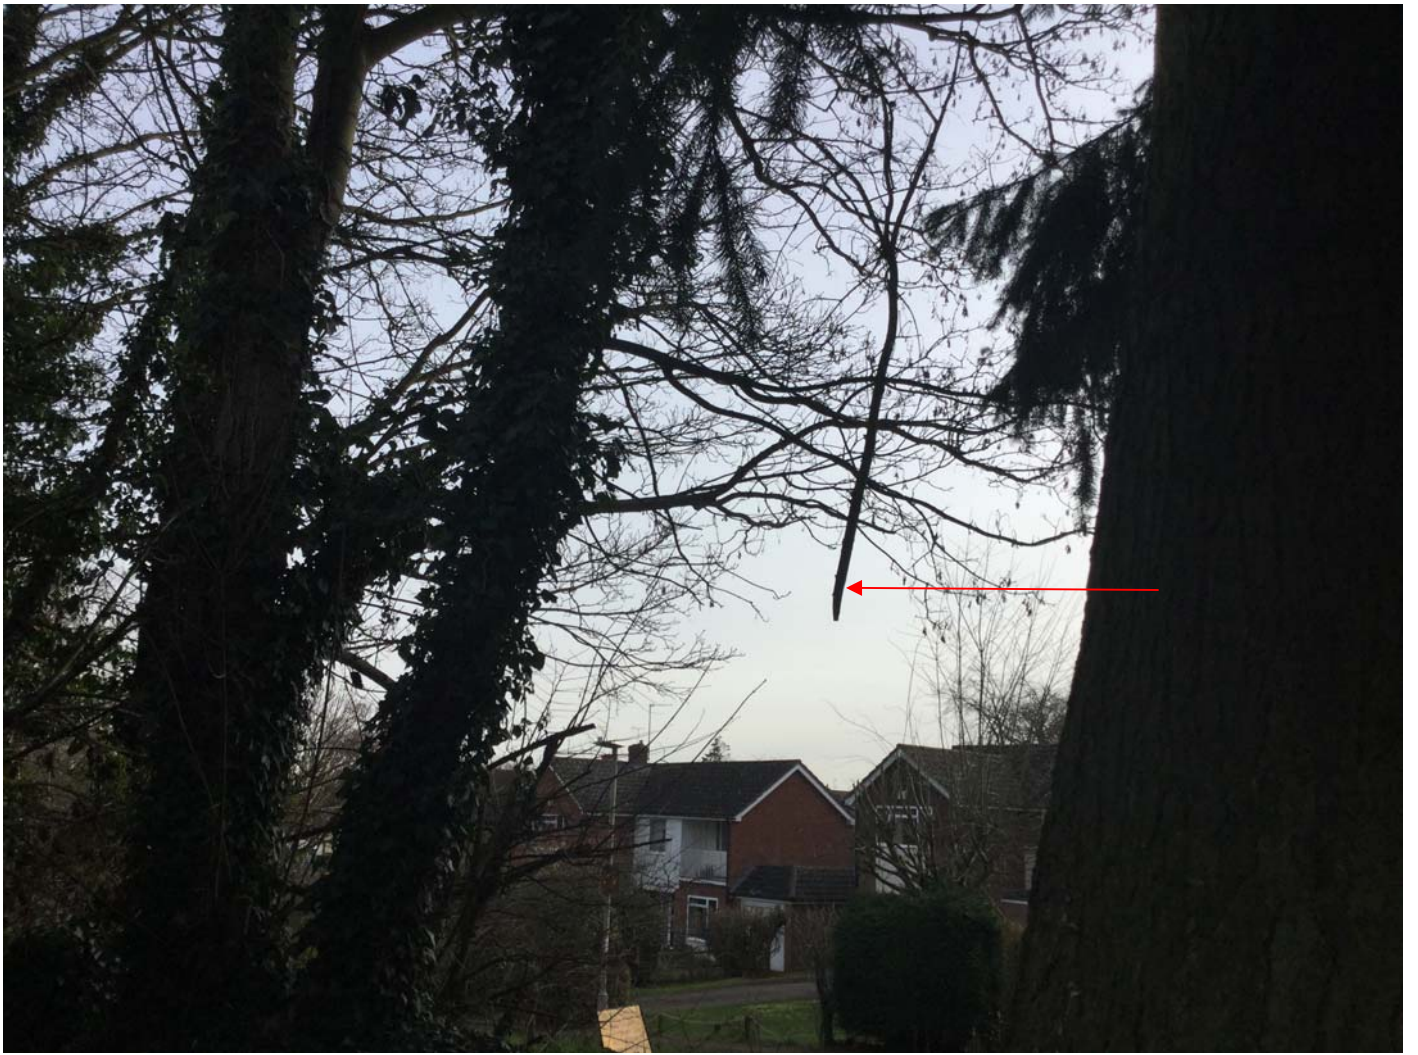
SAL3 Historic branch failure identified by red arrow.

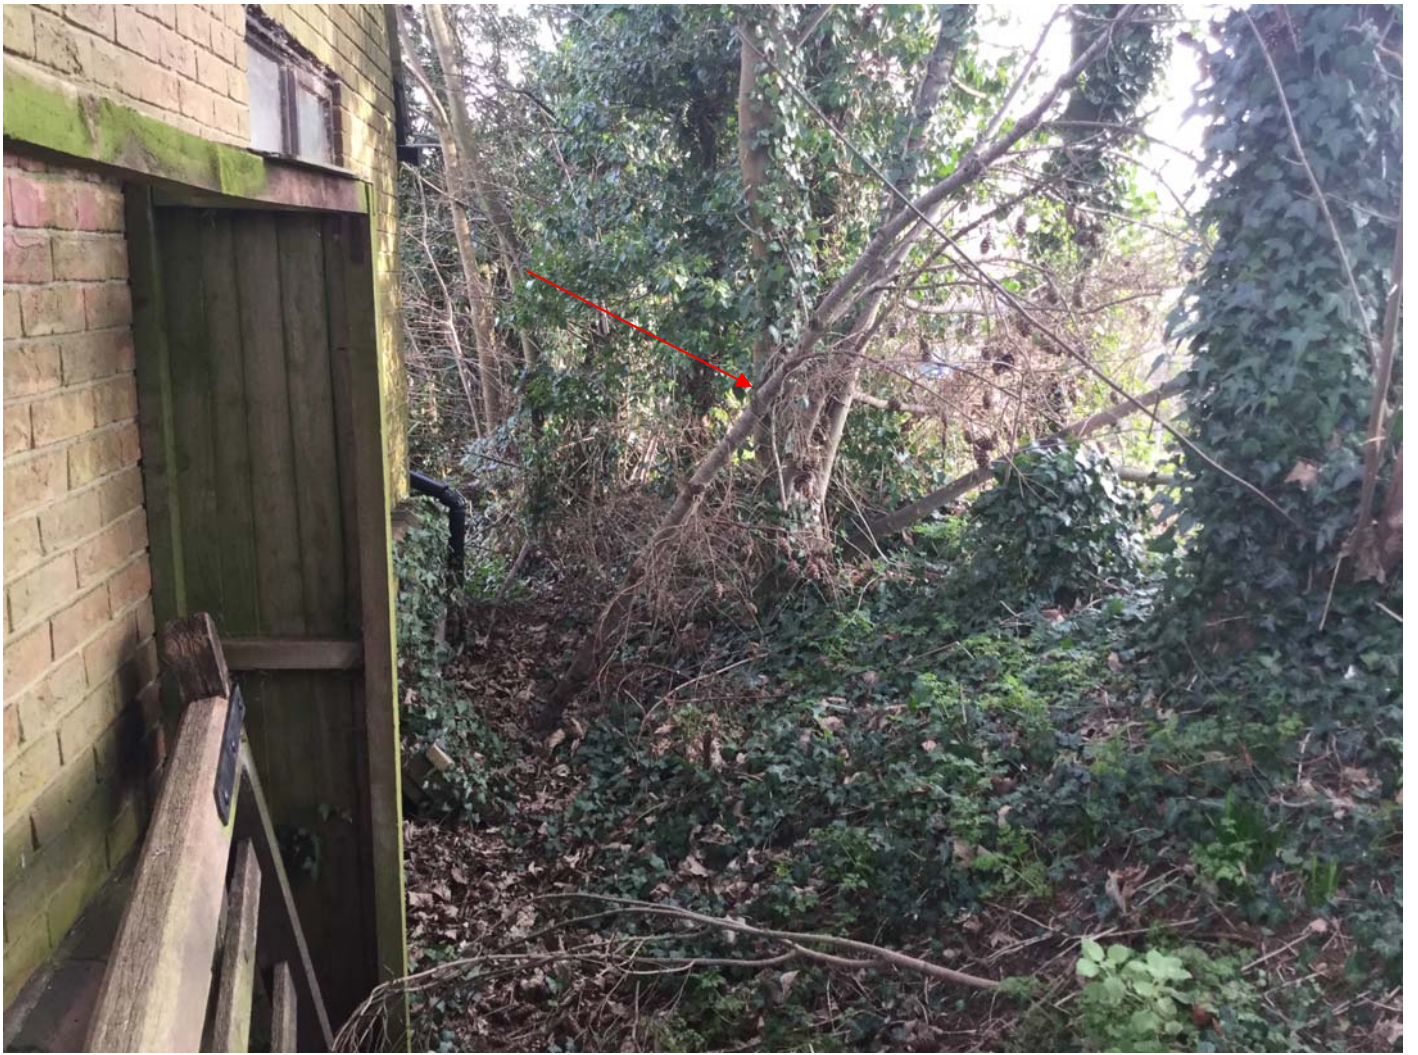
SAL4 Historic branch failure identified by red arrow.

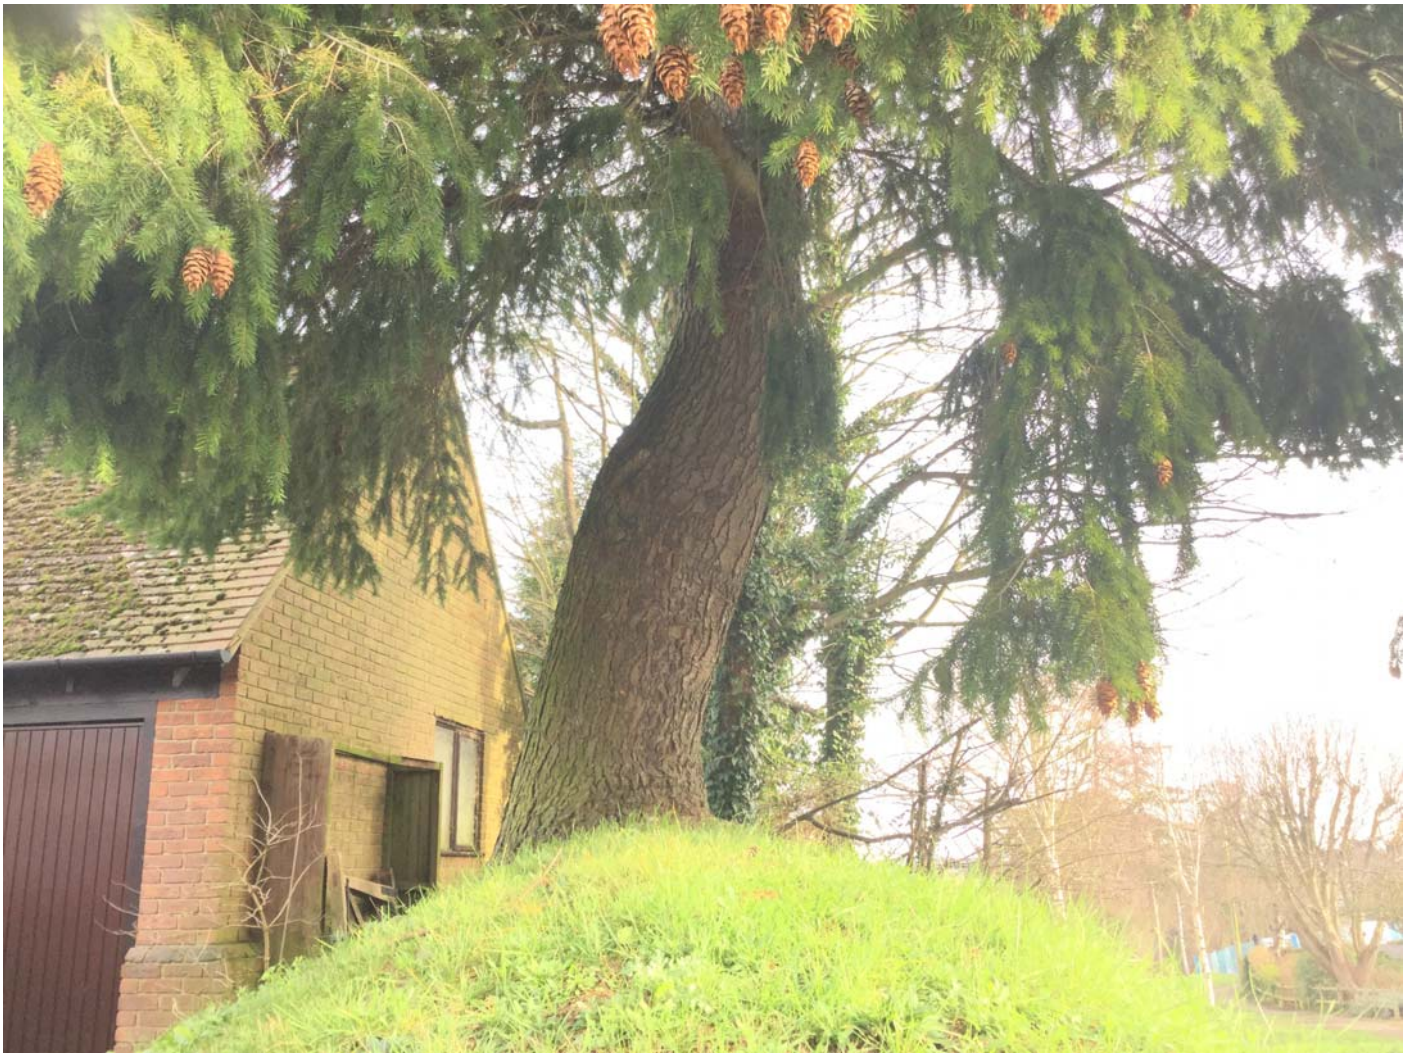
SAL5 Twist in lower stem.

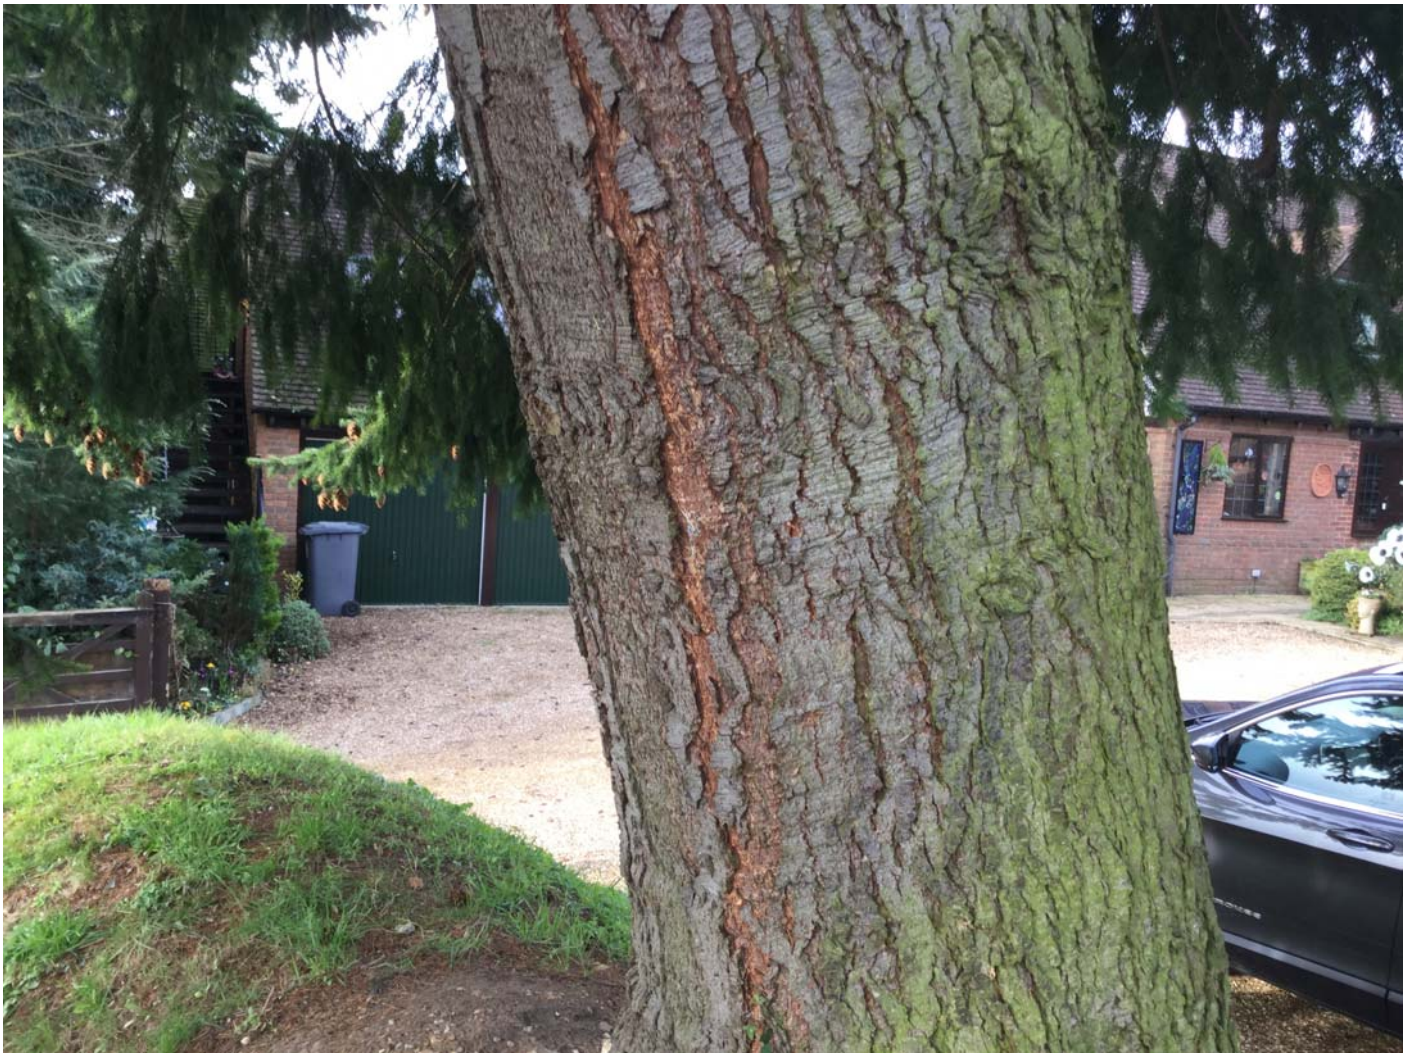
SAL6 Adaptive growth on underside of twist in stem identified by light tan coloured bark showing rapid growth commensurate of a mechanically overloaded area of the tree.

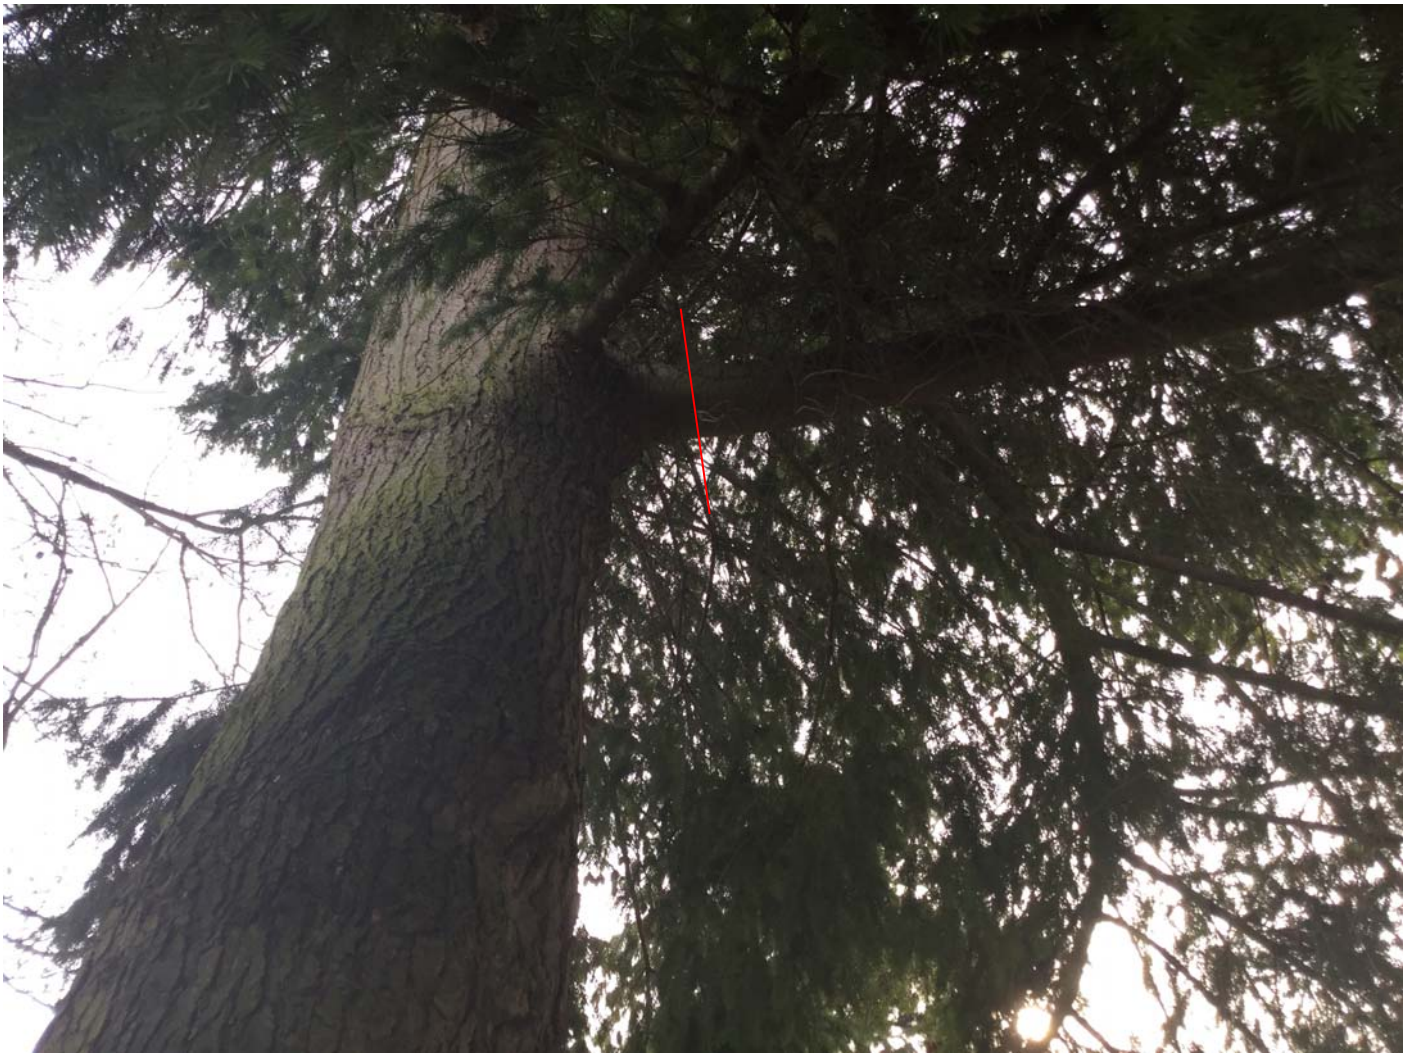
SAL7 Single first branch to the south west forming minor stem over the access road; to be removed.

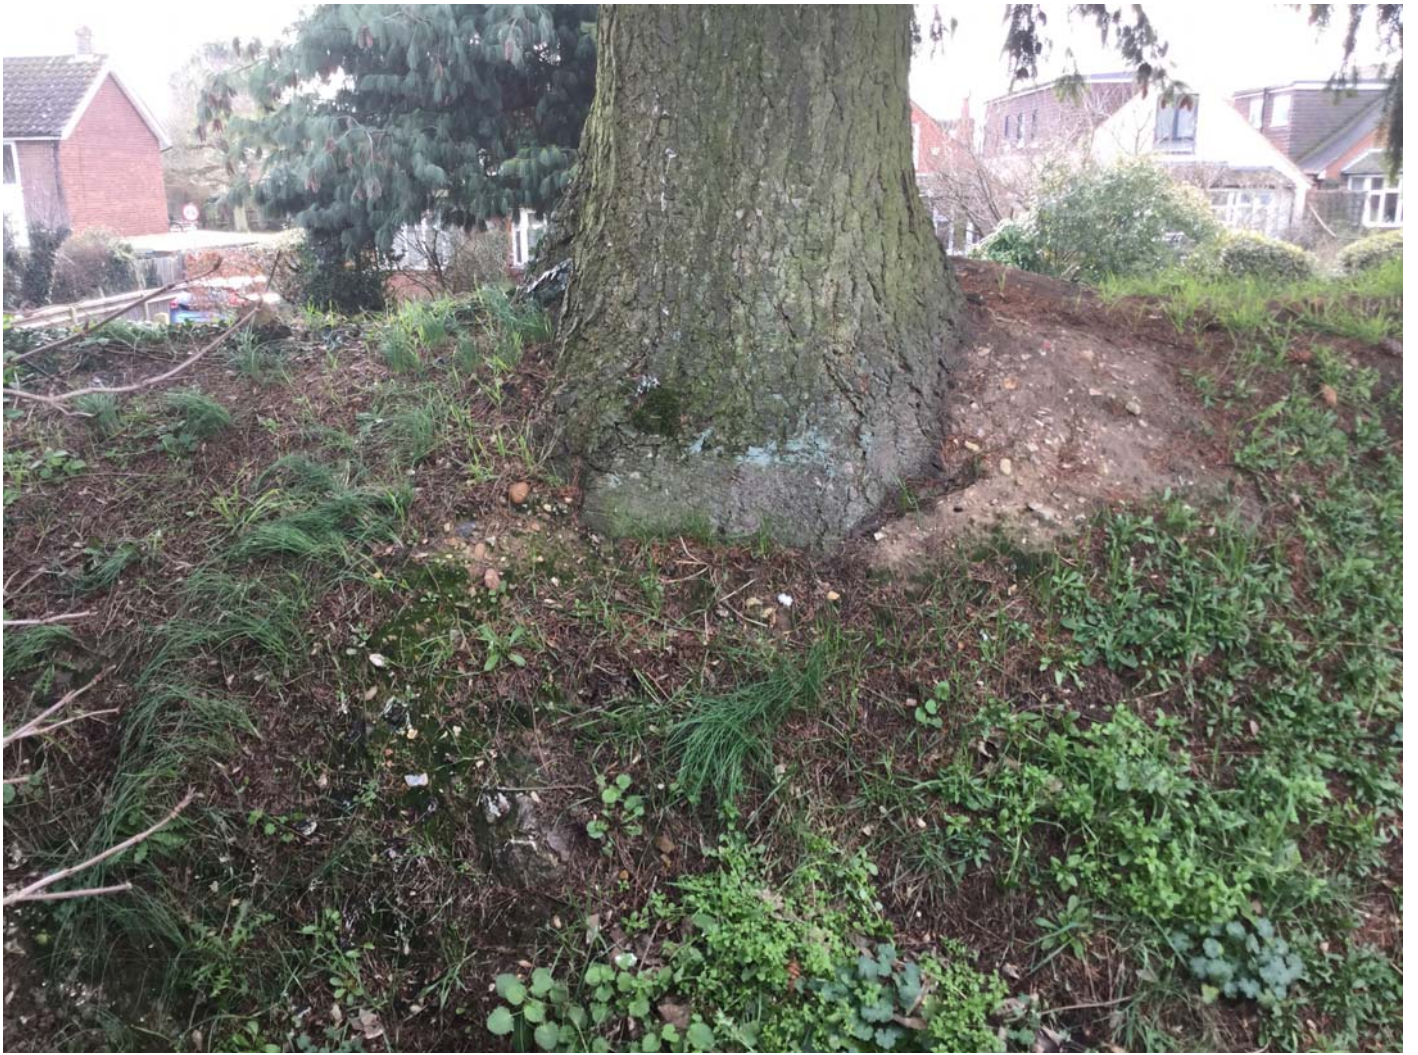
SAL8 Base of tree on ridge of embankment.
