# REPAIR STRATEGY REPORT

Job Description:  
 Scope: **Report on Strategy for Façade Stonework Repairs (Ref V2)**  
 Job Location: **Reading**  
 Stone Type: **Bath**  
 Finish: **Dressed, Rusticated.**

DATE: **03 September 2019**  
 REF: **J2362 / V2**  
 Revision: **0**

| Project<br><b>10 Eldon Road</b> | | | |

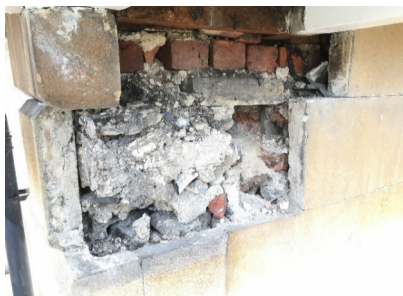
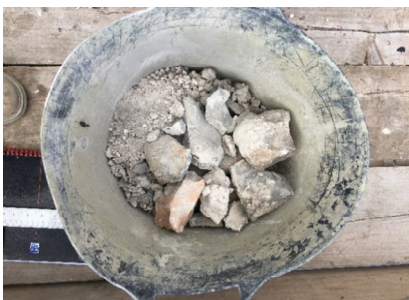
We had expected that the wall might feature some form of inner skin with a rubble fill between the inner and outer leaves of the wall, (possibly with the inner skin being formed of brick most likely). However, instead there appears to be no inner leaf at all, with the entire thickness of the wall beyond the outer skin being formed of mixed rubble fill which includes many small voids between the rubble elements but the matrix held together with some mixed-in cementitious slurry.

Three separate façade opening up areas all with rubble wall to full depth behind.

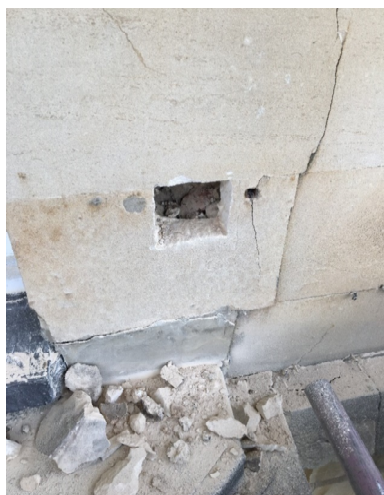
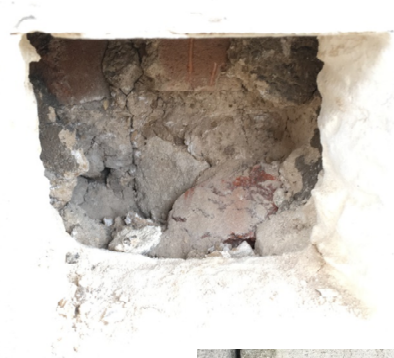
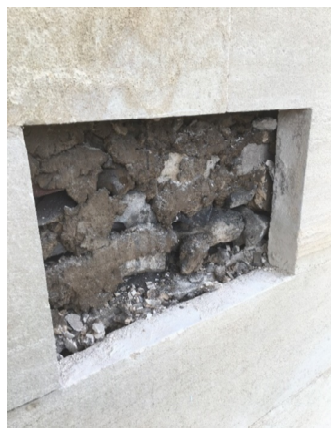
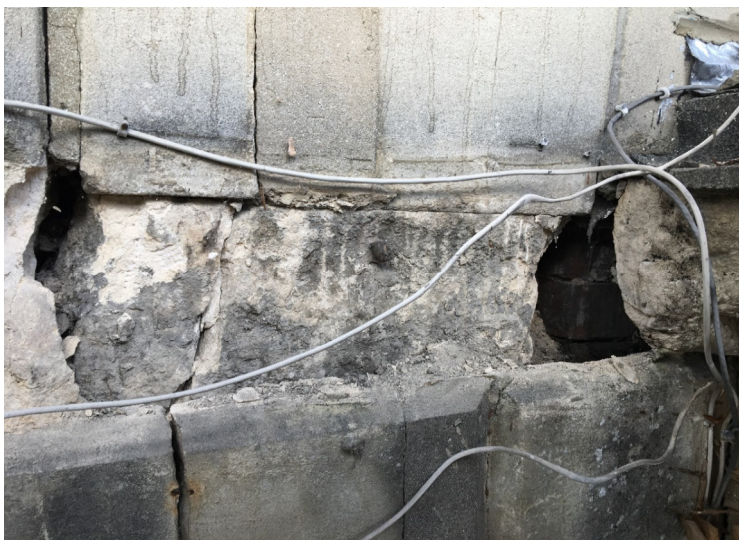
First floor string - face has split off and seems to be supported only on rubble infill, which appears to have settled down. Voids in area obvious.

Also, the Stringer / Band stones at first floor appears to have sheared off and settled. Originally they would have formed a capping / bridging stone linking the rubble inner core and the rusticated stone, hence forming some sort of tying-in function. Having sheared off, they appear to be supported by the rubble core only and this has pushed the rusticated skin outwards. This original function is very difficult to correct or replicate without dismantling the entire wall and rebuilding.

The first floor band / stringer will be capped with new stone which will be pinned onto the existing / remaining stone. Local pinning or stitching may be appropriate, and the treatment would be configured on further local inspection of the areas.

Special treatment for  
stringer stones: Pin a  
facing stone onto the  
remaining stub of original  
stone once concrete repair  
removed .

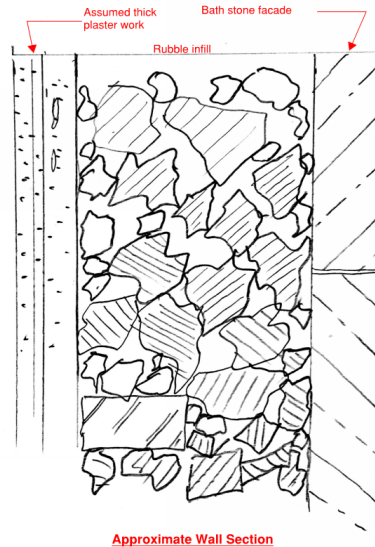
Wall is approximately 350mm thickness overall, including the inner plaster lining and the outer Bath Stone facade. The Bath Stone façade is approximately 60mm thick on the front elevation, perhaps 50mm on the rear elevation. There are occasional 'header' blocks which penetrate deeper into the facade (embedded into the rubble wall), but it is difficult to tell which, and the front elevation seems to have none other than the corner quoins and the window reveals. There are no metal ties or pins within the facade which is unusual.

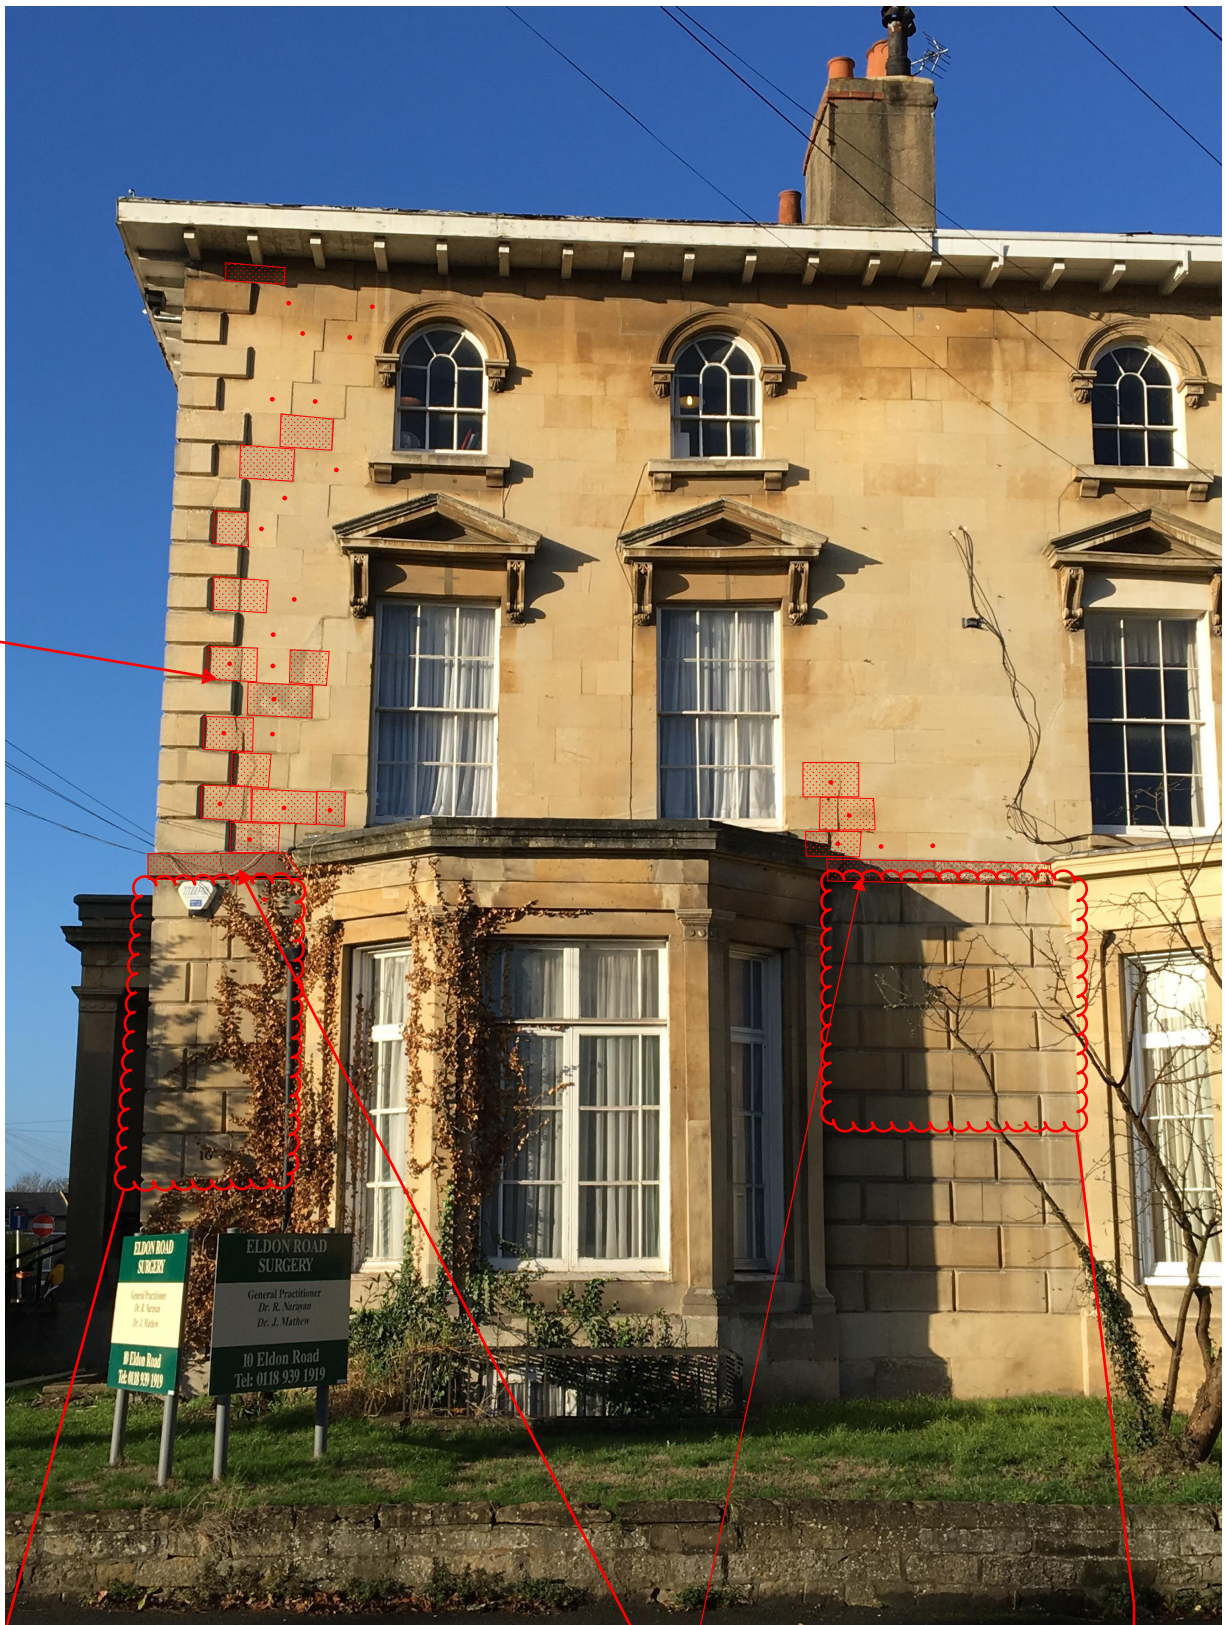
SK 1.1 Front Facade Repair pinning & panel replacements (principles)

Pin-back and replace  
individual panels in similar  
manner. Note that  
impossible to correct the  
lean/ out of plumb in this  
area using this method. So  
purely just stabilising in the  
current position

Pinned face  
(mortar repair  
over heads of  
pins).  
Replacement  
stone panels  
working top to  
bottom.

This section similar  
in principle to the above.  
(i.e. Replacing  
broken Stone &  
pinning back working  
top to bottom  
direction.
