**5 St Peter's Avenue  
Caversham  
Reading  
Berkshire  
RG4 7DD**

## **Preliminary Bat Roost Assessment**

**Ref: R2159/b**

**February 2019**

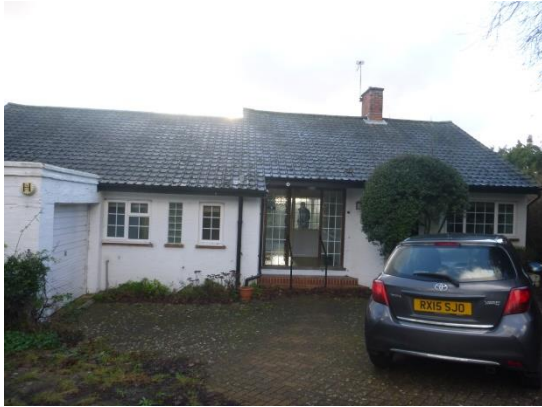
**3.2.1** The detached bungalow had two main pitched roofs and a rear terrace with stairs leading down to the garden and undercrofts. The garage was joined to the front of the bungalow and had a flat roof with brick parapets (**Photographs 1 & 2**).

1. Front of the bungalow viewed from the northeast.

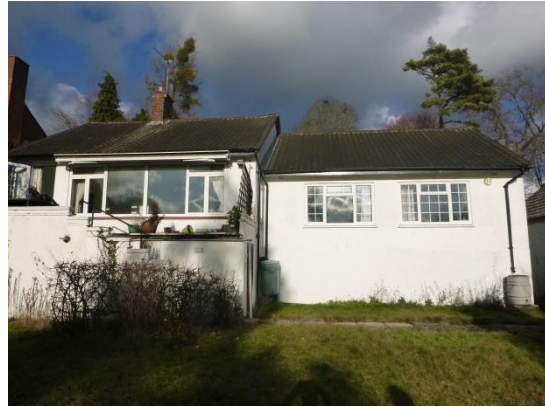
2. Rear of the bungalow viewed from the southwest.

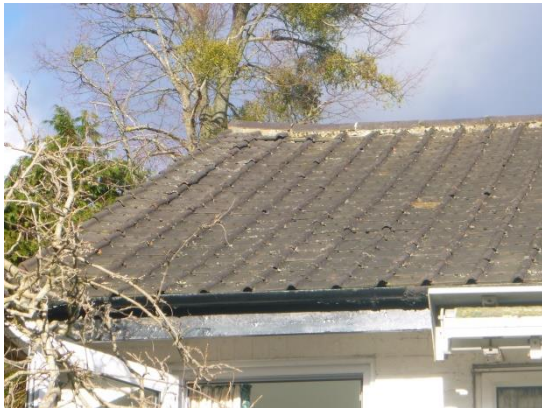
**3.2.2** The pitched roofs were covered with interlocking tiles that were intact and mostly tightly fitted; however, there were a few gaps under lifted tiles offering potential access and roosting opportunities to bats. On the rear elevation, there were several lifted roof tiles in proximity to the verge and ridge at the northwestern gable end and there were occasional small gaps under roof tiles on the slightly lower southeastern pitched roof (**Photographs 3 & 4; Target notes 1 & 2**). There were gaps under the bottom row of tiles but these were unsuitable for bats to access by the position of the guttering (**Target note 3**). Although ridgelines were uneven at the gable ends, the tiles were tightly fitted and the mortar was intact (**Photograph 5; Target note 4**). A roof tile was raised at the base of the chimney on the rear elevation offering a potential access opportunity for roosting bats but the lead flashing was tightly fitted to the roof tiles (**Photographs 6 & 7; Target notes 5 & 6**).

3. Gaps under tiles in proximity to the verge and ridge at the northwestern gable end (rear elevation).

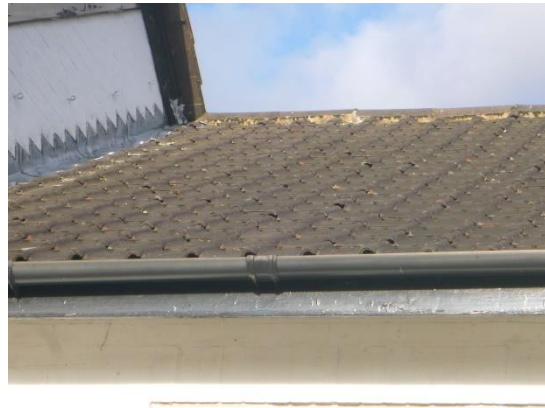
4. Occasional gaps under roof tiles on the southeastern pitched roof (rear elevation).

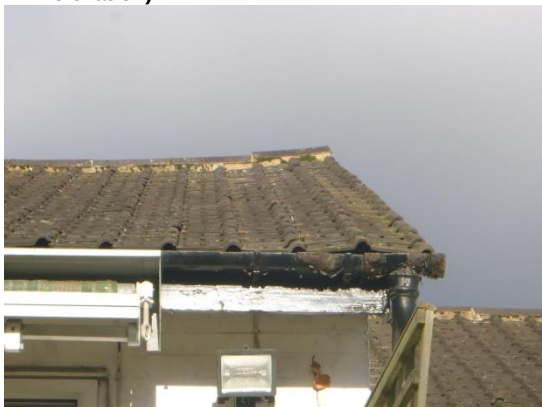
5. Ridge tiles tightly fitted with mortar intact (rear elevation).

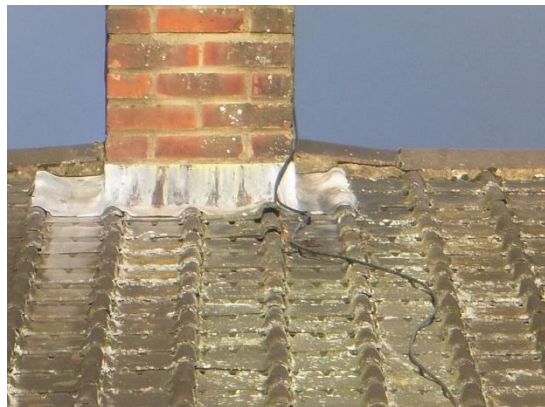
6. Lifted roof tile at the base of the chimney (rear elevation).

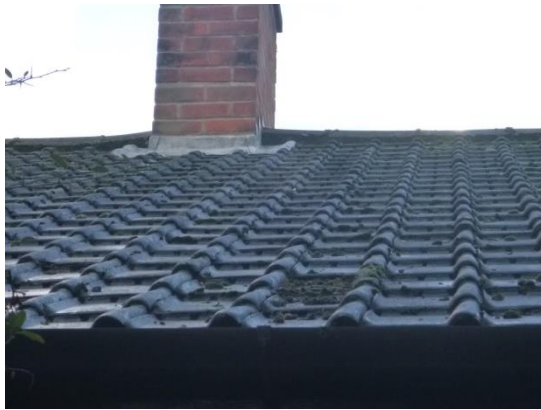
**7. Lead flashing tight around chimney (front elevation).**

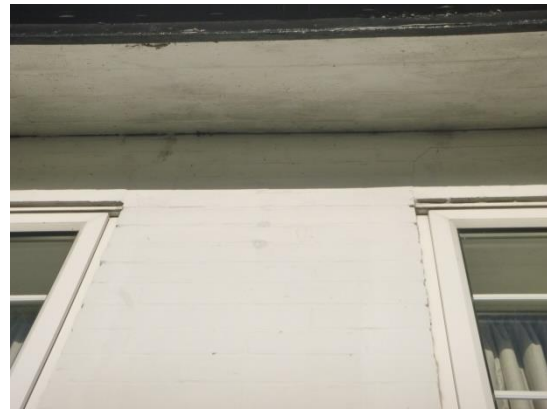
**3.2.3** On the rear elevation, there were narrow gaps between the overhanging eaves and the external wall (**Photograph 8; Target note 7**). A small open-ended cavity was formed between the window and eaves on the front elevation (**Photograph 9; Target note 8**). There was a gap behind the barge board on the southeastern gable end and multiple gaps under the barge board on the northwestern gable end, offering a number of roosting opportunities to bats that typically occupy crevices (**Photographs 10 & 11; Target notes 9 & 10**). The western corner of the house, behind the terrace,

**8. Narrow gap behind overhanging eaves (rear elevation).**

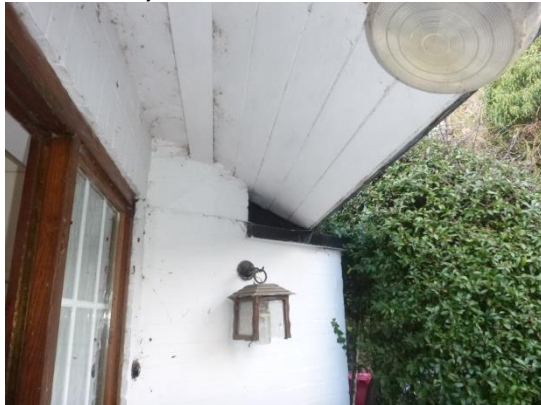
**9. Small open cavity between the window and eaves (front elevation).**

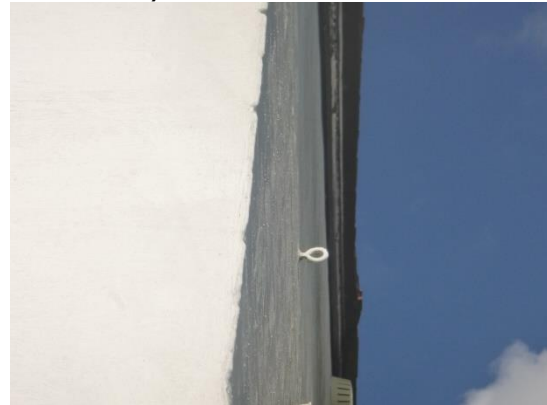
**10. Gap under barge board on the southeastern gable end.**

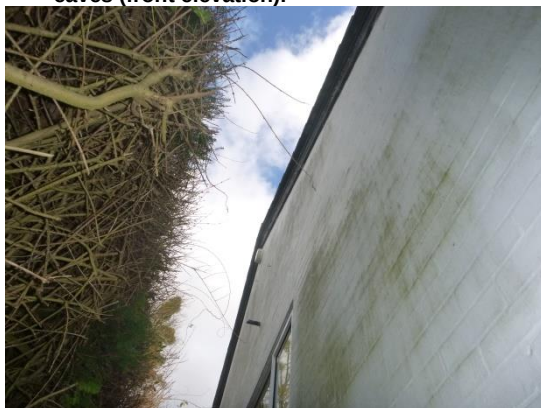
**11. Multiple gaps behind barge board on northwestern gable end.**

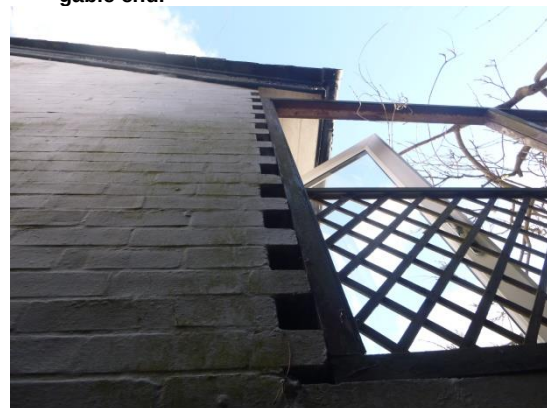
had missing bricks as a design feature which offered no suitable crevices for bats (**Photograph 12**).

**12. Missing bricks on western corner of house.**

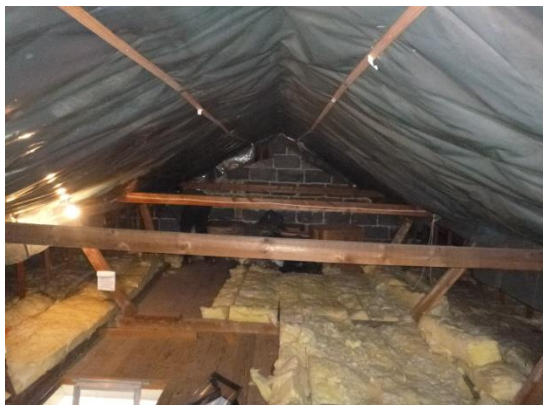
- 3.3.1** The property had one roof void covering the entire footprint, and this was accessible via a loft hatch located on the eastern side of the bungalow (**Photograph 13**). The void was split into two sections by an old external part-brick, part-blockwork wall with a central area removed to allow access throughout (**Photograph 14; Target note 12**). The void had an approximate floor-to-ridge height of 3 metres and both roofs were of 'cut and pitch' construction. The roofs were lined with a plastic sheeting which covered the original, and now disintegrating, bitumen-and-hessian style roofing felt (**Photograph 15; Target note 13**). The plastic sheeting stopped short at the eaves and exposed the original roofing felt and the underside of roof tiles with daylight visible (**Photograph 16; Target note 14**).

**13. Eastern section of roof void viewed from the old external wall.**

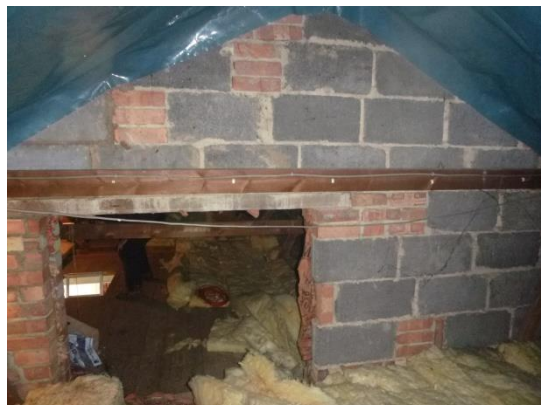
**14. Old external wall in the centre of the roof void.**

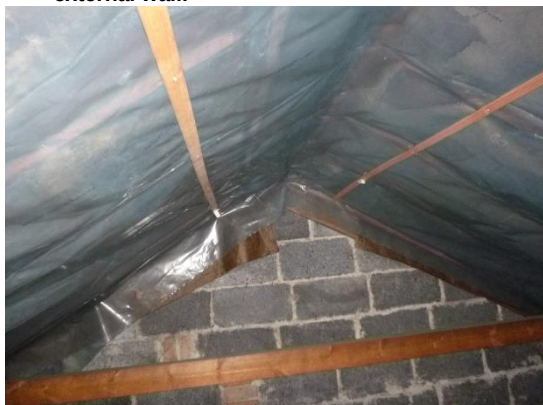
**15. Plastic sheeting covering the old bitumen style roofing felt.**

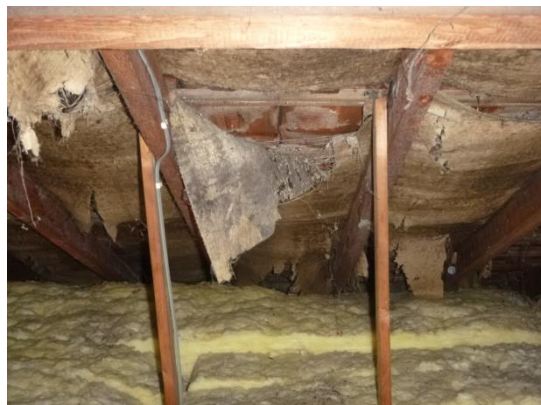
**16. Old bitumen roofing felt exposed near the eaves.**

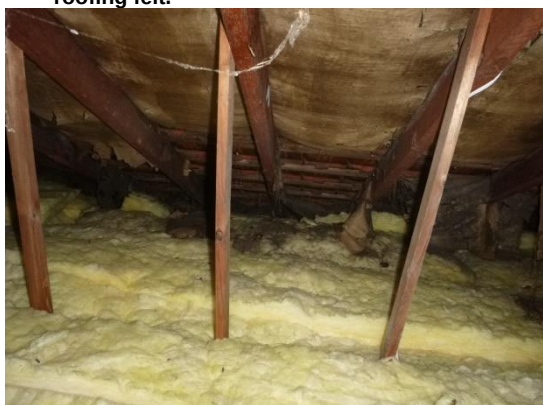
- 3.3.2** In the eastern section, the floor was boarded centrally and with fibreglass insulation (installed in 2009) at the sides; the western section had fewer boards and more fibreglass insulation (**Photograph 17; Target note 15**). The chimney brickwork was rendered and an old wasps' nest was present on its western side where tiles were exposed by the old roofing felt; a raised water tank was situated on the eastern side of the chimney and a large covered water tank sat adjacent (**Photographs 18, 19 & 20; Target notes 16 & 17**). The gable ends were of blockwork construction with a cavity wall that had been insulated with old paper. The southeastern gable end had gaps behind rafters that were filled with paper insulation; daylight was visible through gaps in the paper at the northwestern gable end (**Photographs 21 & 22; Target note 18 & 19**). Rat droppings were scattered throughout the roof void.

**17. Fibreglass insulation in the western section of roof void.**

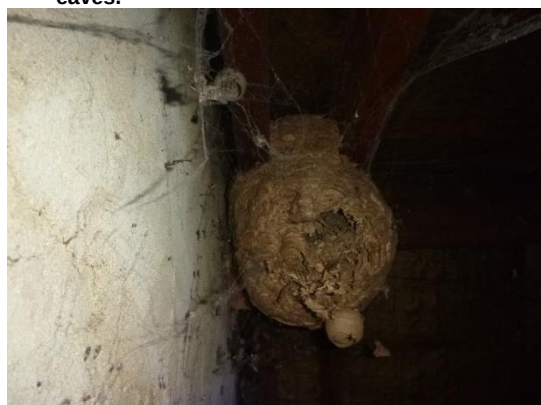
**18. Wasps' nest on the western side of the chimney.**

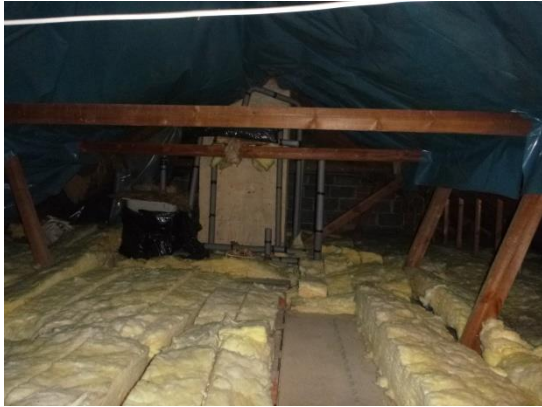
19. Chimney in the western section of the roof void with two water tanks.

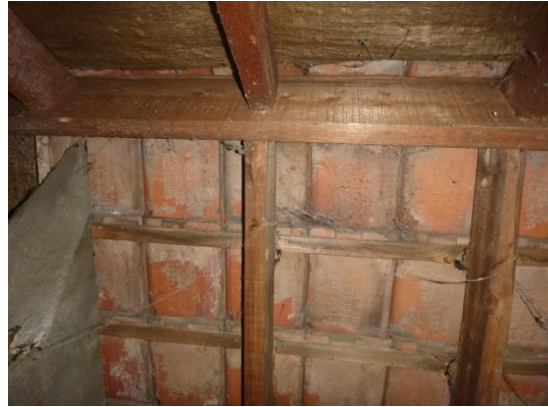
20. Exposed roof tiles west of the chimney.

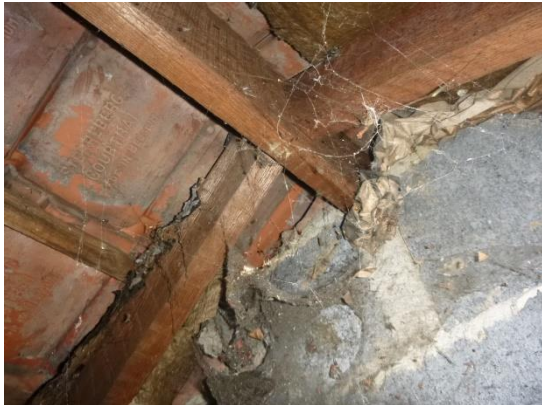
21. Blockwork wall at northwest gable end – cavity insulated with paper but daylight visible through gaps.

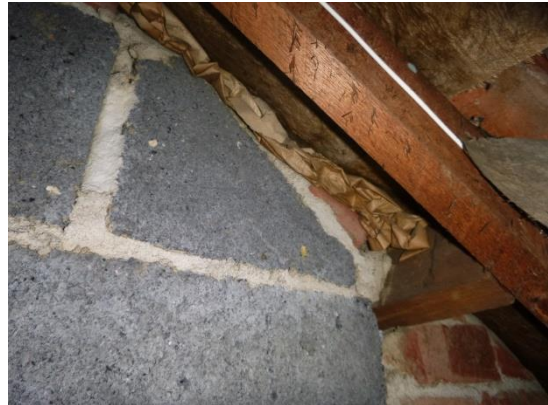
22. Edge of wall behind timber rafters insulated with paper.

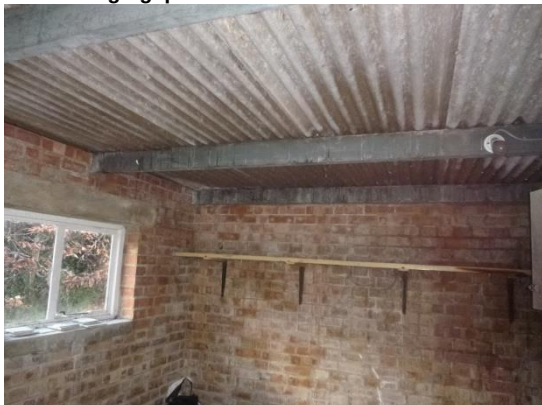
- 3.3.3** The garage was of single-skin brick construction with a corrugated asbestos roof visible from the internal space (**Photograph 23; Target note 20**). There were two windows and a lack of features suitable for roosting bats (**Target note 21**). The two undercrofts were built into the terrace and lacked features suitable for roosting bats (**Photographs 24 & 25**).

23. Internal garage space.

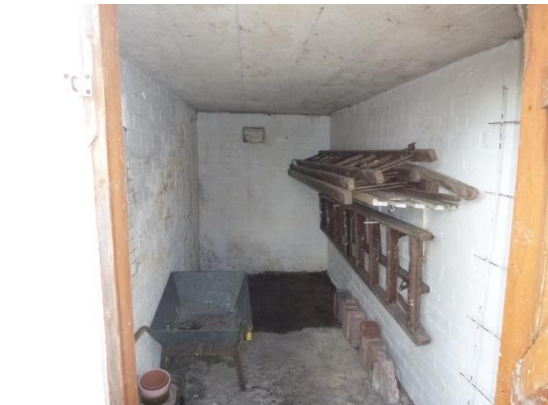
24. Eastern undercroft.

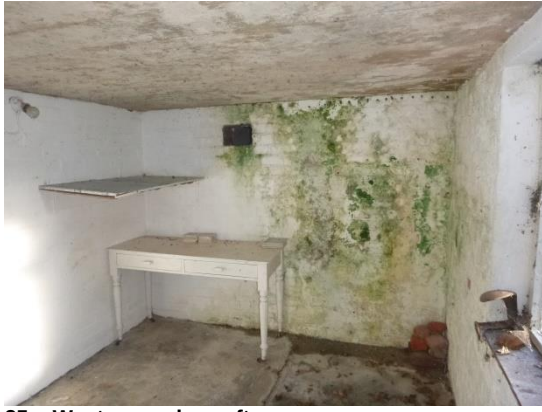
25. Western undercroft.
